April 23, 2016

Re: 13927 SE 22nd St.
Bellevue, WA.

REPORT SUMMARY

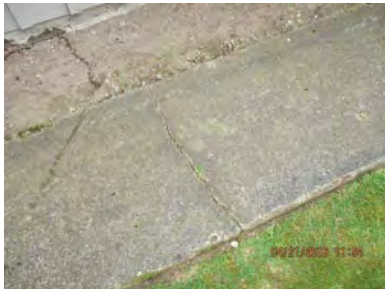
1. The walkway has cracked and settled differentially. This was probably caused by inadequate preparation of the soil prior to the placement of the concrete. This condition can be repaired by pressure grouting the sunken portion of the walkway or by removing and replacing it. The walkway remains functional despite this condition. However, the raised edges of the concrete can be a trip hazard for some people. Repairs should be made as necessary.

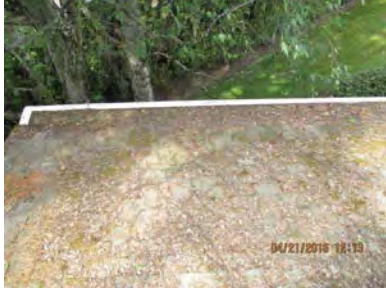
3.5 GUTTERS AND DOWNSPOUTS

2. There is a build-up of organic debris in the gutters. Proper maintenance of gutters and downspouts is essential and should be performed routinely in order to prevent clogging. Maintenance consists primarily of keeping leaves and other organic debris out of the system. Failure to clean the gutters will result in water splash on the building when they overflow. Gutters can be damaged from the water build up and organic matter blocking the gutter. Gutters should be cleaned as necessary to maintain a free flow of water into the downspouts.

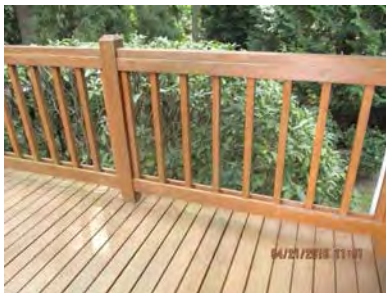
3.8 DECK RAILINGS

3. The spacing between the balusters is too wide. This is a hazard to small children. The balusters should be spaced close enough together so that a 4" sphere cannot pass through. Upgrading the deck railing is recommended if small children are present.

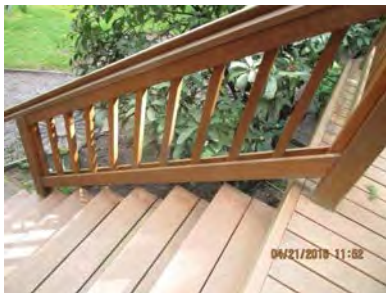
3.9 STAIRS

4. The stair railing baluster spacing is too wide. This is a hazard for small children. The baluster spacing should be reduced as a safety upgrade. Current standards require that a 4" sphere not pass through the railing.

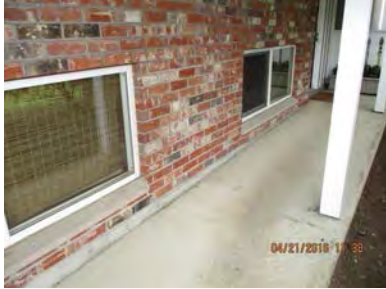
3.12 EXTERIOR WINDOWS

5. The lower window glass is not labeled as tempered safety glass. The existing glass is nonconforming by current building standards and would be hazardous if broken. The installation of safety glass is recommended as a safety upgrade for all windows less than 18" from the walking surface.

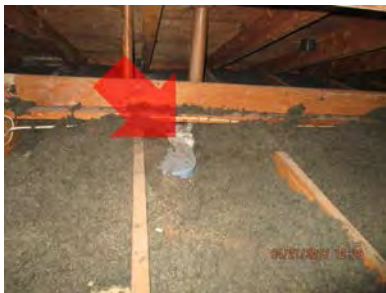
5.3 MECHANICAL VENTILATION SYSTEMS

6. The bathroom vent fan discharges in the attic rather than outside. This is an undesirable condition that causes excessive moisture in the attic and can result in mold or fungus growth. A 4" smooth-wall sheet metal duct should be installed to direct the moisture laden air discharged from the fan out of the attic.

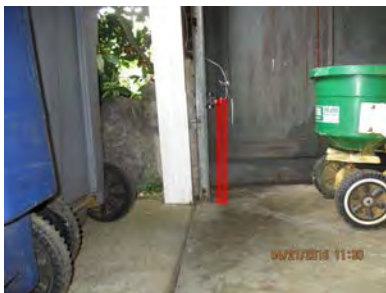
7. The Photo-eye beam was installed to high above the floor of the garage to adequately offer protection for small children and/or pets. We recommend that the photo-eye be lowered to within 4-6" of the floor.

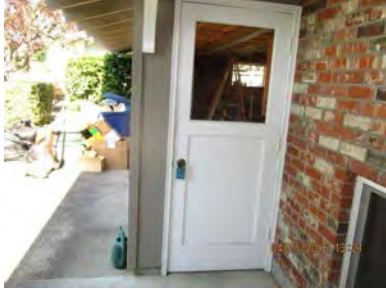
9. The glass in the garage door is not tempered safety glass. Tempered glass can be identified by the etched emblem in one corner of each pane. A higher margin of safety could be achieved if the glass was approved safety glass. Consideration should be given to replacing the glass as a safety upgrade.

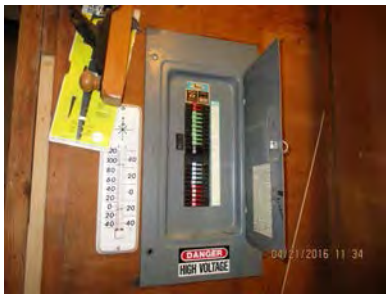
11. The main service panel was manufactured by Zinsco. Zinsco panels and circuit breakers have not been manufactured for some time, and some Zinsco circuit breakers have been known to fail to trip at their rated amperage. The panel and circuit breakers are considered a latent hazard and can fail leading to electrical fires. Replacement of this panel is recommended as a safety upgrade.

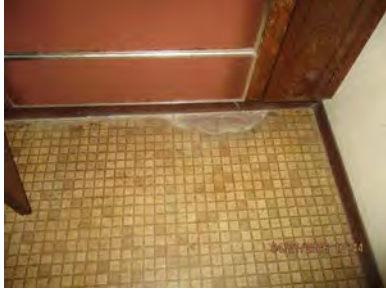
15. The vinyl flooring is torn and damaged and is nearing the end of its service life. Flooring replacement is recommended.

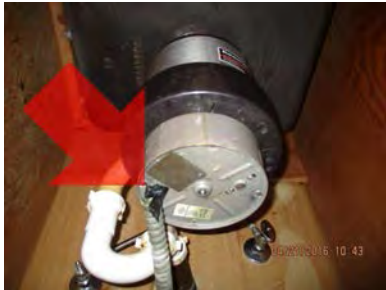
18. The garbage disposal is not working. It should be repaired or replaced as necessary.

The cord is not clamped where it enters the disposal. This could damage the wires or cause a ground fault. The cord should be clamped in accordance with industry standards.

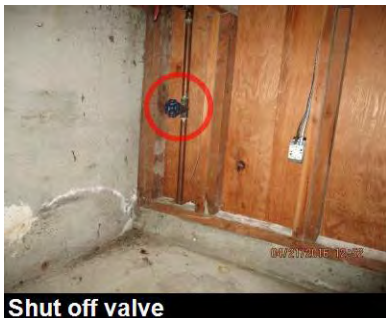
Shut off valve

19. The shut off valve did not shut the water off completely. It should be repaired or replaced as necessary.

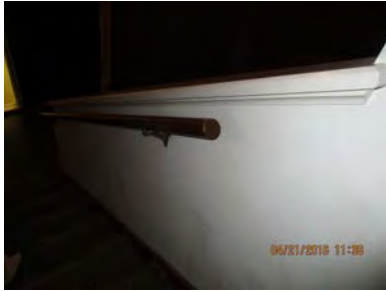
20. The stairs were used several times during the inspection. The stair components are properly installed however one railing deficiency was noted during use. The railing ends do not return to the wall. This is a safety hazard. The installation of a continuous handrail should be considered as a safety upgrade.

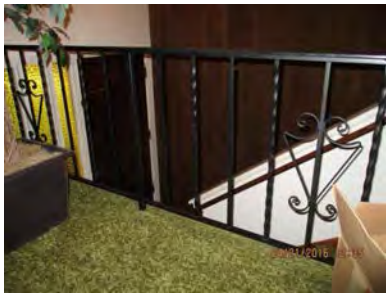
14.4 GUARD RAILINGS

21. The spacing between the balusters is too wide. This is a hazard to small children. The balusters should be spaced close enough together so that a 4" sphere cannot pass through. Upgrading the guard railing is recommended if small children are present.

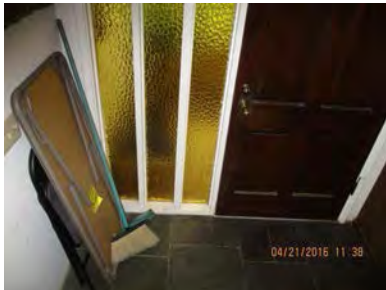
14.8 WINDOWS

22. The stairway landing window glass is not labeled as tempered safety glass. The existing glass is nonconforming by current building standards and would be hazardous if broken. The installation of safety glass is recommended as a safety upgrade.

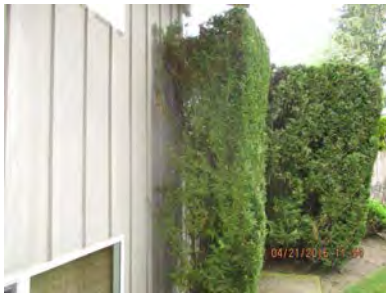
2. Trees are touching the building on the east side. Low hanging tree branches can damage the roof. Tree branches should be trimmed back where necessary.

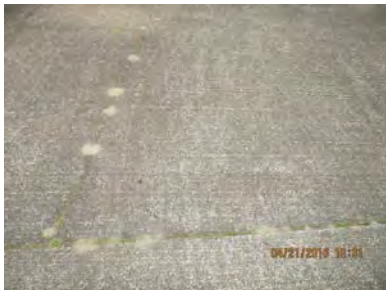
2.4 DRIVEWAY

3. Cracks were observed in the concrete surface of the driveway. Minor cracks can be sealed to minimize moisture entry and further settlement of the concrete. Minor cracks are common and do not affect the serviceability of the concrete.

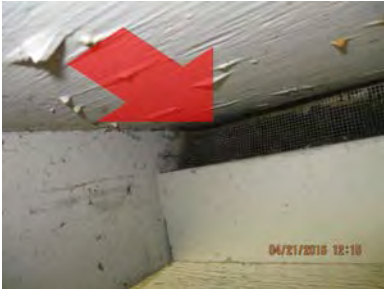
4. There is a loose soffit vent cover on the front of the house. The vent cover should be secured to prevent insect, bird and rodent entry.

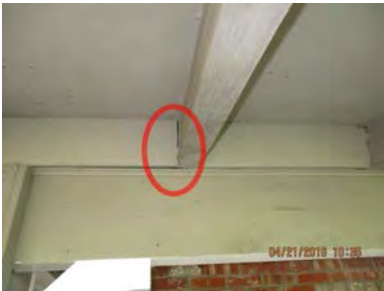
5. There are large gaps over 1/4" in size adjacent the soffit vent blocks. These gaps allow insects and rodents to enter the attic. Covering the gaps with screening, a strip of wood and/or caulking is recommended.

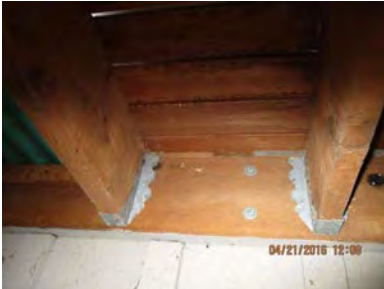
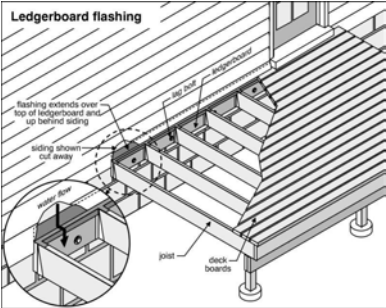
6. There is no flashing at the intersection between the deck and house. This will allow water to enter behind the siding. The installation of flashing in this area is recommended.

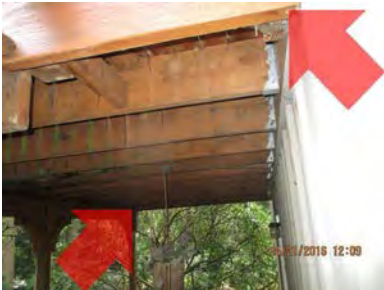
7. The deck structure lacks lateral bracing. The installation of a diagonal brace underneath the deck is recommended.

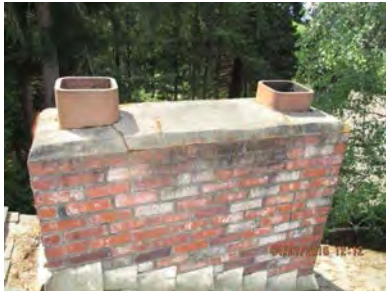
8. The chimney crown is cracked and deteriorated. The mortar chimney crown prevents water from entering and damaging the masonry. Repairing or replacing the chimney crown will extend the service life of the chimney.

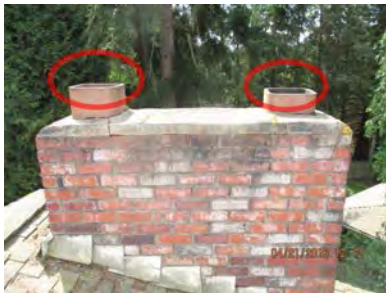
9. The top of the masonry chimney does not have spark arrestor/rain caps. The installation of a spark arrestor/rain cap for each flue is recommended as a safety upgrade and to prevent moisture damage to the inside of the chimney and fireplace. An additional benefit of a rain cap is that it will keep birds and rodents from entering the house when the damper is left open.

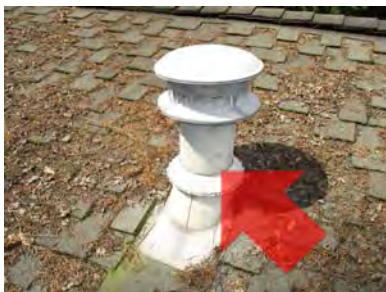
4.5 GAS APPLIANCE VENTS

10. The storm collar is not sealed. This is allowing leakage to occur. Sealing the storm collar is recommended.

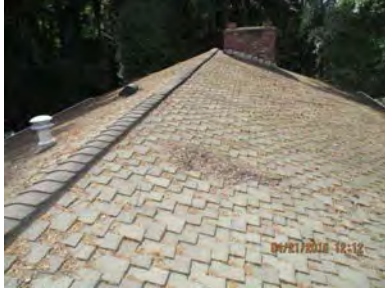
4.7 MAINTENANCE AND REPAIRS

11. The roof is in need of routine maintenance. The surface should be blown off or washed with a high volume low pressure garden hose to remove moss and organic debris. Performing this maintenance will improve the appearance and increase the life expectancy of the roof.

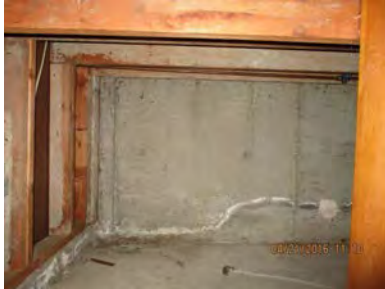
18. Efflorescence was observed on the foundation wall under the stairs. Efflorescence looks like lines of a fine white powder stuck to the wall. It is actually mineral salts that are left over after the water that carries them through the concrete or masonry. Efflorescence is a slow process that indicates long term exposure to moisture. Efflorescence is not toxic and can be easily removed. However, continued exposure of the foundation wall to moisture will cause it to return. To eliminate efflorescence you must reduce moisture on the outside of the foundation wall.

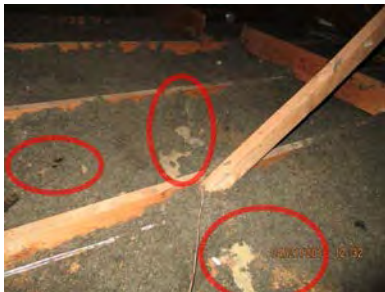
There are numerous thermal bypasses in the attic. A thermal bypass is an opening between an insulated and uninsulated part of the house through which heated air can escape. As air is heated, it rises and pulls cool air in to the space to replace it. This condition will result in significant heat loss. Sealing up all thermal bypass routes is recommended.

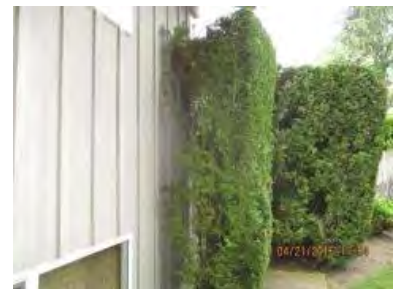
Trees are touching the building on the east side. Low hanging tree branches can damage the roof. Tree branches should be trimmed back where necessary.

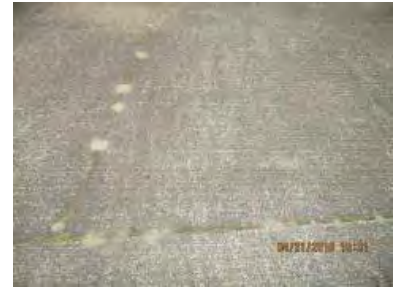
2.4 DRIVEWAY

Cracks were observed in the concrete surface of the driveway. Minor cracks can be sealed to minimize moisture entry and further settlement of the concrete. Minor cracks are common and do not affect the serviceability of the concrete.

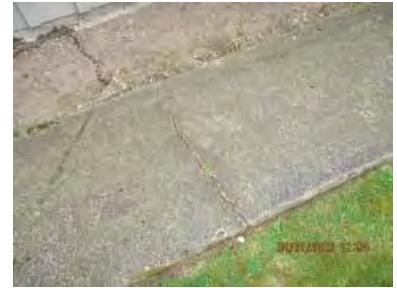
2.5 WALKWAY

The walkway has cracked and settled differentially. This was probably caused by inadequate preparation of the soil prior to the placement of the concrete. This condition can be repaired by pressure grouting the sunken portion of the walkway or by removing and replacing it. The walkway remains functional despite this condition. However, the raised edges of the concrete can be a trip hazard for some people. Repairs should be made as necessary.

Many legal and public works departments have defined a trip hazard as an irregularity in a walking surface exceeding one inch (1") in height. All walking surfaces should maintain, free of a vertical surface change of 3/4" or more, in the interest of public and personal safety.

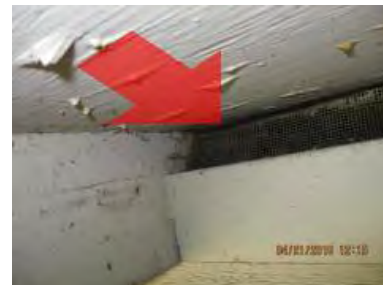
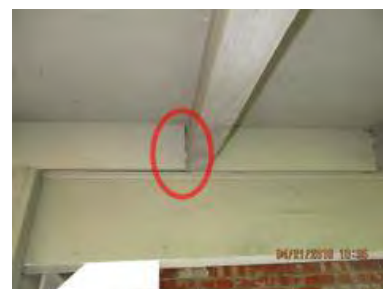
There are large gaps over 1/4" in size adjacent the soffit vent blocks. These gaps allow insects and rodents to enter the attic. Covering the gaps with screening, a strip of wood and/or caulking is recommended.

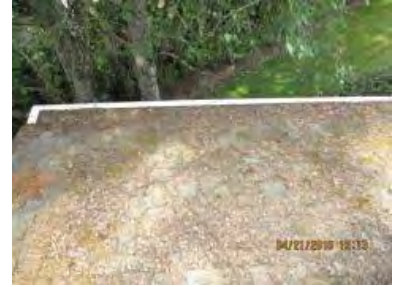
3.5 GUTTERS AND DOWNSPOUTS

There is a build-up of organic debris in the gutters. Proper maintenance of gutters and downspouts is essential and should be performed routinely in order to prevent clogging. Maintenance consists primarily of keeping leaves and other organic debris out of the system. Failure to clean the gutters will result in water splash on the building when they overflow. Gutters can be damaged from the water build up and organic matter blocking the gutter. Gutters should be cleaned as necessary to maintain a free flow of water into the downspouts.

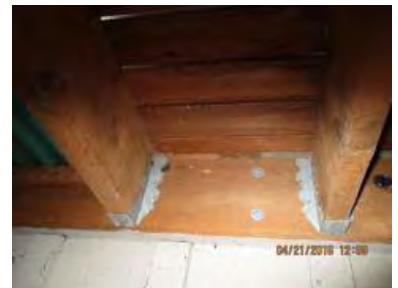
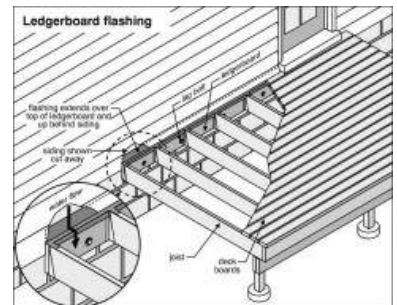
There is no flashing at the intersection between the deck and house. This will allow water to enter behind the siding. The installation of flashing in this area is recommended.

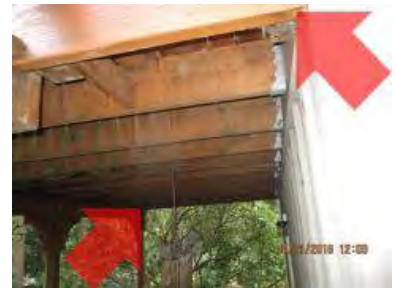
The deck structure lacks lateral bracing. The installation of a diagonal brace underneath the deck is recommended.

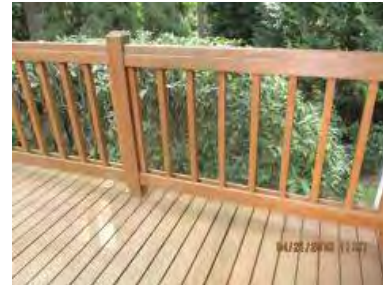
3.8 DECK RAILINGS

The spacing between the balusters is too wide. This is a hazard to small children. The balusters should be spaced close enough together so that a 4" sphere cannot pass through. Upgrading the deck railing is recommended if small children are present.

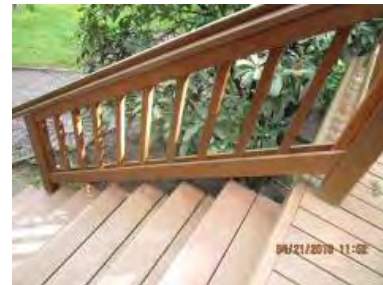
The stair railing baluster spacing is too wide. This is a hazard for small children. The baluster spacing should be reduced as a safety upgrade. Current standards require that a 4" sphere not pass through the railing.

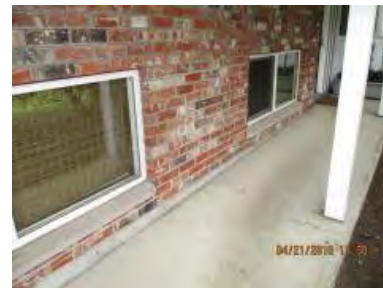
The lower window glass is not labeled as tempered safety glass. The existing glass is nonconforming by current building standards and would be hazardous if broken. The installation of safety glass is recommended as a safety upgrade for all windows less than 18" from the walking surface.

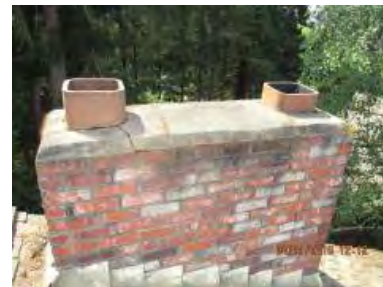
The chimney crown is cracked and deteriorated. The mortar chimney crown prevents water from entering and damaging the masonry. Repairing or replacing the chimney crown will extend the service life of the chimney.

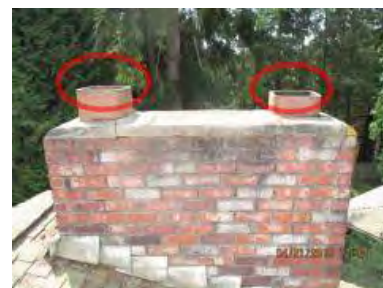
The top of the masonry chimney does not have spark arrestor/rain caps. The installation of a spark arrestor/rain cap for each flue is recommended as a safety upgrade and to prevent moisture damage to the inside of the chimney and fireplace. An additional benefit of a rain cap is that it will keep birds and rodents from entering the house when the damper is left open.

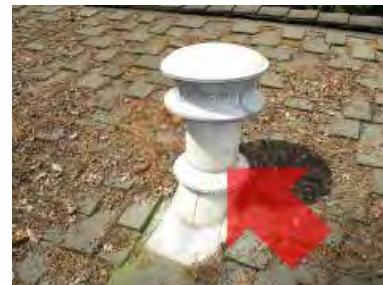
The storm collar is not sealed. This is allowing leakage to occur. Sealing the storm collar is recommended.

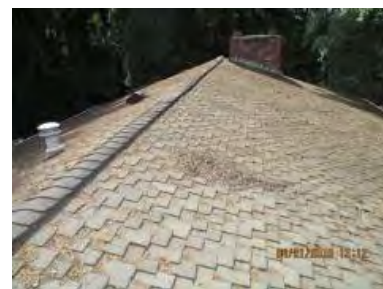
The roof is in need of routine maintenance. The surface should be blown off or washed with a high volume low pressure garden hose to remove moss and organic debris. Performing this maintenance will improve the appearance and increase the life expectancy of the roof.

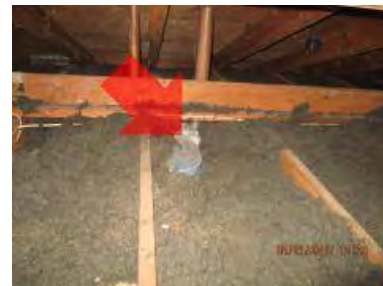
The bathroom vent fan discharges in the attic rather than outside. This is an undesirable condition that causes excessive moisture in the attic and can result in mold or fungus growth. A 4" smooth-wall sheet metal duct should be installed to direct the moisture laden air discharged from the fan out of the attic.

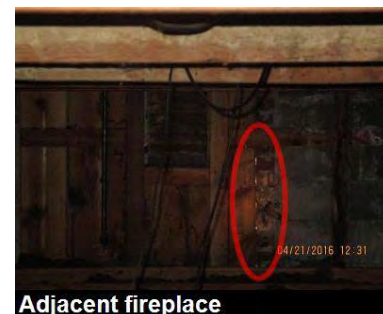
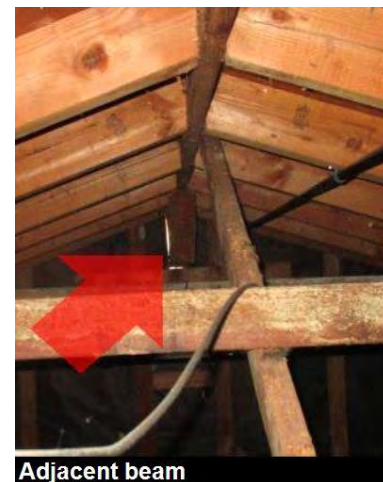
Adjacent fireplace

There is evidence of rodent activity in the attic. The first step in eliminating rodents from the attic is to seal all possible entry points using wire mesh, caulking, wood, stainless steel wool, or aerosol foam. Careful work sealing cracks, holes and gaps over 1/4" in size will discourage further activity. Once this work is completed, snap traps baited with peanut butter should be installed and monitored. The absence of rodents in the traps typically means that the rodents have been excluded from the area.

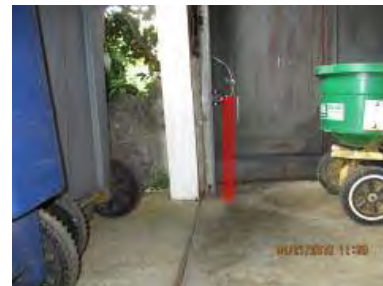
The Photo-eye beam was installed too high above the floor of the garage to adequately offer protection for small children and/or pets. We recommend that the photo-eye be lowered to within 4-6" of the floor.

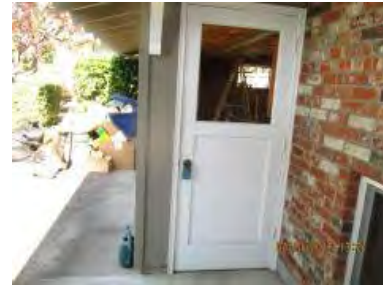
The glass in the garage door is not tempered safety glass. Tempered glass can be identified by the etched emblem in one corner of each pane. A higher margin of safety could be achieved if the glass was approved safety glass. Consideration should be given to replacing the glass as a safety upgrade.

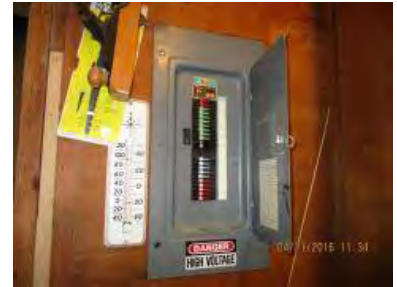
The main service panel was manufactured by Zinsco. Zinsco panels and circuit breakers have not been manufactured for some time, and some Zinsco circuit breakers have been known to fail to trip at their rated amperage. The panel and circuit breakers are considered a latent hazard and can fail leading to electrical fires. Replacement of this panel is recommended as a safety upgrade.

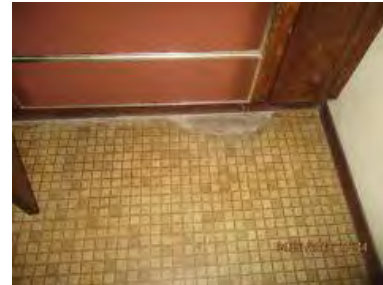
The vinyl flooring is torn and damaged and is nearing the end of its service life. Flooring replacement is recommended.
