**NOTICE TO BUYER: SELLER-PROCURED INSPECTION REPORT**

May 18, 2016

**Re: 17305 NE135th St.**  
**Redmond, WA.**

At your request, a visual inspection of the above referenced property was conducted on May 17, 2016. We have inspected the major structural components, plumbing, heating and electrical systems for signs of significant non-performance, excessive or unusual wear and general state of repair.

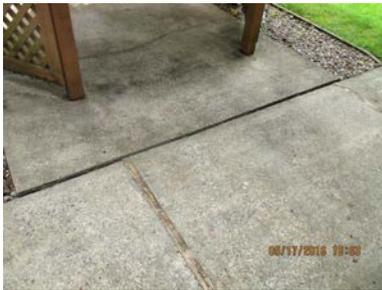
2. The wooden dividers separating the concrete patio sections have deteriorated to a point where the gaps are a trip hazard. Replacement with mortar is recommended.

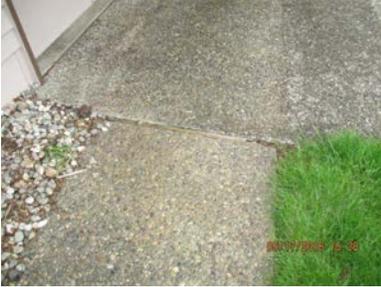
3. One or more of the wooden dividers separating the concrete walkway sections were infested by wood destroying organisms and have deteriorated to a point where they are becoming a trip hazard. Replacement with mortar is recommended.

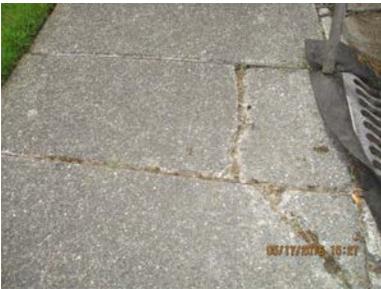
4. The walkway has cracked and settled differentially. This was probably caused by inadequate preparation of the soil prior to the placement of the concrete. This condition can be repaired by pressure grouting the sunken portion of the walkway or by removing and replacing it. The walkway remains functional despite this condition. However, the raised edges of the concrete can be a trip hazard for some people. Grinding down the raised edges of the concrete will mitigate the hazard. Repairs should be made as necessary.

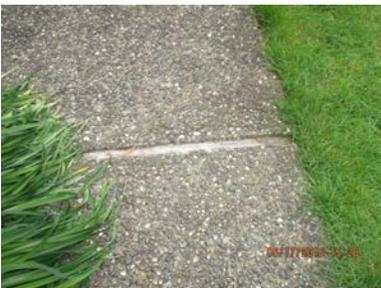
5. When the wooden dividers separating the concrete walkway sections have deteriorated to a point where they become a trip hazard. Replacement with mortar is recommended.

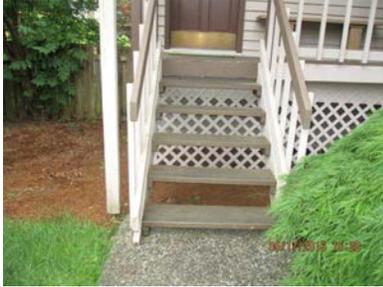
6. The stairs are non-conforming due to the variable and/or excessive rise. Stair design standards require that stair risers do not exceed 8" and that the variation in rise not exceed 3/8" in order to reduce falls from tripping. To increase the margin of safety, consideration should be given to reconfiguring the stairs so that rise and run do not vary by more than 3/8". If this proves to be too impractical or expensive, then we recommend exercising caution when using these stairs.

The stair rise spacing is too wide. This is a hazard for small children. The spacing should be reduced as a safety upgrade. Current standards require that a 4" sphere not pass through the opening.

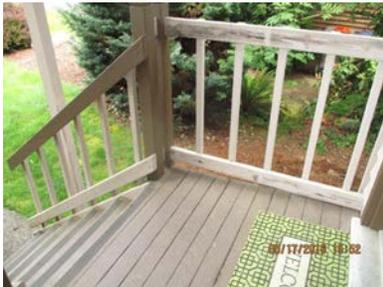
7. The stair railing baluster spacing is too wide. This is a hazard for small children. The baluster spacing should be reduced as a safety upgrade. Current standards require that a 4" sphere not pass through the railing.

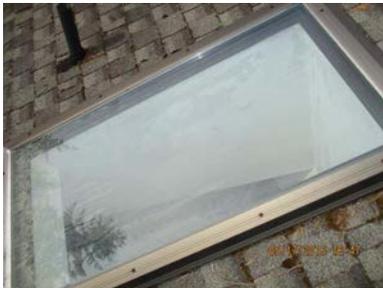
9. The seal between the glass panes has failed in the skylights. Repairs should be made as necessary.

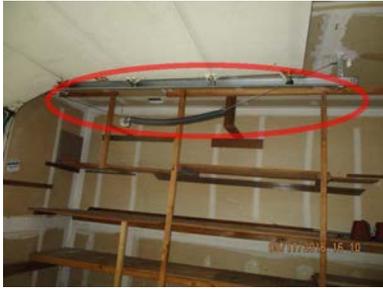
11. The lift assist spring for the right garage door is broken. This makes the door harder to open and can damage the automatic opener. Replacement of the broken spring is recommended.

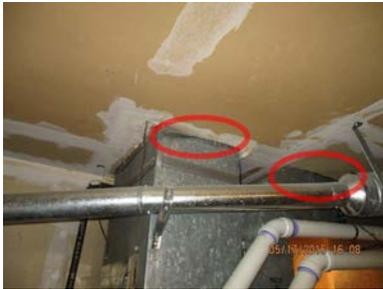
12. There are voids in the fire resistive barrier between the living space and garage that will allow flames to penetrate. The gypsum barrier slows the spread of a fire from the garage to the structure and/or living space. Patching the voids is recommended.

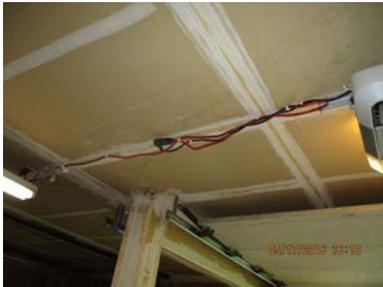
13. An extension cord is used as a temporary power source for the garage door opener. An extension cord is not suitable as a permanent wiring method. The installation of a receptacle within cords length of the motor is recommended.

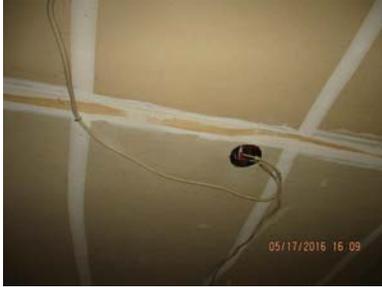
14. There is Romex cable in the garage that is run over the surface of the wall. This cable is vulnerable to damage. The cable should be relocated or protected in conduit.

Splices in cable made outside of a junction box were observed in the garage. This is a fire hazard. The splices should be made inside an approved box with a cover.

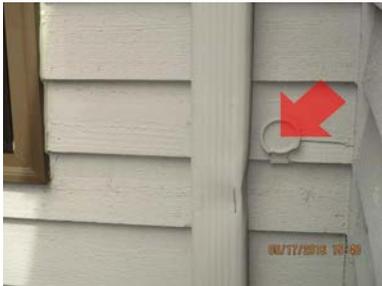
17. An air gap called a Johnson Tee is installed in the kitchen wall. This air gap protects the dishwasher from contamination caused by a backflow of waste water. The cap protruding on the exterior wall opposite the dishwasher is not drilled. This renders the air gap non-functional. Drilling a 1/4" hole in the end of the cap will restore its function. The remaining visible portions of the Johnson Tee were properly installed and functioning as intended.

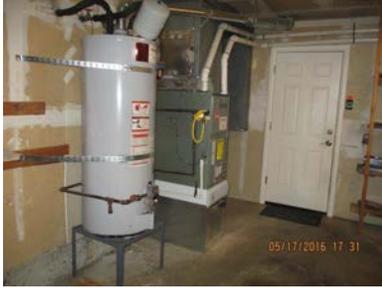
21. The gas pipes in front of the furnace and water heater are not protected by a bumper stop. A vertical steel pipe, bolted to the floor, is typically installed in front of the water heater to prevent a car bumper from damaging the gas lines.

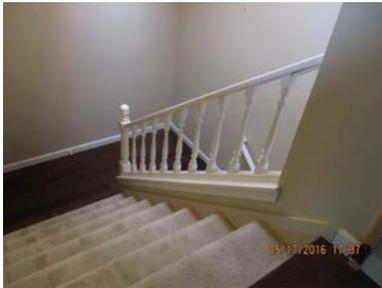
22. The stair railing baluster spacing is too wide. This is a hazard for small children. The baluster spacing should be reduced as a safety upgrade. Current standards require that a 4" sphere not pass through the railing.

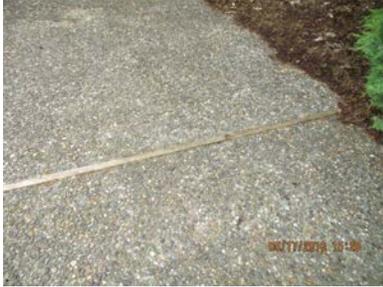
1. One or more of the wooden dividers separating the concrete driveway sections were infested by wood destroying organisms and have deteriorated to a point where they are becoming a trip hazard. Replacement with mortar is recommended.

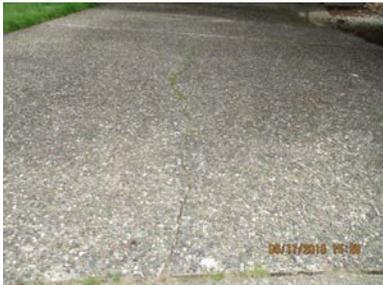
2. Cracks were observed in the concrete surface of the driveway. Minor cracks can be sealed to minimize moisture entry and further settlement of the concrete. Minor cracks are common and do not affect the serviceability of the concrete.

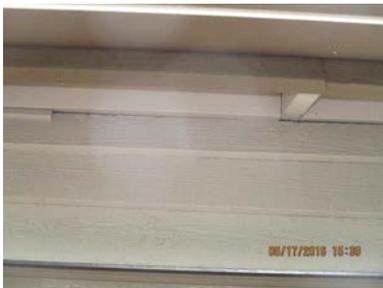
3. There are large gaps over 1/4" in size adjacent the soffit vent blocks. These gaps allow insects and rodents to enter the attic. Covering the gaps with screening, a strip of wood and/or caulking is recommended.

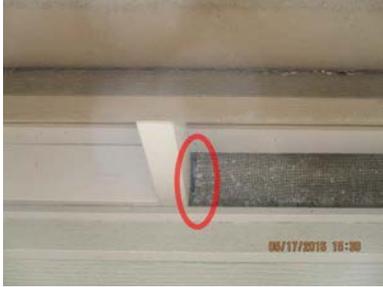
4. There are openings between the ends of the skip sheathing boards under the overhang through which birds and rodents can enter into the attic. These openings should be covered with wood, wire mesh or filled with aerosol foam

There is a large gap adjacent one of the vent screens on the front of the house. The vent screen should be repaired to prevent insect, bird and rodent entry.

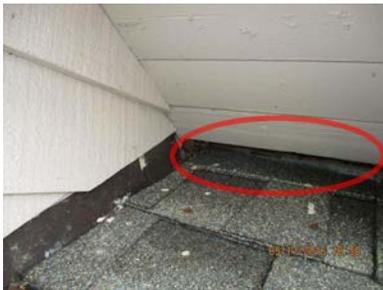
5. There are openings at the intersection between the overhang and the roof through which birds and rodents can enter into the attic. These openings should be covered with wood, wire mesh or filled with aerosol foam.

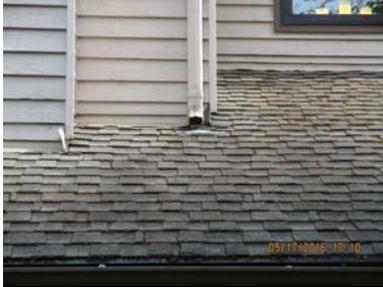
6. Downspouts draining directly onto the asphalt shingle surface causes excessive wear of the roofing material. Downspout extensions should be installed to prevent excessive wear and tear of the roofing.

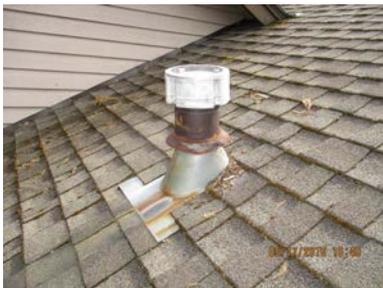
7. The gas appliance vent is corroded above the roof line. Cleaning and painting the vent will prolong its service life.

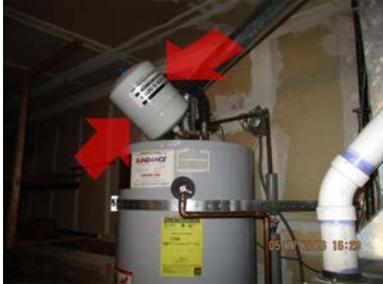
9. The expansion tank is not adequately secured to the wall. This could result in damage to the water pipe and leakage during an earth quake. A seismic restraint should be installed to secure the expansion tank.

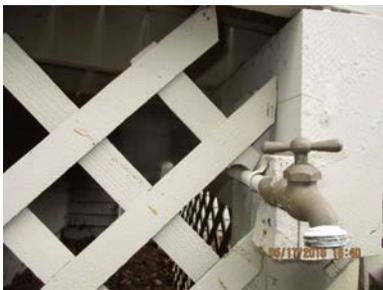
13. There are water pipes on the exterior of the house that will freeze in cold weather. These water pipes should be shut off and drained or protected via a thermostatically installed heat tape.

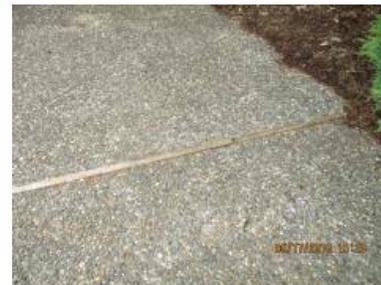
One or more of the wooden dividers separating the concrete driveway sections were infested by wood destroying organisms and have deteriorated to a point where they are becoming a trip hazard. Replacement with mortar is recommended.

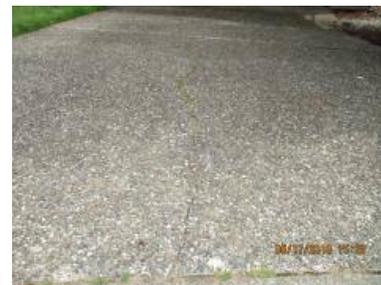
Cracks were observed in the concrete surface of the driveway. Minor cracks can be sealed to minimize moisture entry and further settlement of the concrete. Minor cracks are common and do not affect the serviceability of the concrete.

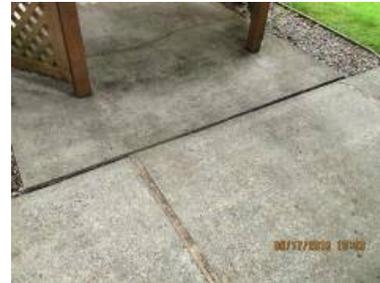
The wooden dividers separating the concrete patio sections have deteriorated to a point where the gaps are a trip hazard. Replacement with mortar is recommended.

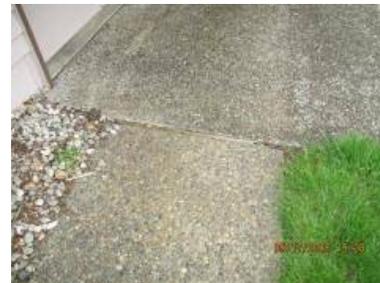
One or more of the wooden dividers separating the concrete walkway sections were infested by wood destroying organisms and have deteriorated to a point where they are becoming a trip hazard. Replacement with mortar is recommended.

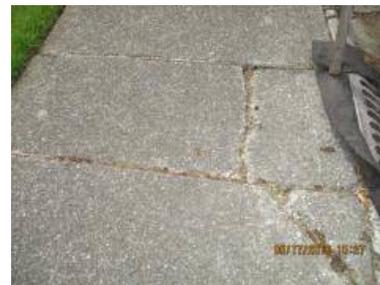
The walkway has cracked and settled differentially. This was probably caused by inadequate preparation of the soil prior to the placement of the concrete. This condition can be repaired by pressure grouting the sunken portion of the walkway or by removing and replacing it. The walkway remains functional despite this condition. However, the raised edges of the concrete can be a trip hazard for some people. Grinding down the raised edges of the concrete will mitigate the hazard. Repairs should be made as necessary.

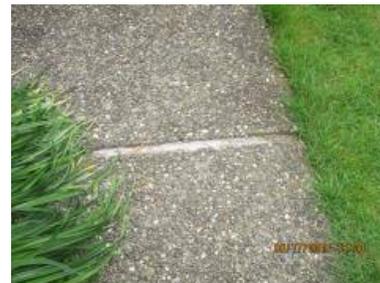
When the wooden dividers separating the concrete walkway sections have deteriorated to a point where they become a trip hazard. Replacement with mortar is recommended.

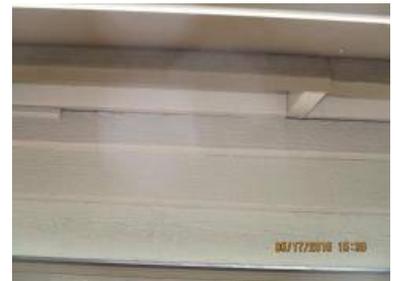
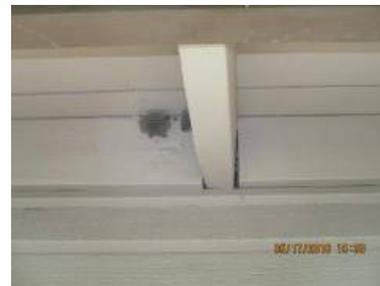
There are large gaps over 1/4" in size adjacent the soffit vent blocks. These gaps allow insects and rodents to enter the attic. Covering the gaps with screening, a strip of wood and/or caulking is recommended.

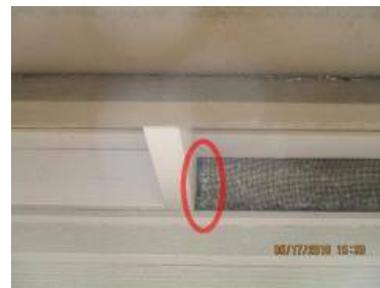
There are openings between the ends of the skip sheathing boards under the overhang through which birds and rodents can enter into the attic. These openings should be covered with wood, wire mesh or filled with aerosol foam

There is a large gap adjacent one of the vent screens on the front of the house. The vent screen should be repaired to prevent insect, bird and rodent entry.

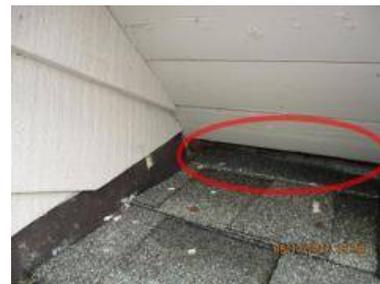
There are openings at the intersection between the overhang and the roof through which birds and rodents can enter into the attic. These openings should be covered with wood, wire mesh or filled with aerosol foam.

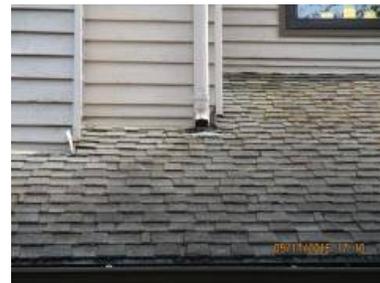
Downspouts draining directly onto the asphalt shingle surface causes excessive wear of the roofing material. Downspout extensions should be installed to prevent excessive wear and tear of the roofing.

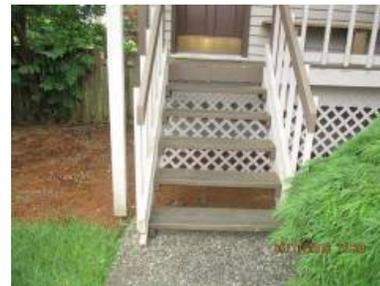
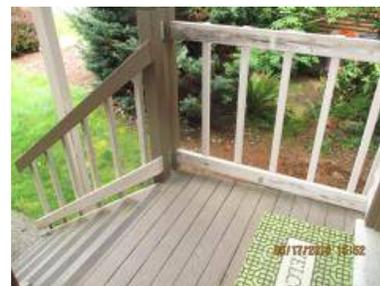
The stair railing baluster spacing is too wide. This is a hazard for small children. The baluster spacing should be reduced as a safety upgrade. Current standards require that a 4" sphere not pass through the railing.

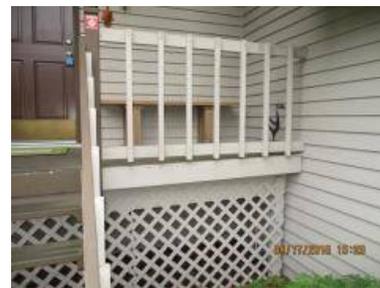
The spacing between the balusters is too wide. This is a hazard to small children. The balusters should be spaced close enough together so that a 4" sphere cannot pass through. Upgrading the porch railing is recommended if small children are present.

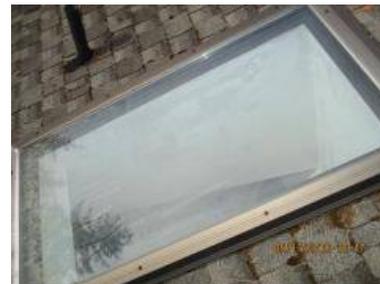
The seal between the glass panes has failed in the skylights. Repairs should be made as necessary.

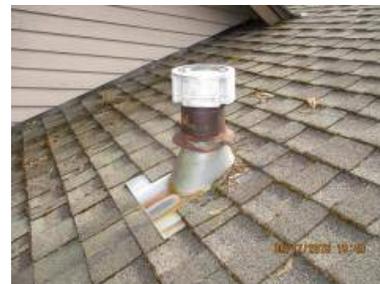
The gas appliance vent is corroded above the roof line. Cleaning and painting the vent will prolong its service life.

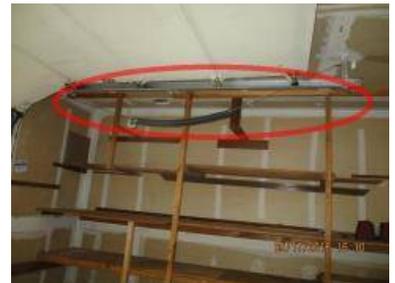
The lift assist spring for the right garage door is broken. This makes the door harder to open and can damage the automatic opener. Replacement of the broken spring is recommended.

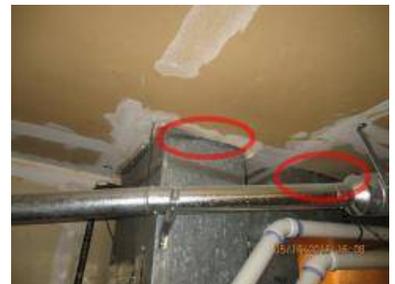
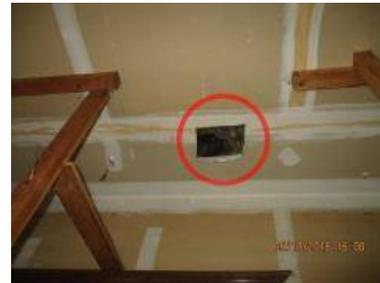
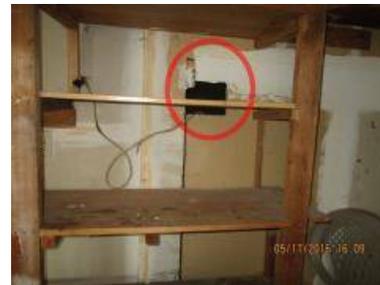
There are voids in the fire resistive barrier between the living space and garage that will allow flames to penetrate. The gypsum barrier slows the spread of a fire from the garage to the structure and/or living space. Patching the voids is recommended.

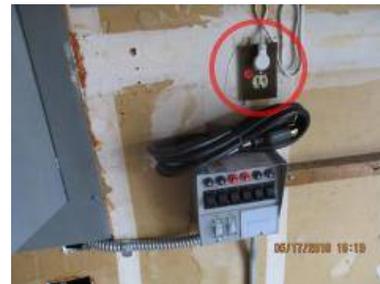
There are unprotected receptacles in the garage. The installation of GFCI protection for all of the garage receptacles is recommended.

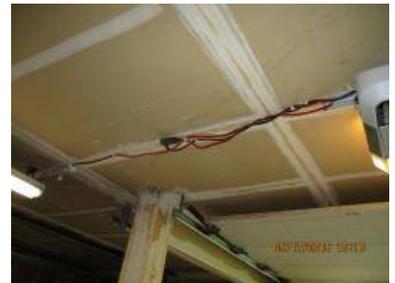
An extension cord is used as a temporary power source for the garage door opener. An extension cord is not suitable as a permanent wiring method. The installation of a receptacle within cords length of the motor is recommended.

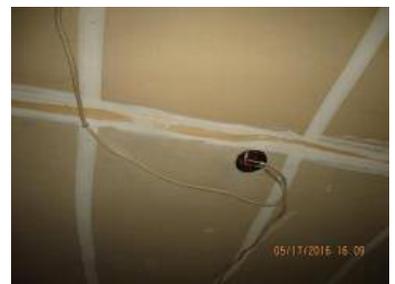
There is Romex cable in the garage that is run over the surface of the wall. This cable is vulnerable to damage. The cable should be relocated or protected in conduit.

Splices in cable made outside of a junction box were observed in the garage. This is a fire hazard. The splices should be made inside an approved box with a cover.

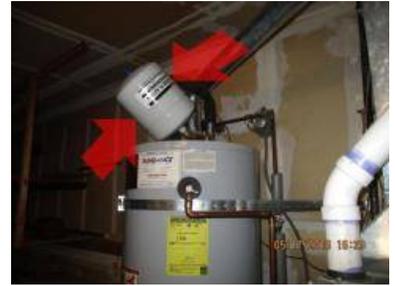
The expansion tank is not adequately secured to the wall. This could result in damage to the water pipe and leakage during an earth quake. A seismic restraint should be installed to secure the expansion tank.

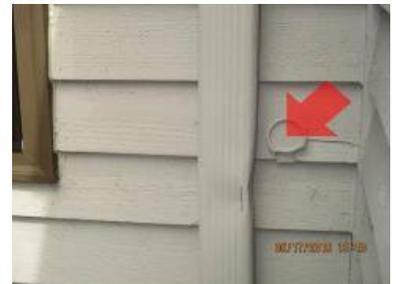
An air gap called a Johnson Tee is installed in the kitchen wall. This air gap protects the dishwasher from contamination caused by a backflow of waste water. The cap protruding on the exterior wall opposite the dishwasher is not drilled. This renders the air gap non-functional. Drilling a 1/4" hole in the end of the cap will restore its function. The remaining visible portions of the Johnson Tee were properly installed and functioning as intended.

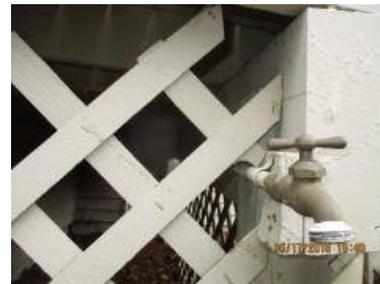
There are water pipes on the exterior of the house that will freeze in cold weather. These water pipes should be shut off and drained or protected via a thermostatically installed heat tape.

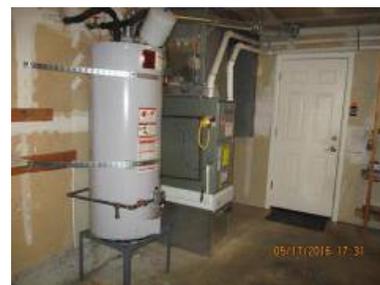
The gas pipes in front of the furnace and water heater are not protected by a bumper stop. A vertical steel pipe, bolted to the floor, is typically installed in front of the water heater to prevent a car bumper from damaging the gas lines.

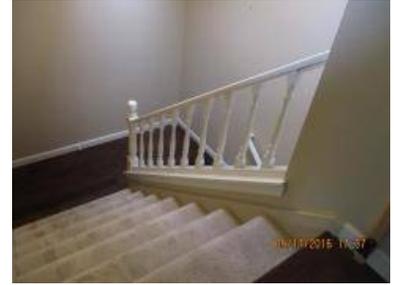
The stair railing baluster spacing is too wide. This is a hazard for small children. The baluster spacing should be reduced as a safety upgrade. Current standards require that a 4" sphere not pass through the railing.
