**NOTICE TO BUYER: SELLER-PROCURED INSPECTION REPORT**

The following notice is given with respect to the Purchase and Sale Agreement dated \_\_\_\_\_  
between \_\_\_\_\_ (“Buyer”)  
and Jason and Carrie Wandler (“Seller”)  
concerning 17717 83rd PI NE, Kenmore WA 98028 (“the Property”).

At your request, a visual inspection of the above referenced property was conducted on May 17, 2016. We have inspected the major structural components, plumbing, heating and electrical systems for signs of significant non-performance, excessive or unusual wear and general state of repair.

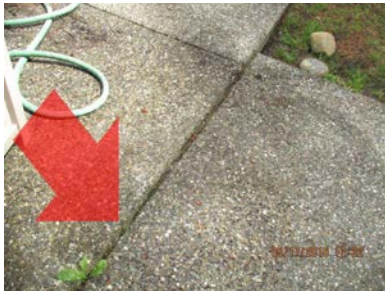
#### 2.5 WALKWAY

1. The walkway has cracked and settled differentially. This was probably caused by inadequate preparation of the soil prior to the placement of the concrete. This condition can be repaired by pressure grouting the sunken portion of the walkway or by removing and replacing it. The walkway remains functional despite this condition. However, the raised edges of the concrete can be a trip hazard for some people. Grinding down the raised edges of the concrete will mitigate the hazard. Repairs should be made as necessary.

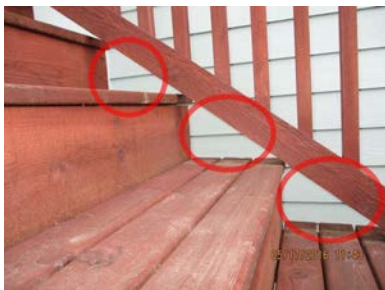
#### 3.8 STAIRS

2. The spacing under stair railing is too wide. This is a hazard for small children. The spacing should be reduced as a safety upgrade. Current standards require that a 4" sphere not pass under the railing.

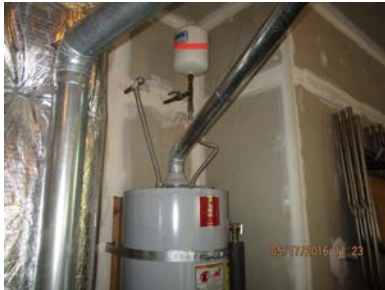
### *9.6 EXPANSION TANK*

5. The expansion tank is not adequately secured to the wall. This could result in damage to the water pipe and leakage during an earth quake. A seismic restraint should be installed to secure the expansion tank.

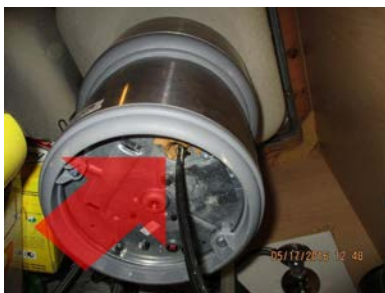
### *10.13 GARBAGE DISPOSAL*

7. The cord is not clamped where it enters the disposal. This could damage the wires or cause a ground fault. The cord should be clamped in accordance with industry standards.

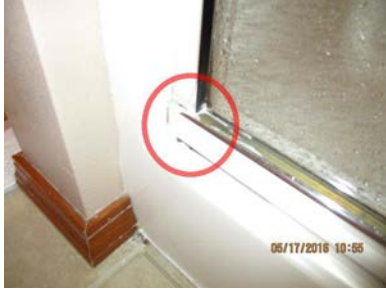
#### *11.28 GLASS ENCLOSURE*

8. The glass enclosure has been leaking at the lower corners. No damage was visible, but resealing or repairing the enclosure is recommended as preventive maintenance.

Leaking shower at corners – Repaired

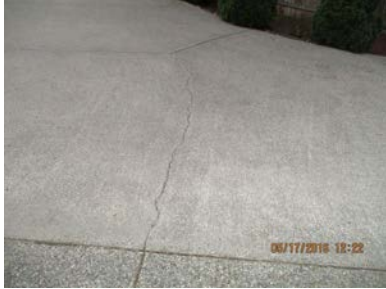
### 2.4 DRIVEWAY

2. Cracks were observed in the concrete surface of the driveway. Minor cracks can be sealed to minimize moisture entry and further settlement of the concrete. Minor cracks are common and do not affect the serviceability of the concrete.

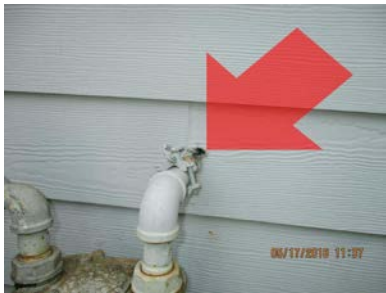
### 3.1 PRIMARY EXTERIOR WALL CLADDING

4. The siding has a large gap adjacent the gas pipe penetration. Consideration should be given to installing flashing and/or caulk to prevent moisture or pest entry into the structure.

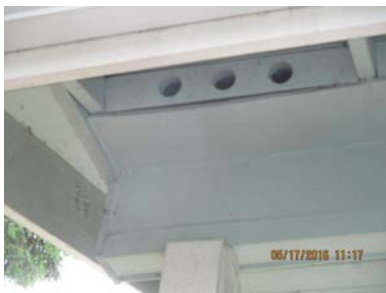
### 3.3 SOFFITS AND OVERHANGS

5. There are large gaps over 1/4" in size adjacent the soffit vent blocks. These gaps allow insects and rodents to enter the attic. Covering the gaps with screening, a strip of wood and/or caulking is recommended.

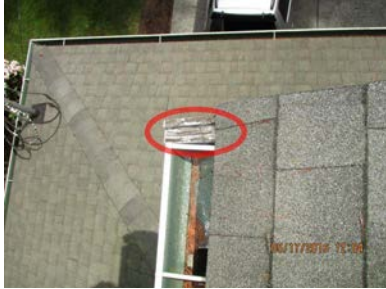
6. The ends of the barge boards are exposed to the weather and are vulnerable to rot damage. To prevent damage to the barge board ends, they should be covered with roofing material or flashing.

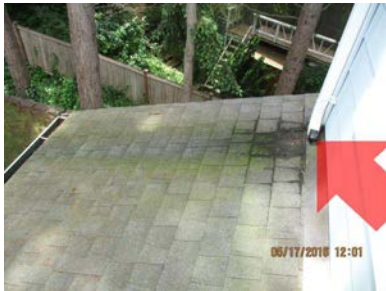
### 3.4 GUTTERS AND DOWNSPOUTS

7. Downspouts draining directly onto the asphalt shingle surface causes excessive wear of the roofing material. Downspout extensions should be installed to prevent excessive wear and tear of the roofing.

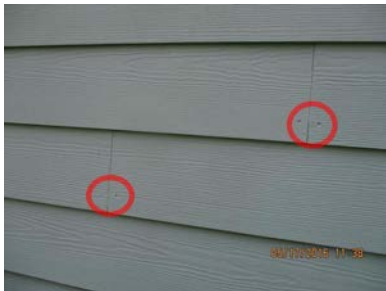
### 3.5 PAINT

8. The bottom edge of the lower sections of siding on the exterior are unprotected. Paint protects the siding from moisture absorption, cupping, checking, warping and rot. Painting of the exposed edges is recommended.

Siding nails that have damaged the surface overlay need to be caulked. Caulking prevents water intrusion of the siding. Consideration should be given to caulking the siding as necessary. Exterior caulking is recommended.

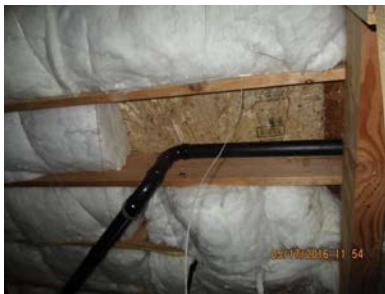
*17.3 FLOOR INSULATION*

14. One of the insulation batts was not properly secured and has falling down. The fallen batt should be reinstalled and secured.

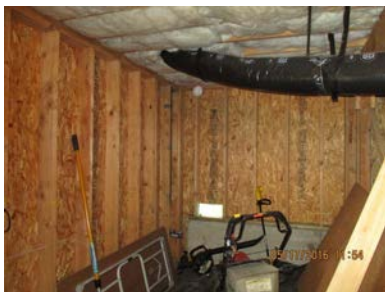
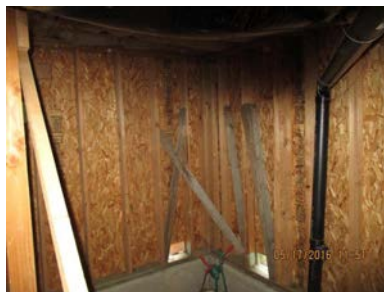
*18.6 SHEAR PANELS*

15. Shear panels are plywood or OSB panels that are mechanically fastened to both vertical and horizontal framing members in critical structural areas of the building. They prevent lateral movement of the structure during an earthquake. Shear panels are often visible in the crawlspace on cripple walls between the first floor and foundation. They may also be installed on interior walls that are covered with drywall. An examination of the crawlspace revealed the absence of shear panels on the cripple walls. The installation of shear panels on the cripple walls is recommended as an upgrade.

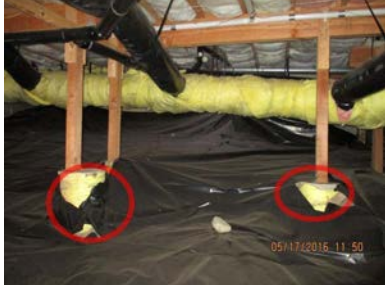
**19.5 PEST CONTROL**

17. Cellulose forms were left in place on the pier footings. This cellulose is conducive to the infestation of various wood destroying organisms. The removal of the cellulose is recommended.

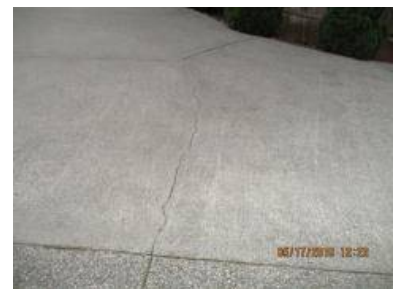
### 2.4 DRIVEWAY

Cracks were observed in the concrete surface of the driveway. Minor cracks can be sealed to minimize moisture entry and further settlement of the concrete. Minor cracks are common and do not affect the serviceability of the concrete.

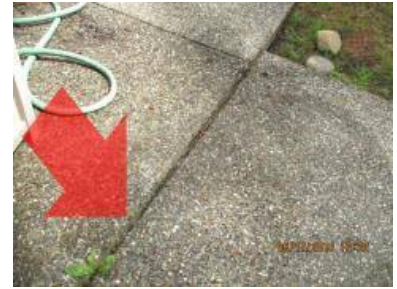
### 2.5 WALKWAY

The walkway has cracked and settled differentially. This was probably caused by inadequate preparation of the soil prior to the placement of the concrete. This condition can be repaired by pressure grouting the sunken portion of the walkway or by removing and replacing it. The walkway remains functional despite this condition. However, the raised edges of the concrete can be a trip hazard for some people. Grinding down the raised edges of the concrete will mitigate the hazard. Repairs should be made as necessary.

Many legal and public works departments have defined a trip hazard as an irregularity in a walking surface exceeding one inch (1") in height. All walking surfaces should maintain, free of a vertical surface change of 3/4" or more, in the interest of public and personal safety.

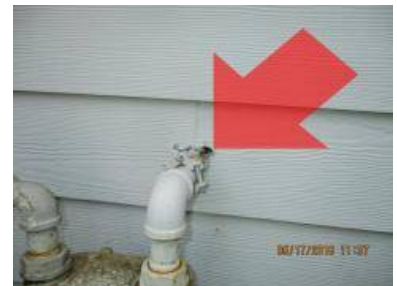
## 3.1 PRIMARY EXTERIOR WALL CLADDING

Hardie Plank cement fiber siding is used as an exterior wall cladding. It is manufactured from Portland Cement, ground sand, cellulose fiber, select additives and water. It is a durable material that will not burn, rot or dent. It holds paint tenaciously. It comes with a limited 50 year, transferable product warranty. It is a very popular material due to its cost and durability. The siding shows minor wear and deterioration typically caused when the exterior finish is not maintained. The deterioration is cosmetic and does not affect the function of the siding. No action is indicated.

The siding has a large gap adjacent the gas pipe penetration. Consideration should be given to installing flashing and/or caulk to prevent moisture or pest entry into the structure.

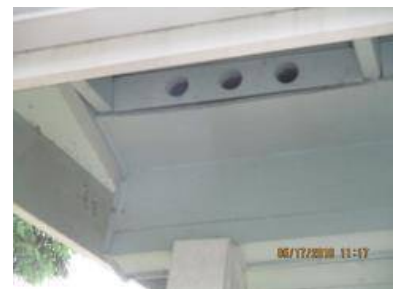
There are large gaps over 1/4" in size adjacent the soffit vent blocks. These gaps allow insects and rodents to enter the attic. Covering the gaps with screening, a strip of wood and/or caulking is recommended.

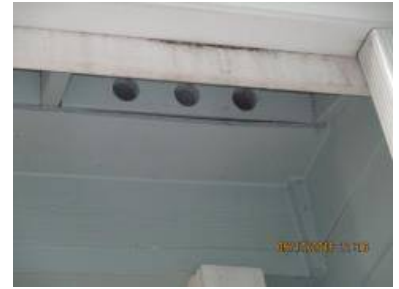
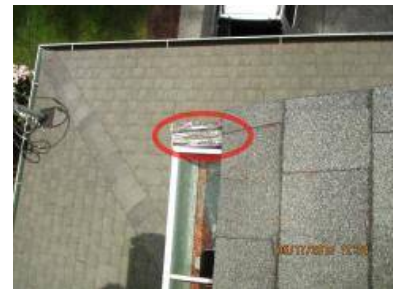
The ends of the barge boards are exposed to the weather and are vulnerable to rot damage. To prevent damage to the barge board ends, they should be covered with roofing material or flashing.

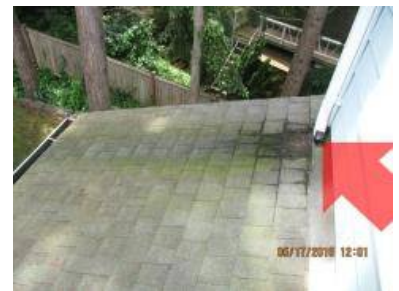
### 3.4 GUTTERS AND DOWNSPOUTS

Downspouts draining directly onto the asphalt shingle surface causes excessive wear of the roofing material. Downspout extensions should be installed to prevent excessive wear and tear of the roofing.

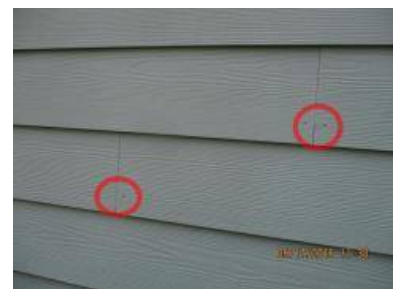
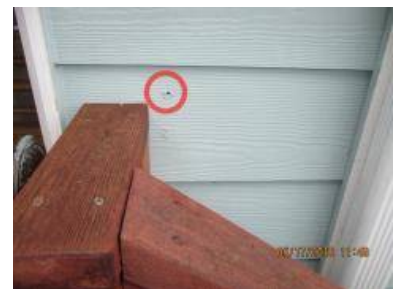
### 3.5 PAINT

The bottom edge of the lower sections of siding on the exterior are unprotected. Paint protects the siding from moisture absorption, cupping, checking, warping and rot. Painting of the exposed edges is recommended.

Siding nails that have damaged the surface overlay need to be caulked. Caulking prevents water intrusion of the siding. Consideration should be given to caulking the siding as necessary. Exterior caulking is recommended.

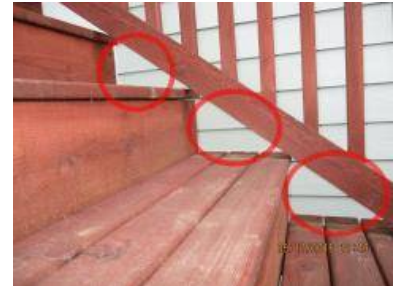
### 3.8 STAIRS

The spacing under stair railing is too wide. This is a hazard for small children. The spacing should be reduced as a safety upgrade. Current standards require that a 4" sphere not pass under the railing.

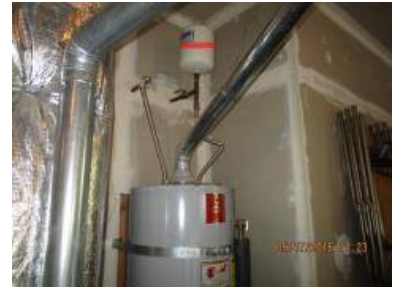
The expansion tank is not adequately secured to the wall. This could result in damage to the water pipe and leakage during an earth quake. A seismic restraint should be installed to secure the expansion tank.

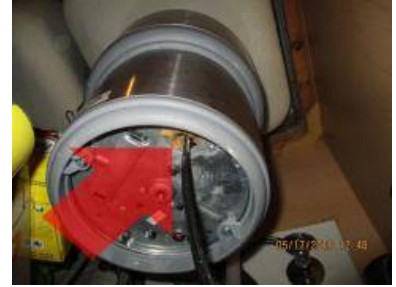
The cord is not clamped where it enters the disposal. This could damage the wires or cause a ground fault. The cord should be clamped in accordance with industry standards.

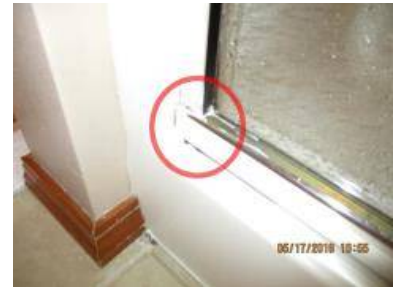
#### **11.28 GLASS ENCLOSURE**

The glass enclosure has been leaking at the lower corners. No damage was visible, but resealing or repairing the enclosure is recommended as preventive maintenance.

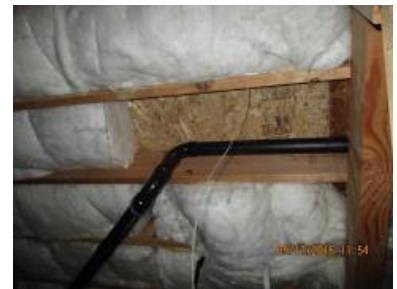
One of the insulation batts was not properly secured and has falling down. The fallen batt should be reinstalled and secured.

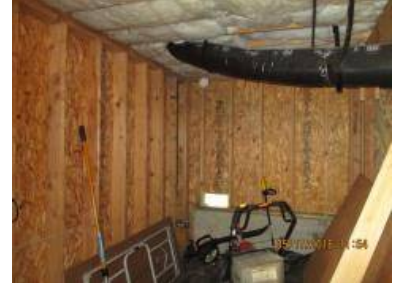
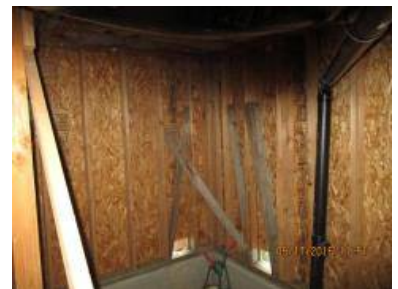
### 18.6 SHEAR PANELS

Shear panels are plywood or OSB panels that are mechanically fastened to both vertical and horizontal framing members in critical structural areas of the building. They prevent lateral movement of the structure during an earthquake. Shear panels are often visible in the crawlspace on cripple walls between the first floor and foundation. They may also be installed on interior walls that are covered with drywall. An examination of the crawlspace revealed the absence of shear panels on the cripple walls. The installation of shear panels on the cripple walls is recommended as an upgrade.

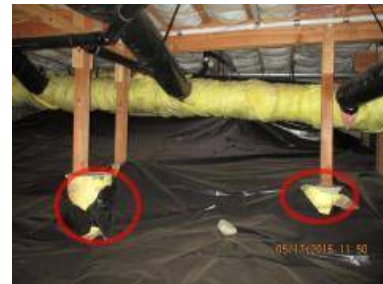
#### **19.5 PEST CONTROL**

Cellulose forms were left in place on the pier footings. This cellulose is conducive to the infestation of various wood destroying organisms. The removal of the cellulose is recommended.
