**NOTICE TO BUYER: SELLER-PROCURED INSPECTION REPORT**

Tim and Lois Adams  
20015 NE 148<sup>th</sup> St  
Woodinville WA 98077

At your request, a visual inspection of the above referenced property was conducted on April 19, 2016. We have inspected the major structural components, plumbing, heating and electrical systems for signs of significant non-performance, excessive or unusual wear and general state of repair.

20015 NE 148th St.  
Woodinville, WA.

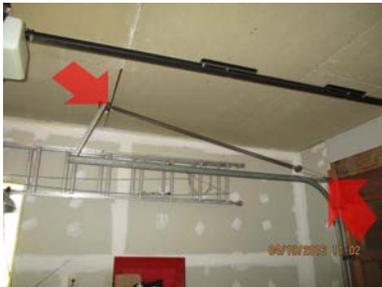
##### *6.2 OVERHEAD GARAGE DOORS*

1. Safeties are cables run through the center of the garage door springs that prevent broken springs from becoming projectiles that can cause injury. There are no safeties installed. The installation of safeties is recommended.

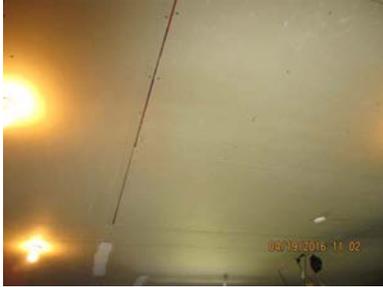
##### *6.4 FIRE SEPARATION*

3. The fire resistive barrier between the garage and the living space is properly installed and in good condition, however, the joints are not taped. Consideration should be given to "fire taping" the drywall as a safety upgrade.

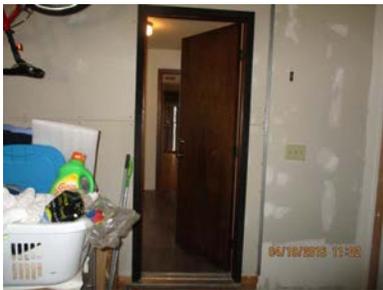
#### 6.5 PASSAGE DOOR

4. The door between the garage and living space is a solid core door. The door is properly installed and is in good condition, however, it lacks a self closing hinge. The installation of a self closing hinge is recommended as a safety upgrade.

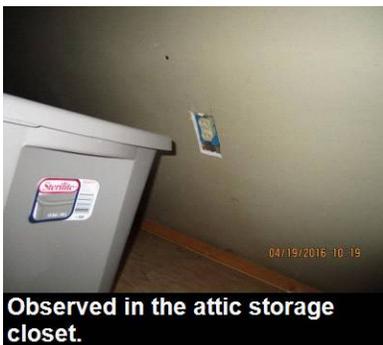
#### 7.11 RECEPTACLES

The cover plate is missing from a receptacle in the attic storage closet. This is a shock and fire hazard. The installation of a cover plate is recommended.

- Receptacle in master bedroom with an open ground was traced to a ground wire that had come loose in a switch-box. The connection was repaired.
- All loose receptacles were corrected.
- A cover plate was installed on the storage space receptacle

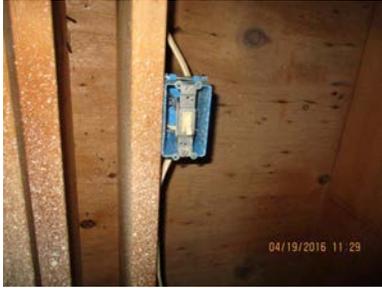
#### 7.14 SWITCHES

7. The cover plate is missing from the wall switch in the attic. This is a shock and fire hazard. The installation of a cover plate is recommended.

- A cover plate was installed on the attic space light switch.

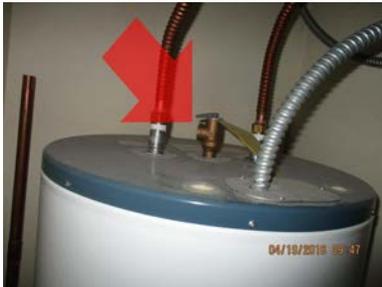
9. The pressure relief valve lacks a drain pipe. This is a scald hazard. The installation of a 3/4" copper, CPVC plastic or galvanized steel drain pipe is recommended. Ideally, the drain should be routed to the exterior. However, running the pipe straight down to the floor eliminates the scald hazard.

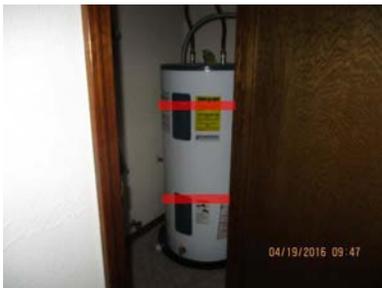
### 9.6 SEISMIC RESTRAINT

10. The water heater is not secured to the wall. A seismic restraint should be installed to secure the water heater and prevent it from falling over during an earthquake. This prevents the gas and water lines from rupturing.

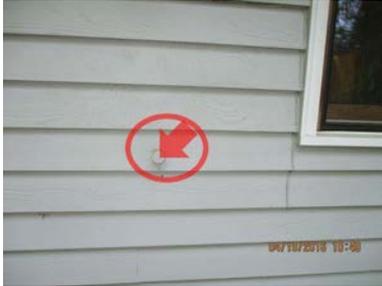
12. An air gap called a Johnson Tee is installed in the kitchen wall. This air gap protects the dishwasher from contamination caused by a backflow of waste water. The cap protruding on the exterior wall opposite the dishwasher is not drilled. This renders the air gap non-functional. Drilling a 1/4" hole in the end of the cap will restore its function. The remaining visible portions of the Johnson Tee were properly installed and functioning as intended.

- A ¼" hole has been drilled into the Johnson Tee pipe cap

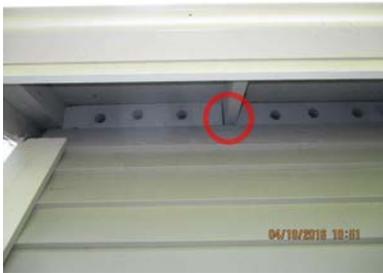
1. There are large gaps over 1/4" in size adjacent the soffit vent blocks. These gaps allow insects and rodents to enter the attic. Covering the gaps with screening, a strip of wood and/or caulking is recommended.

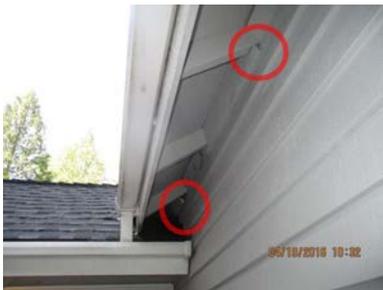
2. There are openings at the intersection between the overhang and the roof through which birds and rodents can enter into the attic. These openings should be covered with wood, wire mesh or filled with aerosol foam.

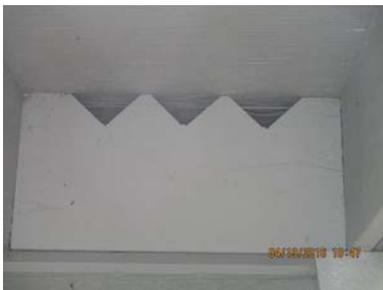
3. There are soffit vent screens that are damaged. This is allowing pests to enter the attic. Quarter inch wire mesh should be secured over the vent holes.

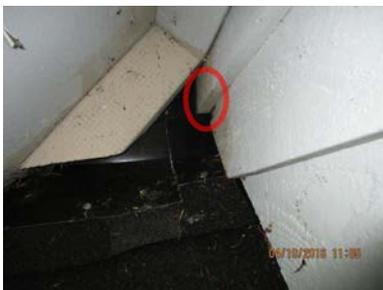
4. There are openings at the flashing between the overhang and the roof through which birds and rodents can enter into the attic. These openings should be covered with wood, wire mesh or filled with aerosol foam.

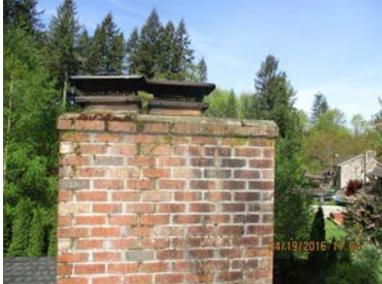
6. Moss/vegetation was observed in several areas around the upper portion of the chimney. This will lead to accelerated deterioration of the brick masonry mortar. We recommend removal of all organic growth. Damaged areas can be repaired by filling in cutout or defective mortar joints with fresh mortar. (Tuck pointing)

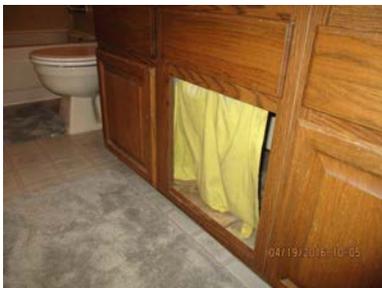
10. The bathroom cabinet door is missing. Replacement is recommended. The cabinet is otherwise in serviceable condition.

- Bathroom cabinet door has been replaced

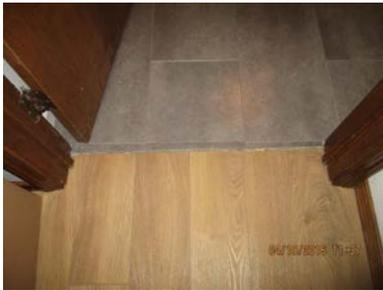
14. The hard surface flooring lacks a transition strip. The raised edge of the flooring is a hazard. We recommend the installation of a floor edge transition strip.

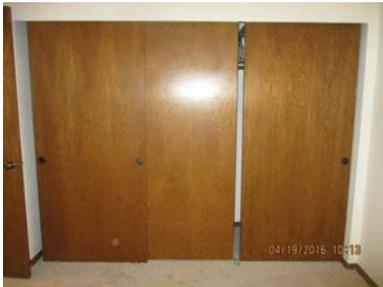
**14.6 CLOSET DOORS**

15. Several of the closet doors in the southwest bedroom are in need of minor adjustment and/or repair.

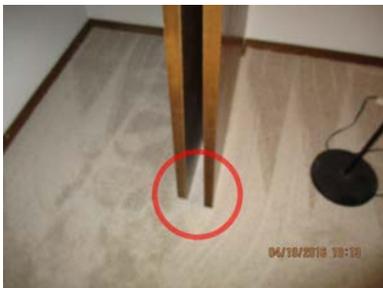
16. The floor guides are missing from the bypass closet doors in the bedrooms. Missing floor guides could result in damage to the doors. The installation of floor guides is recommended.

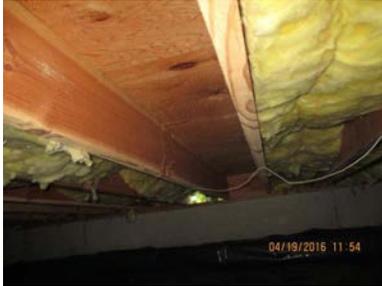
18. The floors are insulated with 6" R-19 fiberglass batts. Some of the insulation batts are missing. The missing batts should be replaced .

- Insulation replaced in the area of the bathroom floor and bathtub plumbing.

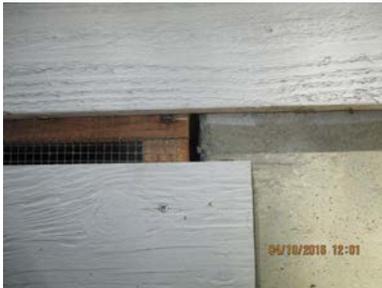
19. The crawlspace access door is not rodent proof. The installation of a tight fitting access door is recommended to exclude rodents from the crawlspace.

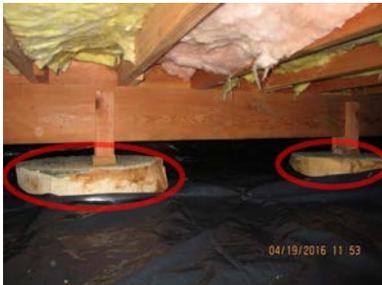
20. Cellulose forms were left in place on the pier footings. This cellulose is conducive to the infestation of various wood destroying organisms. The removal of the cellulose is recommended.

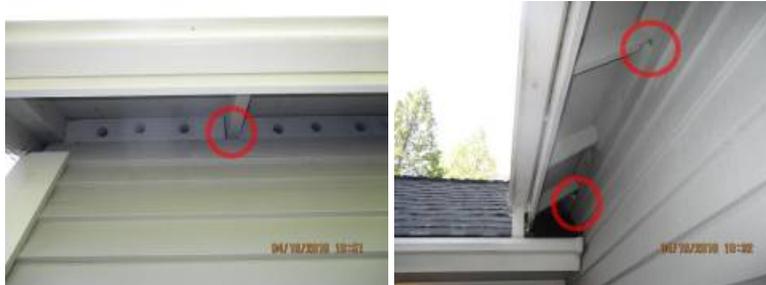
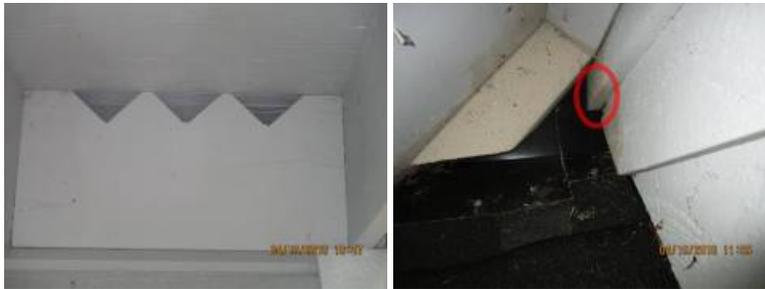
There are openings at the flashing between the overhang and the roof through which birds and rodents can enter into the attic. These openings should be covered with wood, wire mesh or filled with aerosol foam.

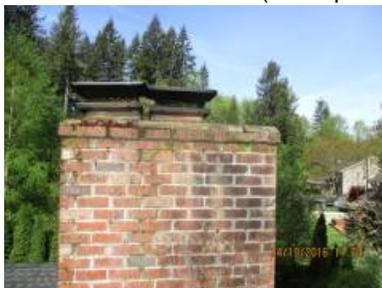
Moss/vegetation was observed in several areas around the upper portion of the chimney. This will lead to accelerated deterioration of the brick masonry mortar. We recommend removal of all organic growth. Damaged areas can be repaired by filling in cutout or defective mortar joints with fresh mortar. (Tuck pointing)

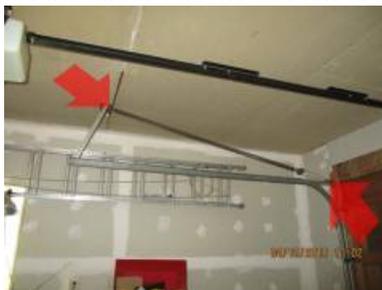
Safeties are cables run through the center of the garage door springs that prevent broken springs from becoming projectiles that can cause injury. There are no safeties installed. The installation of safeties is recommended.

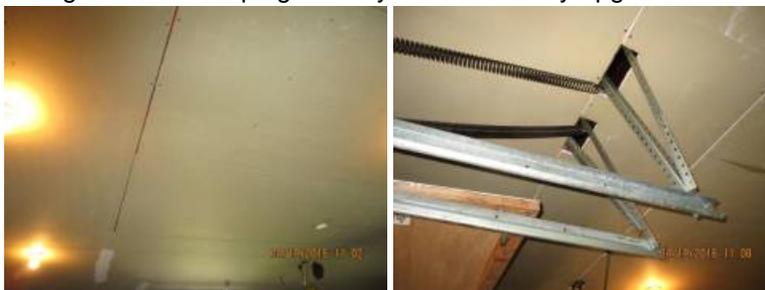
The fire resistive barrier between the garage and the living space is properly installed and in good condition, however, the joints are not taped. Consideration should be given to "fire taping" the drywall as a safety upgrade.

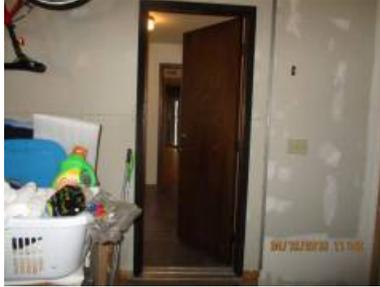
### 6.5 PASSAGE DOOR

The door between the garage and living space is a solid core door. The door is properly installed and is in good condition, however, it lacks a self closing hinge. The installation of a self closing hinge is recommended as a safety upgrade.

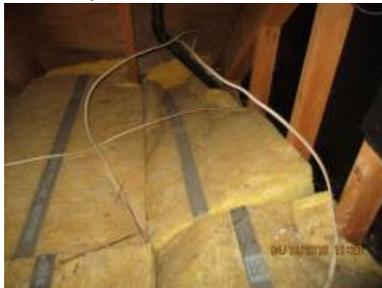
Loose electrical cables were observed in the attic. Loose cables are vulnerable to damage. All loose cables should be secured at 4' intervals using approved cable staples.

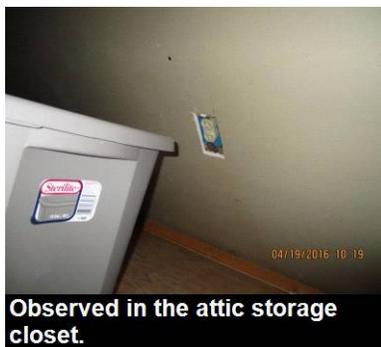
The cover plate is missing from a receptacle in the attic storage closet. This is a shock and fire hazard. The installation of a cover plate is recommended.

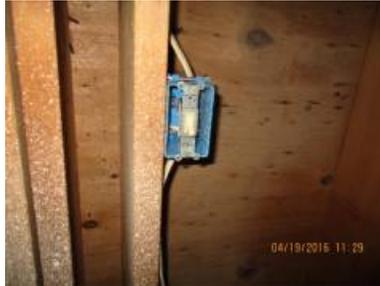
The cover plate is missing from the wall switch in the attic. This is a shock and fire hazard. The installation of a cover plate is recommended.

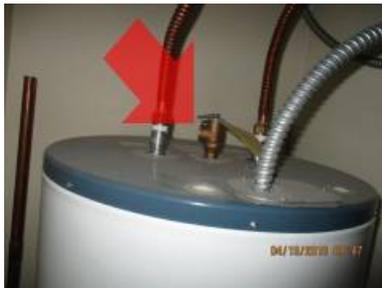
The pressure relief valve lacks a drain pipe. This is a scald hazard. The installation of a 3/4" copper, CPVC plastic or galvanized steel drain pipe is recommended. Ideally, the drain should be routed to the exterior. However, running the pipe straight down to the floor eliminates the scald hazard.

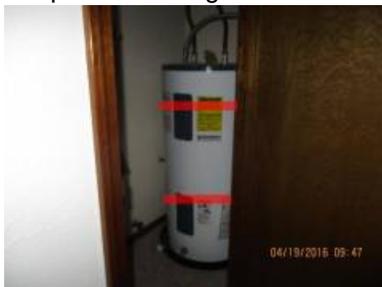
The water heater is not secured to the wall. A seismic restraint should be installed to secure the water heater and prevent it from falling over during an earthquake. This prevents the gas and water lines from rupturing.

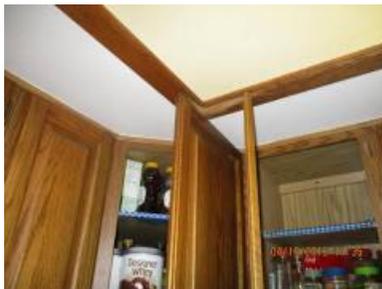
The doors are misaligned. These doors are rubbing the ceiling trim. Modifications are recommended to allow for the doors proper operation.

- Cabinet doors rubbing on ceiling trim has been corrected.

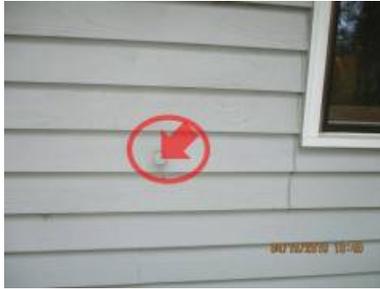
An air gap called a Johnson Tee is installed in the kitchen wall. This air gap protects the dishwasher from contamination caused by a backflow of waste water. The cap protruding on the exterior wall opposite the dishwasher is not drilled. This renders the air gap non-functional. Drilling a 1/4" hole in the end of the cap will restore its function. The remaining visible portions of the Johnson Tee were properly installed and functioning as intended.

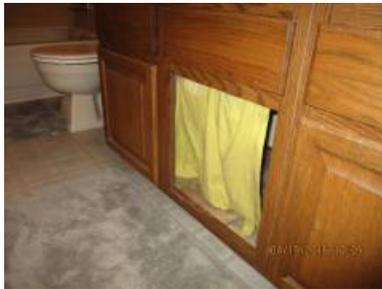
The bathroom cabinet door is missing. Replacement is recommended. The cabinet is otherwise in serviceable condition.

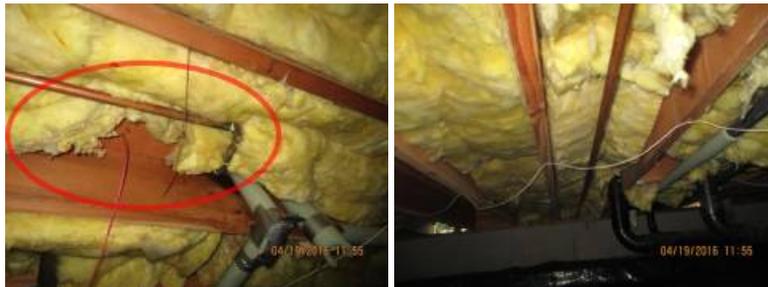
There are water pipes in the crawlspace that are not adequately insulated and could freeze. The installation of foam pipe insulation on all exposed water pipes is recommended.

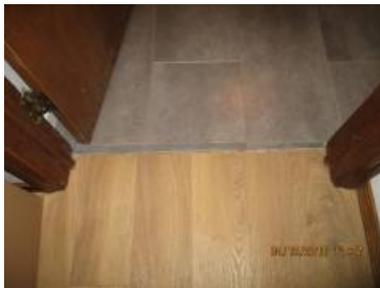
The hard surface flooring lacks a transition strip. The raised edge of the flooring is a hazard. We recommend the installation of a floor edge transition strip.

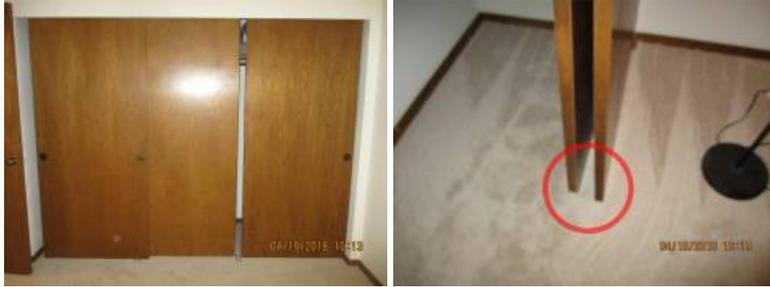
The floor guides are missing from the bypass closet doors in the bedrooms. Missing floor guides could result in damage to the doors. The installation of floor guides is recommended.

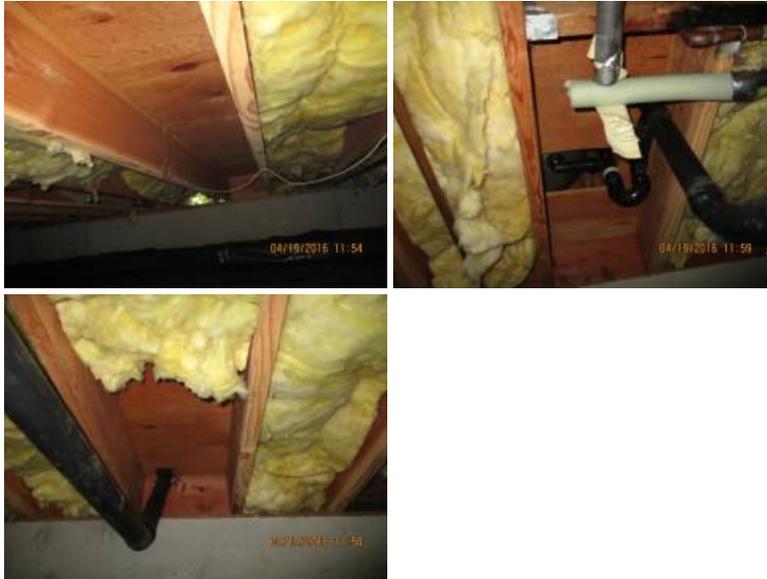
The floors are insulated with 6" R-19 fiberglass batts. Some of the insulation batts are missing. The missing batts should be replaced.

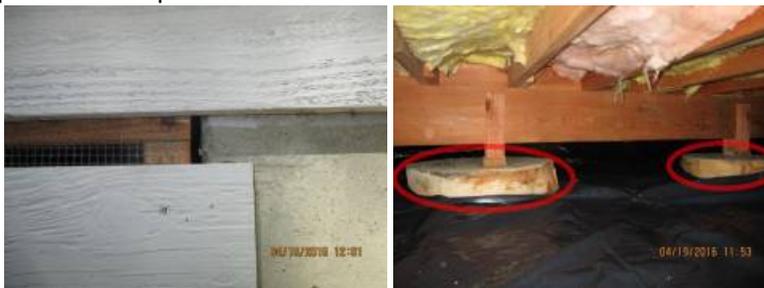
Good building practice requires that foundation walls or pier footings supporting wood frame construction, should extend at least 8" above the finish grade with at least a 6" clearance between the top of the soil and the bottom of the wood finish materials. Untreated wood should be raised 1-2" above surrounding flatwork and should have a moisture barrier such as 30 lb. asphalt impregnated felt installed between the concrete and wood. For additional information and treatment options, you should retain the services of a qualified pest control operator.
