PROJECT INFORMATION  
 OWNER: DAN QUINN  
 PROJECT: 13200 PLACE S.E. 10000  
 DESCRIPTION: 100'x100' PAVEMENT  
 PROJECT NUMBER: 242400-0330

AS-BUILT: 5-21-16 - SC#061  
9024 132<sup>4B</sup> PL. SE.  
PARCEL # 242400-0330

**Inspection Type: PROPERTY SALE - Correction Status: All corrections made**
**Tax ID: 2424000330**
**Inspection Date: 05/21/2016**
**GENERAL SYSTEM TYPE: Gravity**
**Customer / Property Owner Name:** Rob Welch
**Site Address:** 9024 132ND PL SE **City:** NEWCASTLE
**Mail Address:** \_\_\_\_\_ **City:** \_\_\_\_\_ **Zip:** \_\_\_\_\_

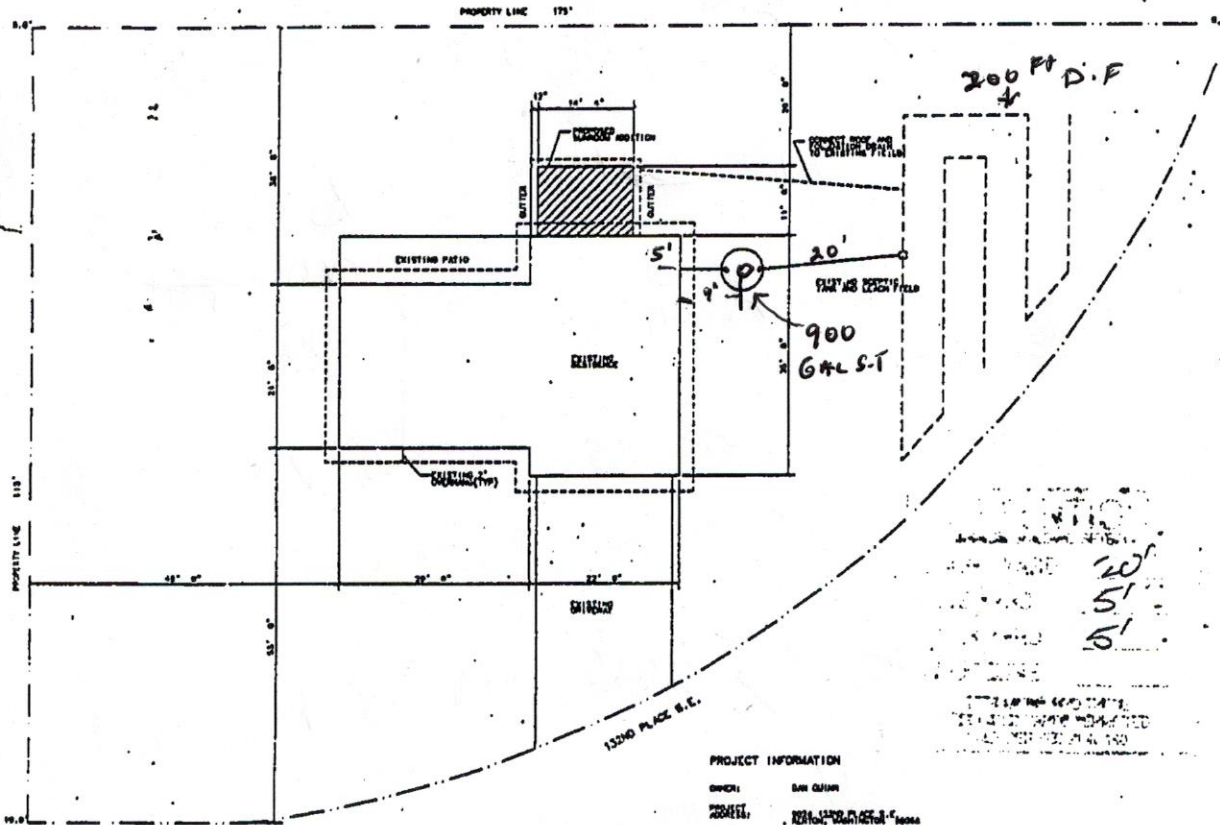
SITE PLAN  
 SCALE: 1/8" = 1'-0"

Drawing modified to show tank location, Septic tank pumped out
