**NOTICE TO BUYER: SELLER-PROCURED INSPECTION REPORT**

The following notice is given with respect to the Purchase and Sale Agreement dated \_\_\_\_\_  
between \_\_\_\_\_ (“Buyer”)  
and Steve and Helene Camara (“Seller”)  
concerning 1119 184th Pl SE, Bothell WA 98012 (“the Property”).

At your request, a visual inspection of the above referenced property was conducted on June 14, 2016. We have inspected the major structural components, plumbing, heating and electrical systems for signs of significant non-performance, excessive or unusual wear and general state of repair.

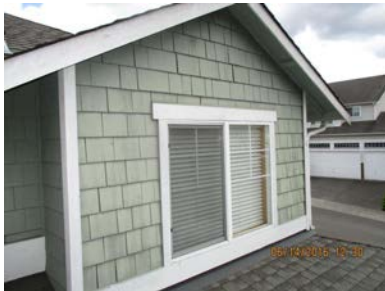
#### 3.6 PAINT

1. The paint on the high exposure areas of the exterior is deteriorated. Paint protects the wood from cupping, checking, warping and rot. Repainting the exposed areas is recommended.

3.6 Paint Done 6/15/16

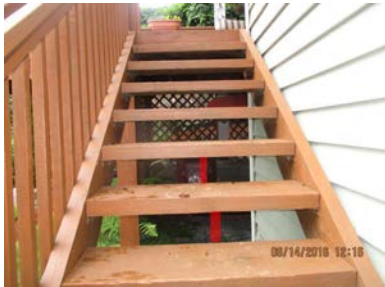
#### 3.9 STAIRS

2. The stair rise spacing is too wide. This is a hazard for small children. The spacing should be reduced as a safety upgrade. Current standards require that a 4" sphere not pass through the opening.

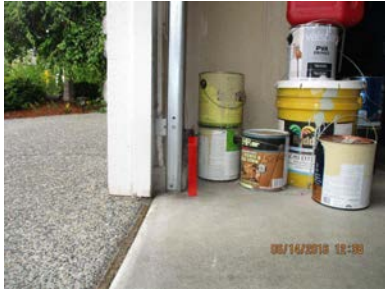
#### 6.3 GARAGE DOOR OPENER

3. The Photo-eye beam was installed to high above the floor of the garage to adequately offer protection for small children and/or pets. We recommend that the photo-eye be lowered to within 4-6" of the floor.

Garage Door 6.3 opener Done 6/19/16

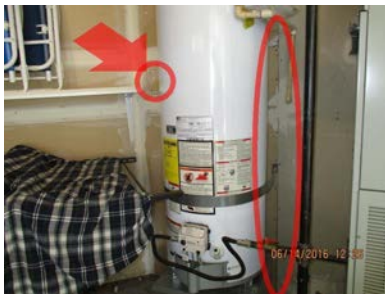
#### 6.4 FIRE SEPARATION

4. The fire resistive barrier between the garage and the living space is properly installed and in good condition, however, the joints adjacent the water heater are not taped. Consideration should be given to "fire taping" the drywall as a safety upgrade.

Fire Separation 6.4 barrier Done 6/18/16

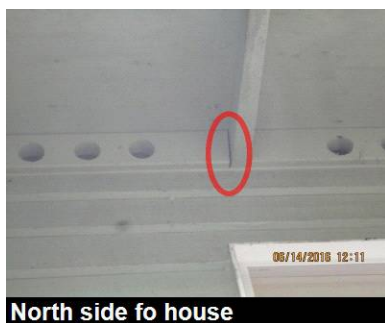
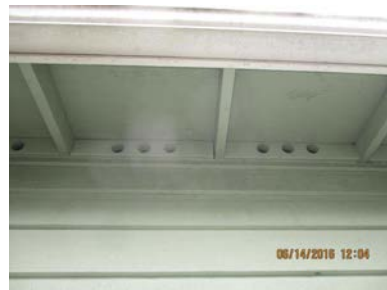
#### **3.4 SOFFITS AND OVERHANGS**

1. There are large gaps over 1/4" in size adjacent the soffit vent blocks. These gaps allow insects and rodents to enter the attic. Covering the gaps with screening, a strip of wood and/or caulking is recommended.

Building Exterior 3.4 Caulked 6/15/16

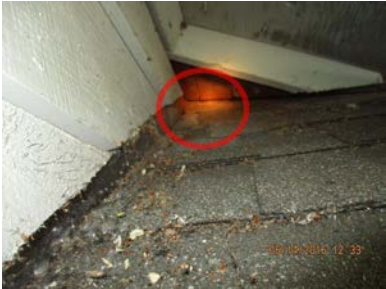
2. There are openings at the intersection between the overhang and the roof through which birds and rodents can enter into the attic. These openings should be covered with wood, wire mesh or filled with aerosol foam.

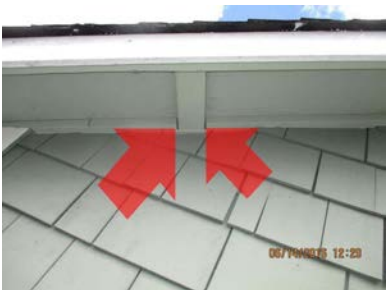
3. There are openings adjacent the ends of the outlook boards under the overhang through which insects and rodents can enter into the attic. These openings should be covered with wood, wire mesh or filled with aerosol foam.

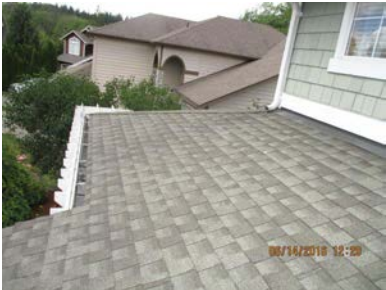
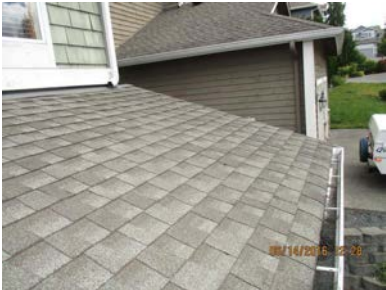
3.5 GUTTERS AND DOWNSPOUTS

4. Downspouts draining directly onto the asphalt shingle surface causes excessive wear of the roofing material. Downspout extensions should be installed to prevent excessive wear and tear of the roofing.

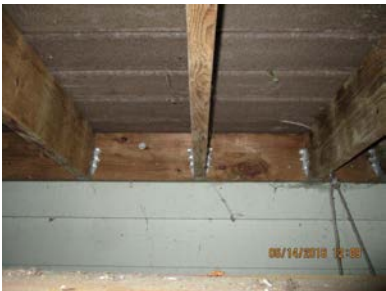
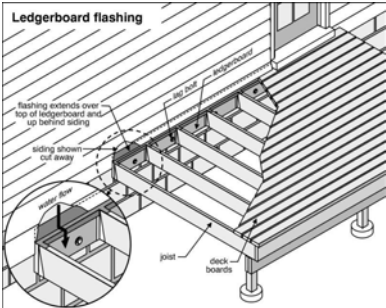
3.7 DECK

5. There is no flashing at the intersection between the deck and house. This will allow water to enter behind the siding. The installation of flashing in this area is recommended.

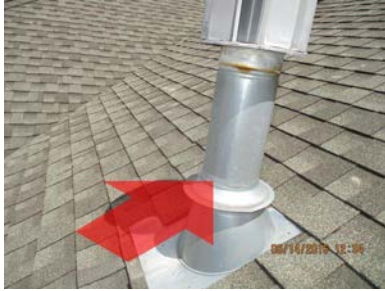
**4.5 GAS APPLIANCE VENTS**

6. The storm collar is not sealed. This is allowing leakage to occur. Sealing the storm collar is recommended.

Gas Appliance Vent 4.5 Done. 6/20/16

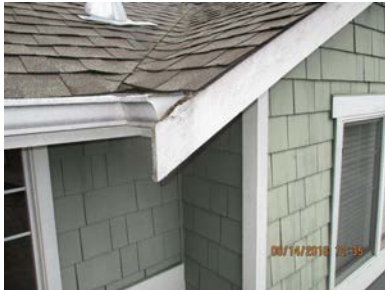
**4.7 MAINTENANCE AND REPAIRS**

7. The ends of the barge boards are exposed to the weather. This will eventually cause them to rot. To prevent damage to the barge board ends, they should be covered with roofing material or flashing.

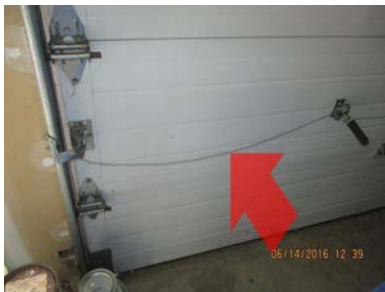
**6.2 OVERHEAD GARAGE DOORS**

8. The single garage door hardware is in need of adjustment and repair.

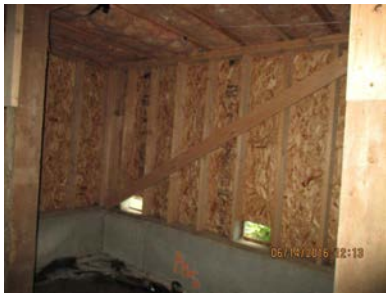
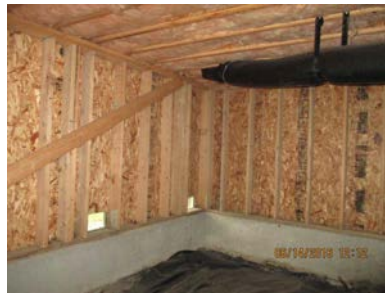
**18.7 SHEAR PANELS**

15. Shear panels are plywood or OSB panels that are mechanically fastened to both vertical and horizontal framing members in critical structural areas of the building. They prevent lateral movement of the structure during an earthquake. Shear panels are often visible in the crawlspace on cripple walls between the first floor and foundation. They may also be installed on interior walls that are covered with drywall. An examination of the crawlspace revealed the absence of shear panels on the cripple walls. The installation of shear panels on the cripple walls is recommended as an upgrade.

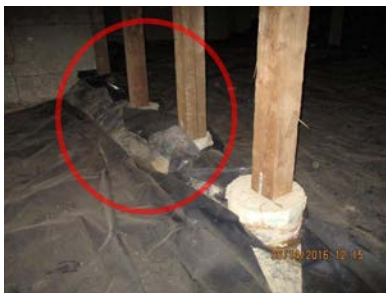
**19.4 VAPOR RETARDER**

16. The support post concrete piers are covered with the plastic vapor retarder. This allows the transmission of water vapor from the soil up and into the floor framing. The plastic vapor retarder should be removed from the pier so that it covers the entire surface of the soil only.

Crawl space 19.4 Done 6/19/16

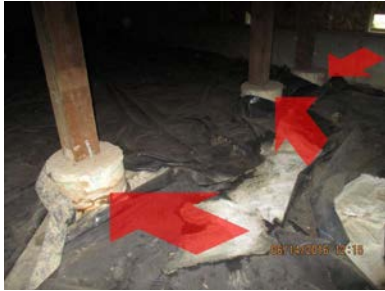
**19.5 PEST CONTROL**

17. Cellulose forms were left in place on the pier footings. This cellulose is conducive to the infestation of various wood destroying organisms. The removal of the cellulose is recommended.

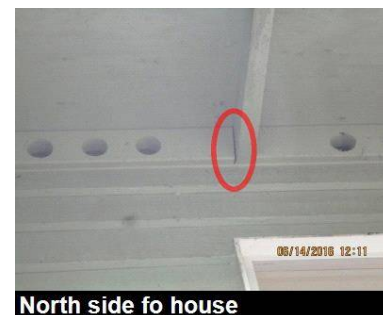
There are large gaps over 1/4" in size adjacent the soffit vent blocks. These gaps allow insects and rodents to enter the attic. Covering the gaps with screening, a strip of wood and/or caulking is recommended.

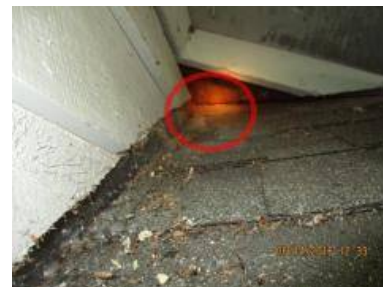
There are openings at the intersection between the overhang and the roof through which birds and rodents can enter into the attic. These openings should be covered with wood, wire mesh or filled with aerosol foam.

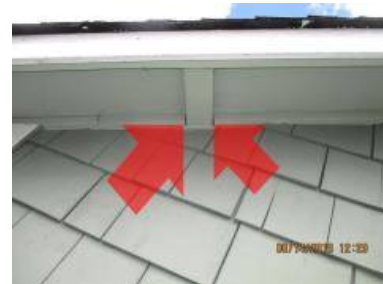
There are openings adjacent the ends of the outlook boards under the overhang through which insects and rodents can enter into the attic. These openings should be covered with wood, wire mesh or filled with aerosol foam.

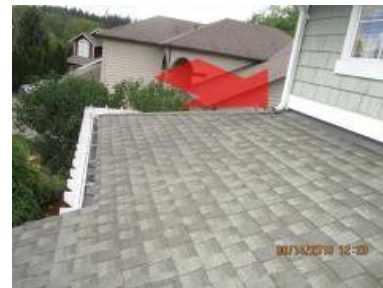
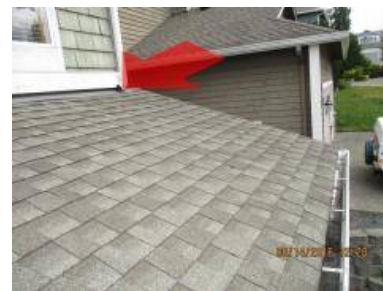
### 3.5 GUTTERS AND DOWNSPOUTS

Downspouts draining directly onto the asphalt shingle surface causes excessive wear of the roofing material. Downspout extensions should be installed to prevent excessive wear and tear of the roofing.

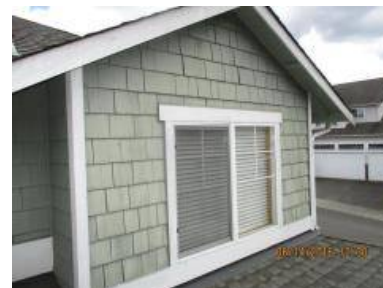
**3.6 PAINT**

The paint on the high exposure areas of the exterior is deteriorated. Paint protects the wood from cupping, checking, warping and rot. Repainting the exposed areas is recommended.

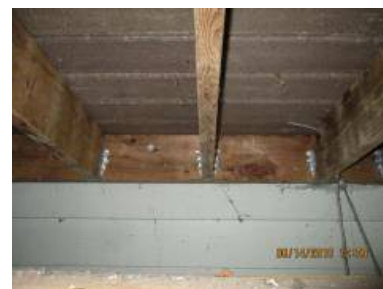
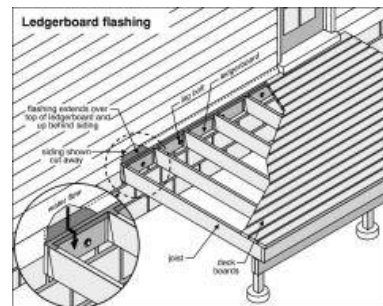
**3.7 DECK**

There is no flashing at the intersection between the deck and house. This will allow water to enter behind the siding. The installation of flashing in this area is recommended.

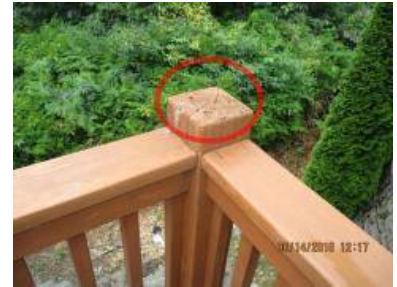
**3.8 DECK RAILINGS**

Minor rot deterioration of the wood deck railing posts was observed. The installation of metal post caps is recommended to prevent water intrusion into the center of the post.

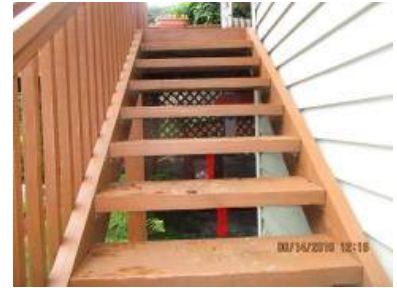
### 3.9 STAIRS

The stair rise spacing is too wide. This is a hazard for small children. The spacing should be reduced as a safety upgrade. Current standards require that a 4" sphere not pass through the opening.

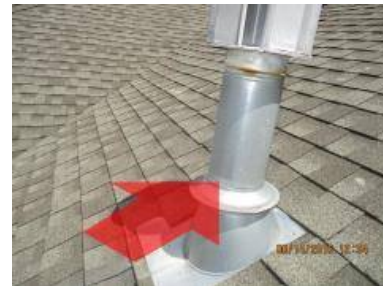
The storm collar is not sealed. This is allowing leakage to occur. Sealing the storm collar is recommended.

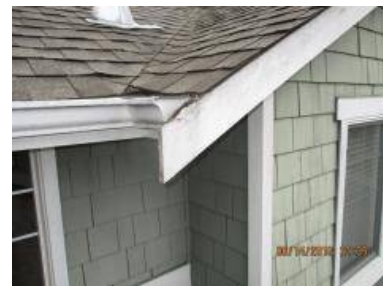
#### 4.7 MAINTENANCE AND REPAIRS

The ends of the barge boards are exposed to the weather. This will eventually cause them to rot. To prevent damage to the barge board ends, they should be covered with roofing material or flashing.

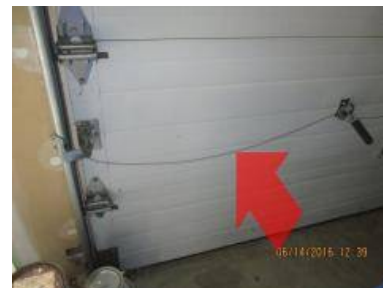
The single garage door hardware is in need of adjustment and repair.

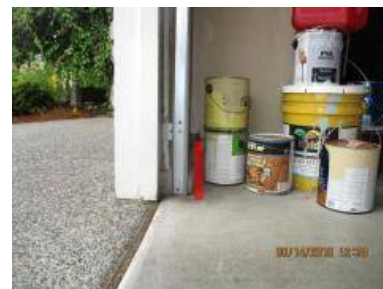
### 6.3 GARAGE DOOR OPENER

The Photo-eye beam was installed too high above the floor of the garage to adequately offer protection for small children and/or pets. We recommend that the photo-eye be lowered to within 4-6" of the floor.

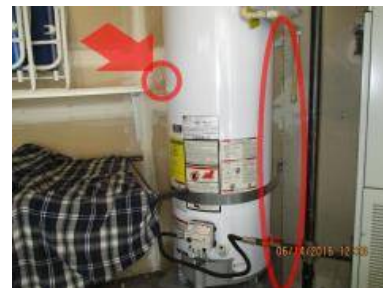
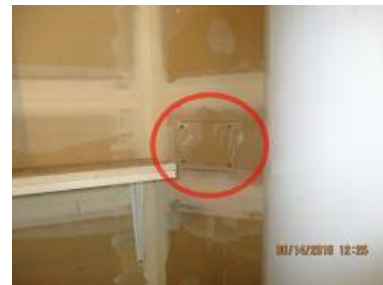
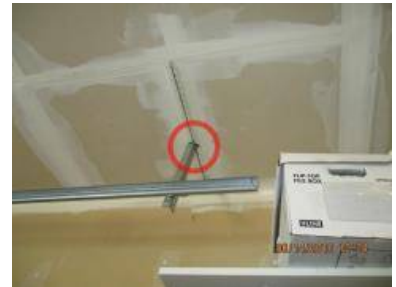
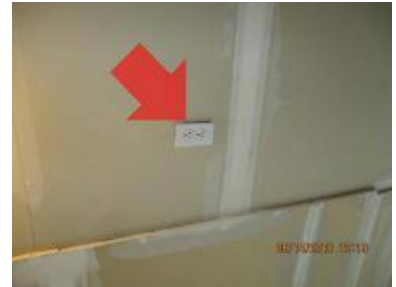
### 6.4 FIRE SEPARATION

The fire resistive barrier between the garage and the living space is properly installed and in good condition, however, the joints adjacent the water heater are not taped. Consideration should be given to "fire taping" the drywall as a safety upgrade.

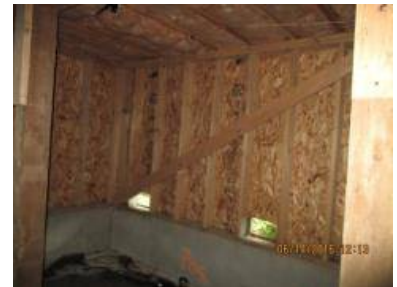
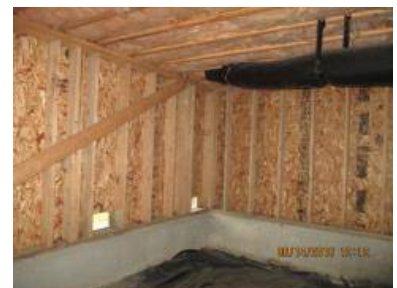
### 18.7 SHEAR PANELS

Shear panels are plywood or OSB panels that are mechanically fastened to both vertical and horizontal framing members in critical structural areas of the building. They prevent lateral movement of the structure during an earthquake. Shear panels are often visible in the crawlspace on cripple walls between the first floor and foundation. They may also be installed on interior walls that are covered with drywall. An examination of the crawlspace revealed the absence of shear panels on the cripple walls. The installation of shear panels on the cripple walls is recommended as an upgrade.

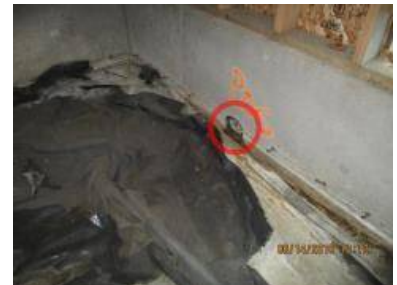
A drain has been installed in the crawlspace to remove incoming ground water. The drain was not tested and its adequacy was not determined.

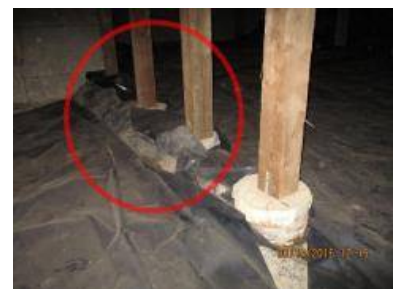
The support post concrete piers are covered with the plastic vapor retarder. This allows the transmission of water vapor from the soil up and into the floor framing. The plastic vapor retarder should be removed from the pier so that it covers the entire surface of the soil only.

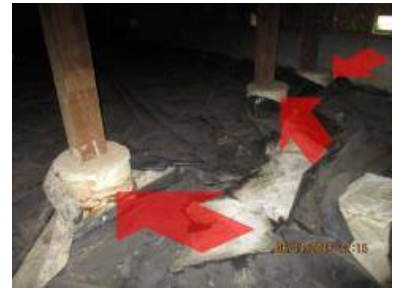
### 19.5 PEST CONTROL

Cellulose forms were left in place on the pier footings. This cellulose is conducive to the infestation of various wood destroying organisms. The removal of the cellulose is recommended.
