NOTICE TO BUYER: SELLER-PROCURED INSPECTION REPORT

13405 179th Ave NE

At your request, a visual inspection of the above referenced property was conducted on May 24, 2016. We have inspected the major structural components, plumbing, heating and electrical systems for signs of significant non-performance, excessive or unusual wear and general state of repair.

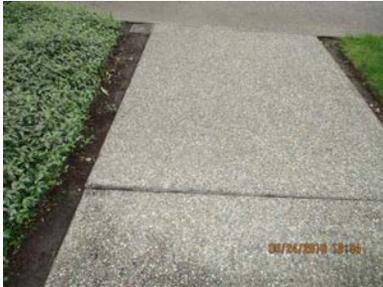
2.6 WALKWAY

2. The walkway has cracked and settled differentially. This was probably caused by inadequate preparation of the soil prior to the placement of the concrete. This condition can be repaired by pressure grouting the sunken portion of the walkway, grinding down the high edge of the concrete or by removing and replacing it. The walkway remains functional despite this condition. However, the raised edges of the concrete can be a trip hazard for some people. Grinding down the raised edges of the concrete will mitigate the hazard. Repairs should be made as necessary.

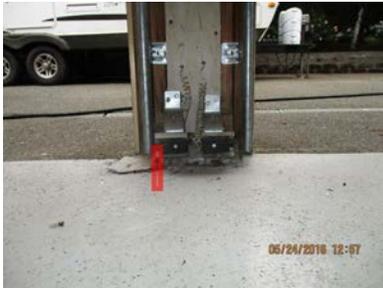
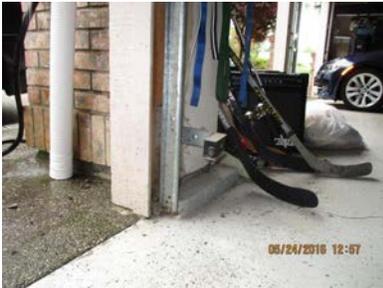
4. The Photo-eye beam for one of the garage doors was installed to high above the floor of the garage to adequately offer protection for small children and/or pets. We recommend that the photo-eye be lowered to within 4-6" of the floor.

The Photo-eye beam was installed to low to the floor of the garage to adequately offer protection for small children and/or pets for two of the doors. We recommend that the photo-eye be raised to within 4-6" of the floor.

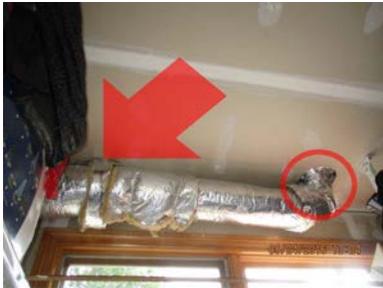
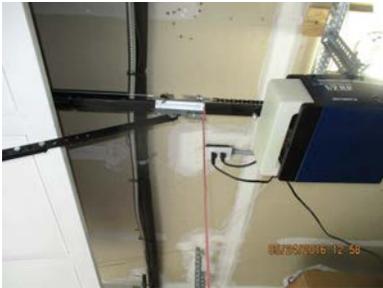
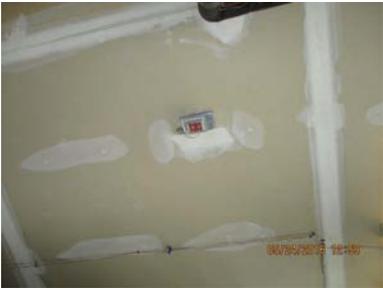
6.4 FIRE SEPARATION

5. There are voids in the fire resistive barrier between the living space and garage that will allow flames to penetrate. The gypsum barrier slows the spread of a fire from the garage to the structure and/or living space. Patching the voids is recommended.

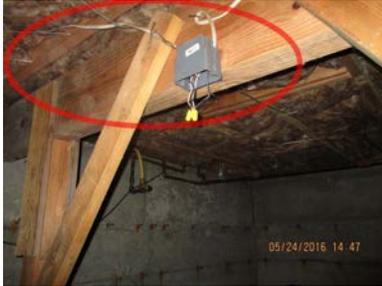
7. Splices in cable made outside of a junction box were observed in the crawlspace. This is a fire hazard. The splices should be made inside an approved box with a cover.

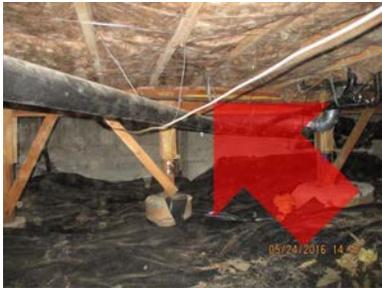
8. A loose electrical cable was observed in the crawlspace. Loose cables are vulnerable to damage. All loose cables should be secured at 4' intervals using approved cable staples.

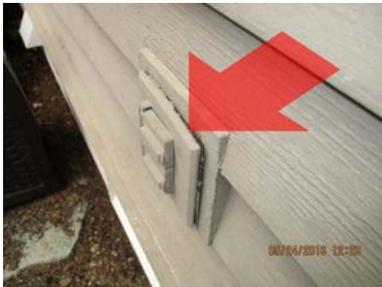
The cover plate is loose at the exterior receptacle. This is a shock and fire hazard. The installation of a weather tight cover plate is recommended.

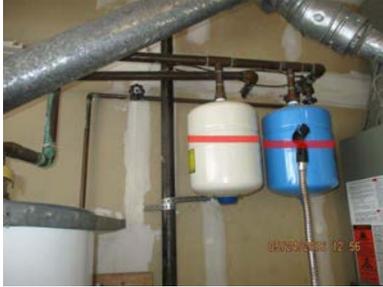
10.6 EXPANSION TANK

11. The expansion tanks are not adequately secured to the wall. This could result in damage to the water pipe and leakage during an earth quake. A seismic restraint should be installed to secure the expansion tanks.

10.6 Fixed

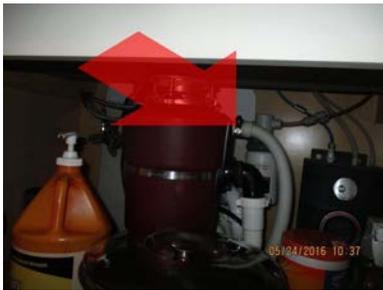
11.8 AIR GAP

13. The dishwasher drain lacks an air gap. The dishwasher will function without one, but there is a risk of contamination of the inside of the dishwasher by waste water. The installation of an air gap is recommended.

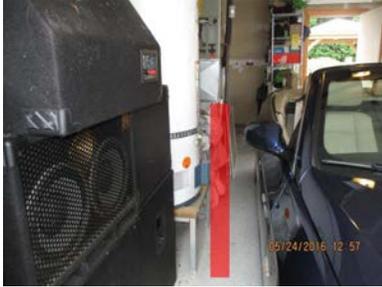
14.10 GAS PIPING

16. The gas pipes in front of the furnace and water heater are not protected by a bumper stop. A vertical steel pipe, bolted to the floor, is typically installed in front of the water heater to prevent a car bumper from damaging the gas lines.

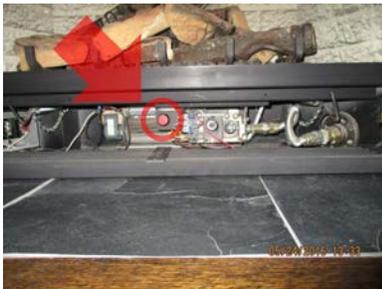
16.1 METAL FIREPLACES

18. The pilot light was not working and the direct vent fireplace in the family room was not tested. The operation of this gas appliance was not verified.

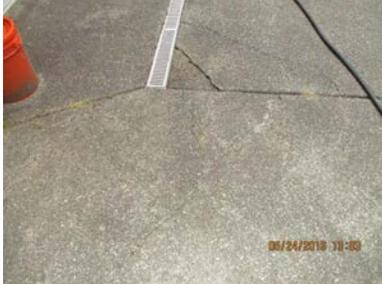
2.4 DRIVEWAY

2. A small section of the driveway has cracked and settled differentially. This was probably caused by inadequate preparation of the soil prior to the placement of the concrete. This condition can be repaired by pressure grouting the sunken portion of the driveway or by removing and replacing it. The driveway remains functional despite this condition.

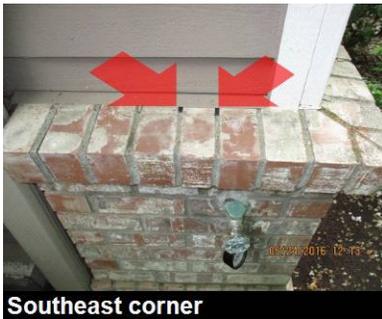
3.2 SECONDARY EXTERIOR WALL CLADDING

3. Deteriorated mortar joints of the brick veneer is allowing for moisture penetration. Consideration should be given to retooling (Tuck pointing) the defective mortar joints.

3.2 Fixed

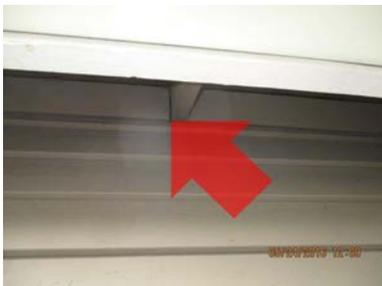
3.4 SOFFITS AND OVERHANGS

4. There is a large gap over 1/4" in size adjacent one of the soffit vent blocks. Large gaps allow insects and rodents to enter the attic. Covering the gap with screening, a strip of wood and/or caulking is recommended.

3.4 There was only one gap and it is now filled

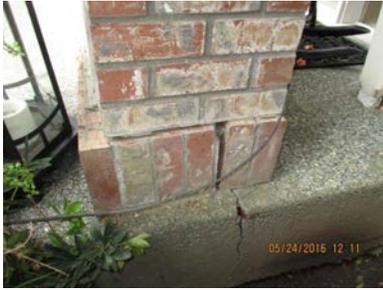
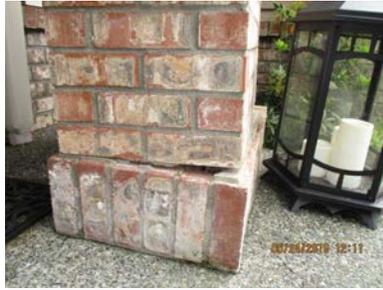
3.7 PORCH

5. The front porch stoop has rotated away from the foundation. This is caused by settlement of the backfill under the stoop. This will not adversely affect the foundation. In most cases, settlement occurs within the first few years after the concrete porch stoop is built. This condition is not likely to worsen in the near future. If further movement or settlement is observed, pressure grouting for additional support could be considered.

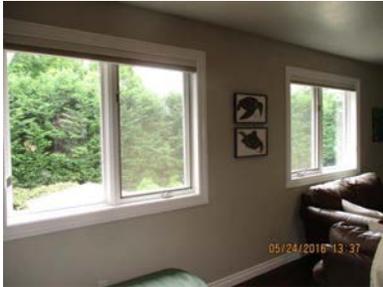
15.8 WINDOWS

11. Two of the windows in the family room do not operate smoothly which makes them difficult to open and close. Windows should be adjusted or repaired as necessary to improve operation.

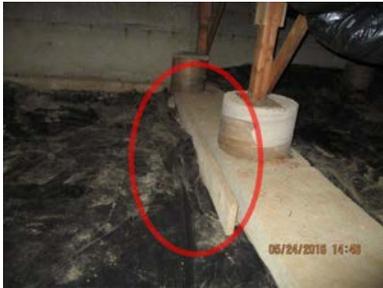
13. Form wood was left in place on the footings. This wood is conducive to the infestation of various wood destroying organisms. The removal of the form wood is recommended.

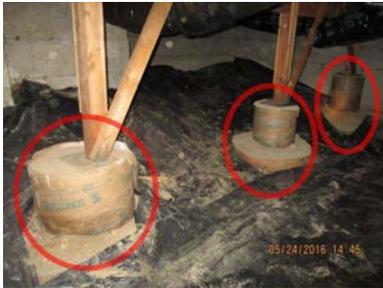
14. Cellulose forms were left in place on the pier footings. This cellulose is conducive to the infestation of various wood destroying organisms. The removal of the cellulose is recommended.

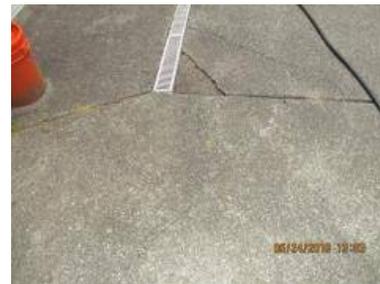
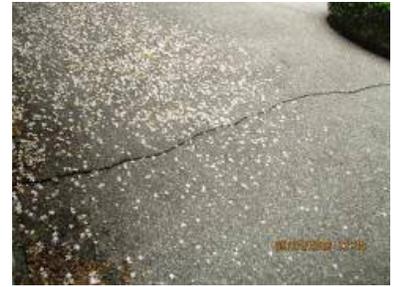
2.5 PATIO

The patio has settled differentially. This was probably caused by inadequate preparation of the soil prior to the placement of the concrete. This condition can be repaired by pressure grouting the sunken portion of the patio, grinding down the high edge of the concrete or by removing and replacing it. The patio remains functional despite this condition. However, the raised edges of the concrete can be a trip hazard for some people. Repairs should be made as necessary.

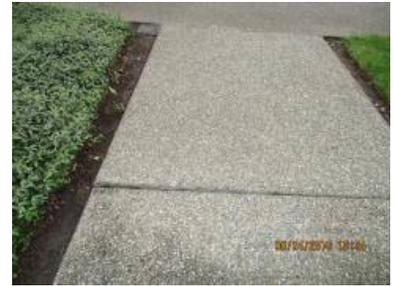
2.6 WALKWAY

The walkway has cracked and settled differentially. This was probably caused by inadequate preparation of the soil prior to the placement of the concrete. This condition can be repaired by pressure grouting the sunken portion of the walkway, grinding down the high edge of the concrete or by removing and replacing it. The walkway remains functional despite this condition. However, the raised edges of the concrete can be a trip hazard for some people. Grinding down the raised edges of the concrete will mitigate the hazard. Repairs should be made as necessary.

Many legal and public works departments have defined a trip hazard as an irregularity in a walking surface exceeding one inch (1") in height. All walking surfaces should maintain, free of a vertical surface change of 3/4" or more, in the interest of public and personal safety.

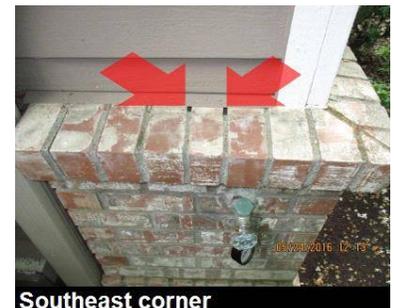
Southeast corner

Deteriorated mortar joints of the brick veneer is allowing for moisture penetration. Consideration should be given to retooling (Tuck pointing) the defective mortar joints.

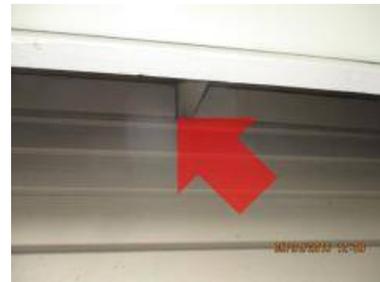
There are large gaps over 1/4" in size adjacent the soffit vent blocks. These gaps allow insects and rodents to enter the attic. Covering the gaps with screening, a strip of wood and/or caulking is recommended.

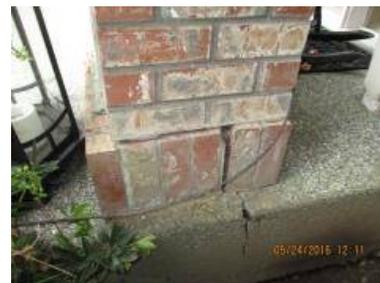
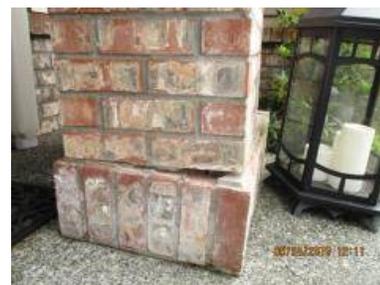
3.7 PORCH

The front porch stoop has rotated away from the foundation. This is caused by settlement of the backfill under the stoop. This will not adversely affect the foundation. In most cases, settlement occurs within the first few years after the concrete porch stoop is built. This condition is not likely to worsen in the near future. If further movement or settlement is observed, pressure grouting for additional support could be considered.

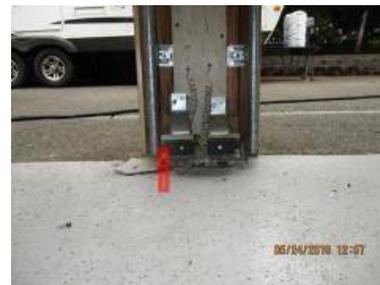
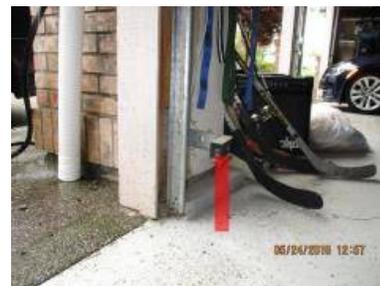
The Photo-eye beam was installed to low to the floor of the garage to adequately offer protection for small children and/or pets for two of the doors. We recommend that the photo-eye be raised to within 4-6" of the floor.

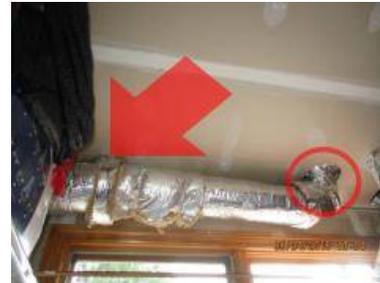
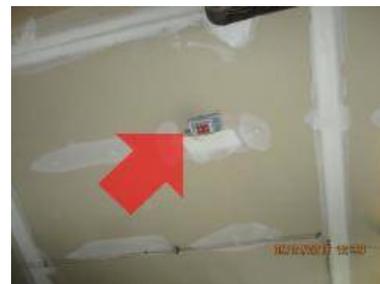
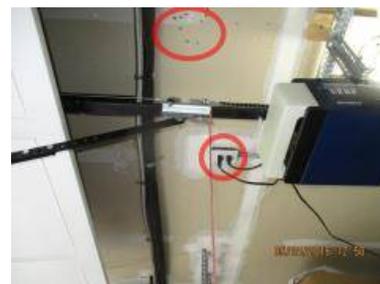
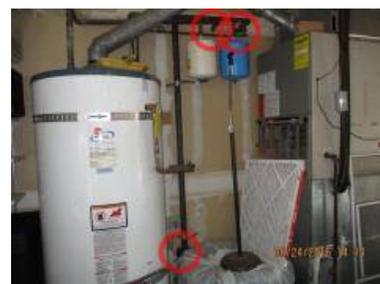
6.4 FIRE SEPARATION

There are voids in the fire resistive barrier between the living space and garage that will allow flames to penetrate. The gypsum barrier slows the spread of a fire from the garage to the structure and/or living space. Patching the voids is recommended.

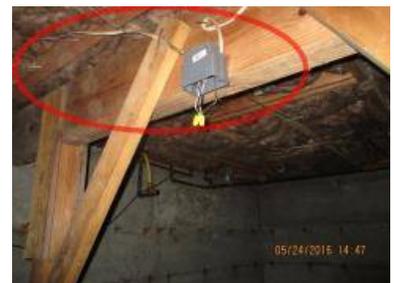
Splices in cable made outside of a junction box were observed in the crawlspace. This is a fire hazard. The splices should be made inside an approved box with a cover.

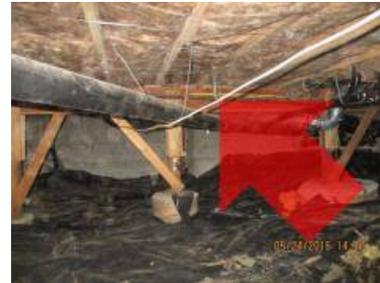
A loose electrical cable was observed in the crawlspace. Loose cables are vulnerable to damage. All loose cables should be secured at 4' intervals using approved cable staples.

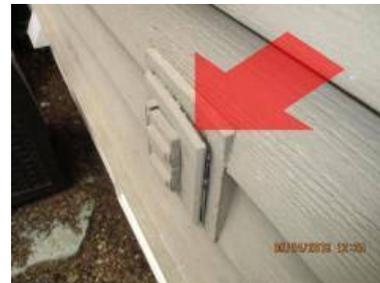
The cover plate is loose at the exterior receptacle. This is a shock and fire hazard. The installation of a weather tight cover plate is recommended.

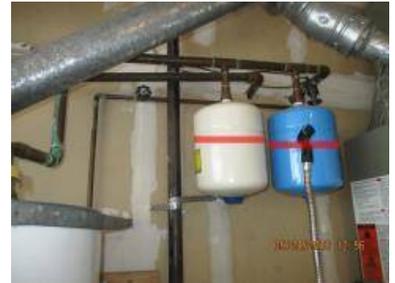
The expansion tanks are not adequately secured to the wall. This could result in damage to the water pipe and leakage during an earth quake. A seismic restraint should be installed to secure the expansion tanks.

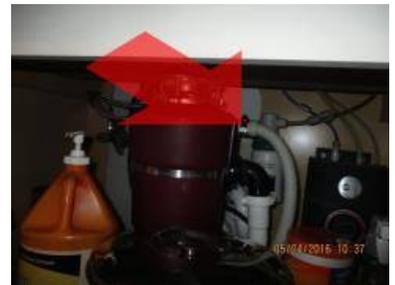
11.8 AIR GAP

The dishwasher drain lacks an air gap. The dishwasher will function without one, but there is a risk of contamination of the inside of the dishwasher by waste water. The installation of an air gap is recommended.

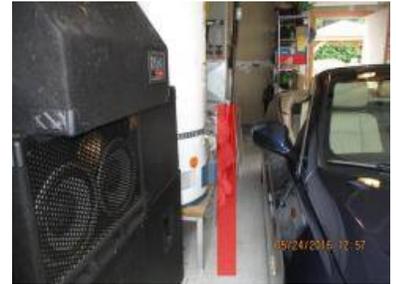
14.10 GAS PIPING

The gas pipes in front of the furnace and water heater are not protected by a bumper stop. A vertical steel pipe, bolted to the floor, is typically installed in front of the water heater to prevent a car bumper from damaging the gas lines.

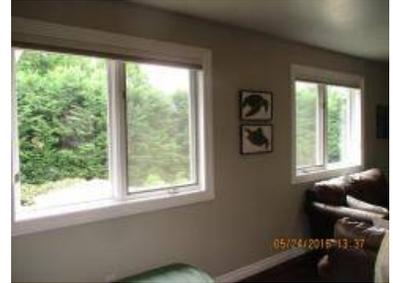
Two of the windows in the family room do not operate smoothly which makes them difficult to open and close. Windows should be adjusted or repaired as necessary to improve operation.

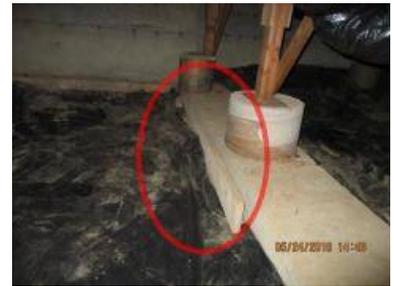
Form wood was left in place on the footings. This wood is conducive to the infestation of various wood destroying organisms. The removal of the form wood is recommended.

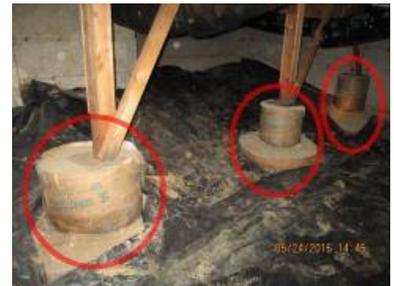
Cellulose forms were left in place on the pier footings. This cellulose is conducive to the infestation of various wood destroying organisms. The removal of the cellulose is recommended.
