NOTICE TO BUYER: SELLER-PROCURED INSPECTION REPORT

June 9, 2016

**Re: 14315 173rd Pl. NE
Redmond, WA.**

At your request, a visual inspection of the above referenced property was conducted on June 7, 2016. We have inspected the major structural components, plumbing, heating and electrical systems for signs of significant non-performance, excessive or unusual wear and general state of repair.

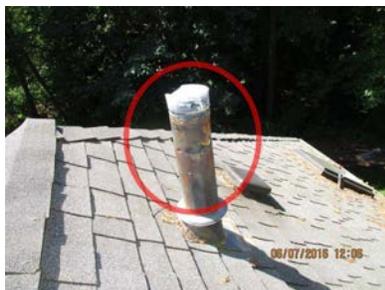
1. The cap is missing from the top of the gas appliance vent. This can affect the reliability of the gas appliance. The installation of a U.L. listed type B vent cap is recommended.

Portions of the gas appliance vent pipe may need to be replaced to assure proper mounting of the vent cap.

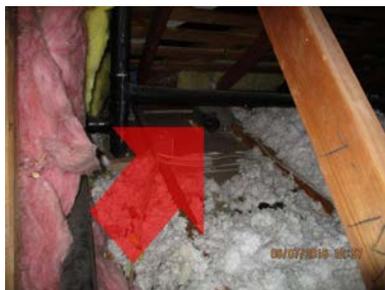
2. The bathroom vent fan discharges in the attic rather than outside. This is an undesirable condition that causes excessive moisture in the attic and can result in mold or fungus growth. A 4" smooth-wall sheet metal duct should be installed to direct the moisture laden air discharged from the fan out of the attic.

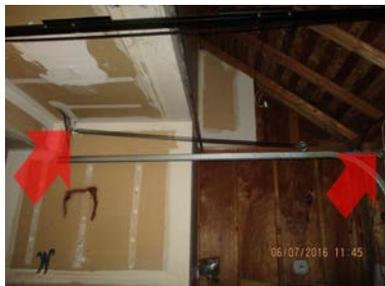
3. Safeties are cables run through the center of the garage door springs that prevent broken springs from becoming projectiles that can cause injury. There are no safeties installed. The installation of safeties is recommended.

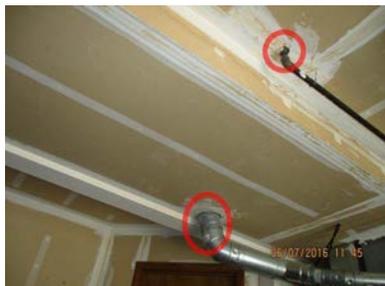
5. There are voids in the fire resistive barrier between the living space and garage that will allow flames to penetrate. The gypsum barrier slows the spread of a fire from the garage to the structure and/or living space. Patching the voids is recommended.

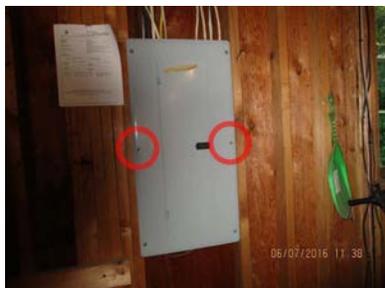
7. Screws that secure the panel cover to the panel box are missing. This is a potential hazard. Missing screws should be replaced with the original style blunt end screws.

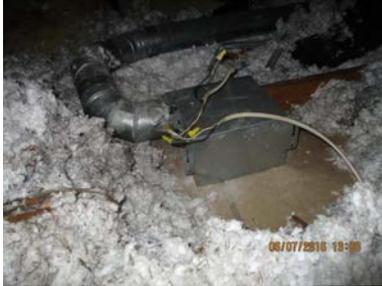
8. Splices in cable made outside of a junction box were observed in the attic. This is a fire hazard. The splices should be made inside an approved box with a cover.

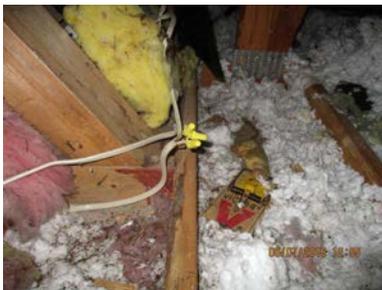
9. Loose electrical cables were observed in the attic. Loose cables are vulnerable to damage. All loose cables should be secured at 4' intervals using approved cable staples.

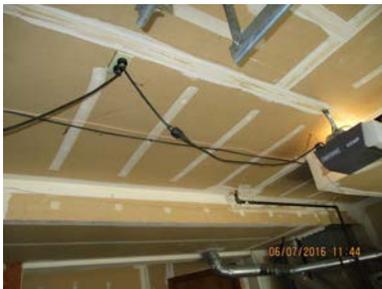
10. An extension cord is used as a temporary power source for the garage door openers. An extension cord is not suitable as a permanent wiring method. The installation of a receptacle within cords length of the motors is recommended.

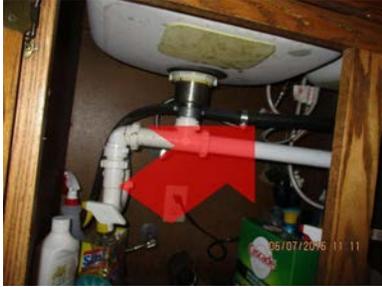
contamination of the inside of the dishwasher by waste water. The installation of an air gap is recommended.

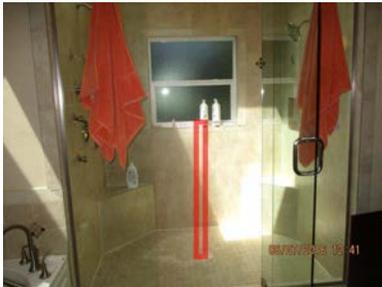
16. The bottom edge of the shower wall window is less than 60" above the standing surface and drain inlet and is not safety glass. The glass should be replaced with tempered safety glass in order to prevent possible injury in the event of breakage.

The window in the shower wall surround is vulnerable to water intrusion. It is essential the the window sill be kept sealed. The installation of a shower curtain over the window will also help reduce water intrusion problems.

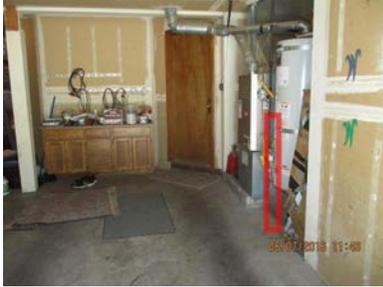
17. The gas pipes in front of the furnace and water heater are not protected by a bumper stop. A vertical steel pipe, bolted to the floor, is typically installed in front of the water heater to prevent a car bumper from damaging the gas lines.

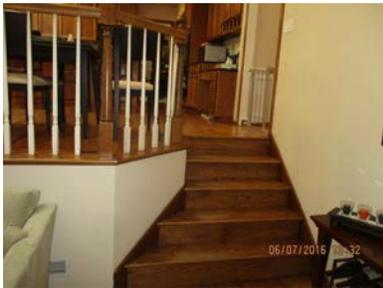
18. There is no handrail in the lower stairwell. This is a safety hazard. The installation of a graspable handrail that conforms to present industry standards is recommended.

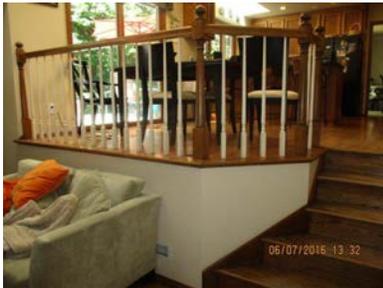
19. The spacing between the balusters is too wide. This is a hazard to small children. The balusters should be spaced close enough together so that a 4" sphere cannot pass through. Upgrading the guard railing is recommended if small children are present.

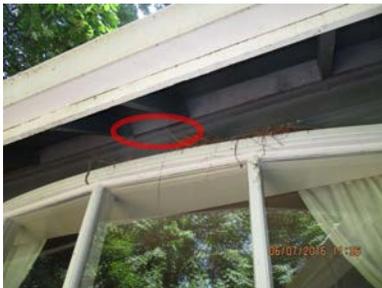
1. There are large gaps over 1/4" in size adjacent the soffit vent blocks. These gaps allow insects and rodents to enter the attic. Covering the gaps with screening, a strip of wood and/or caulking is recommended.

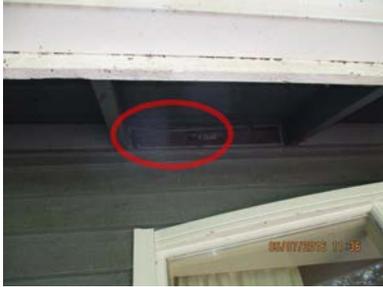
2. There is a damaged soffit vent on the front of the house. The vent screen should be repaired to prevent insect, bird and rodent entry.

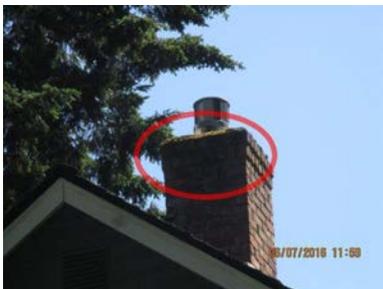
3. Moss/vegetation was observed in several areas around the upper portion of the chimney. This will lead to accelerated deterioration of the brick masonry mortar. We recommend removal of all organic growth. Damaged areas can be repaired by filling in cutout or defective mortar joints with fresh mortar. (Tuck pointing)

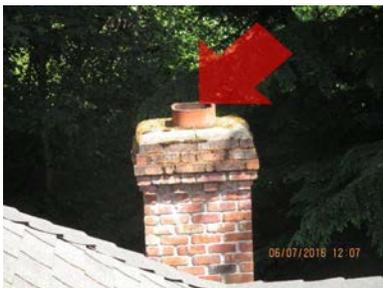
4. The top of the north masonry chimney does not have a spark arrestor/rain cap. The installation of a spark arrestor/rain cap is recommended as a safety upgrade and to prevent moisture damage to the inside of the chimney and fireplace. An additional benefit of a rain cap is that it will keep birds and rodents from entering the house when the damper is left open.

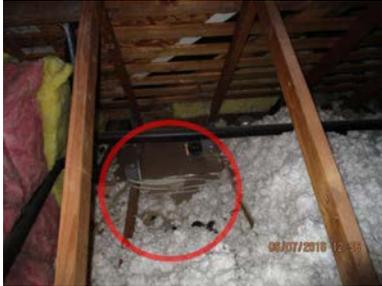
in to the space to replace it. This condition will result in significant heat loss. Sealing up all thermal bypass routes is recommended.

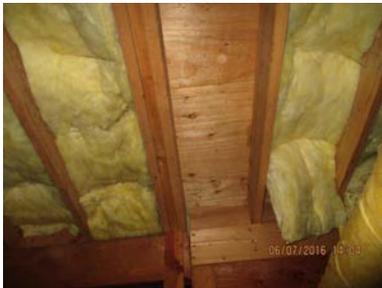
18. Some of the insulation batts are missing and several were not properly secured and have falling down. The fallen batts should be reinstated and secured. The missing batts should be replaced.

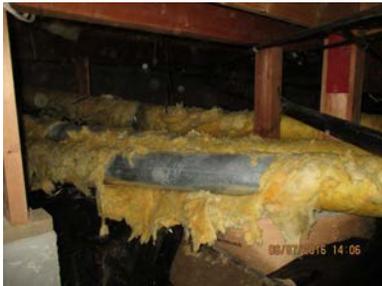
19. Some of the duct insulation is missing or has fallen off the ducts. This increases the amount of heat loss. The installation of new duct insulation is recommended in areas where insulation is missing.

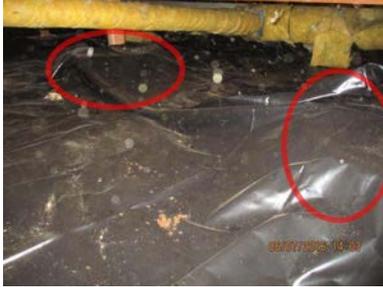
20. The support post concrete piers are covered with the plastic vapor retarder. This allows the transmission of water vapor from the soil up and into the floor framing. The plastic vapor retarder should be removed from the pier so that it covers the entire surface of the soil only.

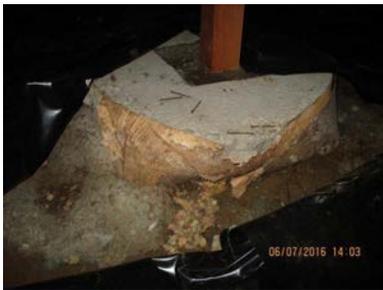
21. There is evidence of rodent activity in the crawlspace. The first step in eliminating rodents from the crawlspace is to seal all possible entry points using wire mesh, caulking, wood, stainless steel wool, aerosol foam or mortar. Careful work sealing cracks, holes, gaps, and covering ground water drain inlets will discourage rodent activity. Once this work is completed, snap traps baited with peanut butter should be installed and monitored. The absence of rodents in the traps typically means that the rodents have been excluded from the area.

Cellulose forms were left in place on the pier footings. This cellulose is conducive to the infestation of various wood destroying organisms. The removal of the cellulose is recommended.

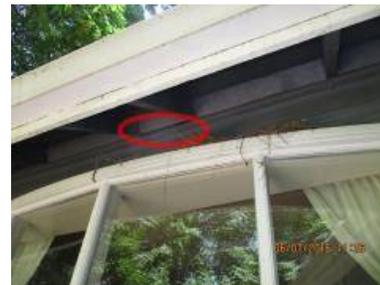
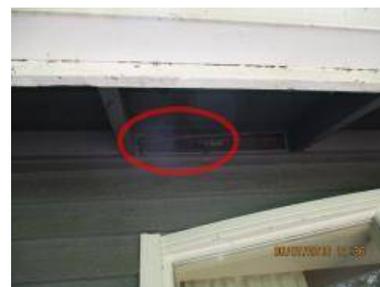
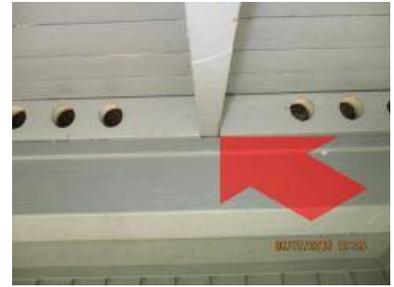
There is a damaged soffit vent on the front of the house. The vent screen should be repaired to prevent insect, bird and rodent entry.

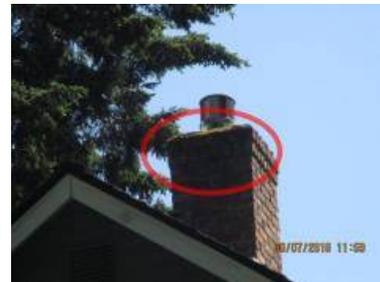
Moss/vegetation was observed in several areas around the upper portion of the chimney. This will lead to accelerated deterioration of the brick masonry mortar. We recommend removal of all organic growth. Damaged areas can be repaired by filling in cutout or defective mortar joints with fresh mortar. (Tuck pointing)

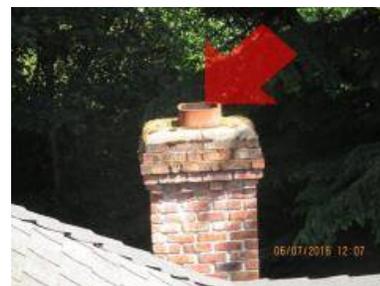
The top of the north masonry chimney does not have a spark arrestor/rain cap. The installation of a spark arrestor/rain cap is recommended as a safety upgrade and to prevent moisture damage to the inside of the chimney and fireplace. An additional benefit of a rain cap is that it will keep birds and rodents from entering the house when the damper is left open.

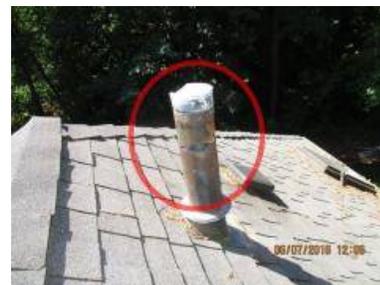
Portions of the gas appliance vent pipe may need to be replaced to assure proper mounting of the vent cap.

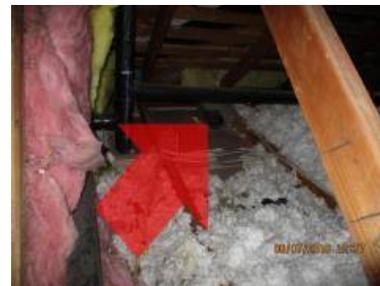
The bathroom vent fan discharges in the attic rather than outside. This is an undesirable condition that causes excessive moisture in the attic and can result in mold or fungus growth. A 4" smooth-wall sheet metal duct should be installed to direct the moisture laden air discharged from the fan out of the attic.

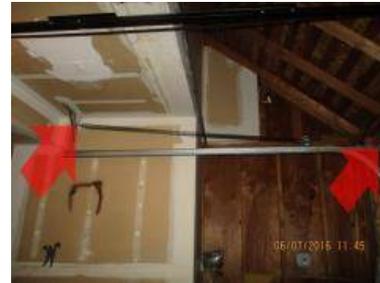
Safeties are cables run through the center of the garage door springs that prevent broken springs from becoming projectiles that can cause injury. There are no safeties installed. The installation of safeties is recommended.

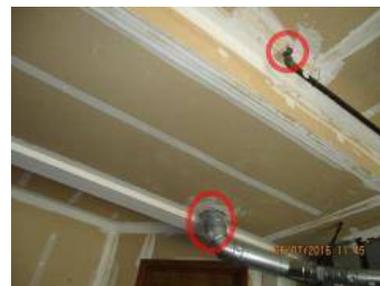
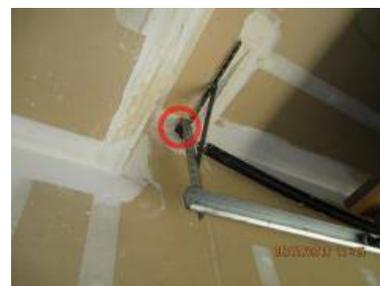
There are voids in the fire resistive barrier between the living space and garage that will allow flames to penetrate. The gypsum barrier slows the spread of a fire from the garage to the structure and/or living space. Patching the voids is recommended.

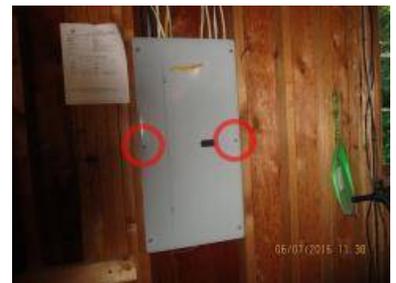
Screws that secure the panel cover to the panel box are missing. This is a potential hazard. Missing screws should be replaced with the original style blunt end screws.

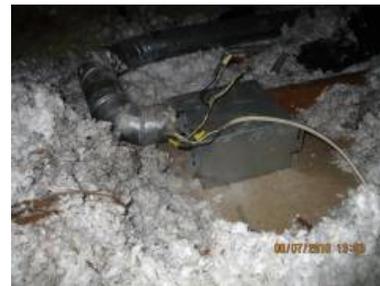
Splices in cable made outside of a junction box were observed in the attic. This is a fire hazard. The splices should be made inside an approved box with a cover.

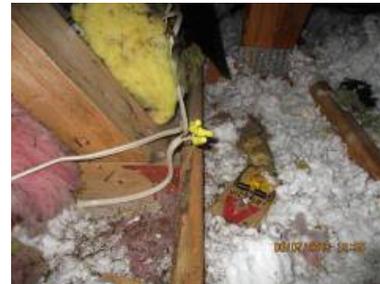
Loose electrical cables were observed in the attic. Loose cables are vulnerable to damage. All loose cables should be secured at 4' intervals using approved cable staples.

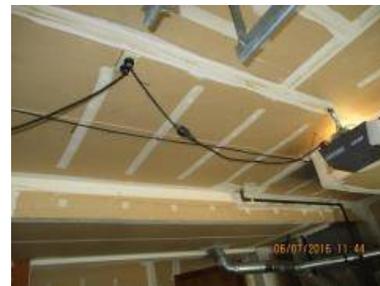
An extension cord is used as a temporary power source for the garage door openers. An extension cord is not suitable as a permanent wiring method. The installation of a receptacle within cords length of the motors is recommended.

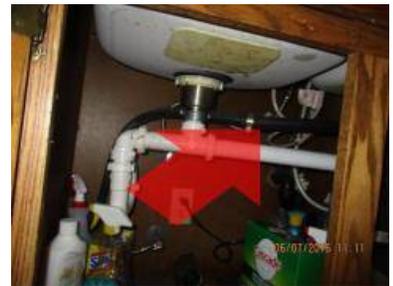
The dishwasher drain lacks an air gap. The dishwasher will function without one, but there is a risk of contamination of the inside of the dishwasher by waste water. The installation of an air gap is recommended.

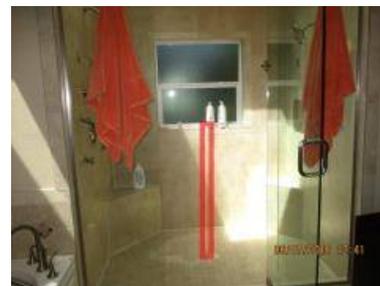
The window in the shower wall surround is vulnerable to water intrusion. It is essential the the window sill be kept sealed. The installation of a shower curtain over the window will also help reduce water intrusion problems.

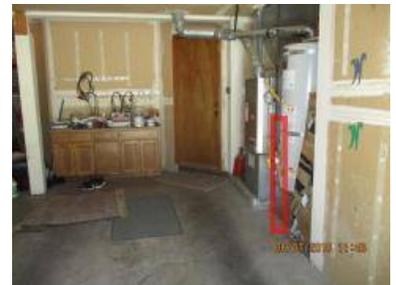
The gas pipes in front of the furnace and water heater are not protected by a bumper stop. A vertical steel pipe, bolted to the floor, is typically installed in front of the water heater to prevent a car bumper from damaging the gas lines.

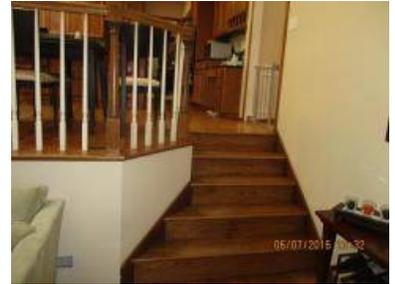
There is no handrail in the lower stairwell. This is a safety hazard. The installation of a graspable handrail that conforms to present industry standards is recommended.

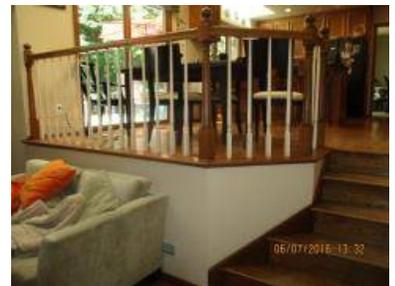
The spacing between the balusters is too wide. This is a hazard to small children. The balusters should be spaced close enough together so that a 4" sphere cannot pass through. Upgrading the guard railing is recommended if small children are present.

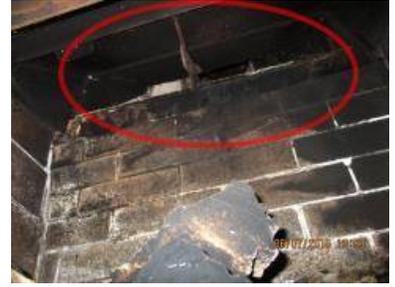
The living rooms fireplace damper is stuck in the open position. This allows heat to escape up the chimney and could result in odors emanating from the fireplace. Repairing the damper is recommended.

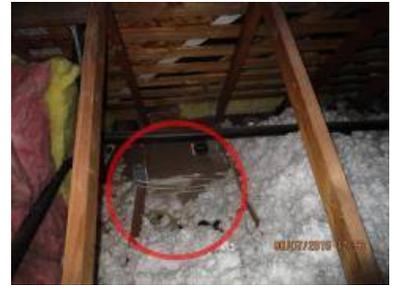
There are several thermal bypasses in the attic. A thermal bypass is an opening between an insulated and uninsulated part of the house through which heated air can escape. As air is heated, it rises and pulls cool air in to the space to replace it. This condition will result in significant heat loss. Sealing up all thermal bypass routes is recommended.

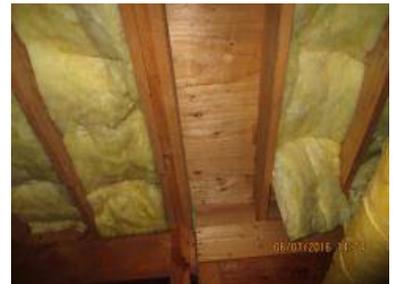
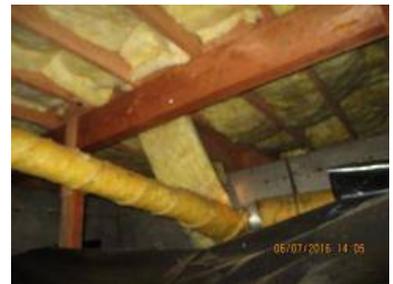
Some of the insulation batts are missing and several were not properly secured and have falling down. The fallen batts should be reinstalled and secured. The missing batts should be replaced.

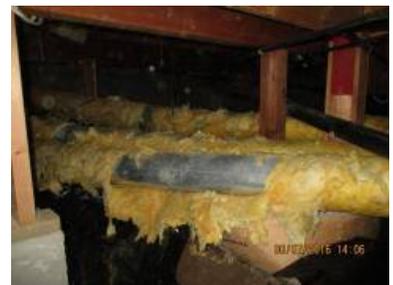
Some of the duct insulation is missing or has fallen off the ducts. This increases the amount of heat loss. The installation of new duct insulation is recommended in areas where insulation is missing.

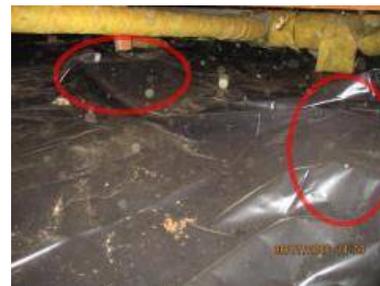
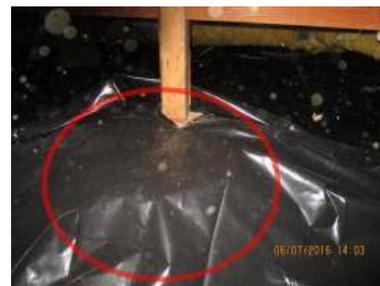
The support post concrete piers are covered with the plastic vapor retarder. This allows the transmission of water vapor from the soil up and into the floor framing. The plastic vapor retarder should be removed from the pier so that it covers the entire surface of the soil only.

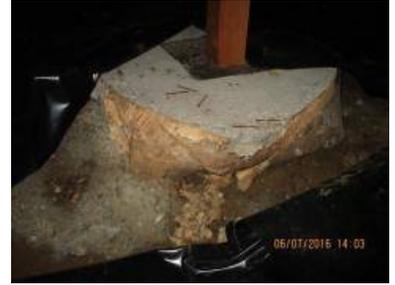
Cellulose forms were left in place on the pier footings. This cellulose is conducive to the infestation of various wood destroying organisms. The removal of the cellulose is recommended.
