**NOTICE TO BUYER: SELLER-PROCURED INSPECTION REPORT**

The following notice is given with respect to the Purchase and Sale Agreement dated \_\_\_\_\_  
between \_\_\_\_\_ (“Buyer”)  
and **Robert Welch** \_\_\_\_\_ (“Seller”)  
concerning **9024 132nd Pl SE, Newcastle** (“the Property”).

May 21, 2016

9024 132nd Pl. SE  
Newcastle WA.

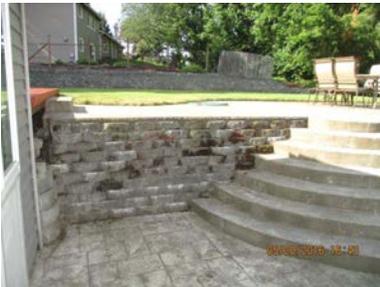
1. There is no guardrail at the patio. This is a hazard for small children. The installation of a guardrail that conforms to present industry standards is recommended if small children are present.

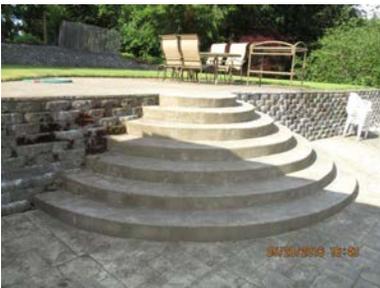
**2.7 STEPS**

2. There is no handrail along the stairs. This is a hazard. The installation of a handrail along the stairs is recommended.

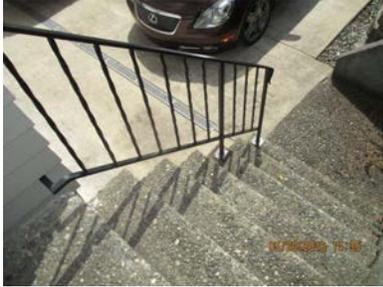
**3.7 STAIRS**

3. The spacing under stair railing is too wide. This is a hazard for small children. The spacing should be reduced as a safety upgrade. Current standards require that a 4" sphere not pass under the railing.

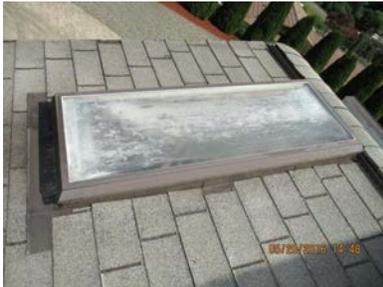
5. The seal between the glass panes has failed in the skylight above the family room. Repairs should be made as necessary.

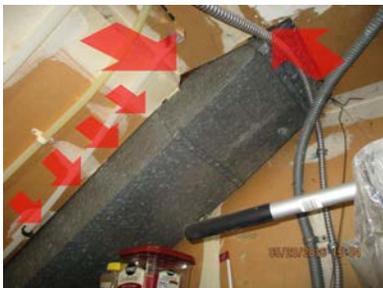
7. There are voids in the fire resistive barrier between the living space and garage that will allow flames to penetrate. The gypsum barrier slows the spread of a fire from the garage to the structure and/or living space. Patching the voids is recommended.

6.4: Installed fire resistant barrier.

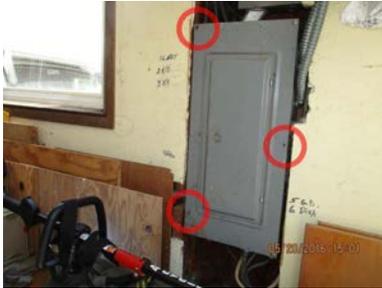
9. Screws that secure the panel cover to the panel box are missing. This is a potential hazard. Missing screws should be replaced with the original style blunt end screws.

7.9: Installed missing screws in service panel.

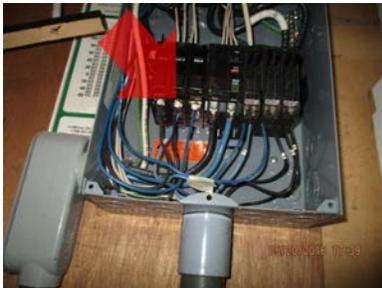
### 7.11 OVER CURRENT PROTECTION

10. One of the circuits in the subpanel is double tapped. Double tapping means that two conductors share a single terminal. Double tapped terminals can loosen and overheat and therefore are not permitted unless the terminal is specifically listed for multiple wires. This defect is easily repaired by connecting the two wires to a "pig tail", securing them with a wire cap, and then inserting the pig tail conductor under the terminal.

7.11: Rewired to provide circuit breaker with single tap connection.

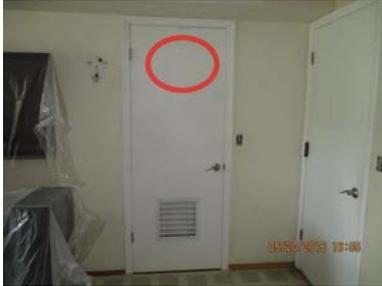
14. The combustion supply is inadequate. Most appliance manufacturers and municipalities require that there be at least two openings of 100 square inches. The upper opening should be within 12" of the ceiling. The lower opening should be within 12" of the floor. A louvered closet door is also adequate. The supply of combustion air can come from outside, or can come from inside the house, providing that the area it is being drawn from communicates freely with the rest of the house.

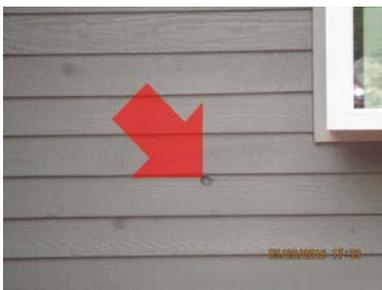
17. An air gap called a Johnson Tee is installed in the kitchen wall. This air gap protects the dishwasher from contamination caused by a backflow of waste water. The cap protruding on the exterior wall opposite the dishwasher is not drilled. This renders the air gap non-functional. Drilling a 1/4" hole in the end of the cap will restore its function. The remaining visible portions of the Johnson Tee were properly installed and functioning as intended.

10.8: Drilled ¼" hole in the end of the cap.

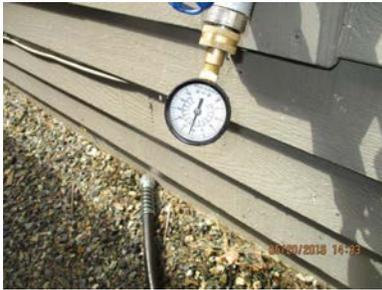
20. The water pressure at 105 PSI is excessive. The normal range is 40-80 PSI. High water pressure can result in leaking valves, detached supply tubes, water hammer and is hard on solenoid valves. The installation of a pressure reduction valve is recommended.

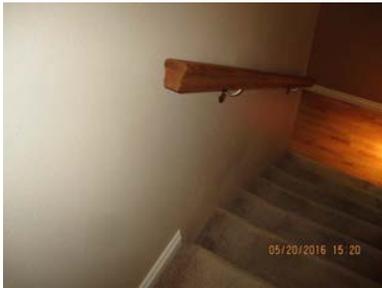
### 14.3 STAIRS

21. The railing ends in the stairwell does not return to the wall. This is a safety hazard. The installation of a continuous handrail should be considered as a safety upgrade.

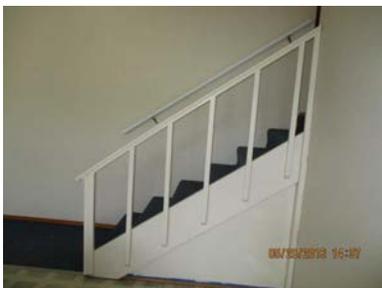
22. The stair railing baluster spacing is too wide. This is a hazard for small children. The baluster spacing should be reduced as a safety upgrade. Current standards require that a 4" sphere not pass through the railing.

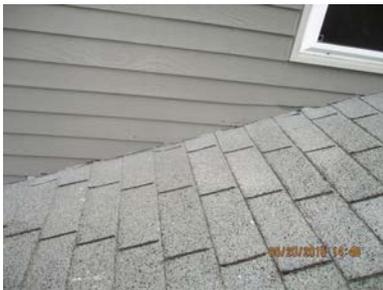
1. The siding is vulnerable to damage where it has been close to or in contact with the roofing material. The siding should be modified and a minimum of a 2" clearance should be maintained between the top of the roofing and bottom of the siding.

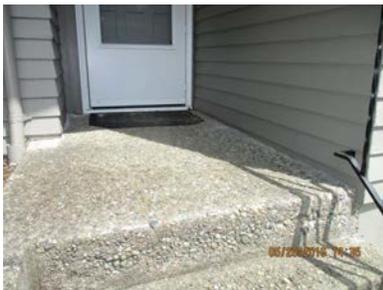
### *3.2 PEST CONTROL*

2. Untreated wood in direct contact with concrete was observed along the entry stoop. Untreated wood should be raised 1-2" above the concrete. Treating the wood with a preservative sometimes will prevent wood destroy organism damage.

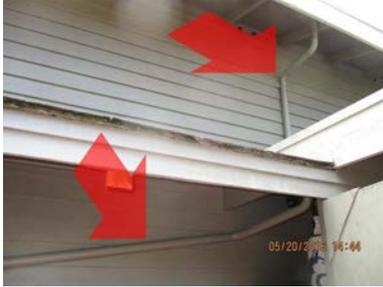
4. The 2" round downspouts are too small and are more vulnerable to clogging than the larger rectangular ones. Consideration should be given to upgrading the downspouts.

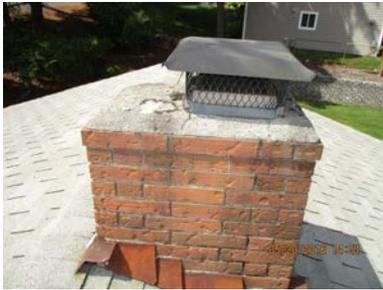
### 4.5 CHIMNEYS

5. The chimney crown is cracked and deteriorated. The mortar chimney crown prevents water from entering and damaging the masonry. Repairing or replacing the chimney crown will extend the service life of the chimney.

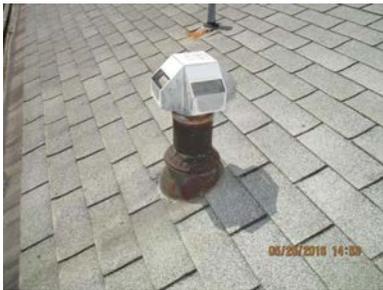
### 4.6 GAS APPLIANCE VENTS

6. The gas appliance vent is corroded above the roof line. Cleaning and painting the vent will prolong its service life.

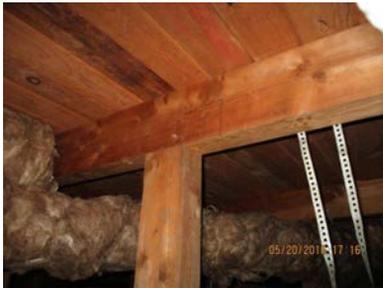
12. There are no gusset plates tying the beams and posts together. The installation of gusset plates is recommend to reduce the likelihood of damage during an earthquake.

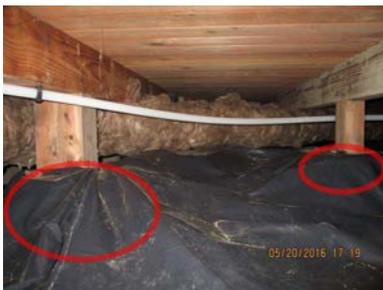
### 19.4 VAPOR RETARDER

13. The support post concrete piers are covered with the plastic vapor retarder. This allows the transmission of water vapor from the soil up and into the floor framing. The plastic vapor retarder should be removed from the pier so that it covers the entire surface of the soil only.

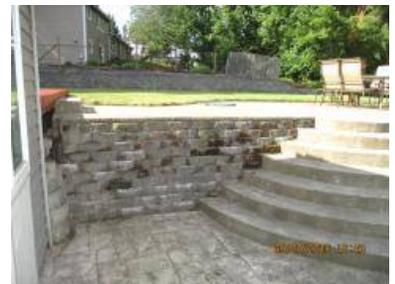
There is no guardrail at the patio. This is a hazard for small children. The installation of a guardrail that conforms to present industry standards is recommended if small children are present.

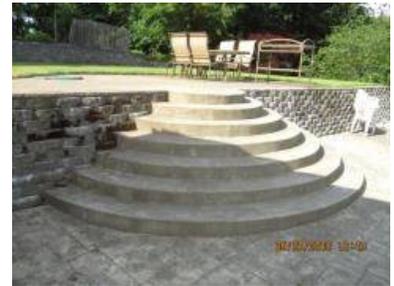
There is no handrail along the stairs. This is a hazard. The installation of a handrail along the stairs is recommended.

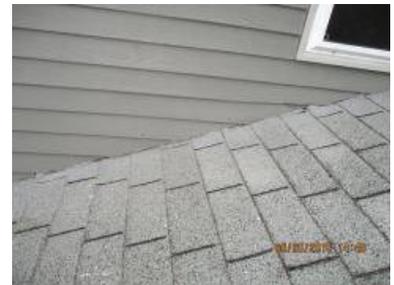
The siding is vulnerable to damage where it has been close to or in contact with the roofing material. The siding should be modified and a minimum of a 2" clearance should be maintained between the top of the roofing and bottom of the siding.

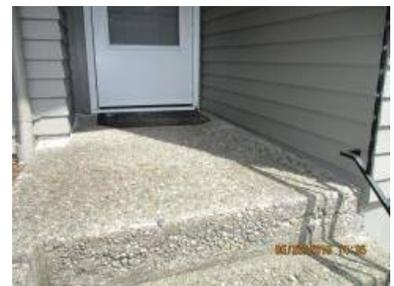
Untreated wood in direct contact with concrete was observed along the entry stoop. Untreated wood should be raised 1-2" above the concrete. Treating the wood with a preservative sometimes will prevent wood destroy organism damage.

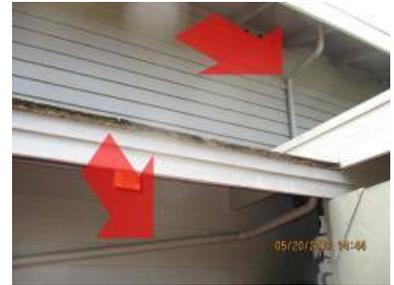
The 2" round downspouts are too small and are more vulnerable to clogging than the larger rectangular ones. Consideration should be given to upgrading the downspouts.

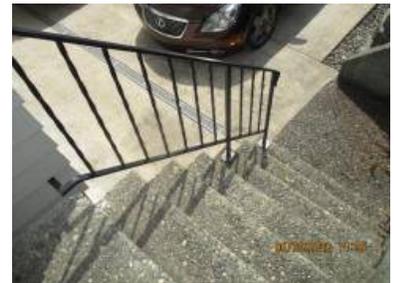
The spacing under stair railing is too wide. This is a hazard for small children. The spacing should be reduced as a safety upgrade. Current standards require that a 4" sphere not pass under the railing.

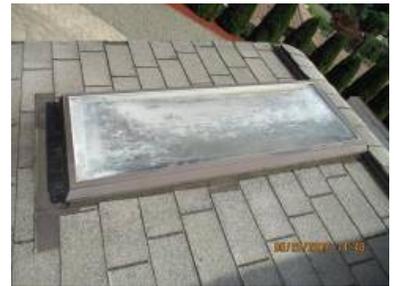
The seal between the glass panes has failed in the skylight above the family room. Repairs should be made as necessary.

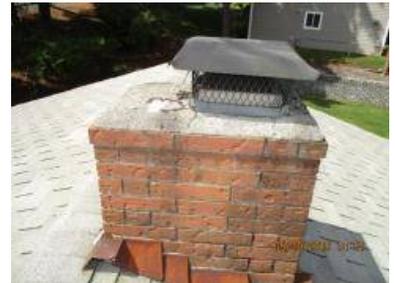
The chimney crown is cracked and deteriorated. The mortar chimney crown prevents water from entering and damaging the masonry. Repairing or replacing the chimney crown will extend the service life of the chimney.

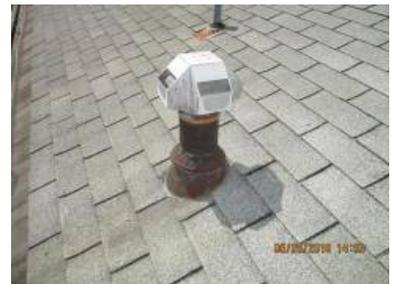
The gas appliance vent is corroded above the roof line. Cleaning and painting the vent will prolong its service life.

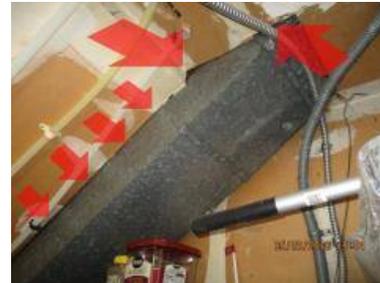
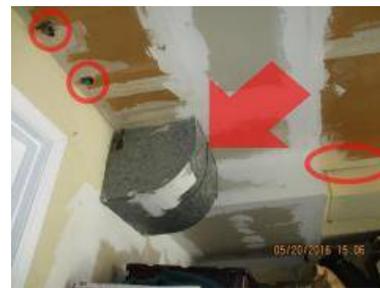
There are voids in the fire resistive barrier between the living space and garage that will allow flames to penetrate. The gypsum barrier slows the spread of a fire from the garage to the structure and/or living space. Patching the voids is recommended.

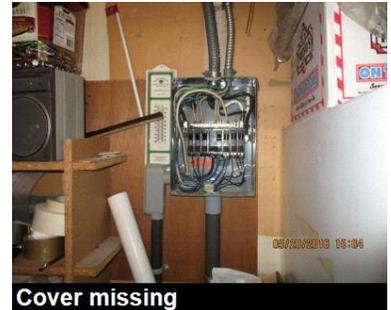
Cover missing

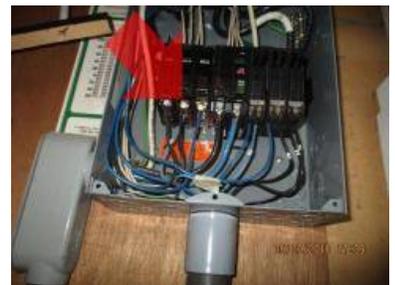
One of the circuits in the subpanel is double tapped. Double tapping means that two conductors share a single terminal. Double tapped terminals can loosen and overheat and therefore are not permitted unless the terminal is specifically listed for multiple wires. This defect is easily repaired by connecting the two wires to a "pig tail", securing them with a wire cap, and then inserting the pig tail conductor under the terminal.

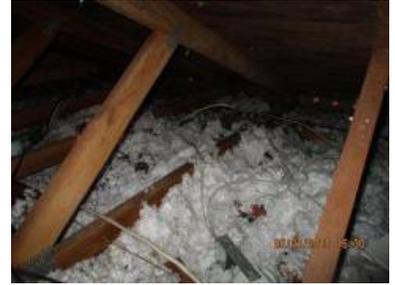
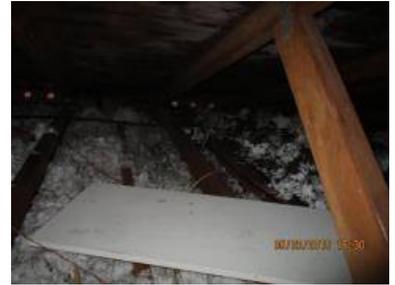
Loose electrical cables were observed in the attic. Loose cables are vulnerable to damage. All loose cables should be secured at 4' intervals using approved cable staples.

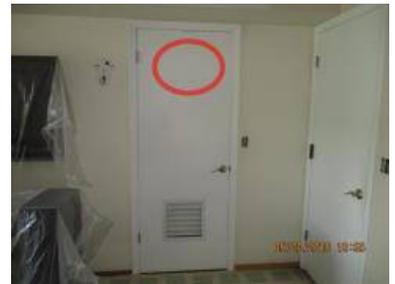
The combustion supply is inadequate. Most appliance manufacturers and municipalities require that there be at least two openings of 100 square inches. The upper opening should be within 12" of the ceiling. The lower opening should be within 12" of the floor. A louvered closet door is also adequate. The supply of combustion air can come from outside, or can come from inside the house, providing that the area it is being drawn from communicates freely with the rest of the house.

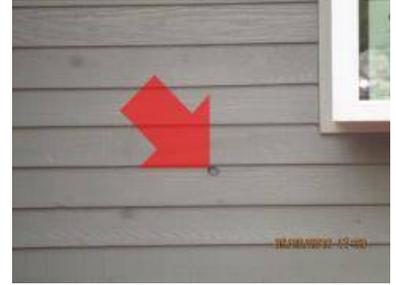
An air gap called a Johnson Tee is installed in the kitchen wall. This air gap protects the dishwasher from contamination caused by a backflow of waste water. The cap protruding on the exterior wall opposite the dishwasher is not drilled. This renders the air gap non-functional. Drilling a 1/4" hole in the end of the cap will restore its function. The remaining visible portions of the Johnson Tee were properly installed and functioning as intended.

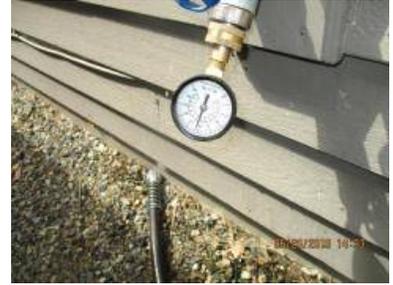
A pressure reduction valve is used to reduce excessively high (i.e., above 80 PSI) water pressure coming in from the water main. It is normally installed inside the house in the main water line just downstream of the main shut off valve.

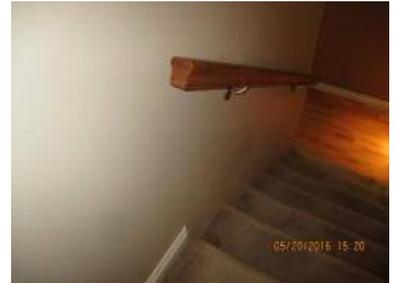
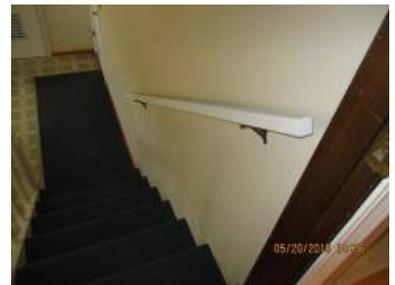
The railing ends in the stairwell does not return to the wall. This is a safety hazard. The installation of a continuous handrail should be considered as a safety upgrade.

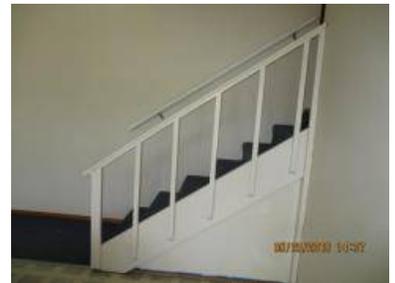
The stair railing baluster spacing is too wide. This is a hazard for small children. The baluster spacing should be reduced as a safety upgrade. Current standards require that a 4" sphere not pass through the railing.

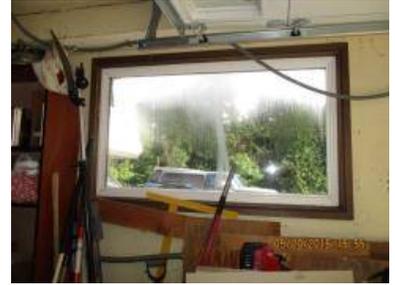
There is condensation or mineral deposits between the panes of glass in one of the insulated glass window panes. This indicates a failed seal. The glass assembly should be replaced, which is the only method for correcting this deficiency.

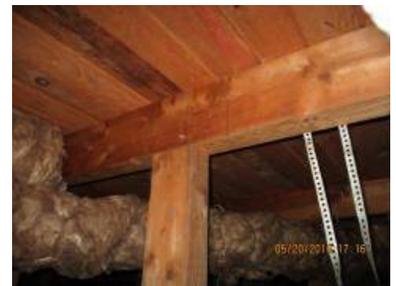
There are no gusset plates tying the beams and posts together. The installation of gusset plates is recommend to reduce the likelihood of damage during an earthquake.

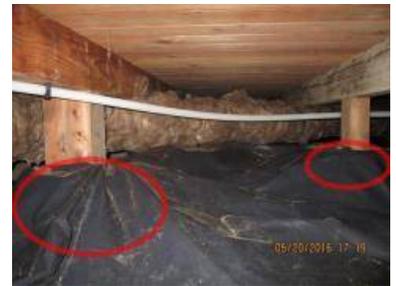
The support post concrete piers are covered with the plastic vapor retarder. This allows the transmission of water vapor from the soil up and into the floor framing. The plastic vapor retarder should be removed from the pier so that it covers the entire surface of the soil only.
