Jeff and Jennifer Killingsworth

10421 324<sup>th</sup> PI SE

Issaquah WA 98027

At your request, a visual inspection of the above referenced property was conducted on August 16, 2016. We have inspected the major structural components, plumbing, heating and electrical systems for signs of significant non-performance, excessive or unusual wear and general state of repair.

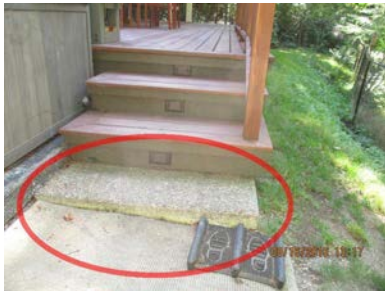
#### 3.10 STAIRS

2. The landing for the steps is too small. This creates a potential trip hazard. Stair landings should be 36" square. Consideration should be given to modifying the landing area.

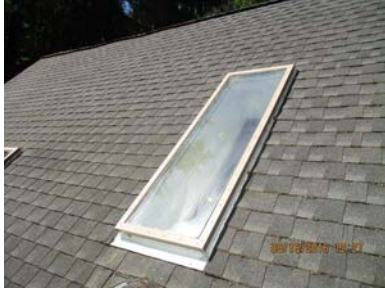
#### 4.4 SKYLIGHTS

3. There is condensation or mineral deposits between the panes of glass in the skylights. This indicates failed seals. The glass assemblies should be replaced, which is the only method for correcting this deficiency.

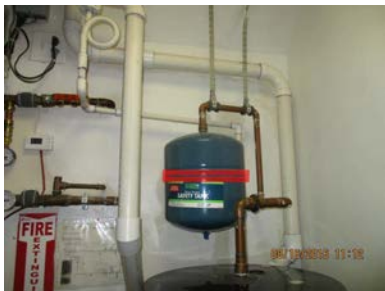
*9.6 EXPANSION TANK*

7. The expansion tank is not adequately secured to the wall. This could result in damage to the water pipe and leakage during an earth quake. A seismic restraint should be installed to secure the expansion tank.

9.6 Item 7: Expansion tank strapping

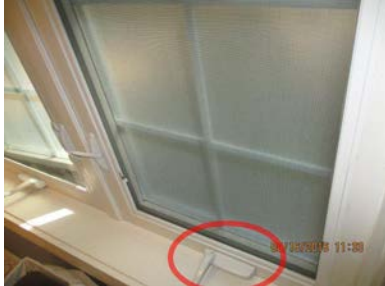
**14.7 WINDOWS**

12. The crank handles operating the opening assist mechanisms for the windows in the master bedroom are not working. The crank handles should be replaced and the function of the window openers tested.

14.7 Item 12: Window crank

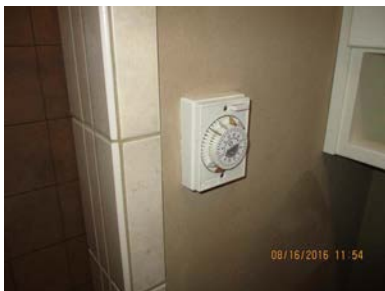
**14.8 FRESH AIR SYSTEM**

13. The whole house fan is located in the upper bathroom. It is intended to remove stale air from the home. It is activated via a switch on the timer. The fan was operated however the timer was not functioning as intended. Replacement is recommended.

14.8 Item 13: Whole house fan control

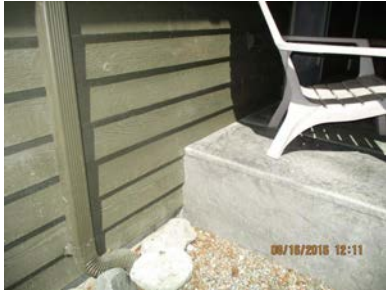
#### **3.3 PEST CONTROL**

1. Untreated wood in direct contact with concrete was observed along the entry stoop. Untreated wood should be raised 1-2" above the concrete. Treating the wood with a preservative sometimes will prevent wood destroy organism damage.

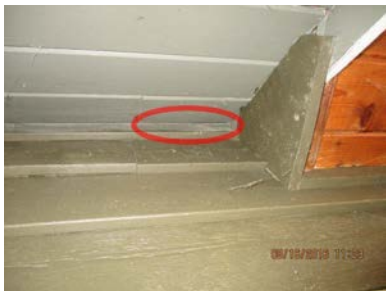
#### **3.4 SOFFITS AND OVERHANGS**

2. There are openings at the intersection between the overhang and the roof through which birds and rodents can enter into the structure. These openings should be covered with wood, wire mesh or filled with aerosol foam.

3.4 Item 2: Close openings

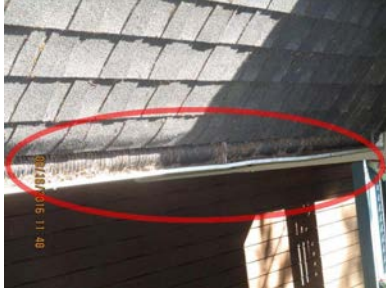
#### **3.5 GUTTERS AND DOWNSPOUTS**

3. There is a build-up of pine needles inside the gutters. Proper maintenance of gutters and downspouts is essential and should be performed routinely in order to prevent clogging. Maintenance consists primarily of keeping leaves and other organic debris out of the system. Failure to clean the gutters will result in water splash on the building when they overflow. Gutters can be damaged under the weight of the water and organic matter inside the gutter. Gutters should be cleaned as necessary to maintain a free flow of water into the downspouts.

3.5 Item 3: Clean gutters

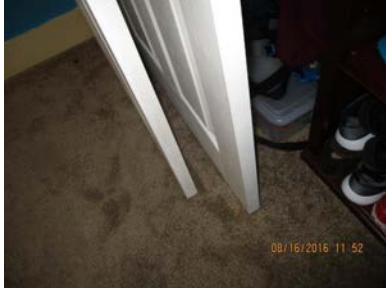
*14.6 CLOSET DOORS*

11. The floor guides are missing from the bypass closet doors in the bedroom. Missing floor guides could result in damage to the doors. The installation of floor guides is recommended.

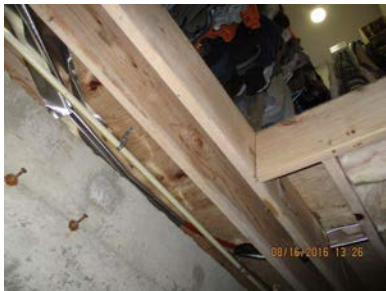
**17.3 FLOOR INSULATION**

12. The floors are insulated with 6" R-19 fiberglass batts. Some of the insulation batts under the master bedroom closet are missing. The missing batts should be replaced.

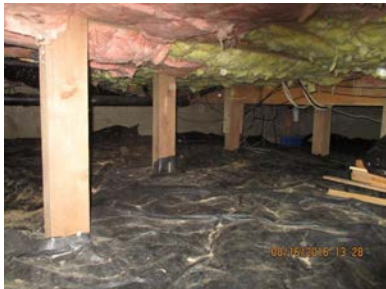
**19.4 VAPOR RETARDER**

13. The support post concrete piers are covered with the plastic vapor retarder. This allows the transmission of water vapor from the soil up and into the floor framing. The plastic vapor retarder should be removed from the pier so that it covers the entire surface of the soil only.

19.4 Item 13: Remove vapor barrier from piers - Corrected

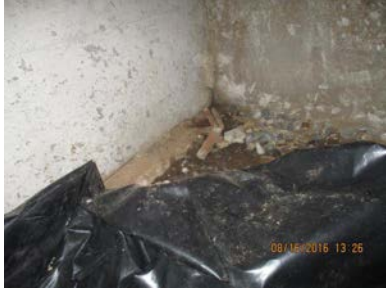
**19.5 PEST CONTROL**

14. Scrap-wood and other cellulose debris was observed on the crawl floor. This wood debris creates conducive conditions for wood boring insects. The removal of all cellulose debris is recommended.

19.5 Item 14: Remove scrap wood - Corrected

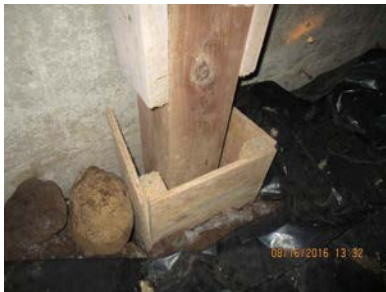
15. Soil is in contact with the bottom of at least one wood post in the crawl space. Good building practice requires that foundation walls or pier footings supporting wood frame construction, extend at least 8" above the finish grade with at least a 6" clearance between the top of the soil and the bottom of the wood finish materials. Soil in direct contact with wood creates a hospitable environment for wood destroying organisms. Establishing these minimum clearances is recommended.

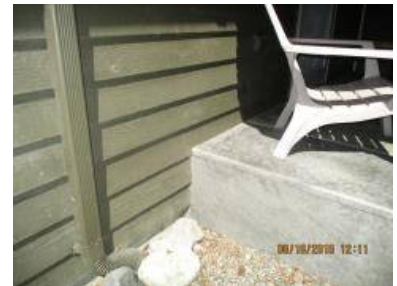
Untreated wood in direct contact with concrete was observed along the entry stoop. Untreated wood should be raised 1-2" above the concrete. Treating the wood with a preservative sometimes will prevent wood destroy organism damage.

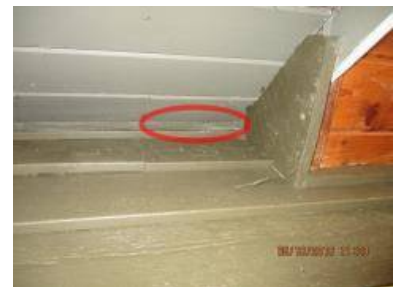
## 3.4 SOFFITS AND OVERHANGS

There are openings at the intersection between the overhang and the roof through which birds and rodents can enter into the structure. These openings should be covered with wood, wire mesh or filled with aerosol foam.

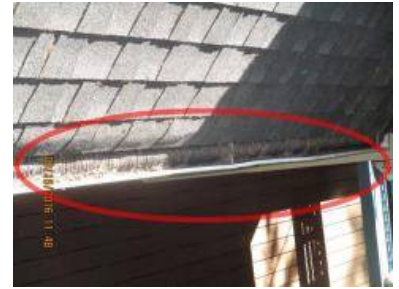
## 3.5 GUTTERS AND DOWNSPOUTS

There is a build-up of pine needles inside the gutters. Proper maintenance of gutters and downspouts is essential and should be performed routinely in order to prevent clogging. Maintenance consists primarily of keeping leaves and other organic debris out of the system. Failure to clean the gutters will result in water splash on the building when they overflow. Gutters can be damaged under the weight of the water and organic matter inside the gutter. Gutters should be cleaned as necessary to maintain a free flow of water into the downspouts.

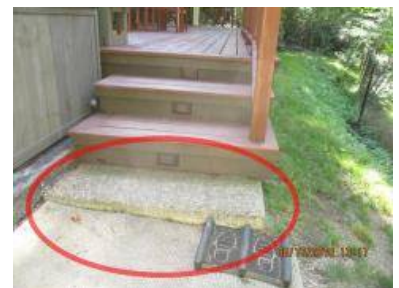
The landing for the steps is too small. This creates a potential trip hazard. Stair landings should be 36" square. Consideration should be given to modifying the landing area.

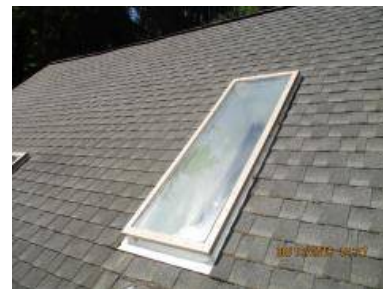
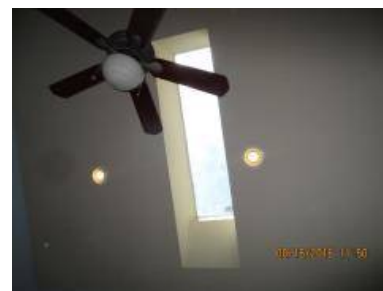
There is condensation or mineral deposits between the panes of glass in the skylights. This indicates failed seals. The glass assemblies should be replaced, which is the only method for correcting this deficiency.

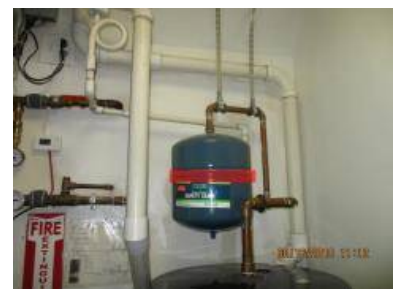
The expansion tank is not adequately secured to the wall. This could result in damage to the water pipe and leakage during an earth quake. A seismic restraint should be installed to secure the expansion tank.

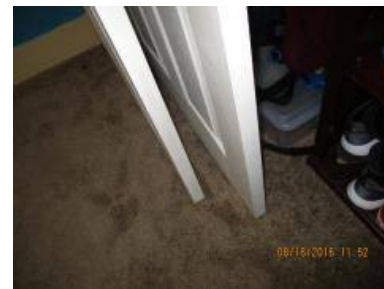
### 14.6 CLOSET DOORS

The floor guides are missing from the bypass closet doors in the bedroom. Missing floor guides could result in damage to the doors. The installation of floor guides is recommended.

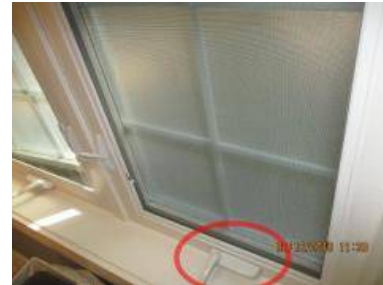
### 14.7 WINDOWS

The crank handles operating the opening assist mechanisms for the windows in the master bedroom are not working. The crank handles should be replaced and the function of the window openers tested.

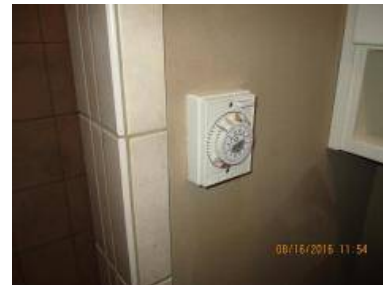
#### 14.8 FRESH AIR SYSTEM

The whole house fan is located in the upper bathroom. It is intended to remove stale air from the home. It is activated via a switch on the timer. The fan was operated however the timer was not functioning as intended. Replacement is recommended.

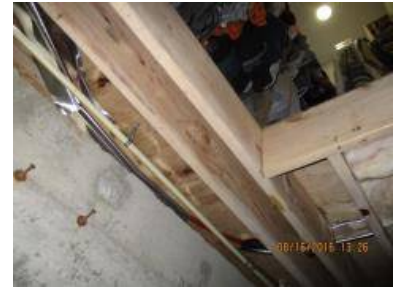
### **17.3 FLOOR INSULATION**

The floors are insulated with 6" R-19 fiberglass batts. Some of the insulation batts under the master bedroom closet are missing. The missing batts should be replaced.

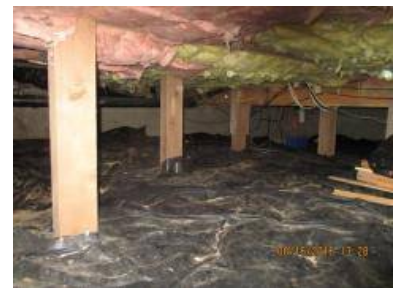
The support post concrete piers are covered with the plastic vapor retarder. This allows the transmission of water vapor from the soil up and into the floor framing. The plastic vapor retarder should be removed from the pier so that it covers the entire surface of the soil only.

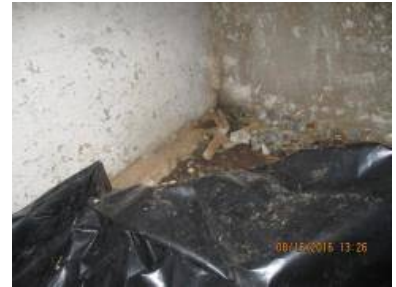
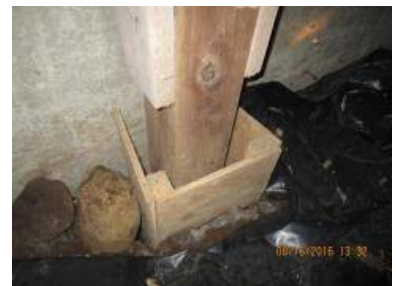
Soil is in contact with the bottom of at least one wood post in the crawl space. Good building practice requires that foundation walls or pier footings supporting wood frame construction, extend at least 8" above the finish grade with at least a 6" clearance between the top of the soil and the bottom of the wood finish materials. Soil in direct contact with wood creates a hospitable environment for wood destroying organisms. Establishing these minimum clearances is recommended.
