Jeff and Jennifer Killingsworth

10421 324<sup>th</sup> PI SE

**NOTICE TO BUYER: SELLER-PROCURED INSPECTION REPORT**

At your request, a visual inspection of the above referenced property was conducted on August 16, 2016. We have inspected the major structural components, plumbing, heating and electrical systems for signs of significant non-performance, excessive or unusual wear and general state of repair.

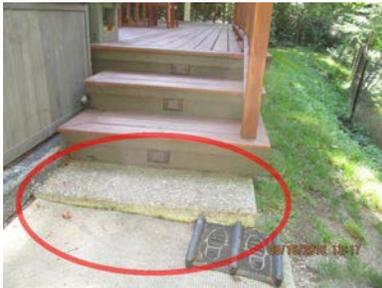
#### 3.10 STAIRS

2. The landing for the steps is too small. This creates a potential trip hazard. Stair landings should be 36" square. Consideration should be given to modifying the landing area.

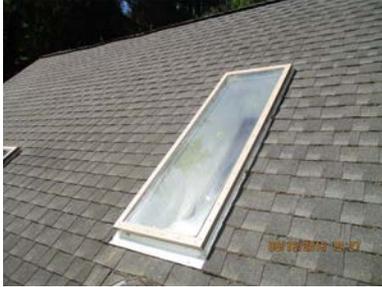
#### 4.4 SKYLIGHTS

3. There is condensation or mineral deposits between the panes of glass in the skylights. This indicates failed seals. The glass assemblies should be replaced, which is the only method for correcting this deficiency.

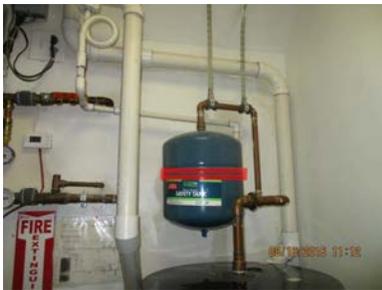
### *9.6 EXPANSION TANK*

7. The expansion tank is not adequately secured to the wall. This could result in damage to the water pipe and leakage during an earth quake. A seismic restraint should be installed to secure the expansion tank.

9.6 Item 7: Expansion tank strapping

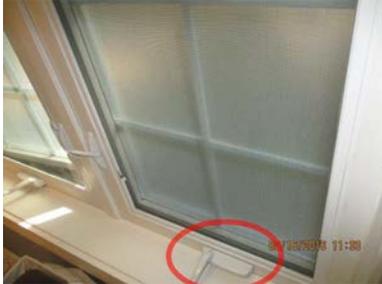
**14.7 WINDOWS**

12. The crank handles operating the opening assist mechanisms for the windows in the master bedroom are not working. The crank handles should be replaced and the function of the window openers tested.

14.7 Item 12: Window crank

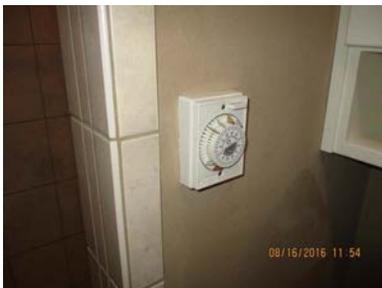
**14.8 FRESH AIR SYSTEM**

13. The whole house fan is located in the upper bathroom. It is intended to remove stale air from the home. It is activated via a switch on the timer. The fan was operated however the timer was not functioning as intended. Replacement is recommended.

14.8 Item 13: Whole house fan control

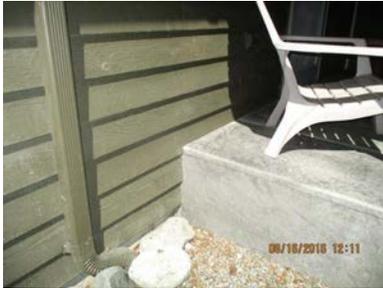
#### **3.3 PEST CONTROL**

1. Untreated wood in direct contact with concrete was observed along the entry stoop. Untreated wood should be raised 1-2" above the concrete. Treating the wood with a preservative sometimes will prevent wood destroy organism damage.

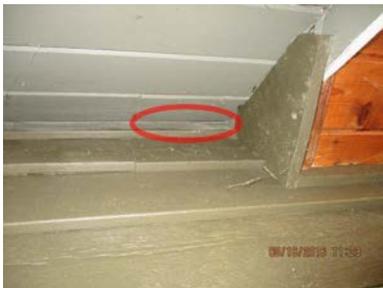
#### **3.4 SOFFITS AND OVERHANGS**

2. There are openings at the intersection between the overhang and the roof through which birds and rodents can enter into the structure. These openings should be covered with wood, wire mesh or filled with aerosol foam.

3.4 Item 2: Close openings

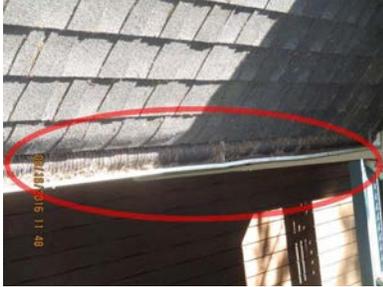
#### **3.5 GUTTERS AND DOWNSPOUTS**

3. There is a build-up of pine needles inside the gutters. Proper maintenance of gutters and downspouts is essential and should be performed routinely in order to prevent clogging. Maintenance consists primarily of keeping leaves and other organic debris out of the system. Failure to clean the gutters will result in water splash on the building when they overflow. Gutters can be damaged under the weight of the water and organic matter inside the gutter. Gutters should be cleaned as necessary to maintain a free flow of water into the downspouts.

3.5 Item 3: Clean gutters

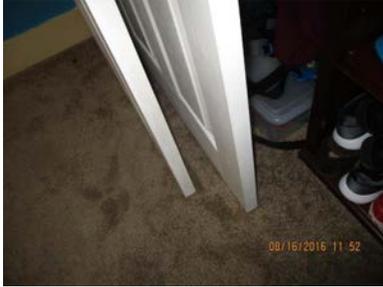
*14.6 CLOSET DOORS*

11. The floor guides are missing from the bypass closet doors in the bedroom. Missing floor guides could result in damage to the doors. The installation of floor guides is recommended.

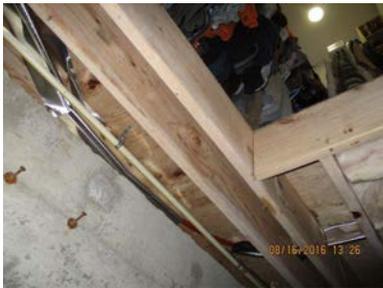
**17.3 FLOOR INSULATION**

12. The floors are insulated with 6" R-19 fiberglass batts. Some of the insulation batts under the master bedroom closet are missing. The missing batts should be replaced.

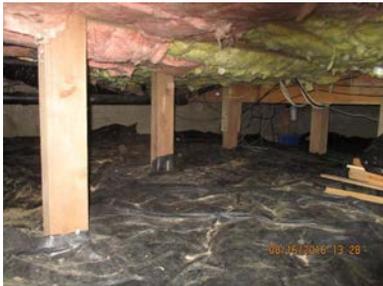
**19.4 VAPOR RETARDER**

13. The support post concrete piers are covered with the plastic vapor retarder. This allows the transmission of water vapor from the soil up and into the floor framing. The plastic vapor retarder should be removed from the pier so that it covers the entire surface of the soil only.

19.4 Item 13: Remove vapor barrier from piers - Corrected

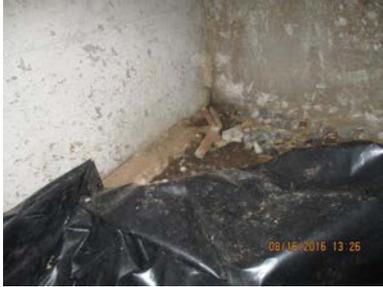
**19.5 PEST CONTROL**

14. Scrap-wood and other cellulose debris was observed on the crawl floor. This wood debris creates conducive conditions for wood boring insects. The removal of all cellulose debris is recommended.

19.5 Item 14: Remove scrap wood - Corrected

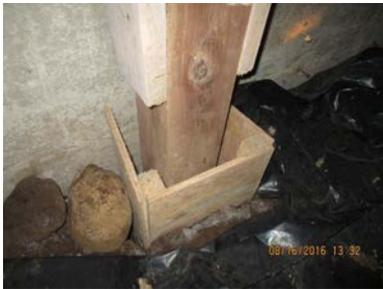
15. Soil is in contact with the bottom of at least one wood post in the crawl space. Good building practice requires that foundation walls or pier footings supporting wood frame construction, extend at least 8" above the finish grade with at least a 6" clearance between the top of the soil and the bottom of the wood finish materials. Soil in direct contact with wood creates a hospitable environment for wood destroying organisms. Establishing these minimum clearances is recommended.

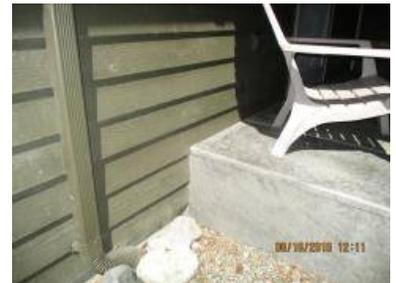
Untreated wood in direct contact with concrete was observed along the entry stoop. Untreated wood should be raised 1-2" above the concrete. Treating the wood with a preservative sometimes will prevent wood destroy organism damage.

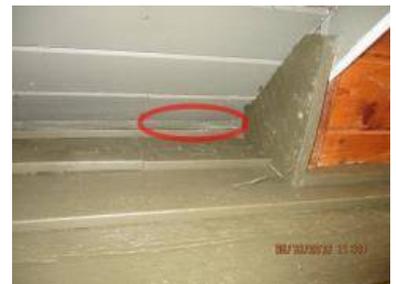
### 3.4 SOFFITS AND OVERHANGS

There are openings at the intersection between the overhang and the roof through which birds and rodents can enter into the structure. These openings should be covered with wood, wire mesh or filled with aerosol foam.

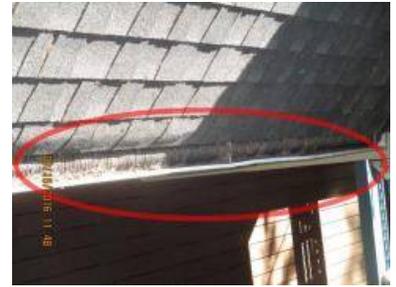
### 3.5 GUTTERS AND DOWNSPOUTS

There is a build-up of pine needles inside the gutters. Proper maintenance of gutters and downspouts is essential and should be performed routinely in order to prevent clogging. Maintenance consists primarily of keeping leaves and other organic debris out of the system. Failure to clean the gutters will result in water splash on the building when they overflow. Gutters can be damaged under the weight of the water and organic matter inside the gutter. Gutters should be cleaned as necessary to maintain a free flow of water into the downspouts.

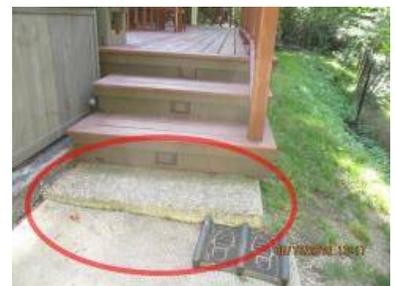
The landing for the steps is too small. This creates a potential trip hazard. Stair landings should be 36" square. Consideration should be given to modifying the landing area.

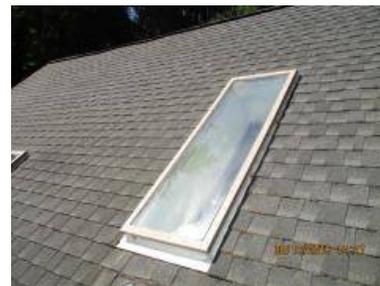
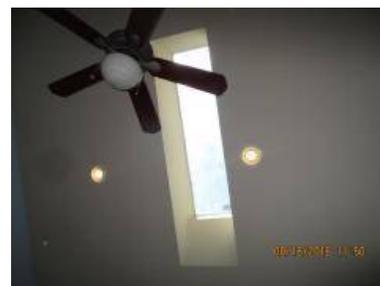
There is condensation or mineral deposits between the panes of glass in the skylights. This indicates failed seals. The glass assemblies should be replaced, which is the only method for correcting this deficiency.

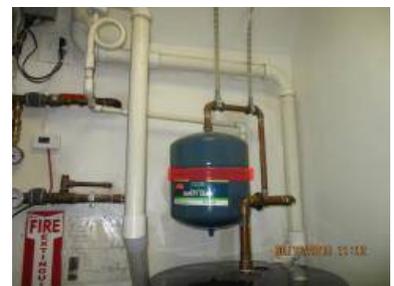
The expansion tank is not adequately secured to the wall. This could result in damage to the water pipe and leakage during an earth quake. A seismic restraint should be installed to secure the expansion tank.

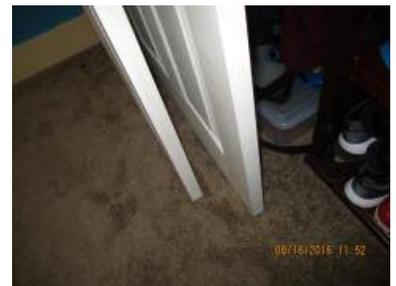
### 14.6 CLOSET DOORS

The floor guides are missing from the bypass closet doors in the bedroom. Missing floor guides could result in damage to the doors. The installation of floor guides is recommended.

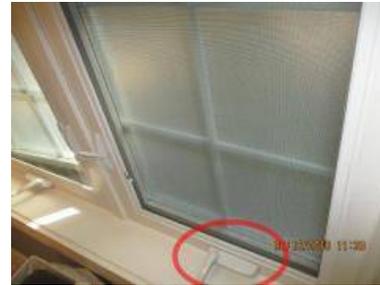
### 14.7 WINDOWS

The crank handles operating the opening assist mechanisms for the windows in the master bedroom are not working. The crank handles should be replaced and the function of the window openers tested.

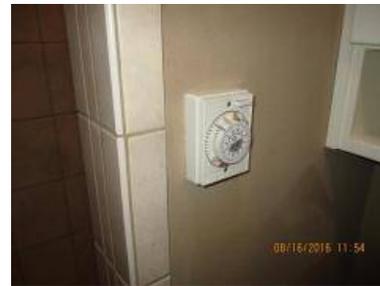
#### 14.8 FRESH AIR SYSTEM

The whole house fan is located in the upper bathroom. It is intended to remove stale air from the home. It is activated via a switch on the timer. The fan was operated however the timer was not functioning as intended. Replacement is recommended.

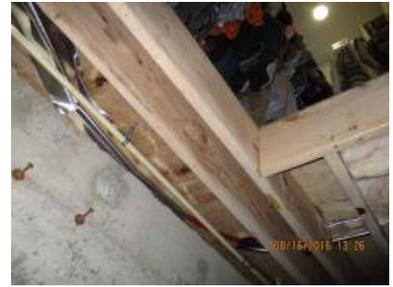
### **17.3 FLOOR INSULATION**

The floors are insulated with 6" R-19 fiberglass batts. Some of the insulation batts under the master bedroom closet are missing. The missing batts should be replaced.

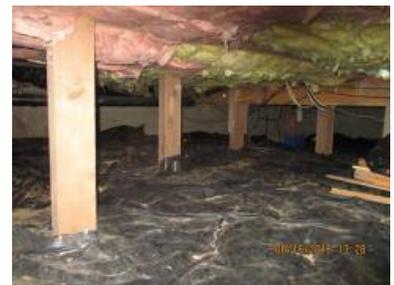
The support post concrete piers are covered with the plastic vapor retarder. This allows the transmission of water vapor from the soil up and into the floor framing. The plastic vapor retarder should be removed from the pier so that it covers the entire surface of the soil only.

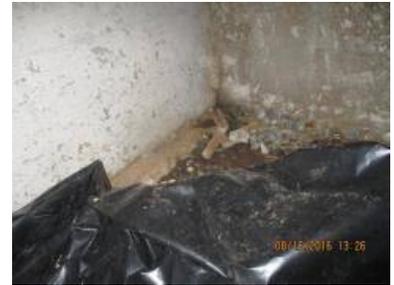
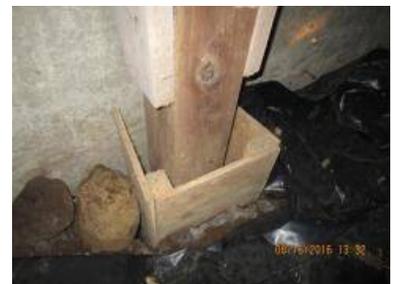
Soil is in contact with the bottom of at least one wood post in the crawl space. Good building practice requires that foundation walls or pier footings supporting wood frame construction, extend at least 8" above the finish grade with at least a 6" clearance between the top of the soil and the bottom of the wood finish materials. Soil in direct contact with wood creates a hospitable environment for wood destroying organisms. Establishing these minimum clearances is recommended.
