Per the seller on 9/15/16, the following items from the inspection summary have been completed:

September 14, 2016

**Re: 17316 175th Ct. NE**  
**Redmond, WA.**

At your request, a visual inspection of the above referenced property was conducted on September 13, 2016. We have inspected the major structural components, plumbing, heating and electrical systems for signs of significant non-performance, excessive or unusual wear and general state of repair.

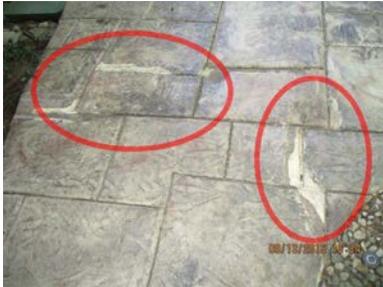
#### 2.5 PATIO

1. There are minor cracks in the patio and trip hazards were present. We recommend all walking surfaces be maintained free of trip hazards.

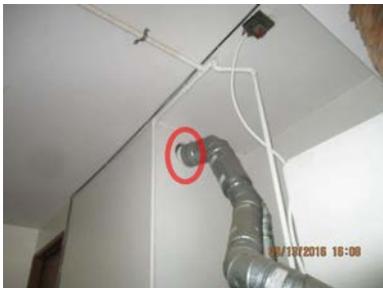
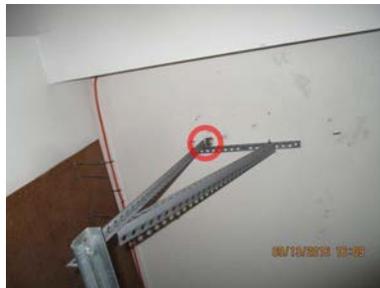
2. There are voids in the fire resistive barrier between the living space and garage that will allow flames to penetrate. The gypsum barrier slows the spread of a fire from the garage to the structure and/or living space. Patching the voids is recommended.

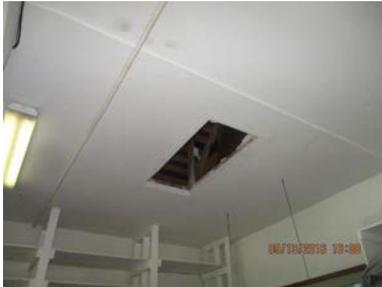
4. The cover for the attic access is missing. This is a safety concern. The gypsum barrier on the ceiling slows the spread of a fire from the garage to the attic. The installation of an access cover is recommended.

Item 6.4.4 - cover attic access

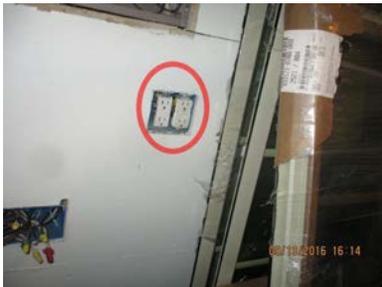
The receptacles on the west wall of the garage are loose. This is a potential shock and a fire hazard. All loose receptacles should be repaired as necessary.

Item 6.6.6 - cover receptacles on west wall

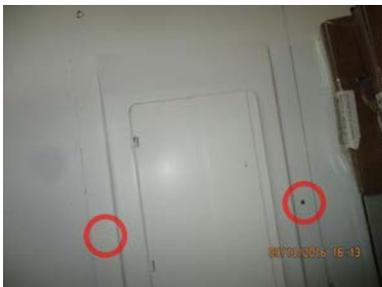
#### 7.8 SERVICE PANEL

7. Screws that secure the panel cover to the panel box are missing. This is a potential hazard. Missing screws should be replaced with the original style blunt end screws.

Item 7.8.7 - replace screws on electrical panel

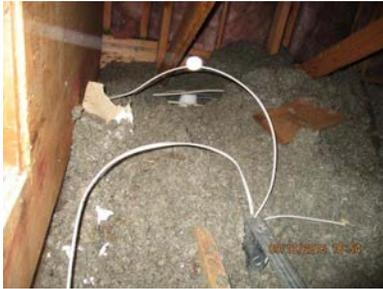
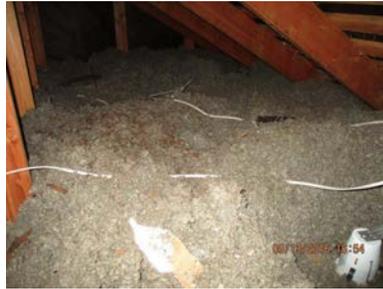
**7.10 WIRING**

8. Loose electrical cables were observed in the attic. Loose cables are vulnerable to damage. All loose cables should be secured at 4' intervals using approved cable staples.

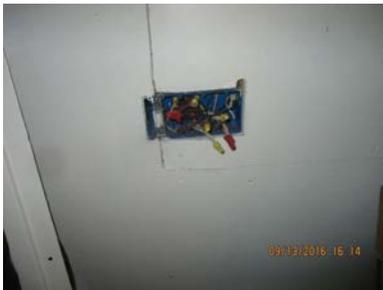
10. Splices in cable made outside of a junction box were observed in the garage. This is a fire hazard. The splices should be made inside an approved box with a cover.

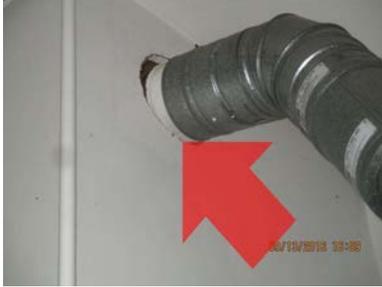
15. The furnace vent connector is too close to a combustible material. This is a hazard. A minimum clearance of 6" is required between the single wall vent connector and the combustible material. The double wall type B vent requires only 1" of clearance. Repairs are recommended.

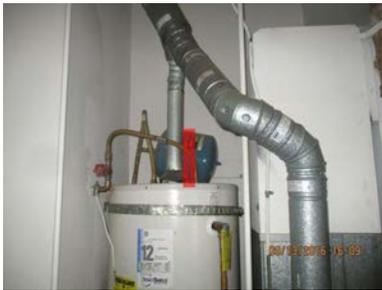
### **9.6 EXPANSION TANK**

16. The expansion tank is not adequately secured to the wall. This could result in damage to the water pipe and leakage during an earth quake. A seismic restraint should be installed to secure the expansion tank.

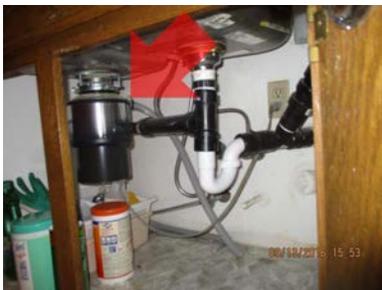
19. The dishwasher drain lacks an air gap. The dishwasher will function without one, but there is a risk of contamination of the inside of the dishwasher by waste water. The installation of an air gap is recommended.

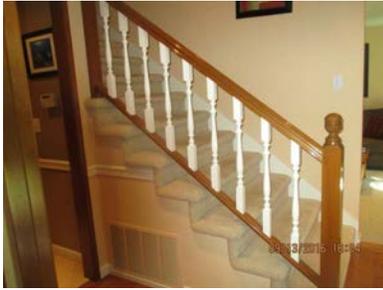
### **14.2 STAIRS**

20. The stair railing baluster spacing is too wide. This is a hazard for small children. The baluster spacing should be reduced as a safety upgrade. Current standards require that a 4" sphere not pass through the railing.

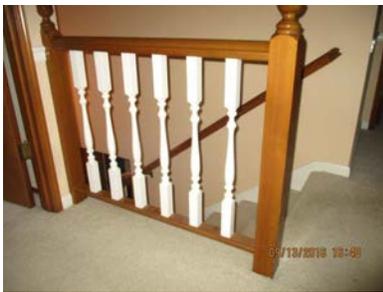
#### 14.3 GUARD RAILINGS

21. The spacing between the balusters is too wide. This is a hazard to small children. The balusters should be spaced close enough together so that a 4" sphere cannot pass through. Upgrading the guard railing is recommended if small children are present.

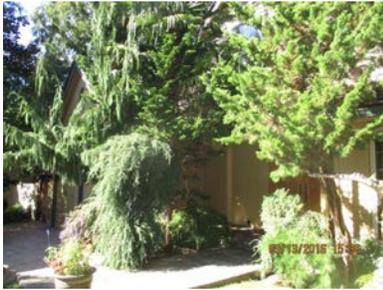
1. Trees are touching the building on the front side. Low hanging tree branches can damage the roof. Tree branches should be trimmed back where necessary.

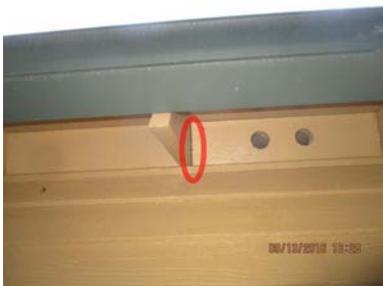
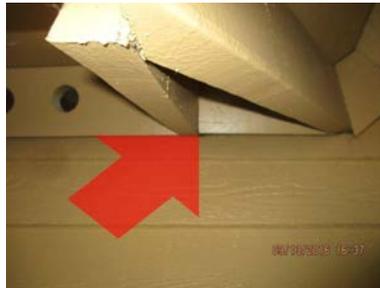
### 3.3 SOFFITS AND OVERHANGS

2. There are large gaps over 1/4" in size adjacent the soffit vent blocks. These gaps allow insects and rodents to enter the attic. Covering the gaps with screening, a strip of wood and/or caulking is recommended.

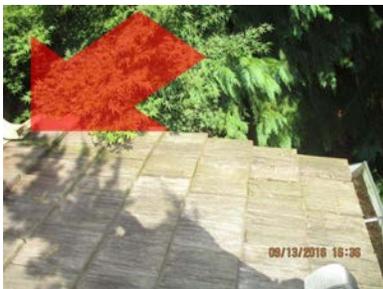
4. Downspouts draining directly onto the asphalt shingle surface causes excessive wear of the roofing material. Downspout extensions should be installed to prevent excessive wear and tear of the roofing.

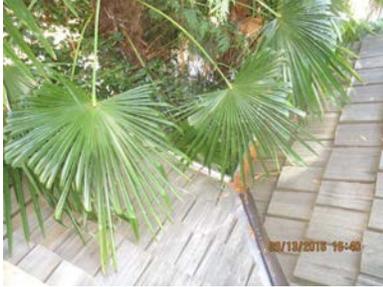
5. There is a build-up of organic debris inside the gutters. Proper maintenance of gutters and downspouts is essential and should be performed routinely in order to prevent clogging. Maintenance consists primarily of keeping leaves and other organic debris out of the system. Failure to clean the gutters will result in water splash on the building when they overflow. Gutters can be damaged under the weight of the water and organic matter inside the gutter. Gutters should be cleaned as necessary to maintain a free flow of water into the downspouts.

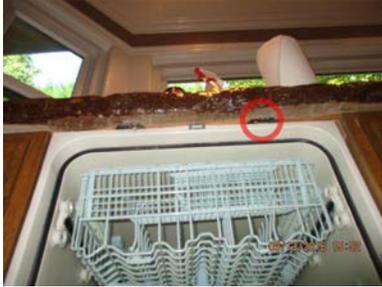
11. The dishwasher is not secured to the countertop. This allows the appliance to move around. The dishwasher should be secured to the bottom of the countertop in accordance with industry standards.

10.11.11 - Dishwasher has been checked and does not move

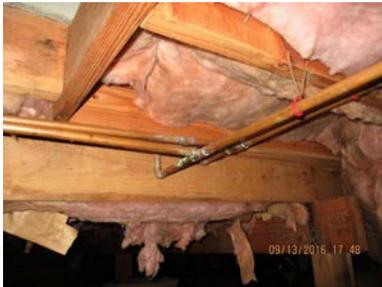
13. There are water pipes in the crawlspace that are not adequately insulated and could freeze. The installation of foam pipe insulation on all exposed water pipes is recommended.

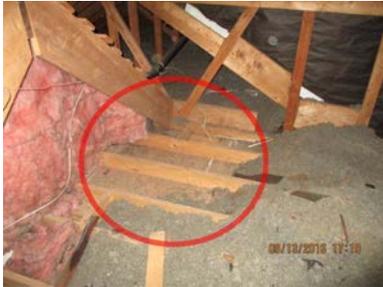
16. There is a large thermal bypasses in the attic. A thermal bypass is an opening between an insulated and uninsulated part of the house through which heated air can escape. As air is heated, it rises and pulls cool air in to the space to replace it. This condition will result in significant heat loss. Sealing up all thermal bypass routes is recommended.

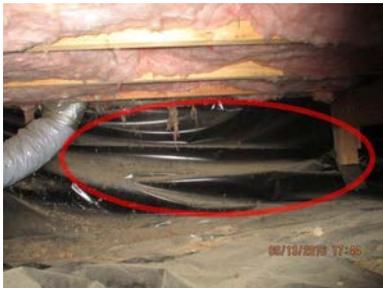
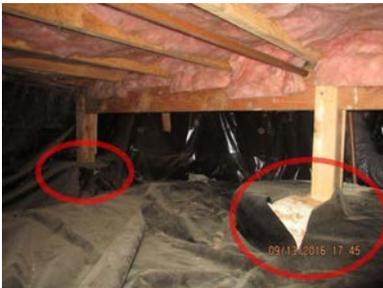
**19.4 VAPOR RETARDER**

17. The foundation walls are covered with the plastic vapor retarder. This allows the transmission of water vapor from the soil up and into the exterior wall framing. The plastic vapor retarder should be removed from the foundation so that it covers the entire surface of the soil only.

The support post concrete piers are covered with the plastic vapor retarder. This allows the transmission of water vapor from the soil up and into the floor framing. The plastic vapor retarder should be removed from the pier so that it covers the entire surface of the soil only.

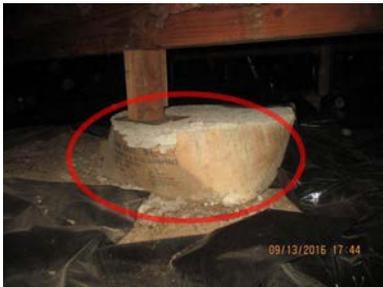
**19.5 PEST CONTROL**

19. Scrap-wood and other cellulose debris was observed on the crawl floor. This wood debris creates conducive conditions for wood boring insects. The removal of all cellulose debris is recommended.

Cellulose forms were left in place on the pier footings. This cellulose is conducive to the infestation of various wood destroying organisms. The removal of the cellulose is recommended.

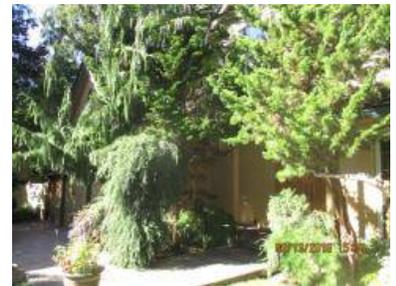
Trees are touching the building on the front side. Low hanging tree branches can damage the roof. Tree branches should be trimmed back where necessary.

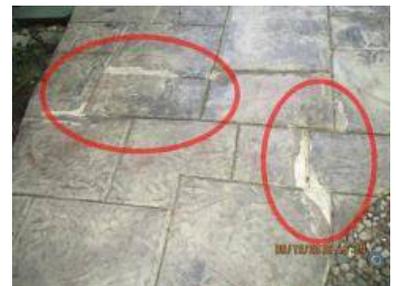
There are minor cracks in the patio and trip hazards were present. We recommend all walking surfaces be maintained free of trip hazards.

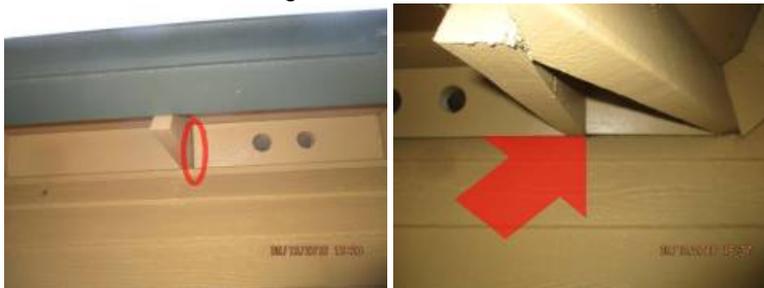
There are large gaps over 1/4" in size adjacent the soffit vent blocks. These gaps allow insects and rodents to enter the attic. Covering the gaps with screening, a strip of wood and/or caulking is recommended.

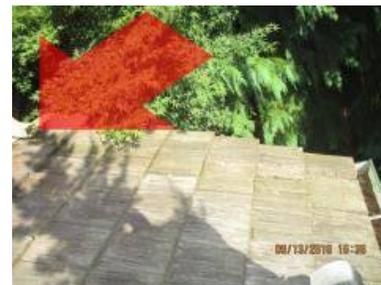
Downspouts draining directly onto the asphalt shingle surface causes excessive wear of the roofing material. Downspout extensions should be installed to prevent excessive wear and tear of the roofing.

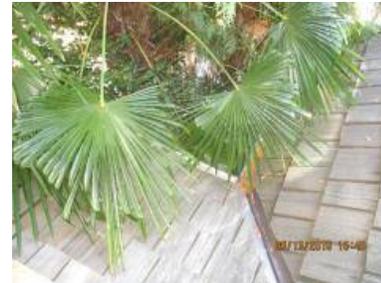
There is a build-up of organic debris inside the gutters. Proper maintenance of gutters and downspouts is essential and should be performed routinely in order to prevent clogging. Maintenance consists primarily of keeping leaves and other organic debris out of the system. Failure to clean the gutters will result in water splash on the building when they overflow. Gutters can be damaged under the weight of the water and organic matter inside the gutter. Gutters should be cleaned as necessary to maintain a free flow of water into the downspouts.

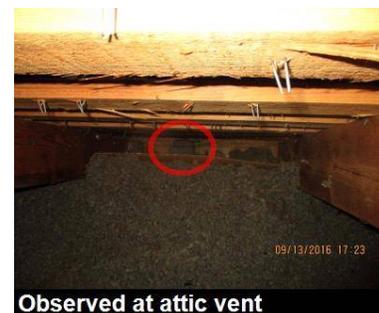
The bathroom vent fan is improperly terminated adjacent to a 3" soffit vent hole. The 3" hole is too small and restricts the flow of air out of the duct causing poor fan performance. The fan duct should be redirected so that it discharges through a roof vent or the soffit vent hole diameter should be increased.

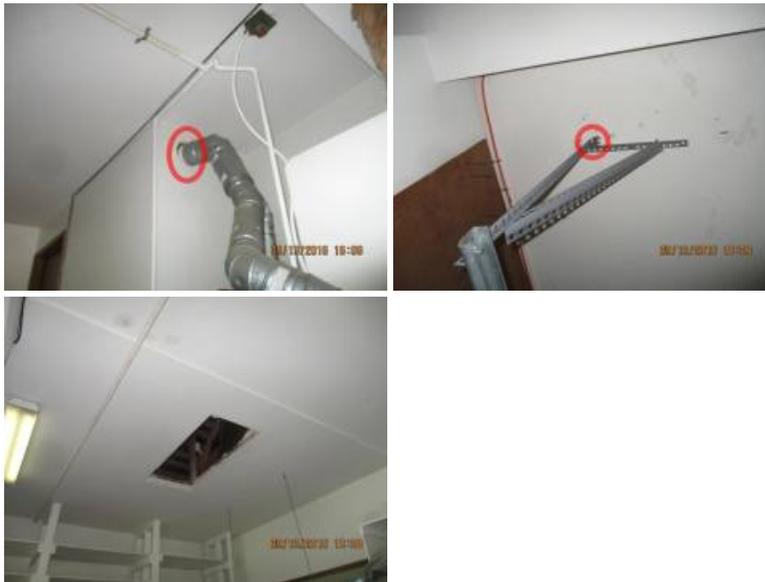
The cover for the attic access is missing. This is a safety concern. The gypsum barrier on the ceiling slows the spread of a fire from the garage to the attic. The installation of an access cover is recommended.

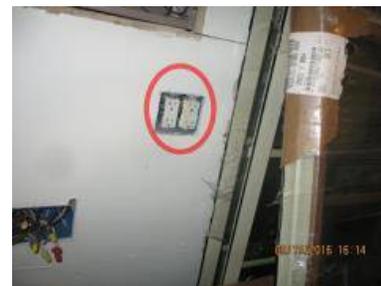
The receptacles on the west wall of the garage are loose. This is a potential shock and a fire hazard. All loose receptacles should be repaired as necessary.

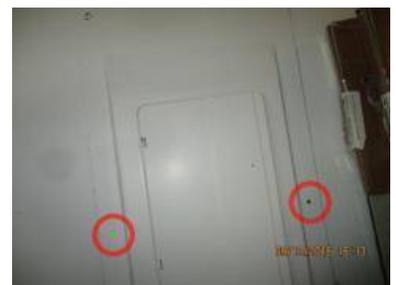
Screws that secure the panel cover to the panel box are missing. This is a potential hazard. Missing screws should be replaced with the original style blunt end screws.

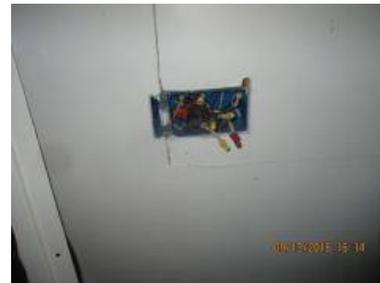
Splices in cable made outside of a junction box were observed in the garage. This is a fire hazard. The splices should be made inside an approved box with a cover.

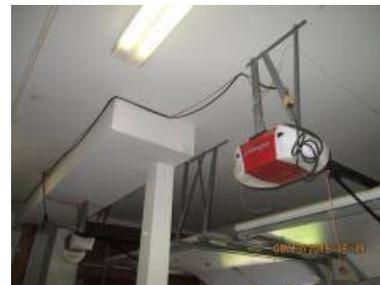
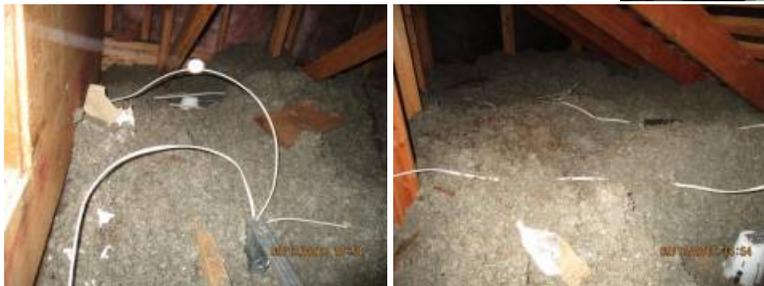
An extension cord is used as a temporary power source for the garage door opener. An extension cord is not suitable as a permanent wiring method. The installation of a receptacle within cords length of the motor is recommended.

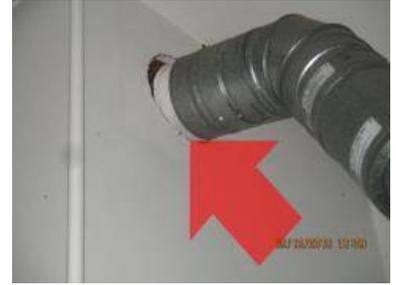
The furnace vent connector is too close to a combustible material. This is a hazard. A minimum clearance of 6" is required between the single wall vent connector and the combustible material. The double wall type B vent requires only 1" of clearance. Repairs are recommended.

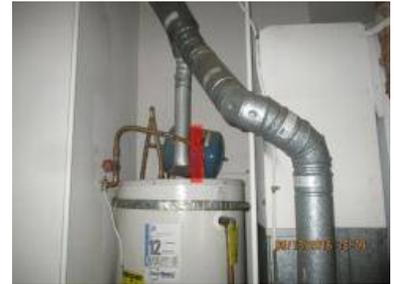
The expansion tank is not adequately secured to the wall. This could result in damage to the water pipe and leakage during an earth quake. A seismic restraint should be installed to secure the expansion tank.

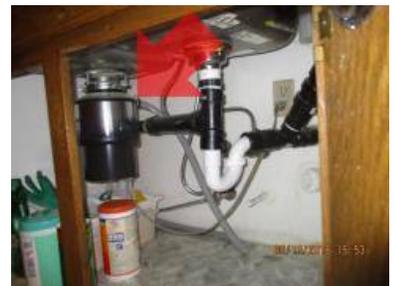
The dishwasher drain lacks an air gap. The dishwasher will function without one, but there is a risk of contamination of the inside of the dishwasher by waste water. The installation of an air gap is recommended.

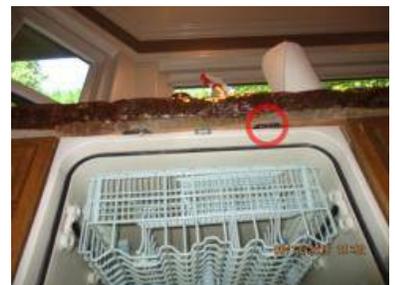
The dishwasher is not secured to the countertop. This allows the appliance to move around. The dishwasher should be secured to the bottom of the countertop in accordance with industry standards.

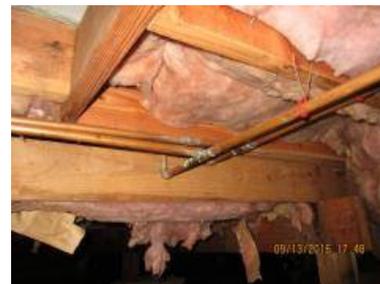
There are water pipes in the crawlspace that are not adequately insulated and could freeze. The installation of foam pipe insulation on all exposed water pipes is recommended.

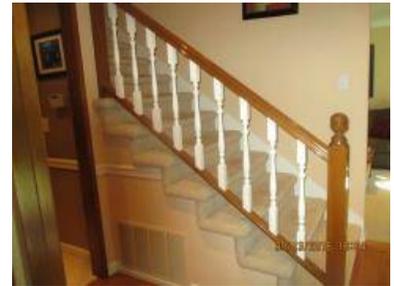
The stair railing baluster spacing is too wide. This is a hazard for small children. The baluster spacing should be reduced as a safety upgrade. Current standards require that a 4" sphere not pass through the railing.

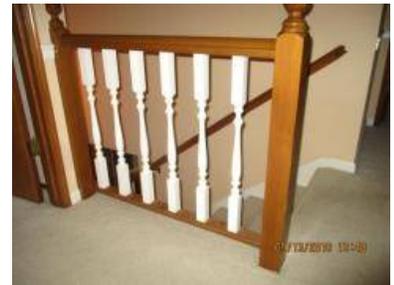
#### 14.3 GUARD RAILINGS

The spacing between the balusters is too wide. This is a hazard to small children. The balusters should be spaced close enough together so that a 4" sphere cannot pass through. Upgrading the guard railing is recommended if small children are present.

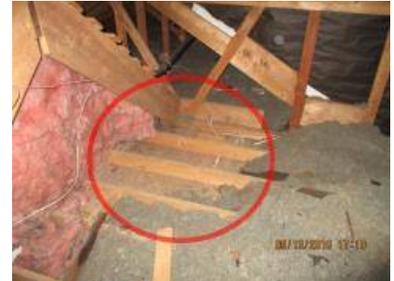
There is a large thermal bypasses in the attic. A thermal bypass is an opening between an insulated and uninsulated part of the house through which heated air can escape. As air is heated, it rises and pulls cool air in to the space to replace it. This condition will result in significant heat loss. Sealing up all thermal bypass routes is recommended.

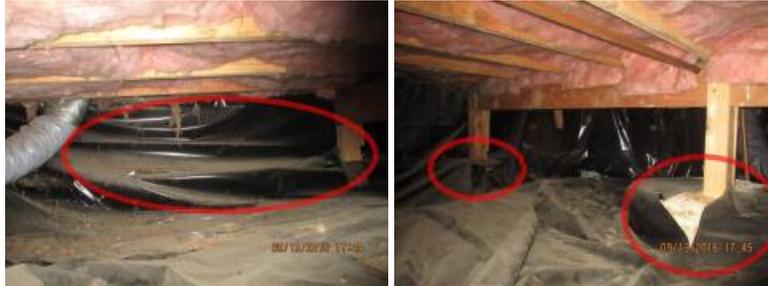
The support post concrete piers are covered with the plastic vapor retarder. This allows the transmission of water vapor from the soil up and into the floor framing. The plastic vapor retarder should be removed from the pier so that it covers the entire surface of the soil only.
