September 14, 2016

Re: 17032 NE 131st Pl.
Redmond, WA.

17032 NE 131st Pl.
Redmond WA.

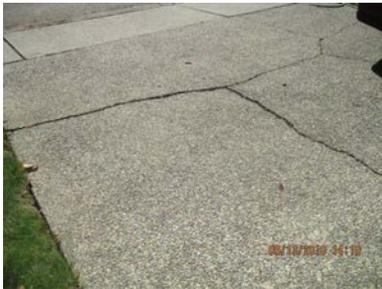
1. The driveway has cracked and settled differentially. This was probably caused by inadequate preparation of the soil prior to the placement of the concrete. This condition can be repaired by pressure grouting the sunken portion of the driveway or by removing and replacing it. The driveway remains functional despite this condition.

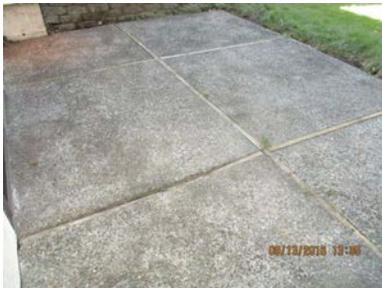
2.5 PATIO

2. One or more of the wooden dividers separating the concrete patio sections were infested by wood destroying organisms and have deteriorated to a point where they are becoming a trip hazard. Replacement with mortar is recommended.

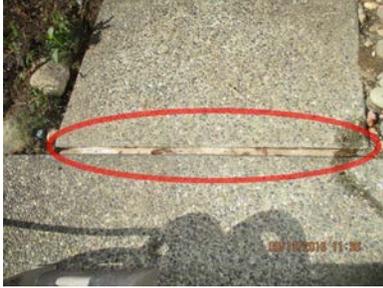
2.6 WALKWAY

3. One or more of the wooden dividers separating the concrete walkway sections were infested by wood destroying organisms and have deteriorated to a point where they are becoming a trip hazard. Replacement with mortar is recommended.

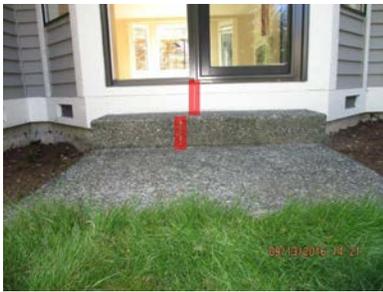
2.7 STEPS

4. The steps are non-conforming due to the variable and/or excessive rise. Stair design standards require that stair risers do not exceed 8" and that the variation in rise not exceed 3/8" in order to reduce falls from tripping. To increase the margin of safety, consideration should be given to reconfiguring the steps so that rise and run do not vary by more than 3/8". If this proves to be too impractical or expensive, then we recommend exercising caution when using these steps.

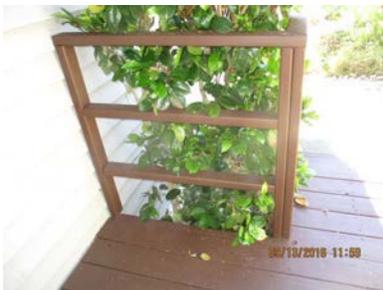
3.7 PORCH RAILING

5. The spacing between the balusters is too wide. This is a hazard to small children. The balusters should be spaced close enough together so that a 4" sphere cannot pass through. Upgrading the porch railing is recommended if small children are present.

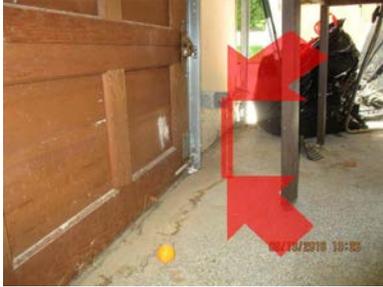
6.3 GARAGE DOOR OPENER

6. The Photo-eye beam was installed too high above the floor of the garage to adequately offer protection for small children and/or pets. We recommend that the photo-eye be lowered to within 4-6" of the floor.

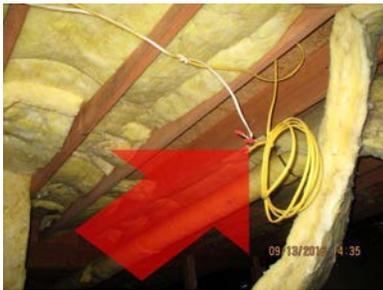
8. There is an abandoned electrical cable with exposed conductors in the crawlspace. This is a shock hazard. The cable should be terminated in a covered junction box or removed.

7.10.8 - Crawl Space Wiring

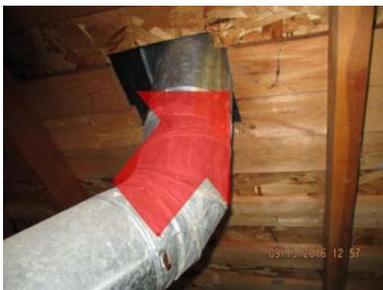
10. The furnace vent connector is too close to a combustible material in the attic. This is a hazard. A minimum clearance of 6" is required between the single wall vent connector and the combustible material. The double wall type B vent requires only 1" of clearance. Repairs are recommended.

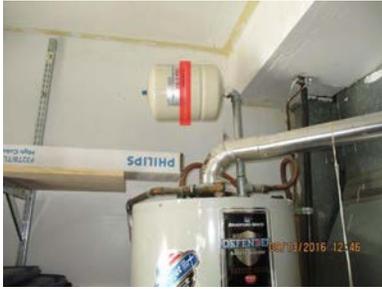
11. The expansion tank is not adequately secured to the wall. This could result in damage to the water pipe

and leakage during an earth quake. A seismic restraint should be installed to secure the expansion tank.

9.6.11 - Expansion Tank Support

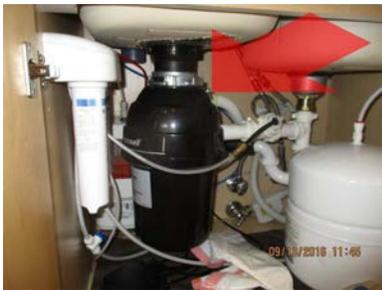
13. The dishwasher drain lacks an air gap. The dishwasher will function without one, but there is a risk of contamination of the inside of the dishwasher by waste water. The installation of an air gap is recommended.

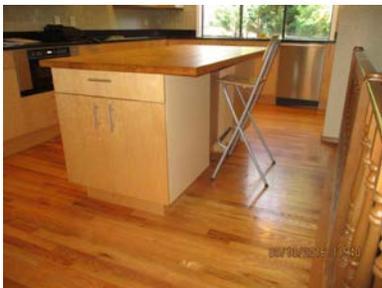
15. There is no receptacle installed in the kitchen cabinet island. The number of receptacles may be inadequate for your particular needs. Consideration should be given to adding additional electrical receptacles.

See
inside
middle
cabinet
for
outlets

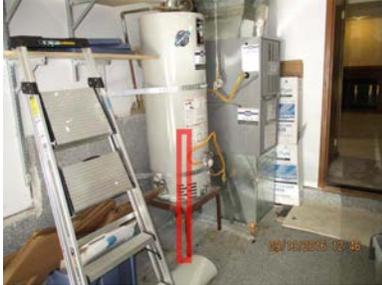
17. The gas pipes in front of the furnace and water heater are not protected by a bumper stop. A vertical steel pipe, bolted to the floor, is typically installed in front of the water heater to prevent a car bumper from damaging the gas lines.

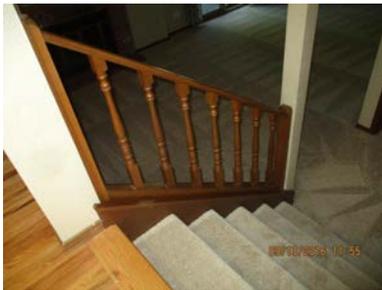
18. The lower stair railing baluster spacing is too wide. This is a hazard for small children. The baluster spacing should be reduced as a safety upgrade. Current standards require that a 4" sphere not pass through the railing.

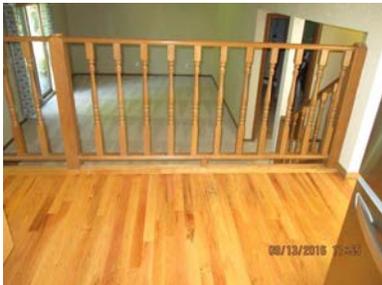
14.3 GUARD RAILINGS

19. The spacing between the balusters is too wide. This is a hazard to small children. The balusters should be spaced close enough together so that a 4" sphere cannot pass through. Upgrading the guard railing is recommended if small children are present.

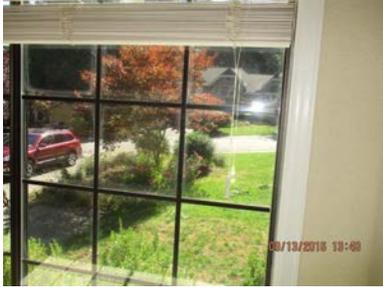
14.7 WINDOWS

20. There is condensation or mineral deposits between the panes of glass in several of the insulated glass windows. This indicates failed seals. The glass assemblies should be replaced, which is the only method for correcting this deficiency.

14.7.20 - Windows

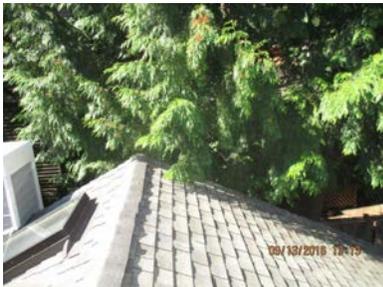
1. Trees are touching the building on the west side. Low hanging tree branches can damage the roof. Tree branches should be trimmed back where necessary.

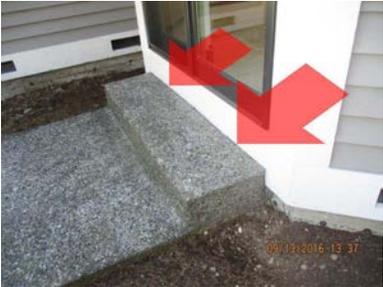
2. Untreated wood in direct contact with concrete was observed along the entry stoop and patio. Untreated wood should be raised 1-2" above the concrete. Treating the wood with a preservative sometimes will prevent wood destroy organism damage.

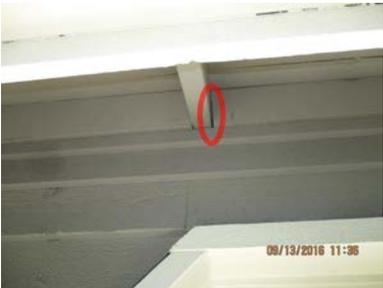
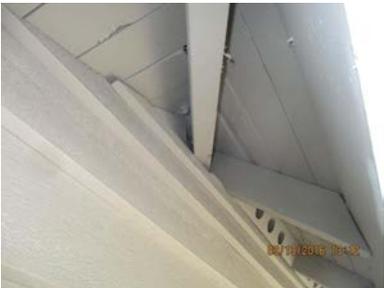
3.3 SOFFITS AND OVERHANGS

3. There are large gaps over 1/4" in size adjacent the soffit vent blocks. These gaps allow insects and rodents to enter the attic. Covering the gaps with screening, a strip of wood and/or caulking is recommended.

There are openings at the intersection between the overhang and the roof through which birds and rodents can enter into the attic. These openings should be covered with wood, wire mesh or filled with aerosol foam.

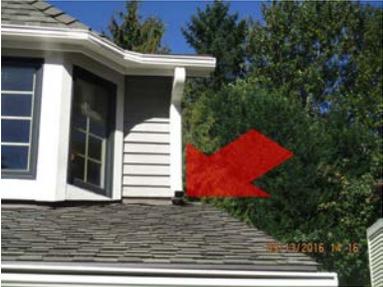
3.4 GUTTERS AND DOWNSPOUTS

4. Downspouts draining directly onto the asphalt shingle surface causes excessive wear of the roofing material. Downspout extensions should be installed to prevent excessive wear and tear of the roofing.

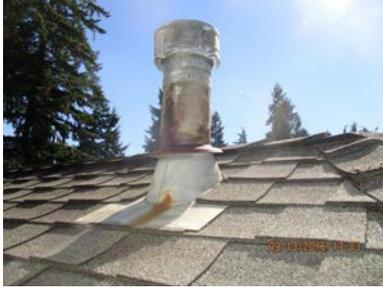
5. The gas appliance vent is corroded above the roof line. Cleaning and painting the vent will prolong its service life.

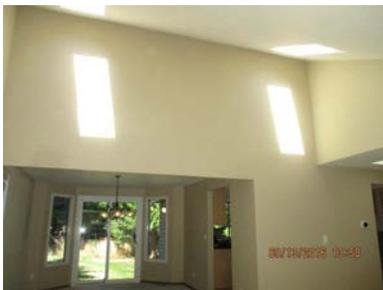
6. There is no access to the attic above the kitchen and dining room. The installation of an attic access under the highest point of the roof is recommended for inspection and servicing of components in the attic.

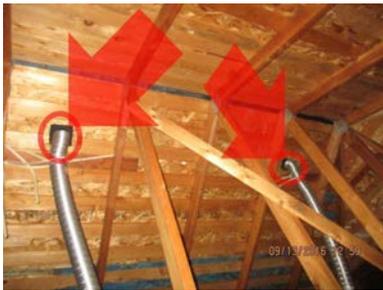
5.3 MECHANICAL VENTILATION SYSTEMS

7. The bathroom vent fans discharge in the attic rather than outside. This is an undesirable condition that causes excessive moisture in the attic and can result in mold or fungus growth. A 4" smooth-wall sheet metal duct should be installed to direct the moisture laden air discharged from the fan out of the attic.

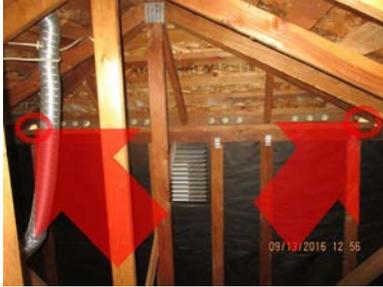
5.4 PEST CONTROL

8. There is evidence of rodent activity in the attic. The first step in eliminating rodents from the attic is to seal all possible entry points using wire mesh, caulking, wood, stainless steel wool, or aerosol foam. Careful work sealing cracks, holes and gaps over 1/4" in size will discourage further activity. Once this work is completed, snap traps baited with peanut butter should be installed and monitored. The absence of rodents in the traps typically means that the rodents have been excluded from the area.

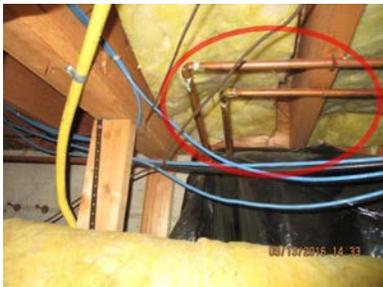
13. There are water pipes in the crawlspace that are not adequately insulated and could freeze. The installation of foam pipe insulation on all exposed water pipes is recommended.

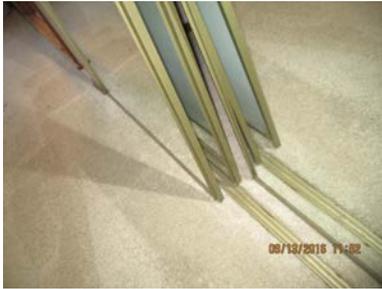
16. The floor guides are missing from the bypass closet doors in the master bedroom. Missing floor guides could result in damage to the doors. The installation of floor guides is recommended.

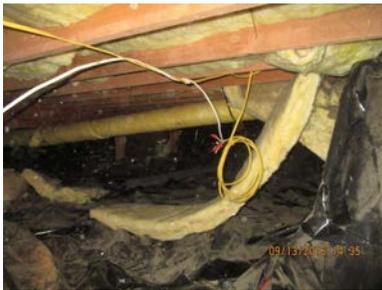
17. Some of the insulation batts were not properly secured and have falling down. The fallen batts should be reinstalled and secured.

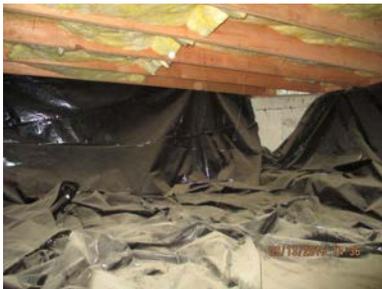
18. The foundation walls are covered with the plastic vapor retarder. This allows the transmission of water vapor from the soil up and into the exterior wall framing. The plastic vapor retarder should be removed from the foundation so that it covers the entire surface of the soil only.

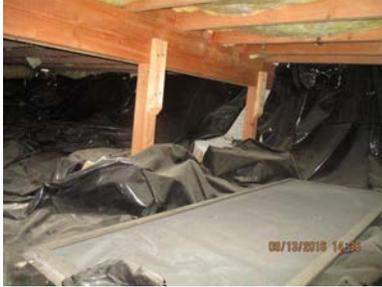
19. The support post concrete piers are covered with the plastic vapor retarder. This allows the transmission of water vapor from the soil up and into the floor framing. The plastic vapor retarder should be removed from the pier so that it covers the entire surface of the soil only.

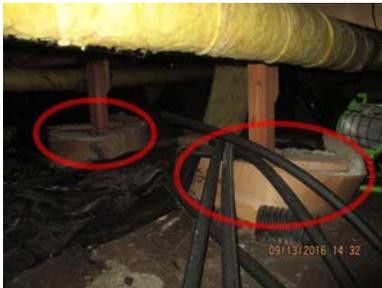
19.5 PEST CONTROL

20. Scrap-wood and other cellulose debris was observed on the crawl floor. This wood debris creates conducive conditions for wood boring insects. The removal of all cellulose debris is recommended.

Cellulose forms were left in place on the pier footings. This cellulose is conducive to the infestation of various wood destroying organisms. The removal of the cellulose is recommended.

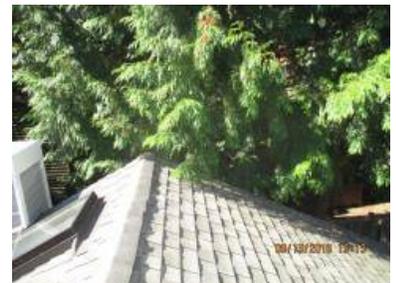
Trees are touching the building on the west side. Low hanging tree branches can damage the roof. Tree branches should be trimmed back where necessary.

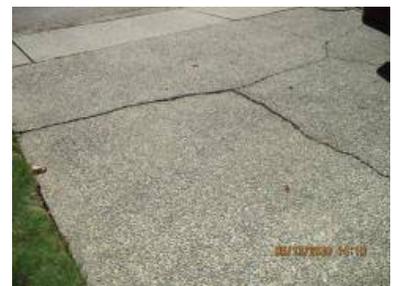
2.4 DRIVEWAY

The driveway has cracked and settled differentially. This was probably caused by inadequate preparation of the soil prior to the placement of the concrete. This condition can be repaired by pressure grouting the sunken portion of the driveway or by removing and replacing it. The driveway remains functional despite this condition.

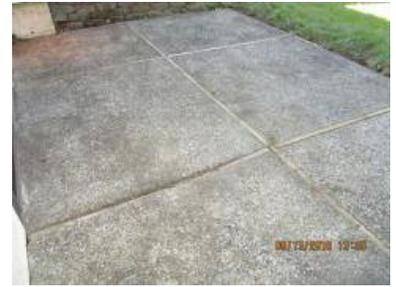
2.5 PATIO

One or more of the wooden dividers separating the concrete patio sections were infested by wood destroying organisms and have deteriorated to a point where they are becoming a trip hazard. Replacement with mortar is recommended.

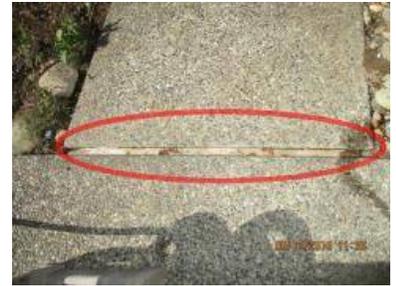
2.6 WALKWAY

Many legal and public works departments have defined a trip hazard as an irregularity in a walking surface exceeding one inch (1") in height. All walking surfaces should maintain, free of a vertical surface change of 3/4" or more, in the interest of public and personal safety.

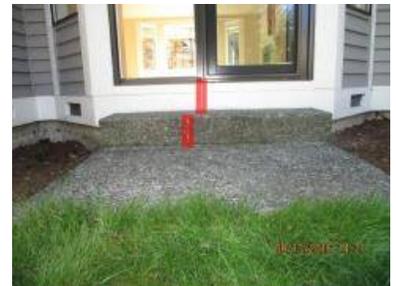
2.7 STEPS

The steps are non-conforming due to the variable and/or excessive rise. Stair design standards require that stair risers do not exceed 8" and that the variation in rise not exceed 3/8" in order to reduce falls from tripping. To increase the margin of safety, consideration should be given to reconfiguring the steps so that rise and run do not vary by more than 3/8". If this proves to be too impractical or expensive, then we recommend exercising caution when using these steps.

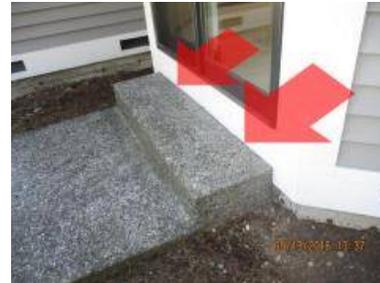
Untreated wood in direct contact with concrete was observed along the entry stoop and patio. Untreated wood should be raised 1-2" above the concrete. Treating the wood with a preservative sometimes will prevent wood destroy organism damage.

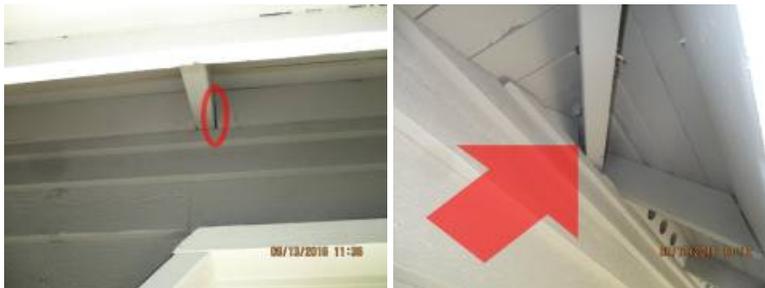
3.3 SOFFITS AND OVERHANGS

There are openings at the intersection between the overhang and the roof through which birds and rodents can enter into the attic. These openings should be covered with wood, wire mesh or filled with aerosol foam.

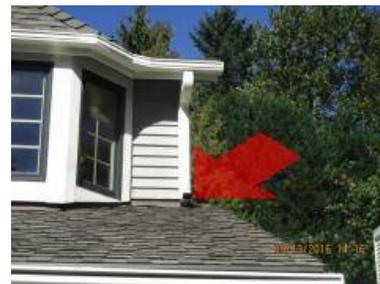
3.4 GUTTERS AND DOWNSPOUTS

Downspouts draining directly onto the asphalt shingle surface causes excessive wear of the roofing material. Downspout extensions should be installed to prevent excessive wear and tear of the roofing.

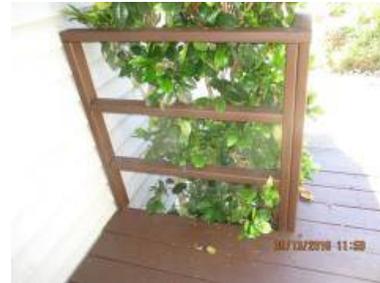
The spacing between the balusters is too wide. This is a hazard to small children. The balusters should be spaced close enough together so that a 4" sphere cannot pass through. Upgrading the porch railing is recommended if small children are present.

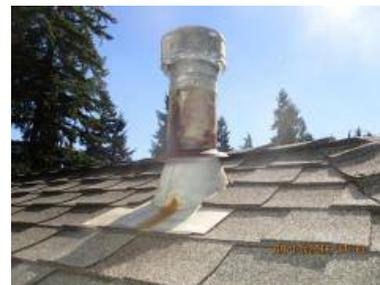
The gas appliance vent is corroded above the roof line. Cleaning and painting the vent will prolong its service life.

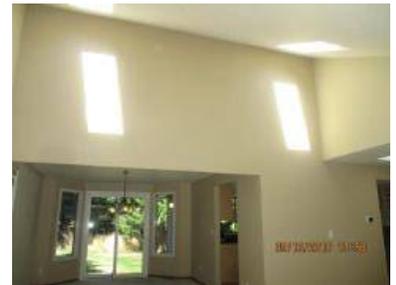
There is no access to the attic above the kitchen and dining room. The installation of an attic access under the highest point of the roof is recommended for inspection and servicing of components in the attic.

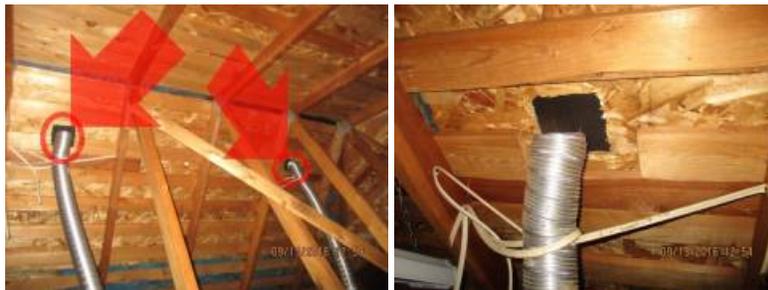
The bathroom vent fans discharge in the attic rather than outside. This is an undesirable condition that causes excessive moisture in the attic and can result in mold or fungus growth. A 4" smooth-wall sheet metal duct should be installed to direct the moisture laden air discharged from the fan out of the attic.

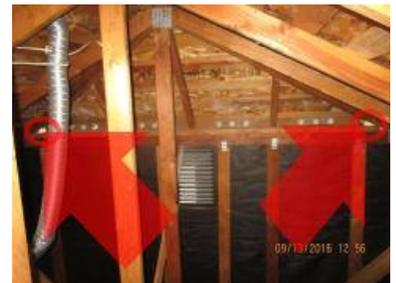
5.4 PEST CONTROL

There is evidence of rodent activity in the attic. The first step in eliminating rodents from the attic is to seal all possible entry points using wire mesh, caulking, wood, stainless steel wool, or aerosol foam. Careful work sealing cracks, holes and gaps over 1/4" in size will discourage further activity. Once this work is completed, snap traps baited with peanut butter should be installed and monitored. The absence of rodents in the traps typically means that the rodents have been excluded from the area.

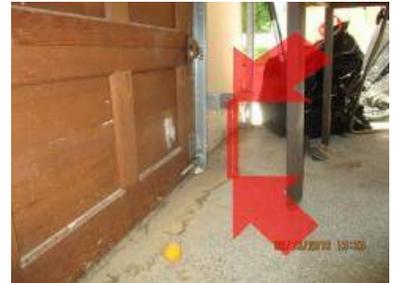
The Photo-eye beam was installed too high above the floor of the garage to adequately offer protection for small children and/or pets. We recommend that the photo-eye be lowered to within 4-6" of the floor.

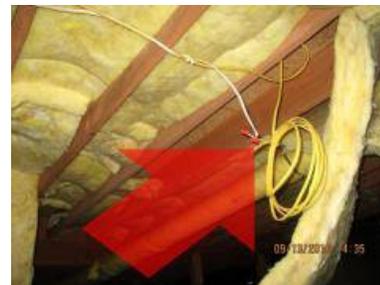
There is an abandoned electrical cable with exposed conductors in the crawlspace. This is a shock hazard. The cable should be terminated in a covered junction box or removed.

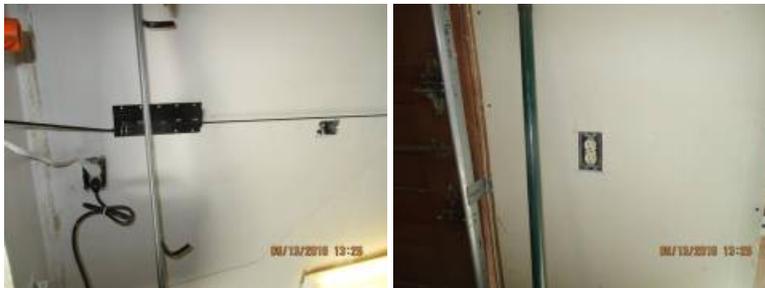
There are junction boxes with missing covers in the garage. This is a fire/shock hazard. Covers should be installed on all junction boxes.

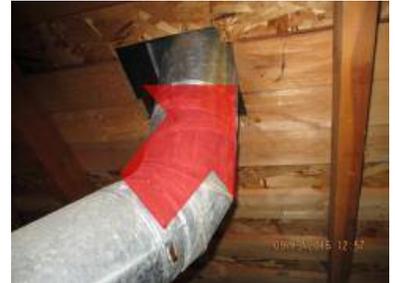
The furnace vent connector is too close to a combustible material in the attic. This is a hazard. A minimum clearance of 6" is required between the single wall vent connector and the combustible material. The double wall type B vent requires only 1" of clearance. Repairs are recommended.

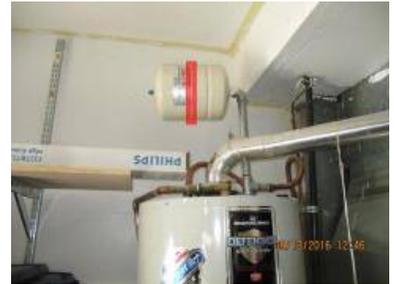
The expansion tank is not adequately secured to the wall. This could result in damage to the water pipe and leakage during an earth quake. A seismic restraint should be installed to secure the expansion tank.

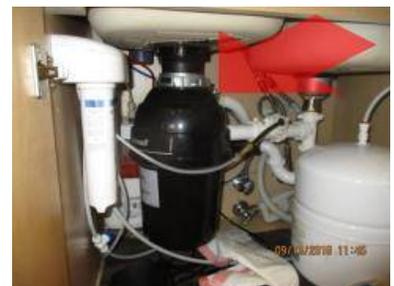
The dishwasher drain lacks an air gap. The dishwasher will function without one, but there is a risk of contamination of the inside of the dishwasher by waste water. The installation of an air gap is recommended.

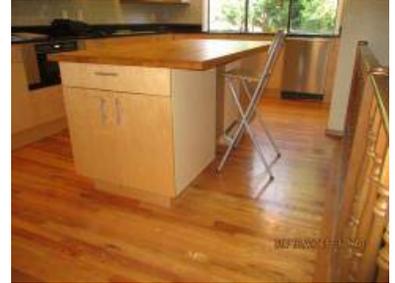
There is no receptacle installed in the kitchen cabinet island. The number of receptacles may be inadequate for your particular needs. Consideration should be given to adding additional electrical receptacles.

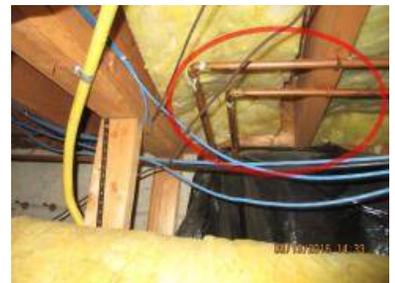
There are water pipes in the crawlspace that are not adequately insulated and could freeze. The installation of foam pipe insulation on all exposed water pipes is recommended.
