NOTICE TO BUYER: SELLER-PROCURED INSPECTION REPORT

17207 NE 141st St

Redmond WA 98052

At your request, a visual inspection of the above referenced property was conducted on September 22, 2016. We have inspected the major structural components, plumbing, heating and electrical systems for signs of significant non-performance, excessive or unusual wear and general state of repair.

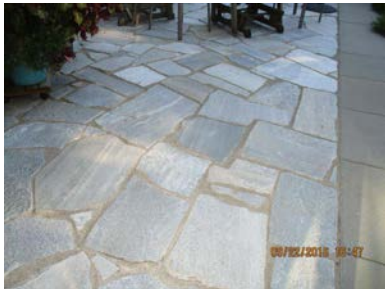
2.5 PATIO

1. The walking surface was not even and trip hazards were present. We recommend all walking surfaces be maintained free of trip hazards.

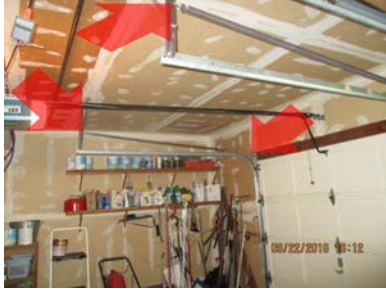
6.2 OVERHEAD GARAGE DOORS

3. Safeties are cables run through the center of the garage door springs that prevent broken springs from becoming projectiles that can cause injury. There are no safeties installed. The installation of safeties is recommended.

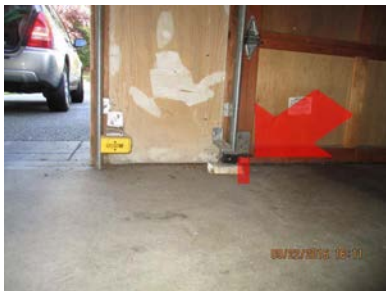
6.3 GARAGE DOOR OPENER

4. One of the Photo-eye beams was installed too low to the floor of the garage to adequately offer protection for small children and/or pets. We recommend that the photo-eye be raised to within 4-6" of the floor.

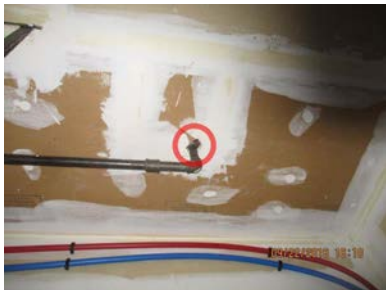
6.4 FIRE SEPARATION

5. There are voids in the fire resistive barrier between the living space and garage that will allow flames to penetrate. The gypsum barrier slows the spread of a fire from the garage to the structure and/or living space. Patching the voids is recommended.

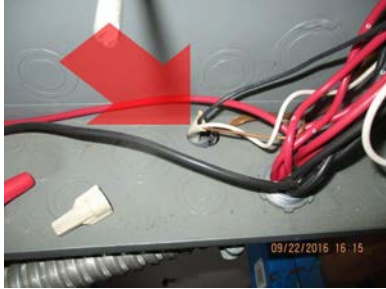
7.8 SERVICE PANEL

6. There is an electrical cable emanating from the service panel that is not clamped. The sharp edge of the panel box could cut through the wire insulation and cause a short circuit or fire. Clamping the cable to the panel box using an approved cable clamp is recommended.

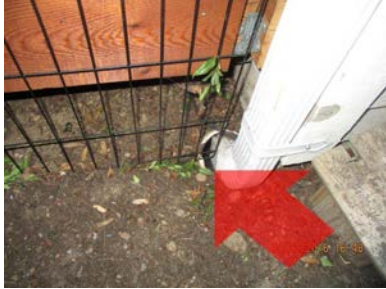
2.1 ROOF WATER DRAIN SYSTEM

1. Several of the inlets to the below grade drain system are at or below grade level. This condition allows beauty bark and dirt to enter the drain inlet and may eventually clog it up. Soil should be moved away from drain line inlets, or the drain line inlets should be extended up above the soil. Drain inlets should be capped to prevent rodent entry.

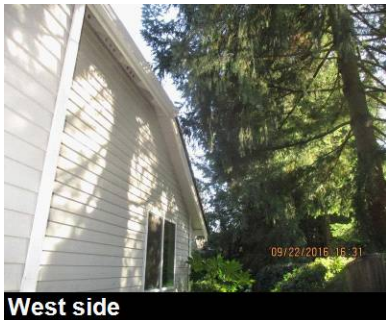
West side

2. Dense shrubbery and trees planted too close to the building can damage siding and the roof overhang and interfere with drainage and air movement, thus promoting fungus growth and accelerated deterioration of exterior finishes and wood. Trees and shrubs in contact with the building also provide carpenter ants with a route into walls or attics. Trees and shrubs should be trimmed back, where required. When landscaping, trees and shrubs should be planted back away from the building so that they have room to grow.

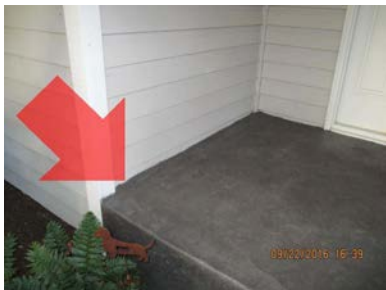
4. Soil is close to or in contact with siding in some areas around the building exterior. Good building practice requires that foundation walls or pier footings supporting wood frame construction, extend at least 8" above the finish grade with at least a 6" clearance between the top of the soil and the bottom of the wood finish materials. Soil in direct contact with wood creates a hospitable environment for wood destroying organisms. Establishing these minimum clearances is recommended.

Untreated wood in direct contact with concrete was observed along the entry stoop. Untreated wood should be raised 1-2" above the concrete. Treating the wood with a preservative sometimes will prevent wood destroy organism damage.

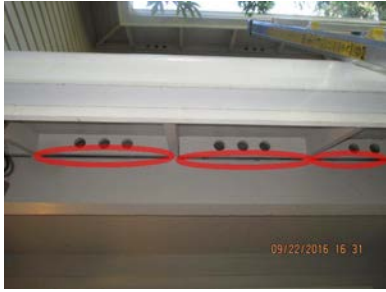
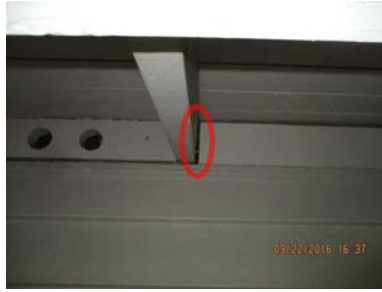
3.3 SOFFITS AND OVERHANGS

5. There are large gaps over 1/4" in size adjacent the soffit vent blocks. These gaps allow insects and

rodents to enter the attic. Covering the gaps with screening, a strip of wood and/or caulking is recommended.

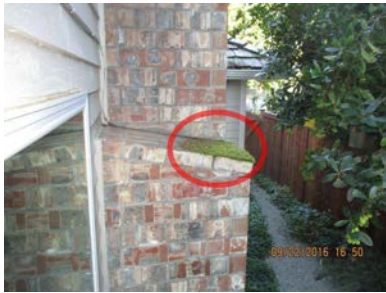
4.4 CHIMNEYS

7. Moss/vegetation was observed in several areas around the chimney. This will lead to accelerated deterioration of the brick masonry mortar. We recommend removal of all organic growth. Damaged areas can be repaired by filling in cutout or defective mortar joints with fresh mortar. (Tuck pointing)

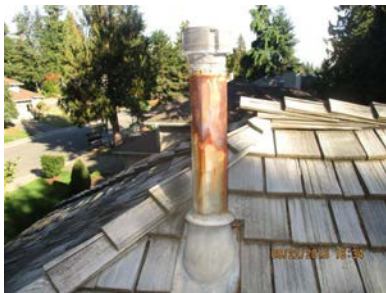
4.5 GAS APPLIANCE VENTS

8. The gas appliance vent is corroded above the roof line. Cleaning and painting the vent will prolong its service life.

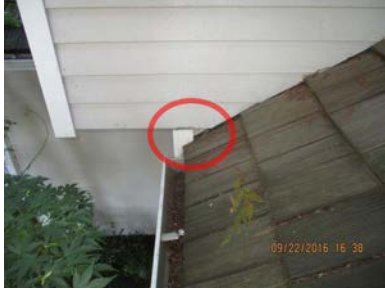
4.6 FLASHINGS

9. There are no kick out flashings at the roof edge to wall intersections above the gutters. This will allow water to enter the wall behind the siding. The installation of kick-out flashings is recommended.

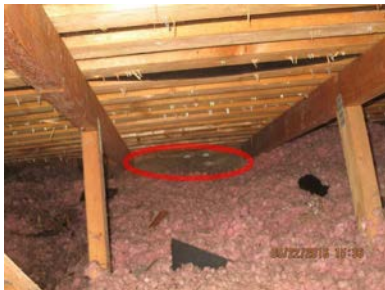
5.2 VENTILATION

11. Wind baffles locations are compromised in some areas of the attic. The proper placement of wind baffles in front of all soffit vents is recommended.

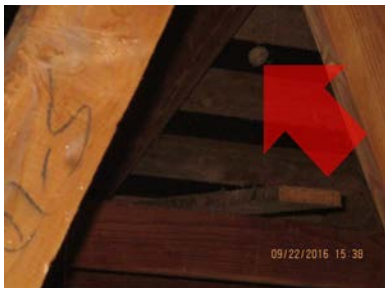
5.4 PEST CONTROL

12. The first step in preventing rodents from entering the attic is to seal all possible entry points using wire mesh, caulking, wood, stainless steel wool, or aerosol foam. Careful work sealing cracks, holes and gaps over 1/4" in size will discourage activity.

There is a yellow jacket (paper wasp) nest in the attic. Yellow jackets are very aggressive in late summer and their sting is painful. Yellow jacket activity can be avoided by sealing all openings into the attic, particularly above the gable end walls and below vent blocks.

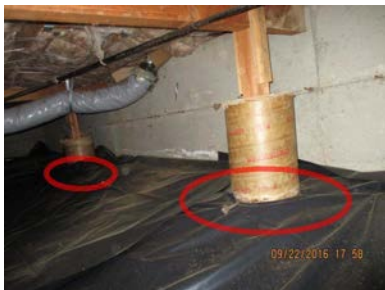
20.4 VAPOR RETARDER

19. The support post concrete piers are covered with the plastic vapor retarder. This allows the transmission of water vapor from the soil up and into the floor framing. The plastic vapor retarder should be removed from the pier so that it covers the entire surface of the soil only.

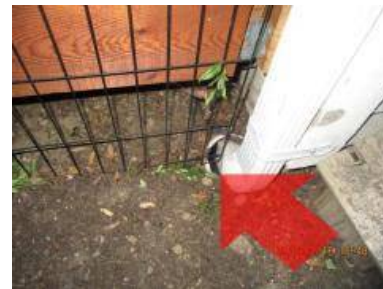
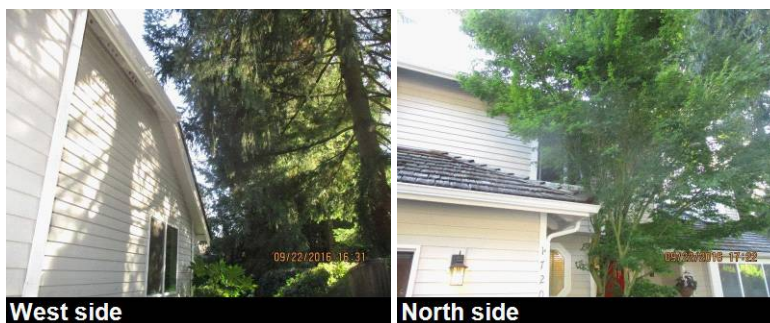
2.3 VEGETATION

Dense shrubbery and trees planted too close to the building can damage siding and the roof overhang and interfere with drainage and air movement, thus promoting fungus growth and accelerated deterioration of exterior finishes and wood. Trees and shrubs in contact with the building also provide carpenter ants with a route into walls or attics. Trees and shrubs should be trimmed back, where required. When landscaping, trees and shrubs should be planted back away from the building so that they have room to grow.

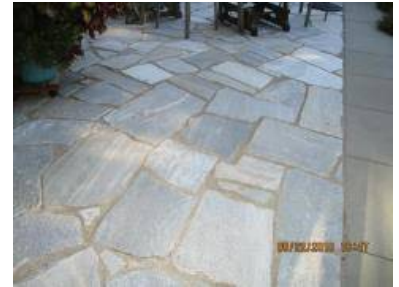
2.5 PATIO

The walking surface was not even and trip hazards were present. We recommend all walking surfaces be maintained free of trip hazards.

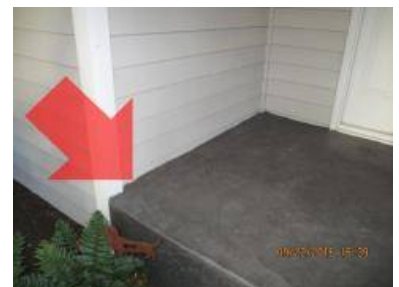
Soil is close to or in contact with siding in some areas around the building exterior. Good building practice requires that foundation walls or pier footings supporting wood frame construction, extend at least 8" above the finish grade with at least a 6" clearance between the top of the soil and the bottom of the wood finish materials. Soil in direct contact with wood creates a hospitable environment for wood destroying organisms. Establishing these minimum clearances is recommended.

Untreated wood in direct contact with concrete was observed along the entry stoop. Untreated wood should be raised 1-2" above the concrete. Treating the wood with a preservative sometimes will prevent wood destroy organism damage.

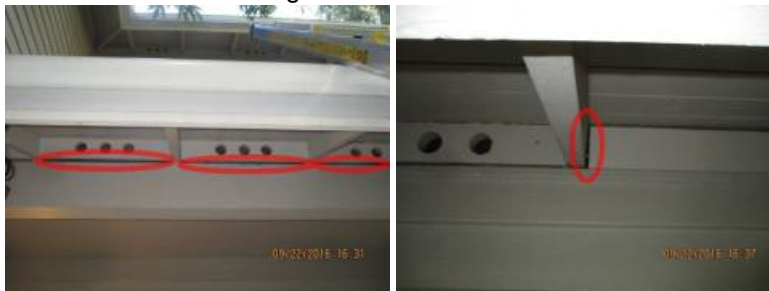
3.3 SOFFITS AND OVERHANGS

There are large gaps over 1/4" in size adjacent the soffit vent blocks. These gaps allow insects and rodents to enter the attic. Covering the gaps with screening, a strip of wood and/or caulking is recommended.

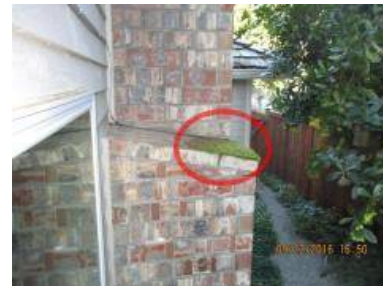
Moss/vegetation was observed in several areas around the chimney. This will lead to accelerated deterioration of the brick masonry mortar. We recommend removal of all organic growth. Damaged areas can be repaired by filling in cutout or defective mortar joints with fresh mortar. (Tuck pointing)

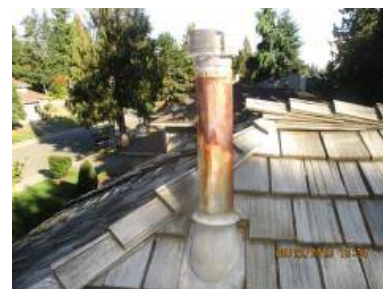
4.5 GAS APPLIANCE VENTS

The gas appliance vent is corroded above the roof line. Cleaning and painting the vent will prolong its service life.

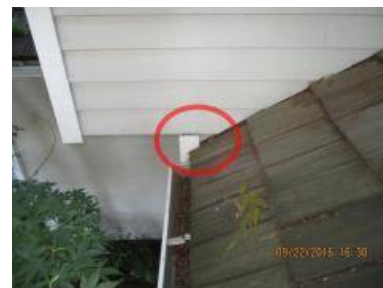
4.6 FLASHINGS

There are no kick out flashings at the roof edge to wall intersections above the gutters. This will allow water to enter the wall behind the siding. The installation of kick-out flashings is recommended.

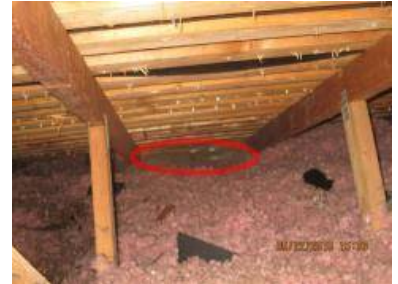
Wind baffles locations are compromised in some areas of the attic. The proper placement of wind baffles in front of all soffit vents is recommended.

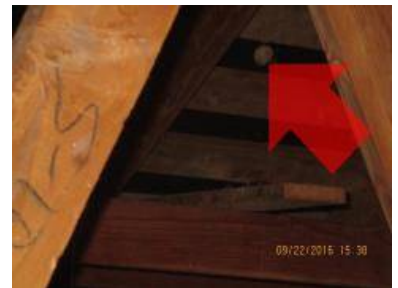
There is a yellow jacket (paper wasp) nest in the attic. Yellow jackets are very aggressive in late summer and their sting is painful. Yellow jacket activity can be avoided by sealing all openings into the attic, particularly above the gable end walls and below vent blocks.

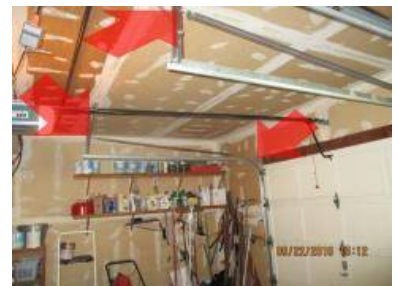
Safeties are cables run through the center of the garage door springs that prevent broken springs from becoming projectiles that can cause injury. There are no safeties installed. The installation of safeties is recommended.

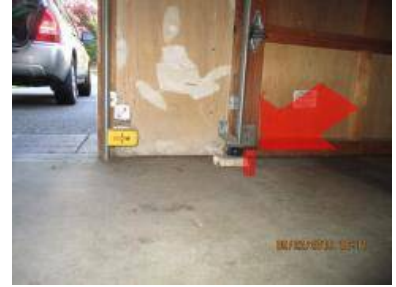
6.3 GARAGE DOOR OPENER

One of the Photo-eye beams was installed too low to the floor of the garage to adequately offer protection for small children and/or pets. We recommend that the photo-eye be raised to within 4-6" of the floor.

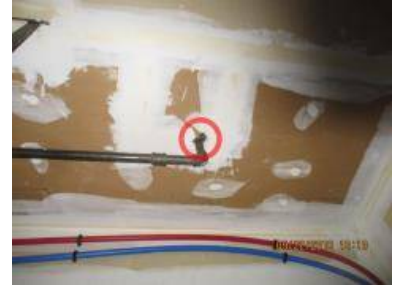
6.4 FIRE SEPARATION

There are voids in the fire resistive barrier between the living space and garage that will allow flames to penetrate. The gypsum barrier slows the spread of a fire from the garage to the structure and/or living space. Patching the voids is recommended.

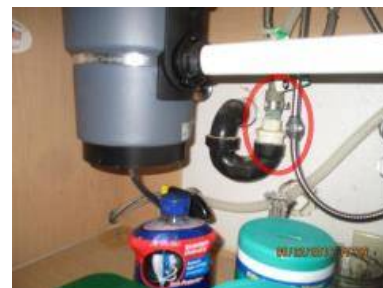
11.8 AIR GAP

The dishwasher drain lacks an air gap. The dishwasher will function without one, but there is a risk of contamination of the inside of the dishwasher by waste water. The installation of an air gap is recommended.

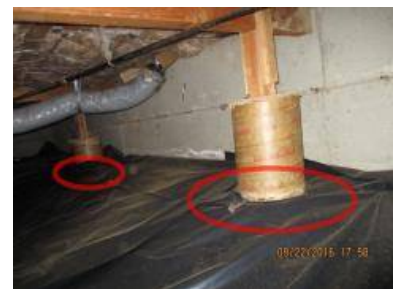
The support post concrete piers are covered with the plastic vapor retarder. This allows the transmission of water vapor from the soil up and into the floor framing. The plastic vapor retarder should be removed from the pier so that it covers the entire surface of the soil only.
