**NOTICE TO BUYER: SELLER-PROCURED INSPECTION REPORT**

February 2, 2017

**Re: 11827 104th Ave NE**  
**Kirkland, WA.**

## REPORT SUMMARY

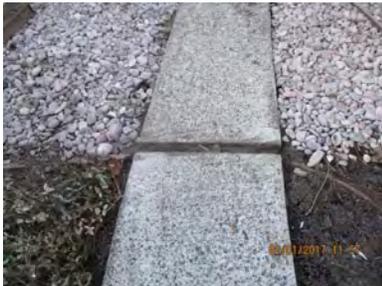
1. The wooden dividers separating the concrete walkway sections have deteriorated to a point where the gaps are a trip hazard. Replacement with mortar is recommended.

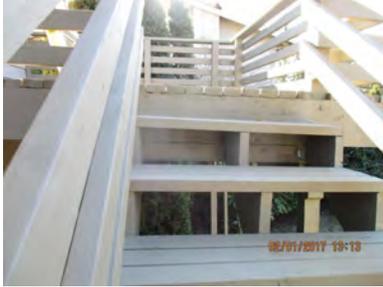
2. The stairs are non-conforming due to the variable and/or excessive rise. Stair design standards require that stair risers do not exceed 8" and that the variation in rise not exceed 3/8" in order to reduce falls from tripping. To increase the margin of safety, consideration should be given to reconfiguring the stairs so that rise and run do not vary by more than 3/8". If this proves to be too impractical or expensive, then we recommend exercising caution when using these stairs.

The stair rise spacing is too wide. This is a hazard for small children. The spacing should be reduced as a safety upgrade. Current standards require that a 4" sphere not pass through the opening.

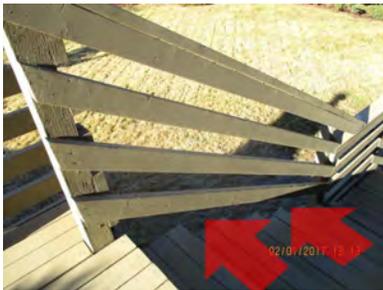
3. The spacing under stair railing is too wide. This is a hazard for small children. The spacing should be reduced as a safety upgrade. Current standards require that a 4" sphere not pass under the railing.

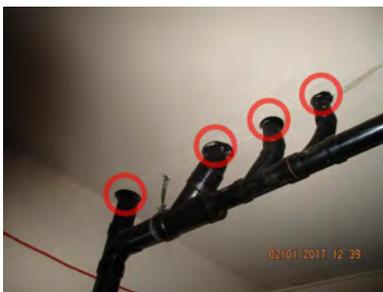
5. There are voids in the fire resistive barrier between the living space and garage that will allow flames to penetrate. The gypsum barrier slows the spread of a fire from the garage to the structure and/or living space. Patching the voids is recommended.

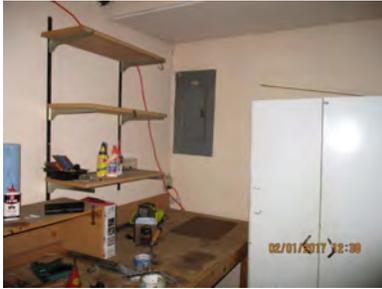
should be maintained in front of the panel cover.

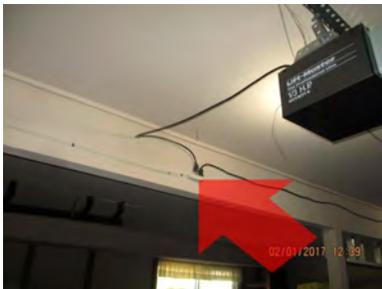
8. An extension cord is used as a temporary power source for the garage door openers. An extension cord is not suitable as a permanent wiring method. The installation of a receptacle within cords length of the motors is recommended.

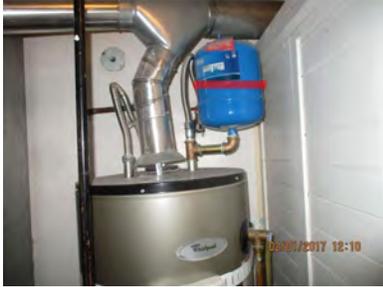
12. The expansion tank is not adequately secured to the wall. This could result in damage to the water pipe and leakage during an earth quake. A seismic restraint should be installed to secure the expansion tank.

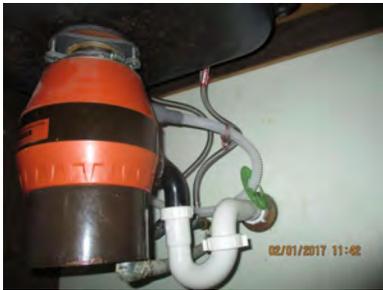
15. The dishwasher drain lacks an air gap. The dishwasher will function without one, but there is a risk of contamination of the inside of the dishwasher by waste water. The installation of an air gap is recommended.

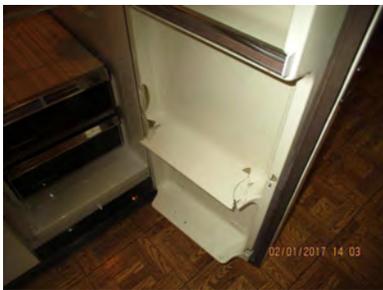
17. The refrigerator door shelf unit is damaged. The door should be repaired or replaced as necessary.

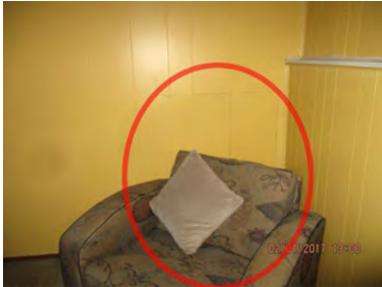
20. The secured panel prevented access and inspection of the area under the stairway entry landing. Defects or deficiencies may exist in inaccessible areas.

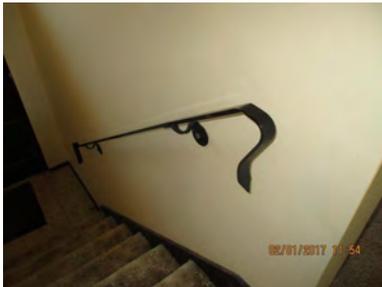
21. The railing ends in the stairwell does not return to the wall. This is a safety hazard. The installation of a continuous handrail should be considered as a safety upgrade.

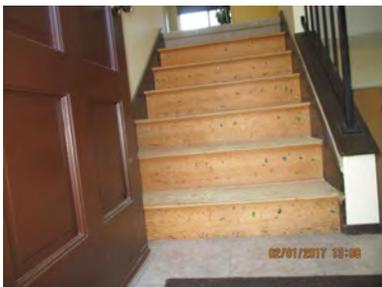
22. The stairs are non-conforming due to the variable and/or excessive rise. Stair design standards require that stair risers do not exceed 8" and that the variation in rise not exceed 3/8" in order to reduce falls from tripping. To increase the margin of safety, consideration should be given to reconfiguring the stairs so that rise and run do not vary by more than 3/8". If this proves to be too impractical or expensive, then we recommend exercising caution when using these stairs.

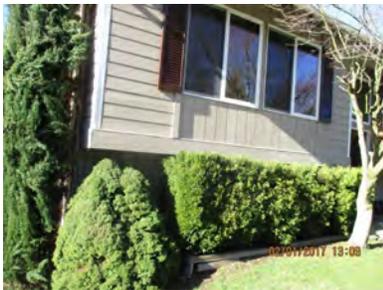
1. Dense shrubbery and trees planted too close to the building can damage siding and the roof overhang and interfere with drainage and air movement, thus promoting fungus growth and accelerated deterioration of exterior finishes and wood. Trees and shrubs in contact with the building also provide carpenter ants with a route into walls or attics. Trees and shrubs should be trimmed back, where required. When landscaping, trees and shrubs should be planted back away from the building so that they have room to grow.

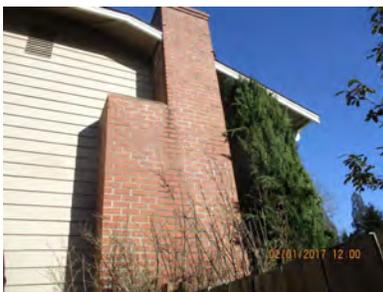
2. Trees are nearly touching the building on the south side. Low hanging tree branches can damage the roof, siding, doors and windows. Tree branches should be trimmed back where necessary.

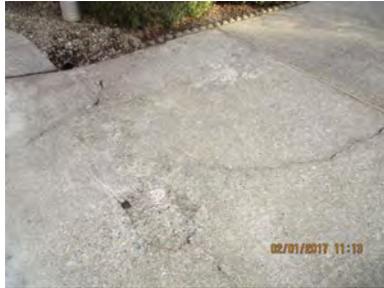
3. The driveway has cracked and settled differentially. This was probably caused by inadequate preparation of the soil prior to the placement of the concrete. This condition can be repaired by pressure grouting the sunken

portion of the driveway or by removing and replacing it. The driveway remains functional despite this condition.

Minor cracks can be sealed to minimize moisture entry and further settlement of the concrete. Minor cracks are common and do not affect the serviceability of the concrete.

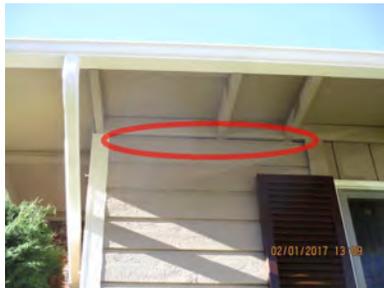
4. There are large gaps over 1/4" in size adjacent the soffit vent blocks. These gaps allow insects and rodents to enter the attic. Covering the gaps with screening, a strip of wood and/or caulking is recommended.

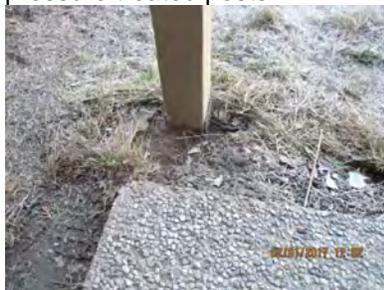
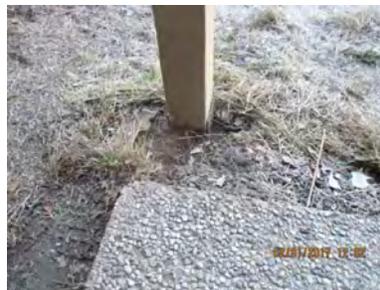
5. The bottom of at least one deck support post is rotted. Rotted posts should be repaired or replaced with pressure treated posts.

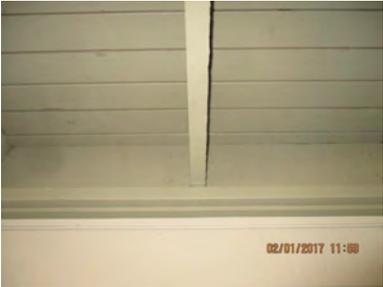
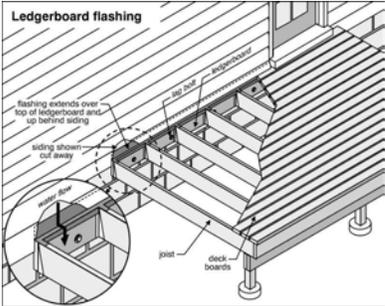
There is no flashing at the intersection between the deck and house. This will allow water to enter behind the siding. The installation of flashing in this area is recommended.

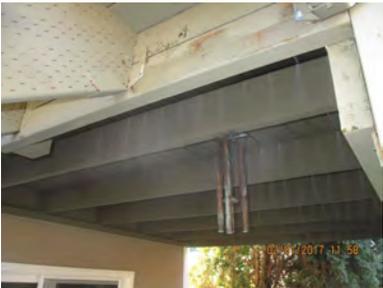
7. The deck structure lacks lateral bracing. The installation of a diagonal brace underneath the deck is recommended.

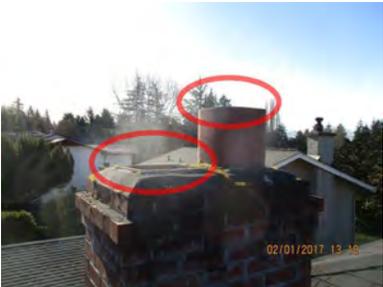
8. The top of the masonry chimney does not have spark arrestor/rain caps. The installation of a spark arrestor/rain cap for each flue is recommended as a safety upgrade and to prevent moisture damage to the inside of the chimney and fireplace. An additional benefit of a rain cap is that it will keep birds and rodents from entering the house when the damper is left open.

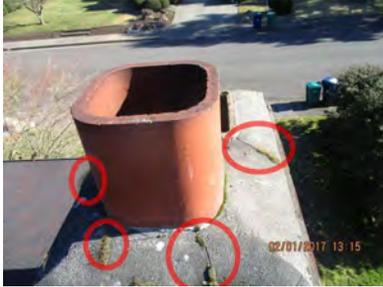
9. The chimney crown is cracked and deteriorated. The mortar chimney crown prevents water from entering and damaging the masonry. Repairing or replacing the chimney crown will extend the service life of the chimney.

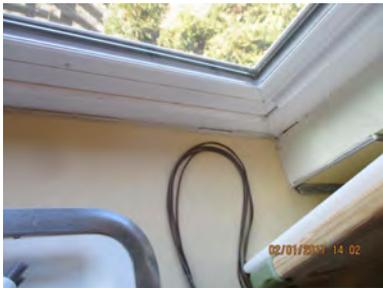
11. The backsplash caulking is cracked. Cracking of the caulk allows water to enter the gap and is difficult to clean. Caulking the cracks and/or gaps is recommended.

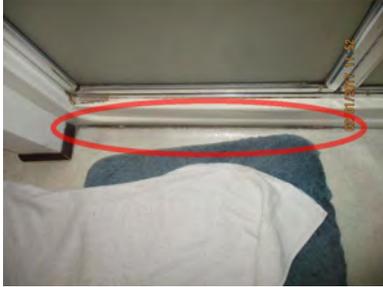
15. The vinyl flooring is damaged from water intrusion into the substrate. The flooring should be replaced as necessary to restore cosmetic appearance. The subfloor underneath the vinyl flooring appears to be solid.

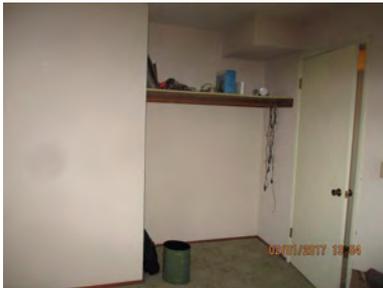
17. Closet doors are missing in the bedroom.

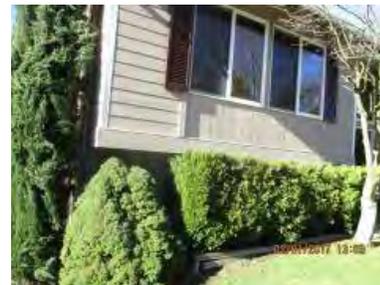
Dense shrubbery and trees planted too close to the building can damage siding and the roof overhang and interfere with drainage and air movement, thus promoting fungus growth and accelerated deterioration of exterior finishes and wood. Trees and shrubs in contact with the building also provide carpenter ants with a route into walls or attics. Trees and shrubs should be trimmed back, where required. When landscaping, trees and shrubs should be planted back away from the building so that they have room to grow.

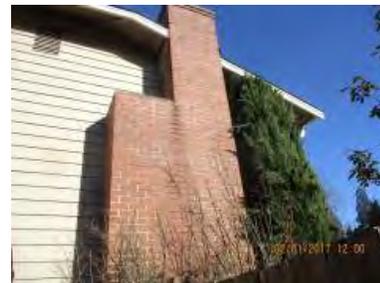
Trees are nearly touching the building on the south side. Low hanging tree branches can damage the roof, siding, doors and windows. Tree branches should be trimmed back where necessary.

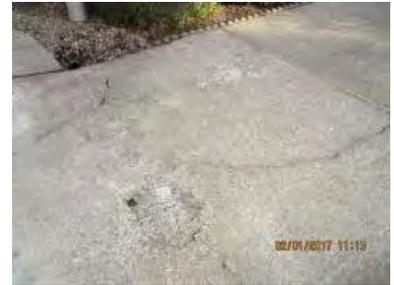
The driveway has cracked and settled differentially. This was probably caused by inadequate preparation of the soil prior to the placement of the concrete. This condition can be repaired by pressure grouting the sunken portion of the driveway or by removing and replacing it. The driveway remains functional despite this condition.

Minor cracks can be sealed to minimize moisture entry and further settlement of the concrete. Minor cracks are common and do not affect the serviceability of the concrete.

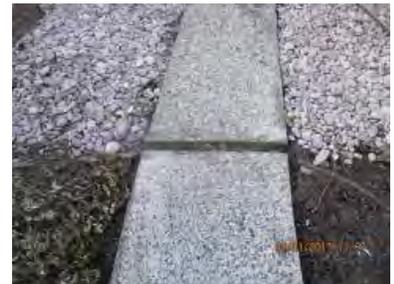
The wooden dividers separating the concrete walkway sections have deteriorated to a point where the gaps are a trip hazard. Replacement with mortar is recommended.

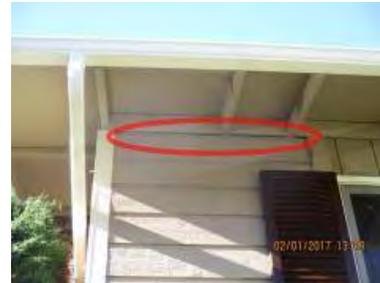
There are large gaps over 1/4" in size adjacent the soffit vent blocks. These gaps allow insects and rodents to enter the attic. Covering the gaps with screening, a strip of wood and/or caulking is recommended.

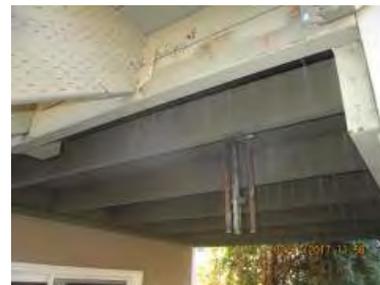
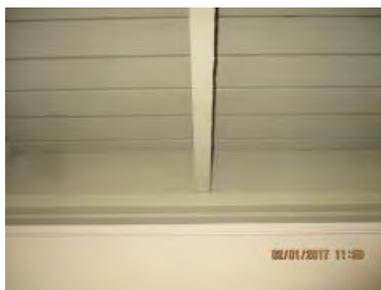
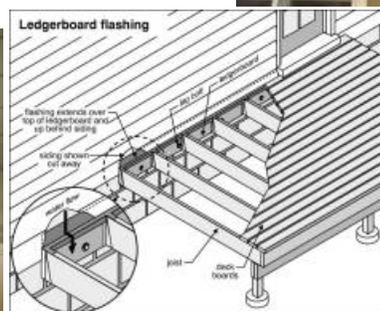
The deck structure lacks lateral bracing. The installation of a diagonal brace underneath the deck is recommended.

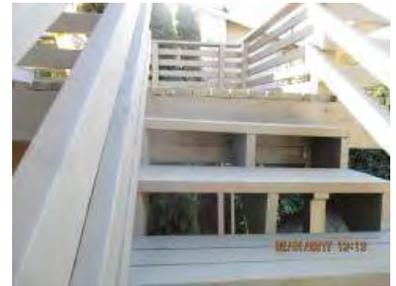
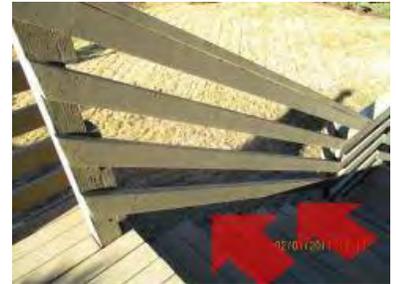
The spacing under stair railing is too wide. This is a hazard for small children. The spacing should be reduced as a safety upgrade. Current standards require that a 4" sphere not pass under the railing.

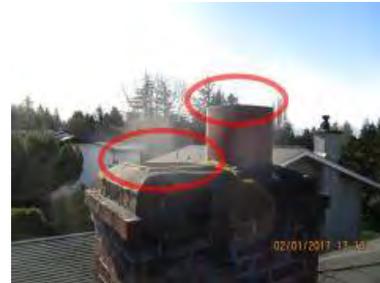
The top of the masonry chimney does not have spark arrestor/rain caps. The installation of a spark arrestor/rain cap for each flue is recommended as a safety upgrade and to prevent moisture damage to the inside of the chimney and fireplace. An additional benefit of a rain cap is that it will keep birds and rodents from entering the house when the damper is left open.

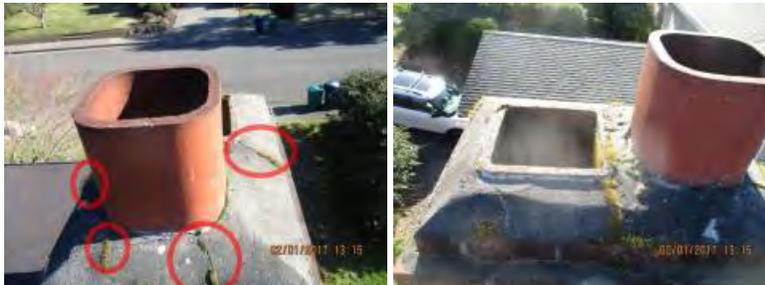
The chimney crown is cracked and deteriorated. The mortar chimney crown prevents water from entering and damaging the masonry. Repairing or replacing the chimney crown will extend the service life of the chimney.

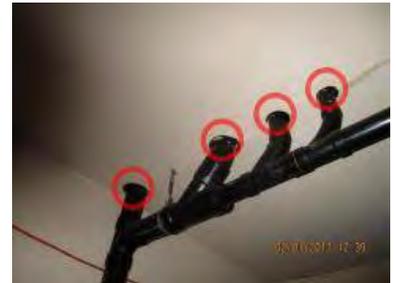
There are voids in the fire resistive barrier between the living space and garage that will allow flames to penetrate. The gypsum barrier slows the spread of a fire from the garage to the structure and/or living space. Patching the voids is recommended.

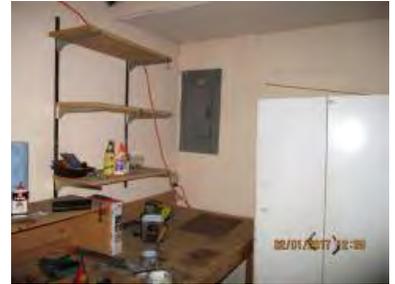
Access to the service panel was limited by shelves installed in front of the panel cover. A 36" clearance should be maintained in front of the panel cover.

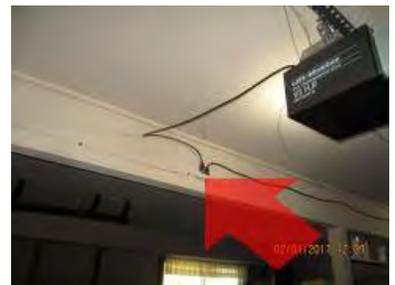
An extension cord is used as a temporary power source for the garage door openers. An extension cord is not suitable as a permanent wiring method. The installation of a receptacle within cords length of the motors is recommended.

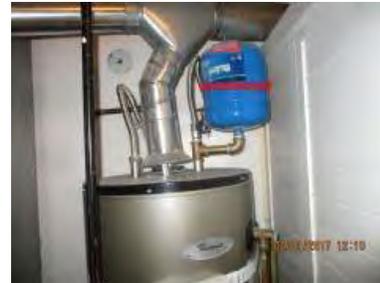
The expansion tank is not adequately secured to the wall. This could result in damage to the water pipe and leakage during an earth quake. A seismic restraint should be installed to secure the expansion tank.

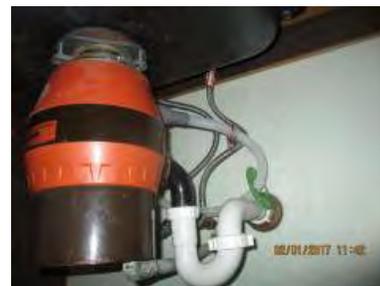
The dishwasher drain lacks an air gap. The dishwasher will function without one, but there is a risk of contamination of the inside of the dishwasher by waste water. The installation of an air gap is recommended.

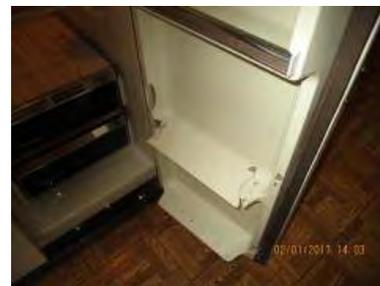
The refrigerator door shelf unit is damaged. The door should be repaired or replaced as necessary.

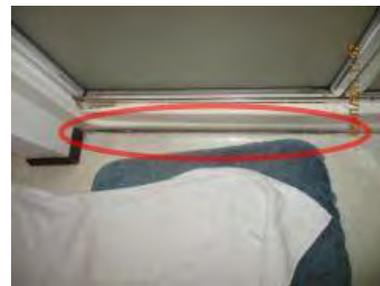
The vinyl flooring is damaged from water intrusion into the substrate. The flooring should be replaced as necessary to restore cosmetic appearance. The subfloor underneath the vinyl flooring appears to be solid.

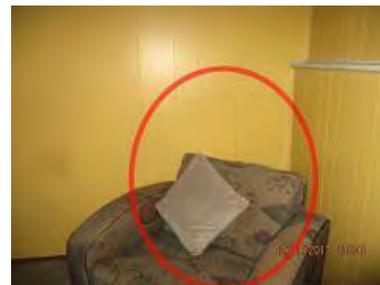
The secured panel prevented access and inspection of the area under the stairway entry landing. Defects or deficiencies may exist in inaccessible areas.

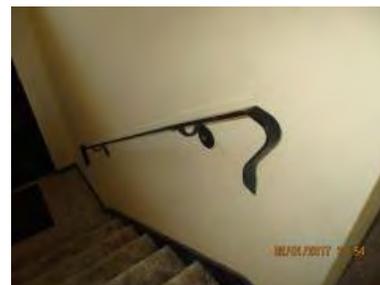
The railing ends in the stairwell does not return to the wall. This is a safety hazard. The installation of a continuous handrail should be considered as a safety upgrade.

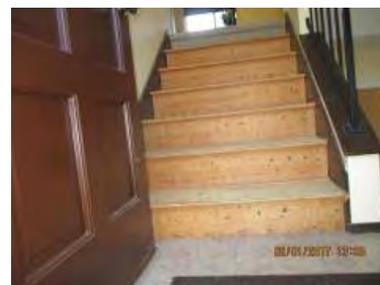
The stairs are non-conforming due to the variable and/or excessive rise. Stair design standards require that stair risers do not exceed 8" and that the variation in rise not exceed 3/8" in order to reduce falls from tripping. To increase the margin of safety, consideration should be given to reconfiguring the stairs so that rise and run do not vary by more than 3/8". If this proves to be too impractical or expensive, then we recommend exercising caution when using these stairs.

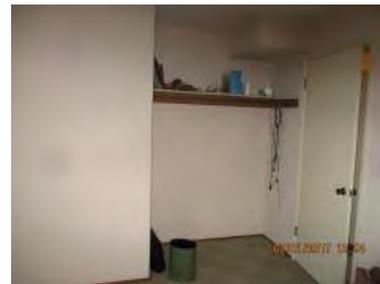
Closet doors are missing in the bedroom.
