Edward and Kirsten Mackay

13938 180th Ave NE, Redmond WA 98052

At your request, a visual inspection of the above referenced property was conducted on March 7, 2017. We have inspected the major structural components, plumbing, heating and electrical systems for signs of significant non-performance, excessive or unusual wear and general state of repair.

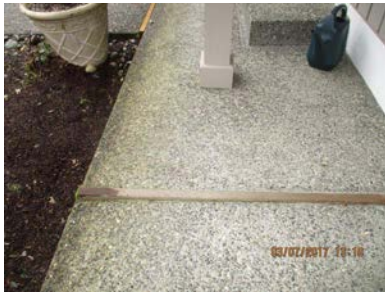
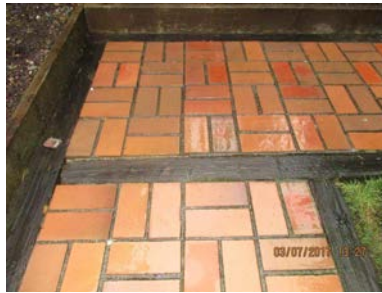
2.6 WALKWAY

1. The walking surface was not even and trip hazards were present. We recommend all walking surfaces be maintained free of trip hazards.

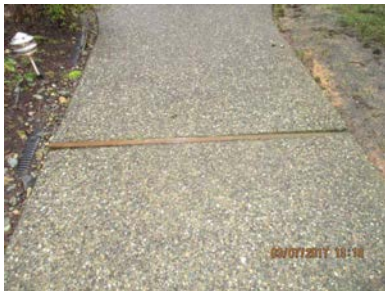
2. When the wooden dividers separating the concrete walkway sections have deteriorated to a point where they become a trip hazard. Replacement with mortar is recommended.

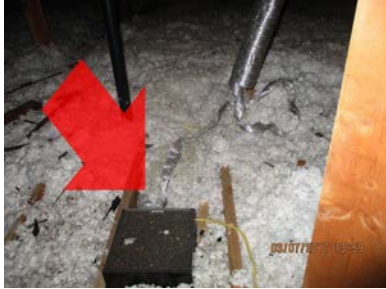
5.3 MECHANICAL VENTILATION SYSTEMS

3. The master bathroom shower vent fan discharges in the attic rather than outside. This is an undesirable condition that causes excessive moisture in the attic and can result in mold or fungus growth. A 4" smooth-wall sheet metal duct should be installed to direct the moisture laden air discharged from the fan out of the attic.

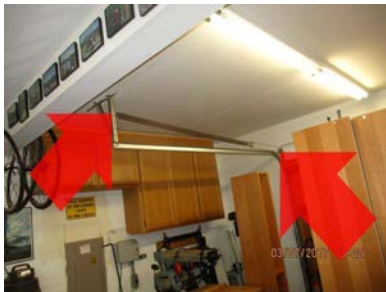
6.2 OVERHEAD GARAGE DOORS

4. Safeties are cables run through the center of the garage door springs that prevent broken springs from becoming projectiles that can cause injury. There are no safeties installed. The installation of safeties is recommended.

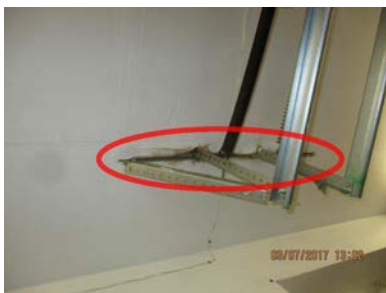
6.4 FIRE SEPARATION

6. There are voids in the fire resistive barrier between the living space and garage that will allow flames to penetrate. The gypsum barrier slows the spread of a fire from the garage to the structure and/or living space. Patching the voids is recommended.

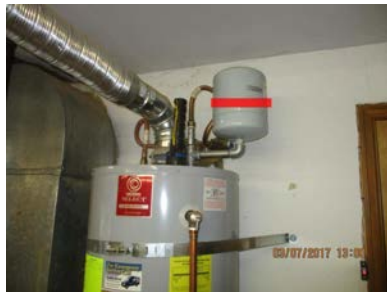
9.6 EXPANSION TANK

11. The expansion tank is not adequately secured to the wall. This could result in damage to the water pipe and leakage during an earth quake. A seismic restraint should be installed to secure the expansion tank.

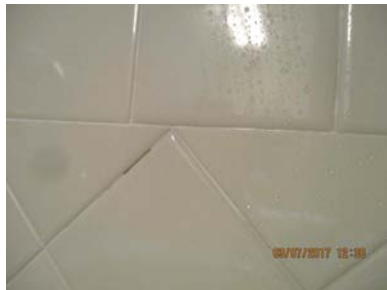
13. Grout is missing from between some of the wall tiles. This can allow water to enter through the tile and can damage the walls. Regrouting the wall tile is recommended.

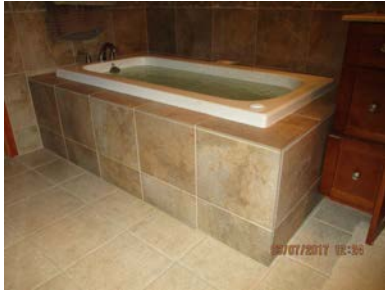
11.25 BATHTUB

14. The hydromassage tub pump and associated plumbing and electrical components were not accessible for inspection. Reportable conditions may exist in this normally accessible area. The installation of an access is recommended for inspection and servicing.

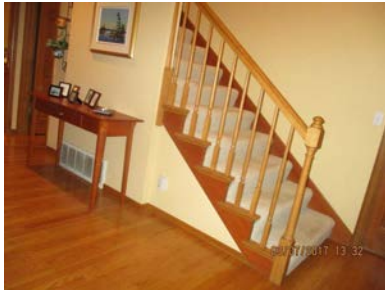
14.2 STAIRS

15. The stair railing baluster spacing is too wide. This is a hazard for small children. The baluster spacing should be reduced as a safety upgrade. Current standards require that a 4" sphere not pass through the railing.

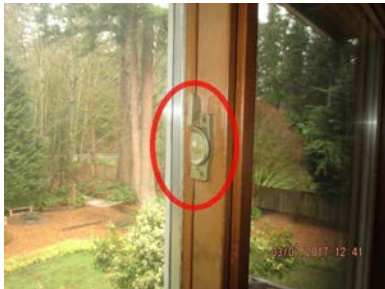
14.7 WINDOWS

16. The latch/locking mechanism for one of the bedroom windows does not secure the window closed. We recommend repairs as necessary to restore the windows proper operation.

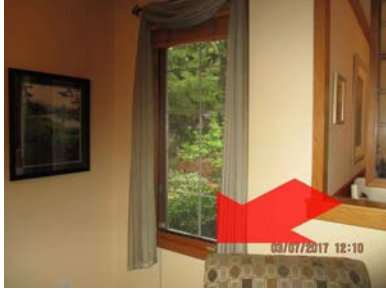
17. The crank handle operating the opening assist mechanism for window in the living room is not working. The crank handle should be replaced and the function of the window opener tested.

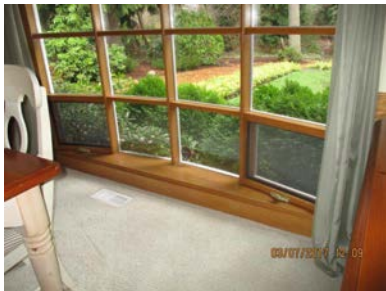
18. The lower window glass is not labeled as tempered safety glass. The existing glass is nonconforming by current building standards and would be hazardous if broken. The installation of safety glass is recommended as a safety upgrade for all windows less than 18" from the walking surface.

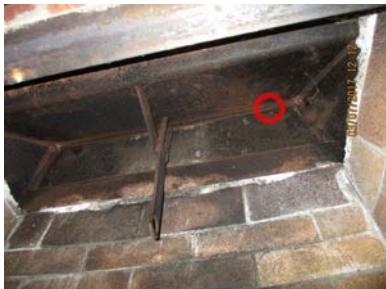
15.3 DAMPERS

20. A C-clamp should be installed on the living room fireplace damper to prevent full closure. This is a safety measure designed to insure that carbon monoxide does not spill out into the room in the event that you forget to open the damper after lighting the gas log.

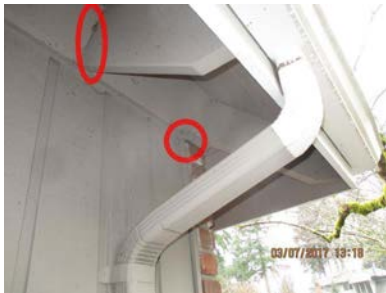
2. There are openings at the intersection between the overhang and the brick cladding through which birds and rodents can enter into the attic. These openings should be covered with wood, wire mesh or filled with aerosol foam.

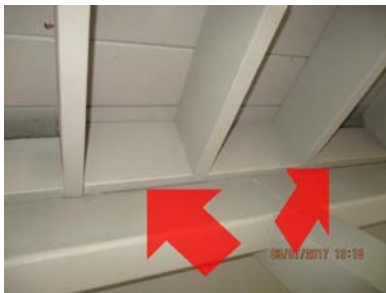
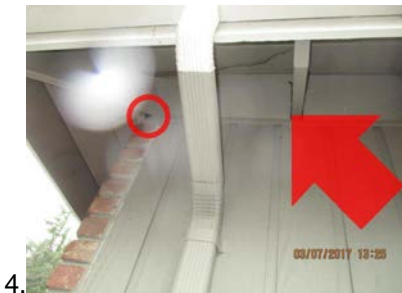
3. There are large gaps over 1/4" in size adjacent the soffit vent blocks. These gaps allow insects and rodents to enter the attic. Covering the gaps with screening, a strip of wood and/or caulking is recommended.

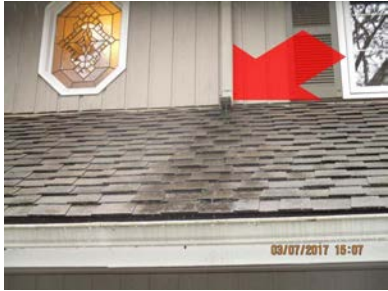
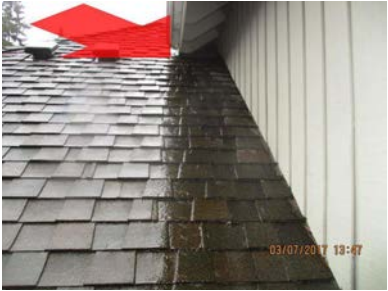
3.5 GUTTERS AND DOWNSPOUTS

Downspouts draining directly onto the asphalt shingle surface causes excessive wear of the roofing material. Downspout extensions to the lower gutters should be installed to prevent excessive wear and tear of the roofing.

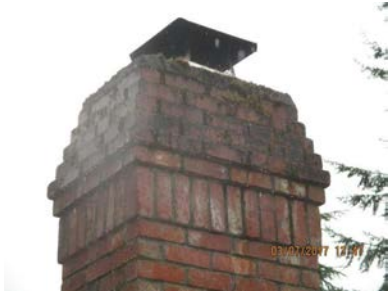
7. The chimney crowns are cracked and deteriorated. The mortar chimney crowns prevent water from entering and damaging the masonry. Repairing or replacing the chimney crowns will extend the service life of the chimneys.

Moss/vegetation was observed in several areas around the upper portion of the chimneys. This will lead to accelerated deterioration of the brick masonry mortar. We recommend removal of all organic growth. Damaged areas can be repaired by filling in cutout or defective mortar joints with fresh mortar. (Tuck pointing)

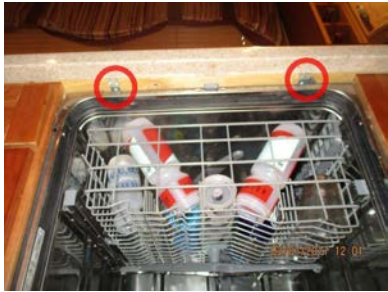
9. The dishwasher is not secured to the countertop. This allows the appliance to move around. The dishwasher should be secured to the bottom of the countertop in accordance with industry standards.

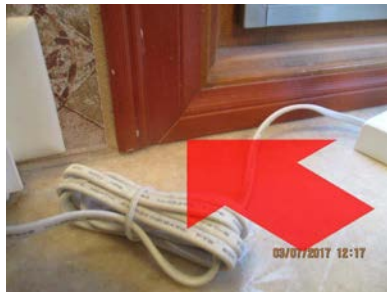
The backsplash is not caulked adjacent the window. This allows water to enter the gap between the window and counter and it is difficult to clean. Caulking should be installed at this location.

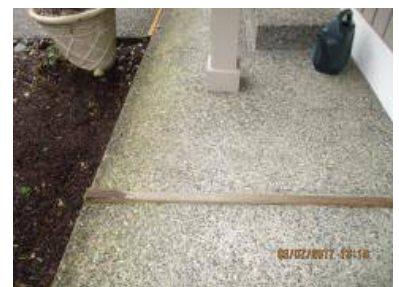
The walking surface was not even and trip hazards were present. We recommend all walking surfaces be maintained free of trip hazards.

Many legal and public works departments have defined a trip hazard as an irregularity in a walking surface exceeding one inch (1") in height. All walking surfaces should maintain, free of a vertical surface change of 3/4" or more, in the interest of public and personal safety.

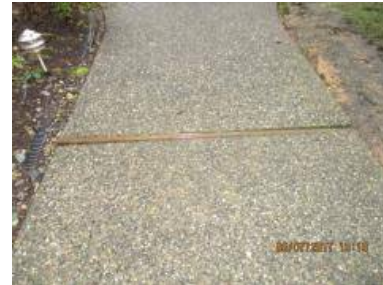
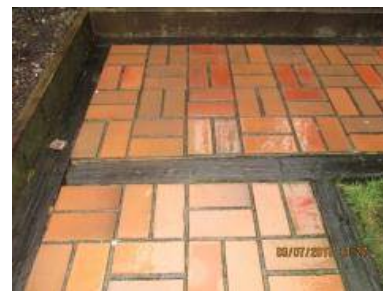
When the wooden dividers separating the concrete walkway sections have deteriorated to a point where they become a trip hazard. Replacement with mortar is recommended.

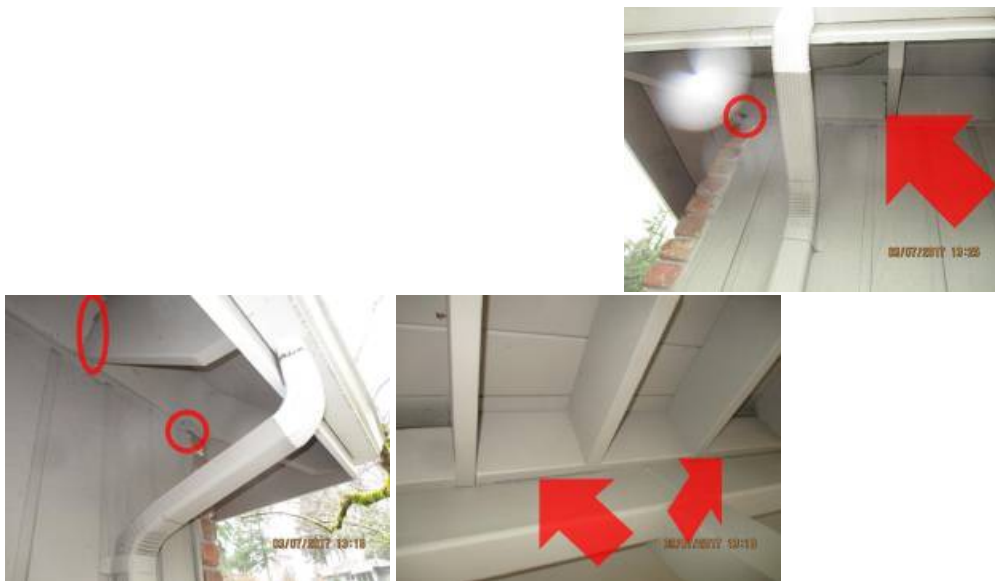
There are large gaps over 1/4" in size adjacent the soffit vent blocks. These gaps allow insects and rodents to enter the attic. Covering the gaps with screening, a strip of wood and/or caulking is recommended.

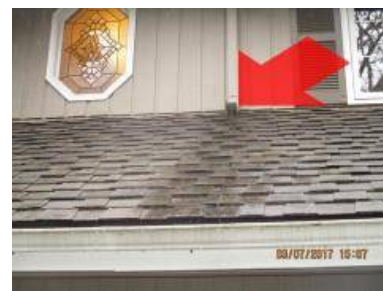
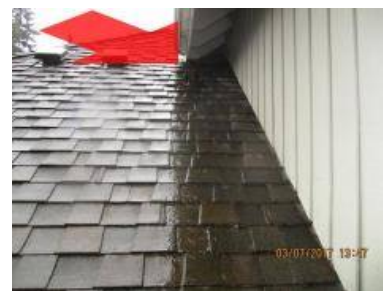
Downspouts draining directly onto the asphalt shingle surface causes excessive wear of the roofing material. Downspout extensions to the lower gutters should be installed to prevent excessive wear and tear of the roofing.

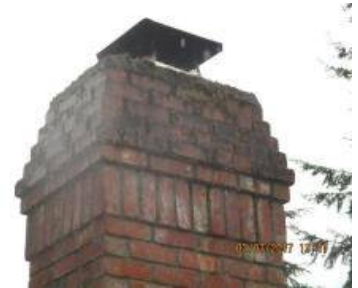
Moss/vegetation was observed in several areas around the upper portion of the chimneys. This will lead to accelerated deterioration of the brick masonry mortar. We recommend removal of all organic growth. Damaged areas can be repaired by filling in cutout or defective mortar joints with fresh mortar. (Tuck pointing)

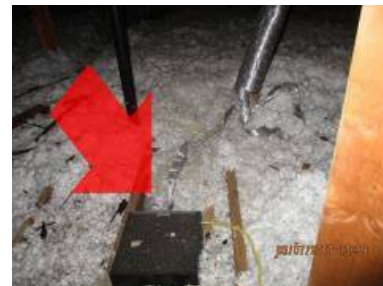
The master bathroom shower vent fan discharges in the attic rather than outside. This is an undesirable condition that causes excessive moisture in the attic and can result in mold or fungus growth. A 4" smooth-wall sheet metal duct should be installed to direct the moisture laden air discharged from the fan out of the attic.

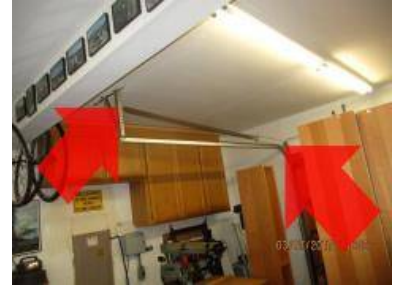
Safeties are cables run through the center of the garage door springs that prevent broken springs from becoming projectiles that can cause injury. There are no safeties installed. The installation of safeties is recommended.

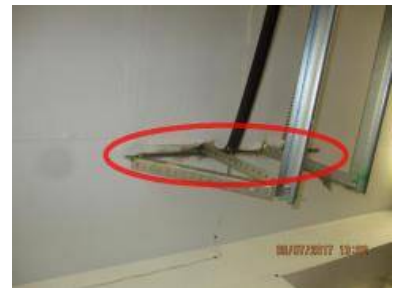
There are voids in the fire resistive barrier between the living space and garage that will allow flames to penetrate. The gypsum barrier slows the spread of a fire from the garage to the structure and/or living space. Patching the voids is recommended.

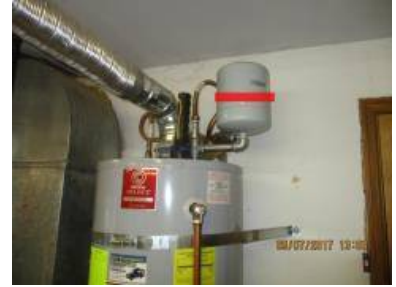
The expansion tank is not adequately secured to the wall. This could result in damage to the water pipe and leakage during an earth quake. A seismic restraint should be installed to secure the expansion tank.

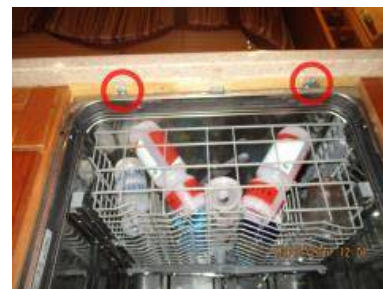
The dishwasher is not secured to the countertop. This allows the appliance to move around. The dishwasher should be secured to the bottom of the countertop in accordance with industry standards.

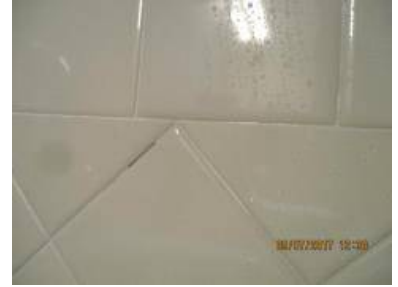
Most ceramic tile is applied directly over gypsum board rather than on a concrete board such as "Durock" or "Wonder Board". Where the tile is applied directly over the gypsum board, it is critical that the tile grout be maintained to prevent water intrusion behind the tile. Missing or cracked grout should be repaired. Inside corners, and penetrations in the tile should be kept sealed with a high quality caulk.

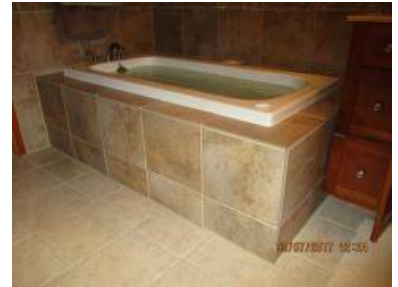
The hydromassage tub pump and associated plumbing and electrical components were not accessible for inspection. Reportable conditions may exist in this normally accessible area. The installation of an access is recommended for inspection and servicing.

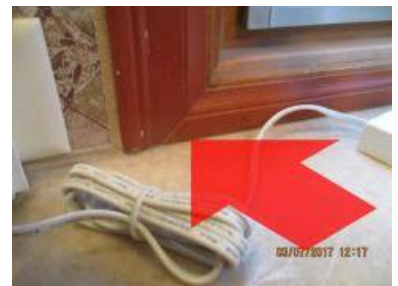
The backsplash is not caulked adjacent the window. This allows water to enter the gap between the window and counter and it is difficult to clean. Caulking should be installed at this location.

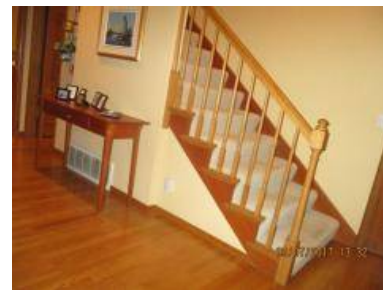
The stair railing baluster spacing is too wide. This is a hazard for small children. The baluster spacing should be reduced as a safety upgrade. Current standards require that a 4" sphere not pass through the railing.

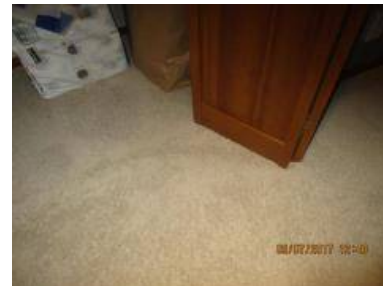
The bifold closet doors rub on the carpet. Doors should be adjusted as necessary.

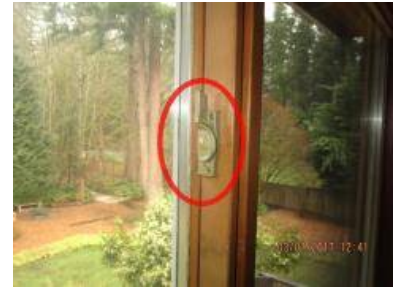
14.7 WINDOWS

The latch/locking mechanism for one of the bedroom windows does not secure the window closed. We recommend repairs as necessary to restore the windows proper operation.

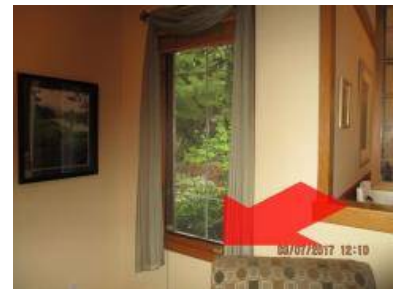
The crank handle operating the opening assist mechanism for window in the living room is not working. The crank handle should be replaced and the function of the window opener tested.

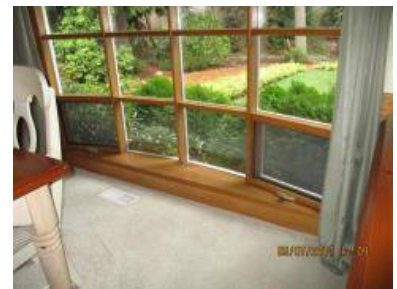
The lower window glass is not labeled as tempered safety glass. The existing glass is nonconforming by current building standards and would be hazardous if broken. The installation of safety glass is recommended as a safety upgrade for all windows less than 18" from the walking surface.

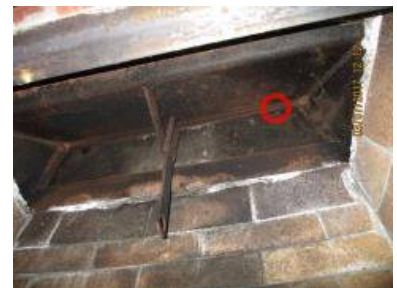
A C-clamp should be installed on the living room fireplace damper to prevent full closure. This is a safety measure designed to insure that carbon monoxide does not spill out into the room in the event that you forget to open the damper after lighting the gas log.
