Sean and Christina Brogan

14419 91st Ave NE

NOTICE TO BUYER: SELLER-PROCURED INSPECTION REPORT

At your request, a visual inspection of the above referenced property was conducted on March 9, 2017. We have inspected the major structural components, plumbing, heating and electrical systems for signs of significant non-performance, excessive or unusual wear and general state of repair.

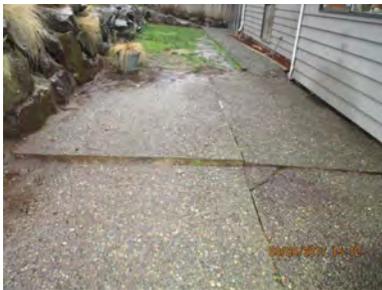
2.6 PATIO

1. The patio has settled differentially. This was probably caused by inadequate preparation of the soil prior to the placement of the concrete. This condition can be repaired by pressure grouting the sunken portion of the patio or by removing and replacing it. The patio remains functional despite this condition. However, the raised edges of the concrete can be a trip hazard for some people. Repairs should be made as necessary.

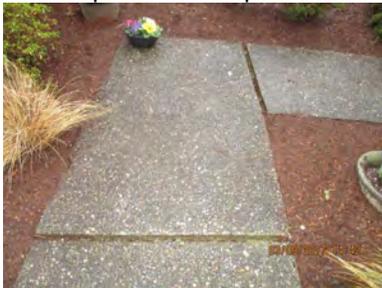
2.7 WALKWAY

2. The wooden dividers separating the concrete walkway sections have deteriorated to a point where the gaps are a trip hazard. Replacement with mortar is recommended.

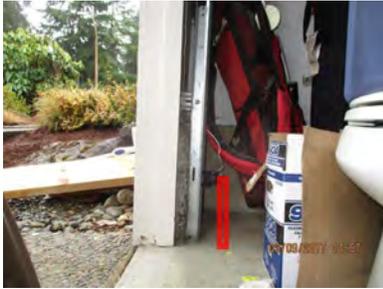
3. The Photo-eye beam was installed to high above the floor of the garage to adequately offer protection for

small children and/or pets. We recommend that the photo-eye be lowered to within 4-6" of the floor.

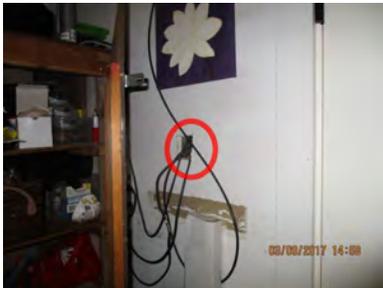
6.4 FIRE SEPARATION

4. There are voids in the fire resistive barrier between the living space and garage that will allow flames to penetrate. The gypsum barrier slows the spread of a fire from the garage to the structure and/or living space. Patching the voids is recommended.

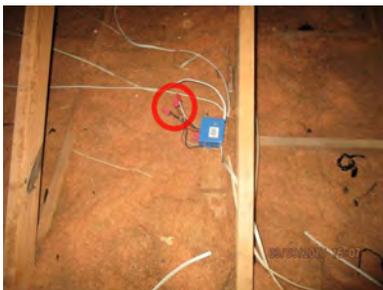
7.10 WIRING

6. Splices in cable made outside of a junction box were observed in the attic. This is a fire hazard. The splices should be made inside an approved box with a cover.

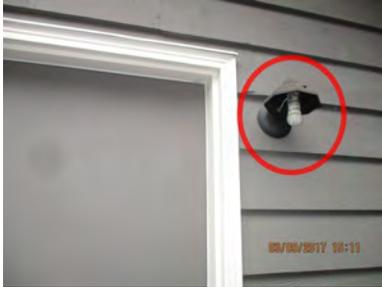
7.13 LIGHTS

9. The luminaries diffuser cover at the exterior is missing. A diffuser cover should be installed to protect the bulb and socket.

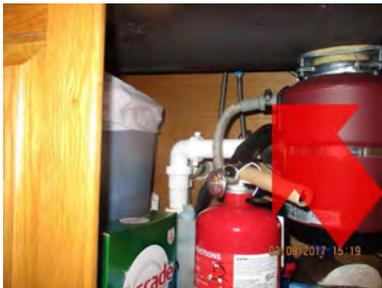
10.8 AIR GAP

11. The dishwasher drain lacks an air gap. The dishwasher will function without one, but there is a risk of contamination of the inside of the dishwasher by waste water. The installation of an air gap is recommended.

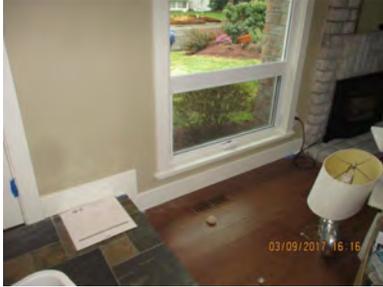
14.6 WINDOWS

12. The lower window glass is not labeled as tempered safety glass. The existing glass is nonconforming by current building standards and would be hazardous if broken. The installation of safety glass is recommended as a safety upgrade for all windows less than 18" from the walking surface.

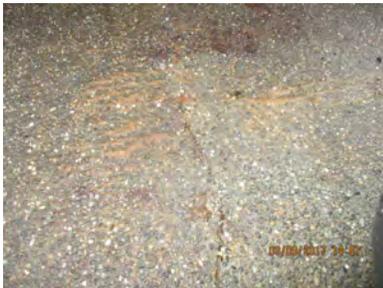
2.5 DRIVEWAY

1. Cracks were observed in the concrete surface of the driveway. Minor cracks can be sealed to minimize moisture entry and further settlement of the concrete. Minor cracks are common and do not affect the serviceability of the concrete.

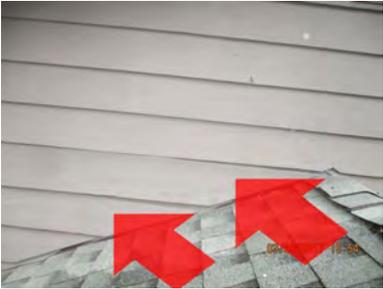
3.1 PRIMARY EXTERIOR WALL CLADDING

2. Sections of siding on the gable end of the house are loose. The loose sections of siding should be repaired and a minimum of a 2" clearance should be maintained between the top of the roofing and bottom of the siding.

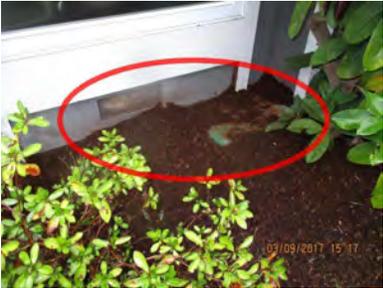
3.2 PEST CONTROL

3. Soil is close to or in contact with siding in some areas around the building exterior. Good building practice requires that foundation walls or pier footings supporting wood frame construction, extend at least 8" above the finish grade with at least a 6" clearance between the top of the soil and the bottom of the wood finish materials. Soil in direct contact with wood creates a hospitable environment for wood destroying organisms. Establishing these minimum clearances is recommended.

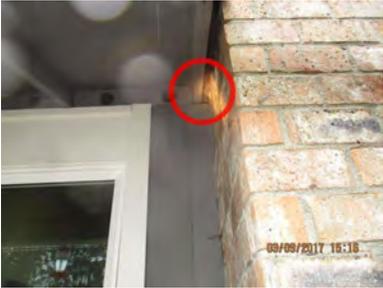
3.3 SOFFITS AND OVERHANGS

4. There are large gaps over 1/4" in size adjacent the fireplace and soffits. These gaps allow insects and rodents to enter the attic. Covering the gaps with screening, a strip of wood and/or caulking is recommended.

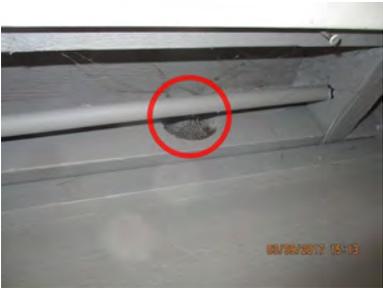
5. There are soffit vent screens that are damaged. This is allowing birds to enter the attic. Quarter inch wire mesh should be installed over the vent holes.

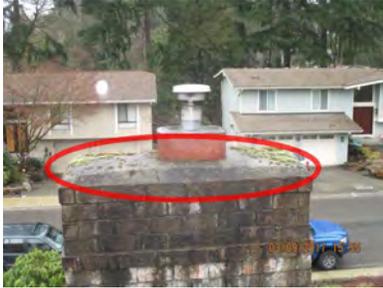
4.4 CHIMNEYS

6. The chimney crown is cracked. The mortar chimney crown prevents water from entering and damaging the masonry. Repairing or replacing the chimney crown will extend the service life of the chimney.

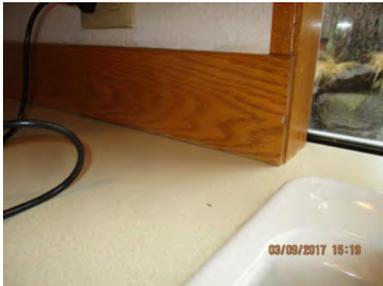
10.1 COUNTERTOPS

8. The backsplash is not caulked. This allows water and food to enter the gap between the back splash and counter and is difficult to clean. Caulking should be installed at this location.

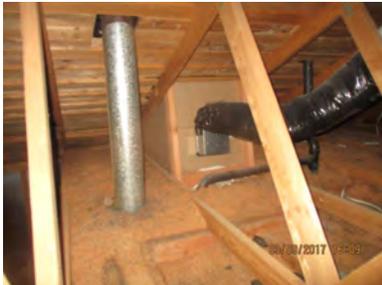
17.2 SKYLIGHT

16. The skylight shaft is not insulated. This condition will result in significant heat loss. The installation of additional attic insulation around the skylight shafts is recommended.

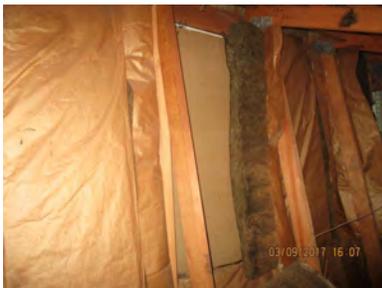
17.3 WALL INSULATION

17. One of the insulation batts has falling down in the attic. The fallen batt should be reinstalled and secured.

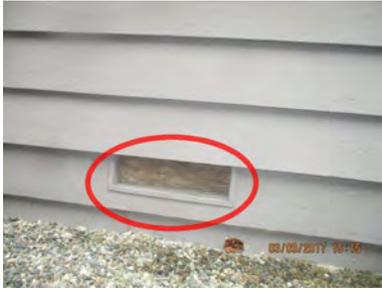
19.3 VENTILATION

18. Several of the vent openings are blocked with insulation. This will block the flow of air. The insulation

should be restricted from blocking the vents to reduce the potential for ventilation issues.

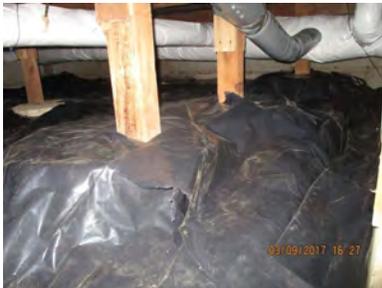
19.4 VAPOR RETARDER

19. The support post concrete piers are covered with the plastic vapor retarder. This allows the transmission of water vapor from the soil up and into the floor framing. The plastic vapor retarder should be removed from the pier so that it covers the entire surface of the soil only.

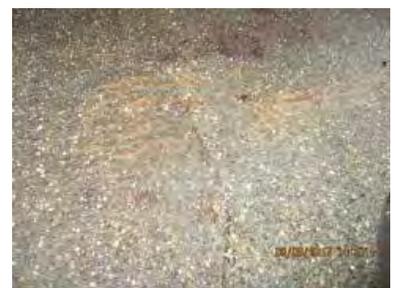
2.5 DRIVEWAY

Cracks were observed in the concrete surface of the driveway. Minor cracks can be sealed to minimize moisture entry and further settlement of the concrete. Minor cracks are common and do not affect the serviceability of the concrete.

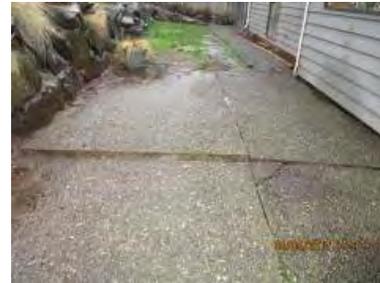
2.6 PATIO

The patio has settled differentially. This was probably caused by inadequate preparation of the soil prior to the placement of the concrete. This condition can be repaired by pressure grouting the sunken portion of the patio or by removing and replacing it. The patio remains functional despite this condition. However, the raised edges of the concrete can be a trip hazard for some people. Repairs should be made as necessary.

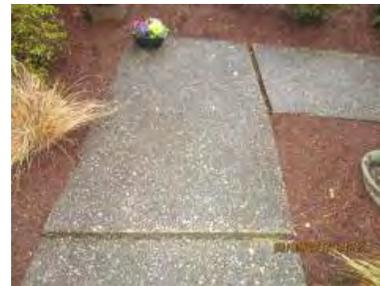
2.7 WALKWAY

The walking surface was not even and trip hazards were present. We recommend all walking surfaces be maintained free of trip hazards.

The wooden dividers separating the concrete walkway sections have deteriorated to a point where the gaps are a trip hazard. Replacement with mortar is recommended.

Many legal and public works departments have defined a trip hazard as an irregularity in a walking surface exceeding one inch (1") in height. All walking surfaces should maintain, free of a vertical surface change of 3/4" or more, in the interest of public and personal safety.

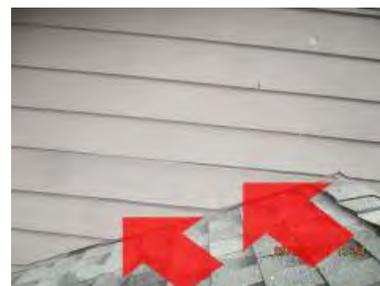
Sections of siding on the gable end of the house are loose. The loose sections of siding should be repaired and a minimum of a 2" clearance should be maintained between the top of the roofing and bottom of the siding.

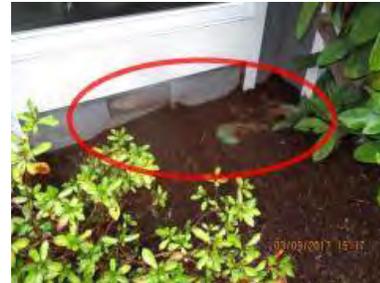
3.2 PEST CONTROL

Soil is close to or in contact with siding in some areas around the building exterior. Good building practice requires that foundation walls or pier footings supporting wood frame construction, extend at least 8" above the finish grade with at least a 6" clearance between the top of the soil and the bottom of the wood finish materials. Soil in direct contact with wood creates a hospitable environment for wood destroying organisms. Establishing these minimum clearances is recommended.

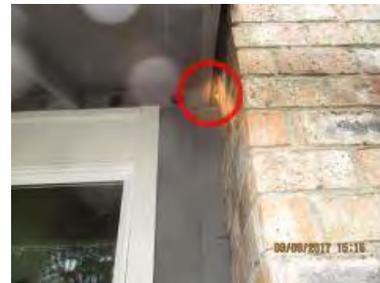
There are large gaps over 1/4" in size adjacent the fireplace and soffits. These gaps allow insects and rodents to enter the attic. Covering the gaps with screening, a strip of wood and/or caulking is recommended.

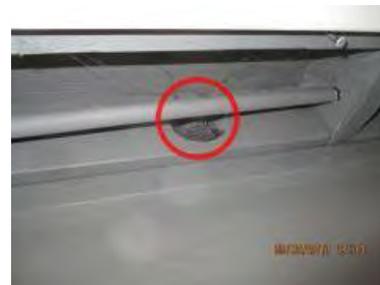
There are soffit vent screens that are damaged. This is allowing birds to enter the attic. Quarter inch wire mesh should be installed over the vent holes.

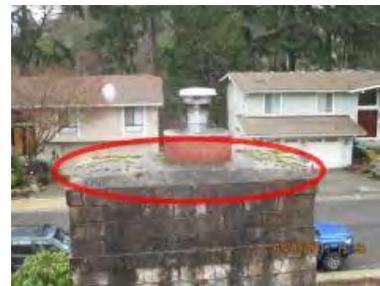
The chimney crown is cracked. The mortar chimney crown prevents water from entering and damaging the masonry. Repairing or replacing the chimney crown will extend the service life of the chimney.

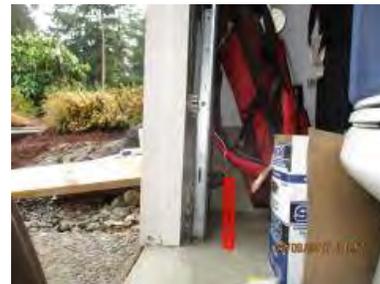
The Photo-eye beam was installed too high above the floor of the garage to adequately offer protection for small children and/or pets. We recommend that the photo-eye be lowered to within 4-6" of the floor.

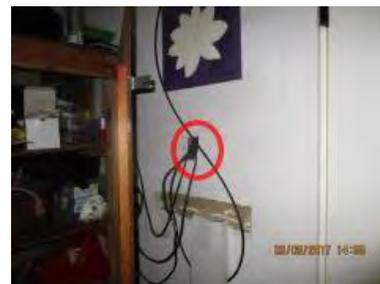
6.4 FIRE SEPARATION

There are voids in the fire resistive barrier between the living space and garage that will allow flames to penetrate. The gypsum barrier slows the spread of a fire from the garage to the structure and/or living space. Patching the voids is recommended.

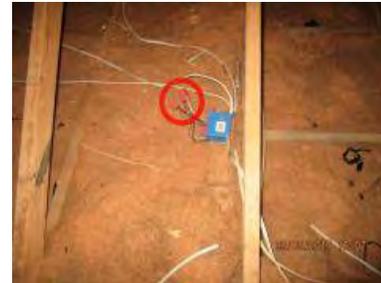
Splices in cable made outside of a junction box were observed in the attic. This is a fire hazard. The splices should be made inside an approved box with a cover.

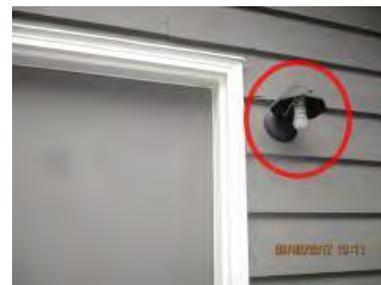
The luminaries diffuser cover at the exterior is missing. A diffuser cover should be installed to protect the bulb and socket.

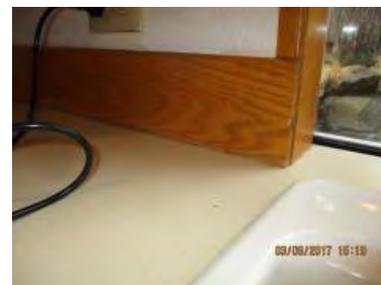
The backsplash is not caulked. This allows water and food to enter the gap between the back splash and counter and is difficult to clean. Caulking should be installed at this location.

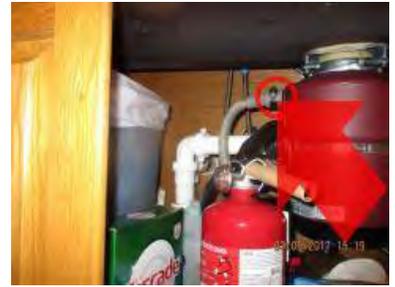
The dishwasher drain lacks an air gap. The dishwasher will function without one, but there is a risk of contamination of the inside of the dishwasher by waste water. The installation of an air gap is recommended.

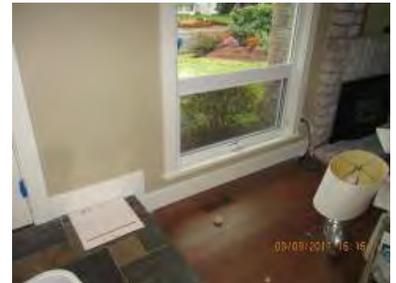
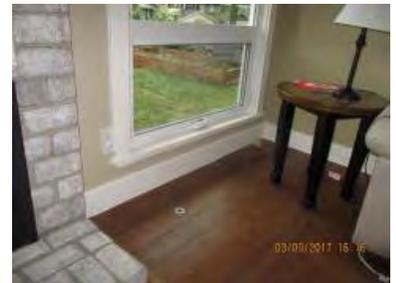
The lower window glass is not labeled as tempered safety glass. The existing glass is nonconforming by current building standards and would be hazardous if broken. The installation of safety glass is recommended as a safety upgrade for all windows less than 18" from the walking surface.

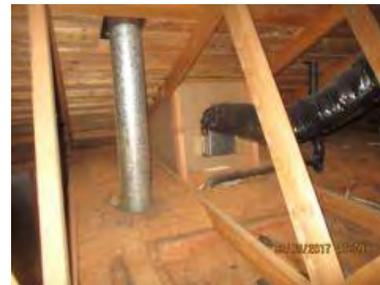
The skylight shaft is not insulated. This condition will result in significant heat loss. The installation of additional attic insulation around the skylight shafts is recommended.

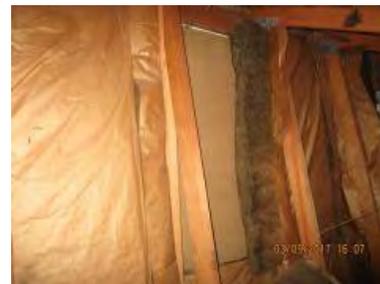
One of the insulation batts has falling down in the attic. The fallen batt should be reinstalled and secured.

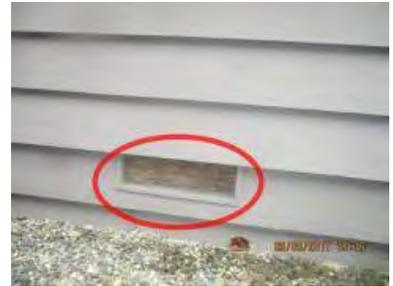
Several of the vent openings are blocked with insulation. This will block the flow of air. The insulation should be restricted from blocking the vents to reduce the potential for ventilation issues.

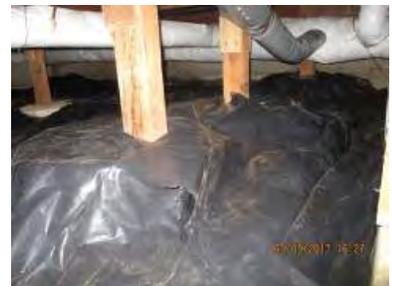
19.4 VAPOR RETARDER

The support post concrete piers are covered with the plastic vapor retarder. This allows the transmission of water vapor from the soil up and into the floor framing. The plastic vapor retarder should be removed from the pier so that it covers the entire surface of the soil only.
