February 9, 2017

Re: 3617 Serene Way
Lynnwood, WA.

At your request, a visual inspection of the above referenced property was conducted on February 8, 2017. We have inspected the major structural components, plumbing, heating and electrical systems for signs of significant non-performance, excessive or unusual wear and general state of repair.

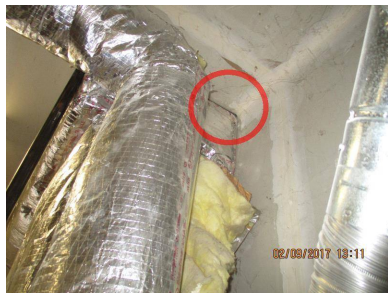
6.4 FIRE SEPARATION

2. There are voids in the fire resistive barrier between the living space and garage that will allow flames to penetrate. The gypsum barrier slows the spread of a fire from the garage to the structure and/or living space. Patching the voids is recommended.

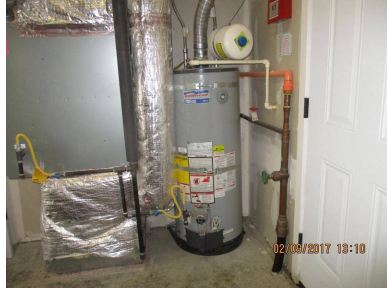
9.13 ELEVATION ABOVE GARAGE FLOOR

7. The water heater is not elevated above the garage floor in accordance with industry standards. This is a hazard. Elevating the water heater so that the burner is at least 18" above the garage floor prevents ignition of gasoline fumes.

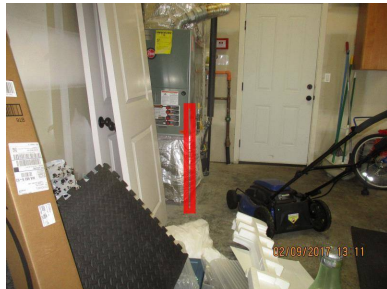
13.10 GAS PIPING

10. The gas pipes in front of the furnace and water heater are not protected by a bumper stop. A vertical steel pipe, bolted to the floor, is typically installed in front of the water heater to prevent a car bumper from damaging the gas lines.

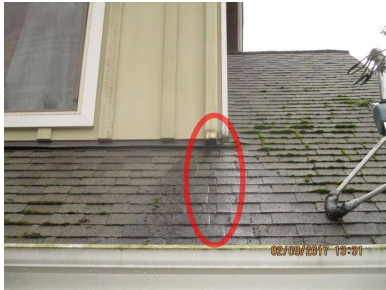
3.4 GUTTERS AND DOWNSPOUTS

1. Downspouts draining directly onto the asphalt shingle surface causes excessive wear of the roofing material. Downspout extensions to the lower gutters should be installed to prevent excessive wear and tear of the roofing.

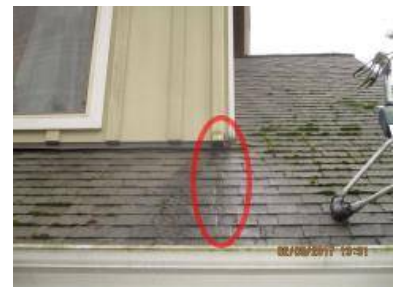
Downspouts draining directly onto the asphalt shingle surface causes excessive wear of the roofing material. Downspout extensions to the lower gutters should be installed to prevent excessive wear and tear of the roofing.

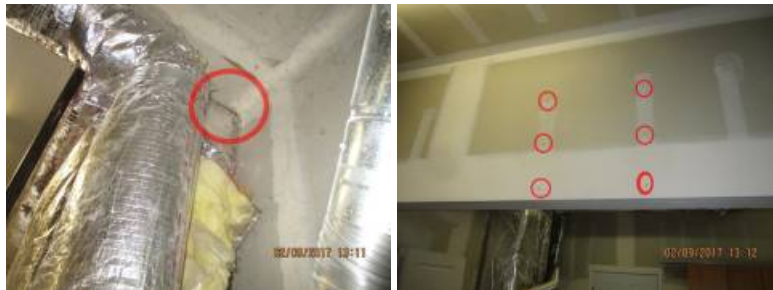
6.4 FIRE SEPARATION

There are voids in the fire resistive barrier between the living space and garage that will allow flames to penetrate. The gypsum barrier slows the spread of a fire from the garage to the structure and/or living space. Patching the voids is recommended.

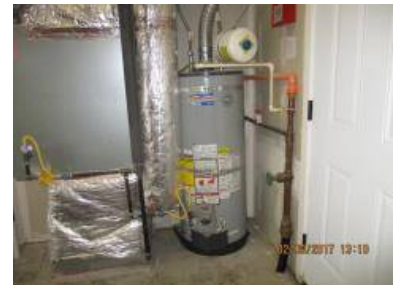
9.13 ELEVATION ABOVE GARAGE FLOOR

The water heater is not elevated above the garage floor in accordance with industry standards. This is a hazard. Elevating the water heater so that the burner is at least 18" above the garage floor prevents ignition of gasoline fumes.

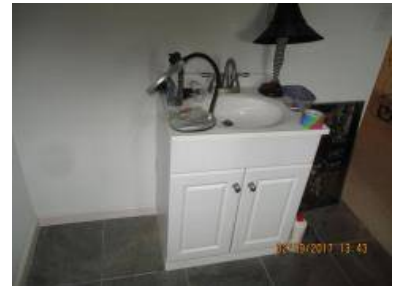
The sink and cabinet were not secured to the floor or wall. Attachment is recommended to prevent damage or leakage to the attached plumbing.

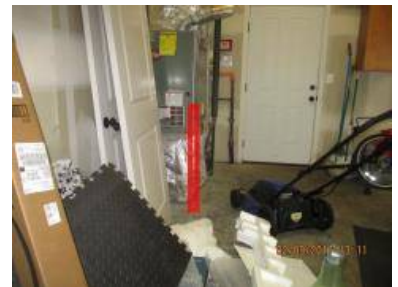
13.10 GAS PIPING

The gas pipes in front of the furnace and water heater are not protected by a bumper stop. A vertical steel pipe, bolted to the floor, is typically installed in front of the water heater to prevent a car bumper from damaging the gas lines.
