March 14, 2017

Re: 5814 147th Ave. NE
Bellevue, WA.

At your request, a visual inspection of the above referenced property was conducted on March 13, 2017. We have inspected the major structural components, plumbing, heating and electrical systems for signs of significant non-performance, excessive or unusual wear and general state of repair.

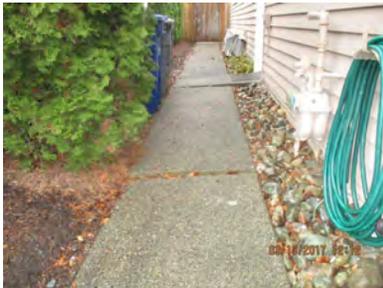
2.6 WALKWAY

1. The walkway has cracked and settled differentially. This was probably caused by inadequate preparation of the soil prior to the placement of the concrete. This condition can be repaired by pressure grouting the sunken portion of the walkway or by removing and replacing it. The walkway remains functional despite this condition. However, the raised edges of the concrete can be a trip hazard for some people. Grinding down the raised edges of the concrete will mitigate the hazard. Repairs should be made as necessary.

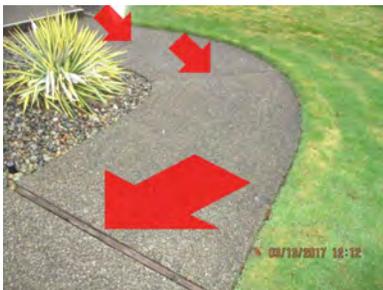
2. The wooden dividers separating the concrete walkway sections have deteriorated to a point where the gaps are a trip hazard. Replacement with mortar is recommended.

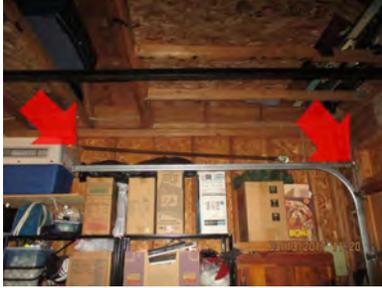
6.2 OVERHEAD GARAGE DOORS

3. Safeties are cables run through the center of the garage door springs that prevent broken springs from becoming projectiles that can cause injury. There are no safeties installed. The installation of safeties is recommended.

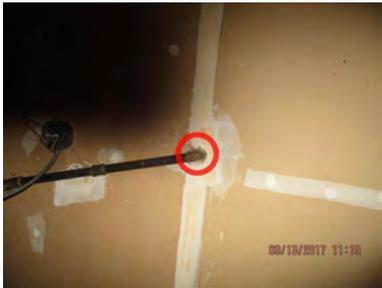
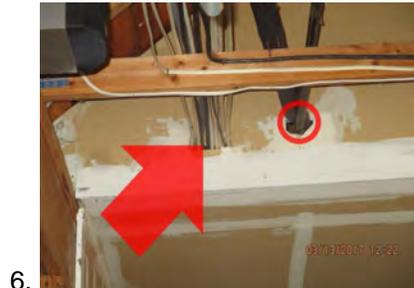
6.4 FIRE SEPARATION

5. There are voids in the fire resistive barrier between the living space and garage that will allow flames to penetrate. The gypsum barrier slows the spread of a fire from the garage to the structure and/or living space. Patching the voids is recommended.

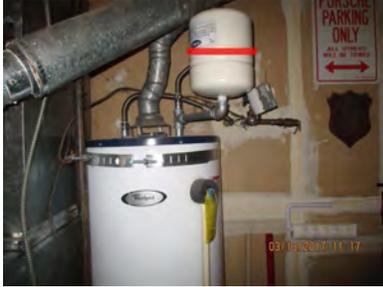
9.6 EXPANSION TANK

10. The expansion tank is not adequately secured to the wall. This could result in damage to the water pipe and leakage during an earth quake. A seismic restraint should be installed to secure the expansion tank.

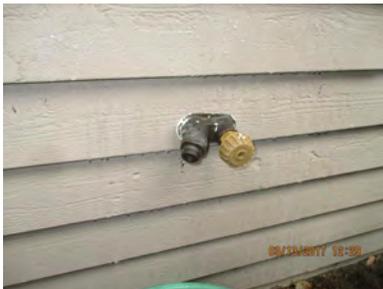
13.10 HOSE BIBBS AND EXTERIOR SUPPLY PIPES

13. The hose bibb on the rear of the building is damaged. This is indicative of a frozen valve. Replacement of the hose bibb is recommended. The other hose bibb was functional.

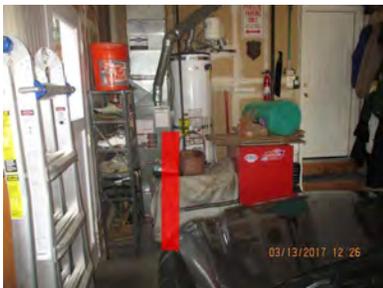
13.11 GAS PIPING

14. The gas pipes in front of the furnace and water heater are not protected by a bumper stop. A vertical steel pipe, bolted to the floor, is typically installed in front of the water heater to prevent a car bumper from damaging the gas lines.

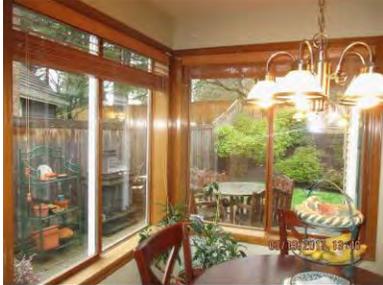
Dining area

15. Several of the windows are stuck. They should be adjusted or repaired as necessary to restore proper operation.

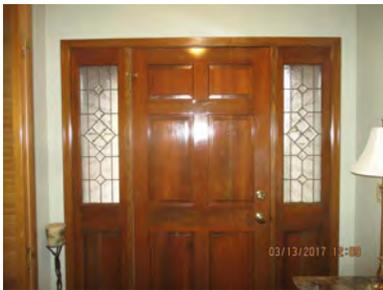
18. The glass in the front door is not tempered safety glass. Tempered glass can be identified by the etched emblem in one corner of each pane. A higher margin of safety could be achieved if the glass was approved safety glass. Consideration should be given to replacing the glass as a safety upgrade.

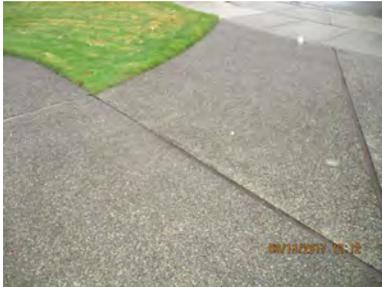
2.4 DRIVEWAY

1. One or more of the wooden dividers separating the concrete driveway sections were infested by wood destroying organisms and have deteriorated to a point where they are becoming a trip hazard. Replacement with mortar is recommended.

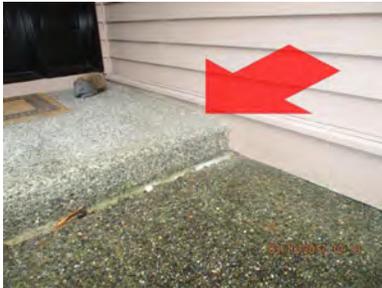
3.3 PEST CONTROL

2. Untreated wood in direct contact with concrete was observed along the front entry stoop. Untreated wood should be raised 1-2" above the concrete. Treating the wood with a preservative sometimes will prevent wood destroy organism damage.

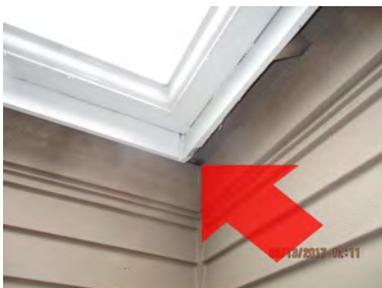
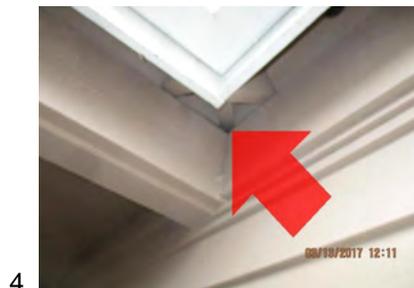
3.4 SOFFITS AND OVERHANGS

3. There are openings at the intersection between the overhang and the roof through which birds and rodents can enter into the attic. These openings should be covered with wood, wire mesh or filled with aerosol foam.

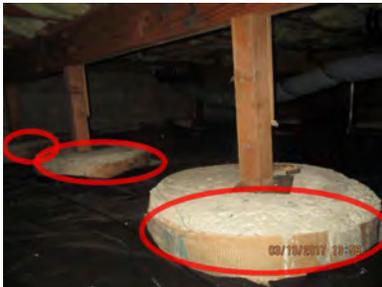
19.5 PEST CONTROL

9. Cellulose forms were left in place on the pier footings. This cellulose is conducive to the infestation of various wood destroying organisms. The removal of the cellulose is recommended.

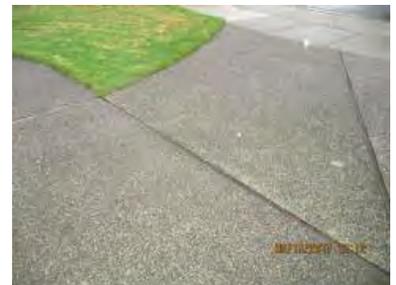
2.4 DRIVEWAY

One or more of the wooden dividers separating the concrete driveway sections were infested by wood destroying organisms and have deteriorated to a point where they are becoming a trip hazard. Replacement with mortar is recommended.

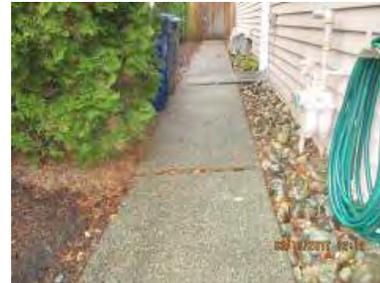
2.6 WALKWAY

The walkway has cracked and settled differentially. This was probably caused by inadequate preparation of the soil prior to the placement of the concrete. This condition can be repaired by pressure grouting the sunken portion of the walkway or by removing and replacing it. The walkway remains functional despite this condition. However, the raised edges of the concrete can be a trip hazard for some people. Grinding down the raised edges of the concrete will mitigate the hazard. Repairs should be made as necessary.

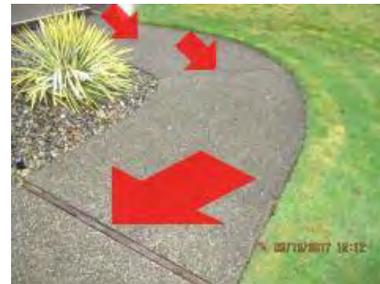
The wooden dividers separating the concrete walkway sections have deteriorated to a point where the gaps are a trip hazard. Replacement with mortar is recommended.

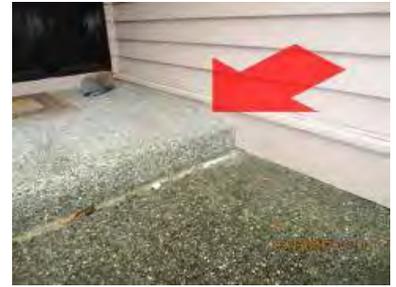
Untreated wood in direct contact with concrete was observed along the front entry stoop. Untreated wood should be raised 1-2" above the concrete. Treating the wood with a preservative sometimes will prevent wood destroy organism damage.

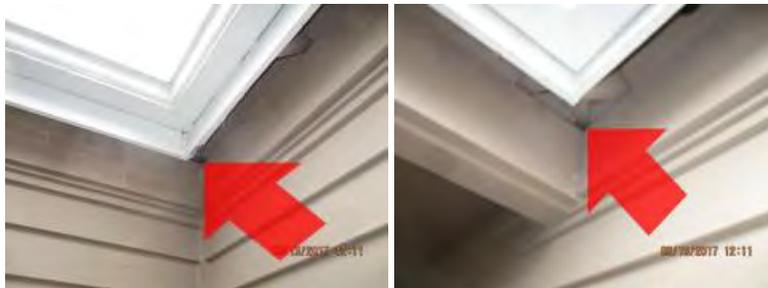
3.4 SOFFITS AND OVERHANGS

There are openings at the intersection between the overhang and the roof through which birds and rodents can enter into the attic. These openings should be covered with wood, wire mesh or filled with aerosol foam.

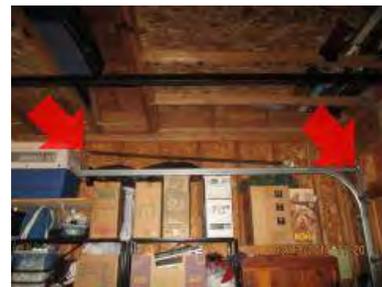
Safeties are cables run through the center of the garage door springs that prevent broken springs from becoming projectiles that can cause injury. There are no safeties installed. The installation of safeties is recommended.

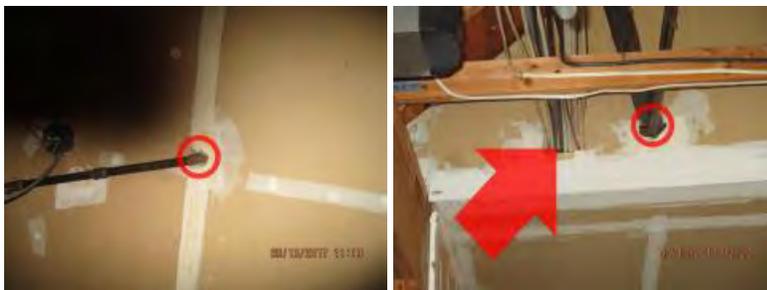
6.4 FIRE SEPARATION

There are voids in the fire resistive barrier between the living space and garage that will allow flames to penetrate. The gypsum barrier slows the spread of a fire from the garage to the structure and/or living space. Patching the voids is recommended.

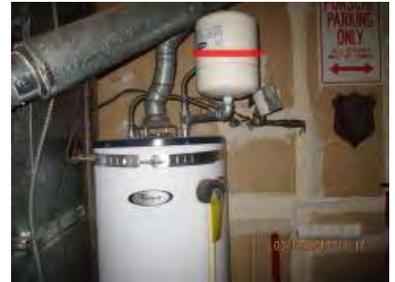
The expansion tank is not adequately secured to the wall. This could result in damage to the water pipe and leakage during an earth quake. A seismic restraint should be installed to secure the expansion tank.

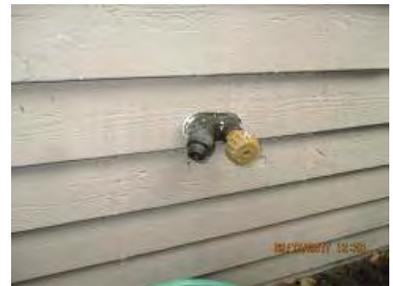
13.10 HOSE BIBBS AND EXTERIOR SUPPLY PIPES

The hose bibb on the rear of the building is damaged. This is indicative of a frozen valve. Replacement of the hose bibb is recommended. The other hose bibb was functional.

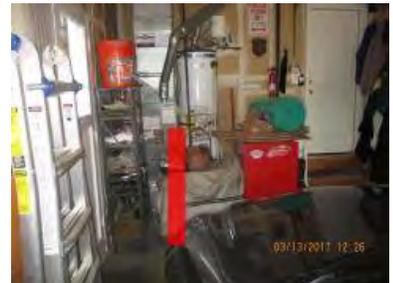
13.11 GAS PIPING

The gas pipes in front of the furnace and water heater are not protected by a bumper stop. A vertical steel pipe, bolted to the floor, is typically installed in front of the water heater to prevent a car bumper from damaging the gas lines.

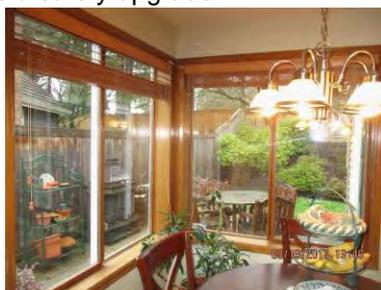
Dining area

Several of the windows are stuck. They should be adjusted or repaired as necessary to restore proper operation.

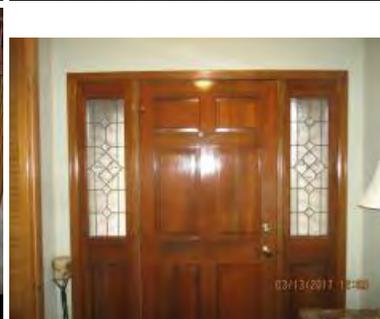
The glass in the front door is not tempered safety glass. Tempered glass can be identified by the etched emblem in one corner of each pane. A higher margin of safety could be achieved if the glass was approved safety glass. Consideration should be given to replacing the glass as a safety upgrade.
