NOTICE TO BUYER: SELLER-PROCURED INSPECTION REPORT

14304 172nd Ave NE, Redmond WA 98052

March 25, 2017

**Re: 14304 172nd Ave. NE
Redmond, WA.**

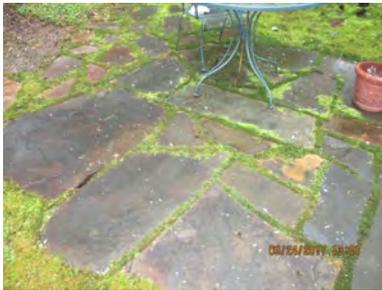
2.6 PATIO

1. The walking surface was not even and trip hazards were present. We recommend all walking surfaces be maintained free of trip hazards.

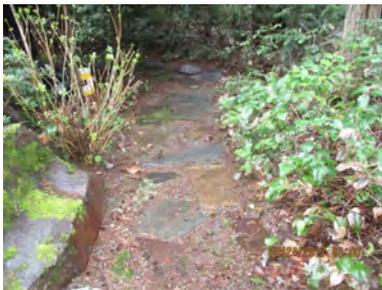
2.7 WALKWAY

2. The walking surface was not even and trip hazards were present. We recommend all walking surfaces be maintained free of trip hazards.

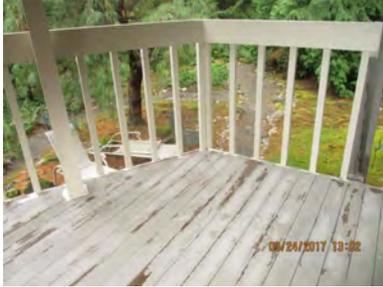
3.7 DECK RAILINGS

3. The spacing between the balusters is too wide. This is a hazard to small children. The balusters should be spaced close enough together so that a 4" sphere cannot pass through. Upgrading the deck railing is recommended if small children are present.

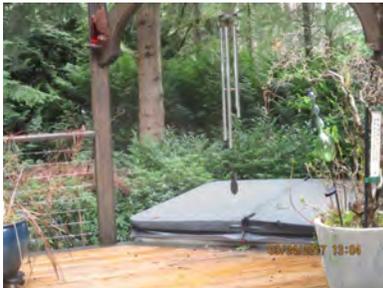
4. The east deck lacks a complete guard railing. This is a hazard. This installation of a guard railing is recommended.

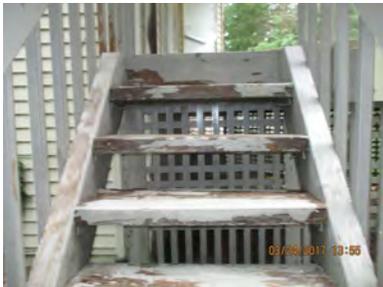
3.8 STAIRS

5. The stair rise spacing is too wide. This is a hazard for small children. The spacing should be reduced as a safety upgrade. Current standards require that a 4" sphere not pass through the opening.

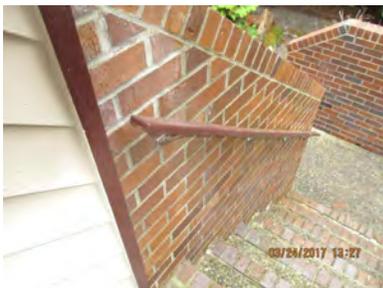
3.10 PORCH RAILING

6. The stairs were used several times during the inspection. The stair components are properly installed however one railing deficiency was noted during use. The railing ends do not return to the wall. This is a safety hazard. The installation of a continuous handrail should be considered as a safety upgrade.

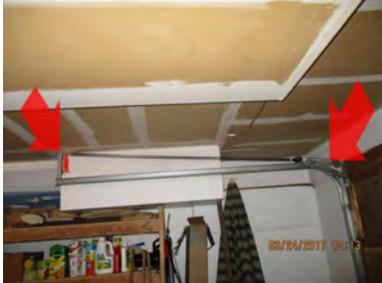
6.2 OVERHEAD GARAGE DOORS

7. Safeties are cables run through the center of the garage door springs that prevent broken springs from becoming projectiles that can cause injury. There are no safeties installed. The installation of safeties is recommended.

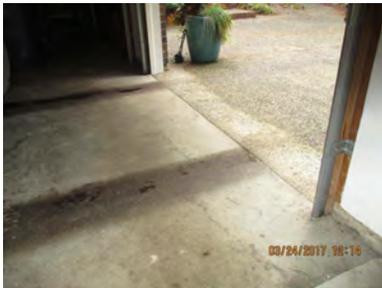
6.3 GARAGE DOOR OPENER

8. There was no photo-eye sensor installed for the center garage door to offer protection for small children and/or pets. We recommend that a photo-eye sensor be installed for the garage door at a height of within 4-6" of the floor.

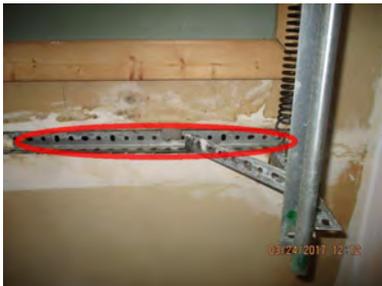
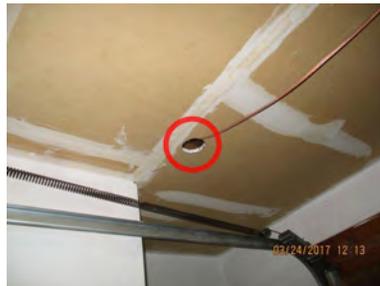
6.4 FIRE SEPARATION

9. There are voids in the fire resistive barrier between the living space and garage that will allow flames to penetrate. The gypsum barrier slows the spread of a fire from the garage to the structure and/or living space. Patching the voids is recommended.

6.4 Voids in the gypsum barrier were patched to reestablish the fire resistant barrier.

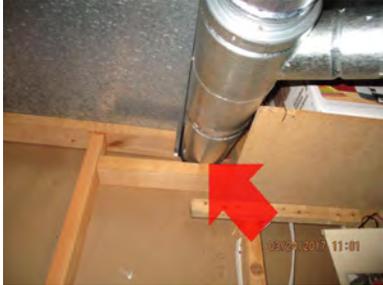
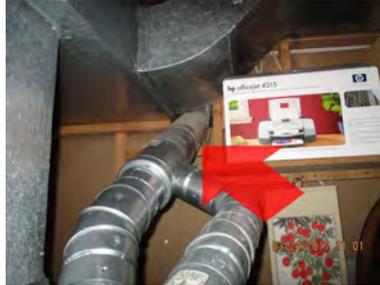
8.9 VENT

13. The furnace vent connector is too close to a combustible material. This is a hazard. A minimum clearance of 6" is required between the single wall vent connector and the combustible material. The double wall type B vent requires only 1" of clearance. Repairs are recommended.

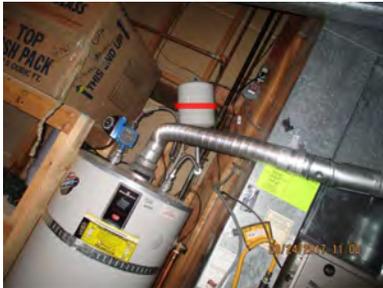
9.6 EXPANSION TANK

15. The expansion tank is not adequately secured to the wall. This could result in damage to the water pipe and leakage during an earth quake. A seismic restraint should be installed to secure the expansion tank.

9.6 A seismic restraint was added to the expansion tank on the water heater.

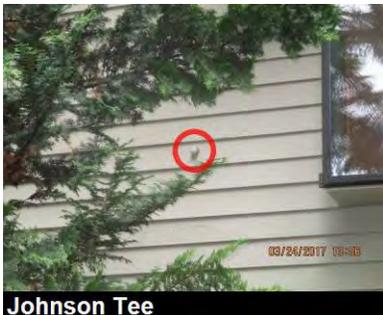
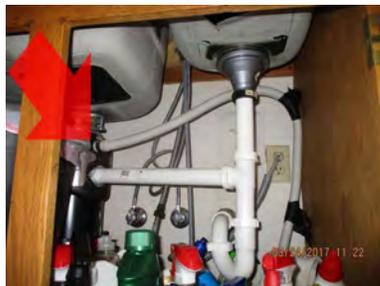
10.8 AIR GAP

10.8 As stated in the installation manual of the dishwasher, an air gap is not required on this model because the drain pipe is more than 8" above the floor - no backflow risk.

17. The dishwasher drain lacks an air gap. The dishwasher will function without one, but there is a risk of contamination of the inside of the dishwasher by waste water. The installation of an air gap is recommended or connection to the Johnson Tee that is installed in the kitchen wall. This air gap protects the dishwasher from contamination caused by a backflow of waste water.

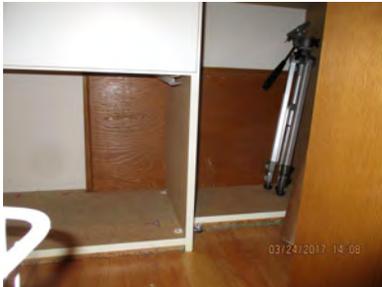
11.28 BATHTUB

21. The access panel was blocked by shelving and the hydromassage tub pump and associated plumbing and electrical components were not accessible for inspection. Reportable conditions may exist in this normally accessible area. We recommend removal of the closet shelf unit to provide for inspection and servicing.

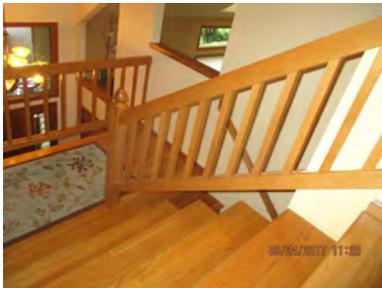
14.2 STAIRS

22. The stair railing baluster spacing is too wide. This is a hazard for small children. The baluster spacing should be reduced as a safety upgrade. Current standards require that a 4" sphere not pass through the railing.

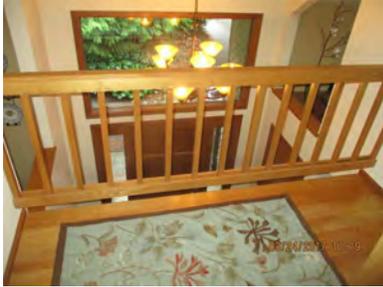
14.3 GUARD RAILINGS

23. The spacing between the balusters is too wide. This is a hazard to small children. The balusters should be spaced close enough together so that a 4" sphere cannot pass through. Upgrading the guard railing is recommended if small children are present.

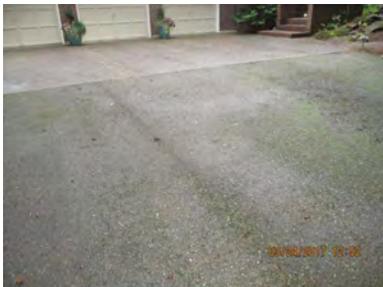
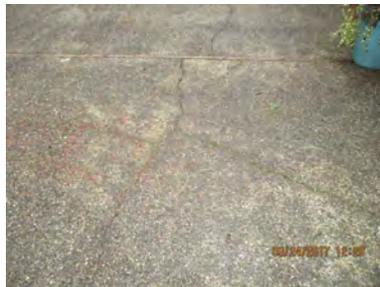
2.5 DRIVEWAY

1. The driveway is paved with asphalt paving mix. The driveway is properly installed and is performing its intended function. Seal coating the surface of the asphalt is recommended to maximize the service life of the paving. Asphalt sealers are available at most home improvement stores.

2. Cracks were observed in the concrete surface of the driveway apron. Minor cracks can be sealed to minimize moisture entry and further settlement of the concrete. Minor cracks are common and do not affect the serviceability of the concrete.

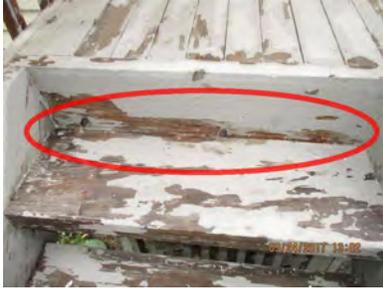
3. Localized areas of rot damaged wood and rot fungi was observed in the west deck framing. Rot weakens the wood and can result in catastrophic failure of the structure. Replacement of all rotted wood is recommended.

behind the siding. The installation of flashing in this area is recommended.

The west decks are not adequately secured to the building. The installation of lag bolts through the ledger board into the wall is recommended.

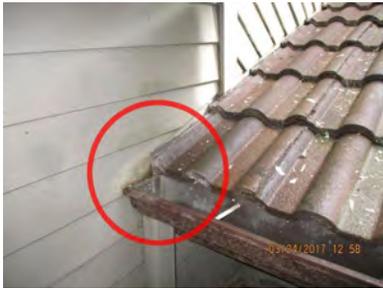
4.4 FLASHINGS

4. There are no kick out flashings at the roof edge to wall intersections above the gutters. This will allow water to enter the wall behind the siding. The installation of kick-out flashings is recommended.

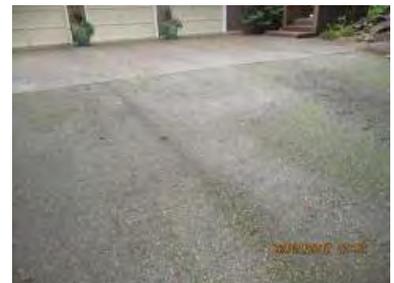
2.5 DRIVEWAY

The driveway is paved with asphalt paving mix. The driveway is properly installed and is performing its intended function. Seal coating the surface of the asphalt is recommended to maximize the service life of the paving. Asphalt sealers are available at most home improvement stores.

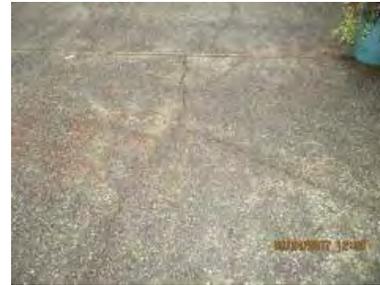
Cracks were observed in the concrete surface of the driveway apron. Minor cracks can be sealed to minimize moisture entry and further settlement of the concrete. Minor cracks are common and do not affect the serviceability of the concrete.

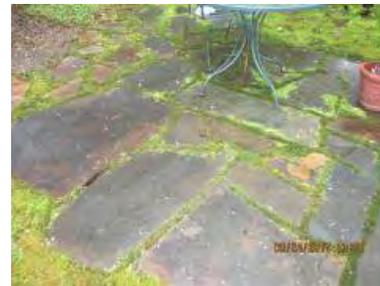
2.6 PATIO

The walking surface was not even and trip hazards were present. We recommend all walking surfaces be maintained free of trip hazards.

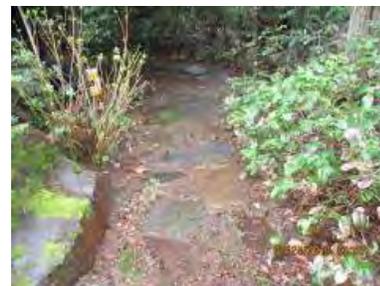
2.7 WALKWAY

The walking surface was not even and trip hazards were present. We recommend all walking surfaces be maintained free of trip hazards.

Many legal and public works departments have defined a trip hazard as an irregularity in a walking surface exceeding one inch (1") in height. All walking surfaces should maintain, free of a vertical surface change of 3/4" or more, in the interest of public and personal safety.

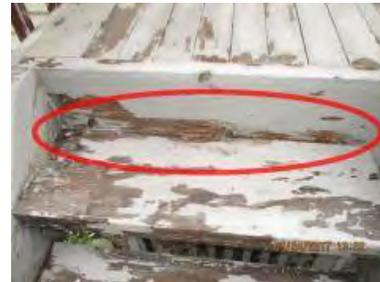
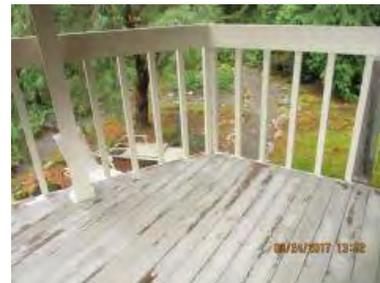
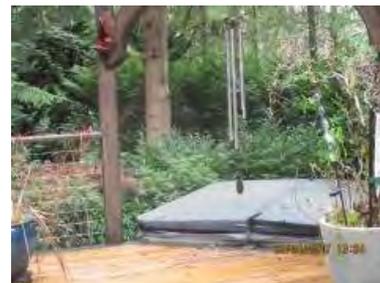
The east deck lacks a complete guard railing. This is a hazard. This installation of a guard railing is recommended.

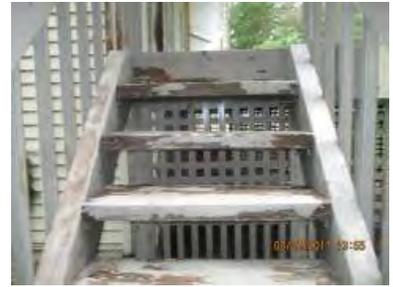
3.8 STAIRS

The stair rise spacing is too wide. This is a hazard for small children. The spacing should be reduced as a safety upgrade. Current standards require that a 4" sphere not pass through the opening.

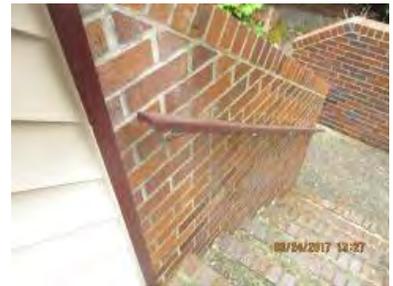
3.10 PORCH RAILING

The stairs were used several times during the inspection. The stair components are properly installed however one railing deficiency was noted during use. The railing ends do not return to the wall. This is a safety hazard. The installation of a continuous handrail should be considered as a safety upgrade.

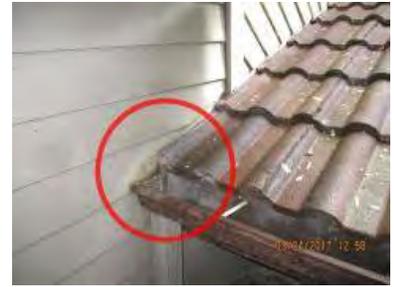
4.4 FLASHINGS

There are no kick out flashings at the roof edge to wall intersections above the gutters. This will allow water to enter the wall behind the siding. The installation of kick-out flashings is recommended.

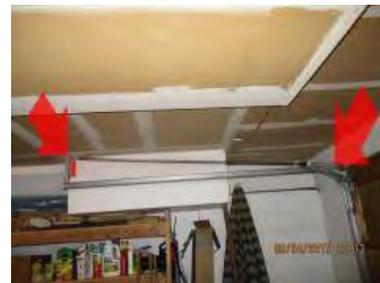
Safeties are cables run through the center of the garage door springs that prevent broken springs from becoming projectiles that can cause injury. There are no safeties installed. The installation of safeties is recommended.

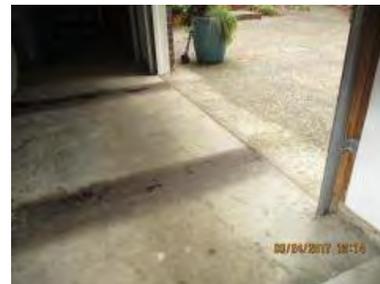
6.3 GARAGE DOOR OPENER

There was no photo-eye sensor installed for the center garage door to offer protection for small children and/or pets. We recommend that a photo-eye sensor be installed for the garage door at a height of within 4-6" of the floor.

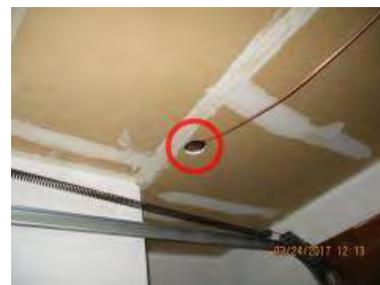
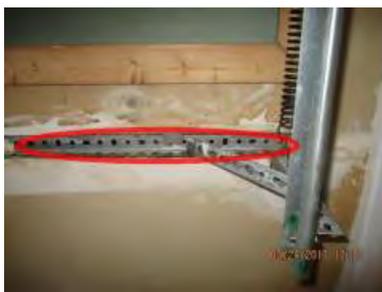
6.4 FIRE SEPARATION

There are voids in the fire resistive barrier between the living space and garage that will allow flames to penetrate. The gypsum barrier slows the spread of a fire from the garage to the structure and/or living space. Patching the voids is recommended.

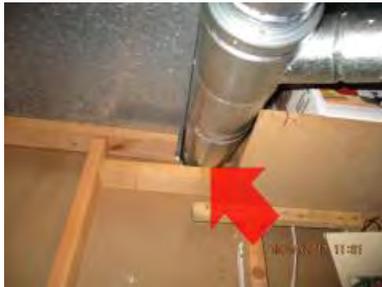
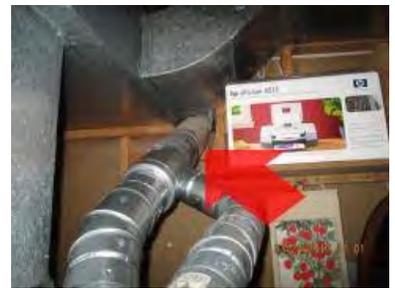
8.9 VENT

The furnace vent connector is too close to a combustible material. This is a hazard. A minimum clearance of 6" is required between the single wall vent connector and the combustible material. The double wall type B vent requires only 1" of clearance. Repairs are recommended.

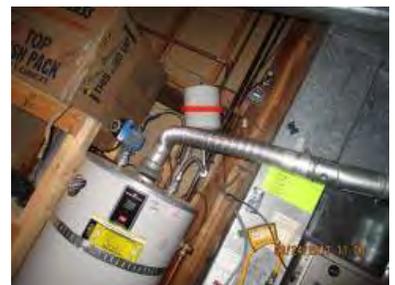
The expansion tank is not adequately secured to the wall. This could result in damage to the water pipe and leakage during an earth quake. A seismic restraint should be installed to secure the expansion tank.

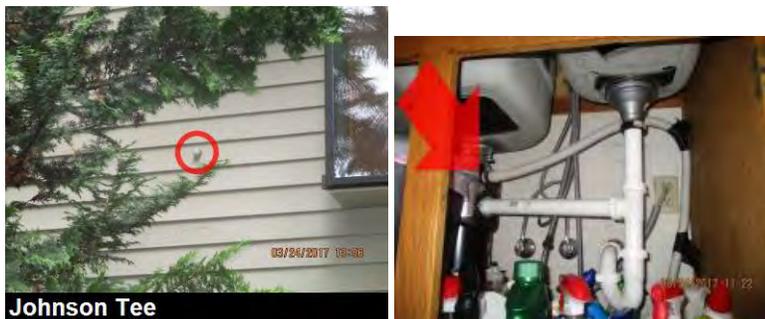
The cap protruding on the exterior wall opposite the dishwasher is not drilled. This renders the air gap non-functional. Drilling a 1/4" hole in the end of the cap will restore its function when connected to the dishwasher.

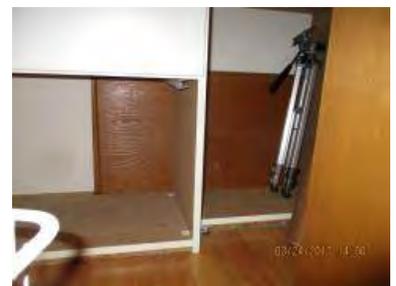
The access panel was blocked by shelving and the hydromassage tub pump and associated plumbing and electrical components were not accessible for inspection. Reportable conditions may exist in this normally accessible area. We recommend removal of the closet shelf unit to provide for inspection and servicing.

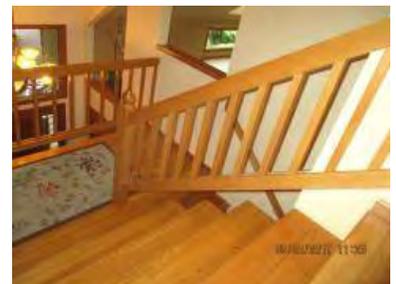
The stair railing baluster spacing is too wide. This is a hazard for small children. The baluster spacing should be reduced as a safety upgrade. Current standards require that a 4" sphere not pass through the railing.

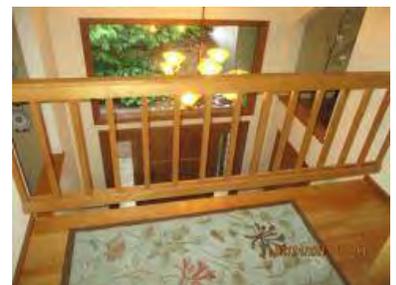
14.3 GUARD RAILINGS

The spacing between the balusters is too wide. This is a hazard to small children. The balusters should be spaced close enough together so that a 4" sphere cannot pass through. Upgrading the guard railing is recommended if small children are present.
