NOTICE TO BUYER: SELLER-PROCURED INSPECTION REPORT

17504 NE 141st St, Redmond WA 98052

At your request, a visual inspection of the above referenced property was conducted on April 11, 2017. We have inspected the major structural components, plumbing, heating and electrical systems for signs of significant non-performance, excessive or unusual wear and general state of repair.

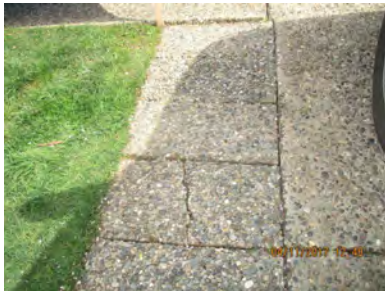
2.6 WALKWAY

1. The walking surface was not even and trip hazards were present. We recommend all walking surfaces be maintained free of trip hazards.

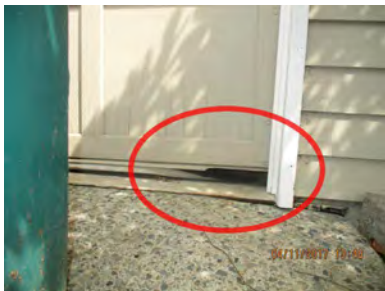
6.2 OVERHEAD GARAGE DOORS

2. The east overhead door is damaged. This is a cosmetic condition that does not affect the function of the door. The damaged door should be repaired as necessary.

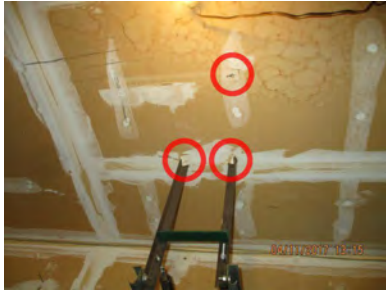
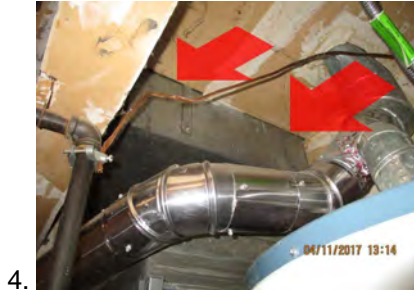
6.4 FIRE SEPARATION

3. There are voids in the fire resistive barrier between the living space and garage that will allow flames to penetrate. The gypsum barrier slows the spread of a fire from the garage to the structure and/or living space.

Patching the voids is recommended.

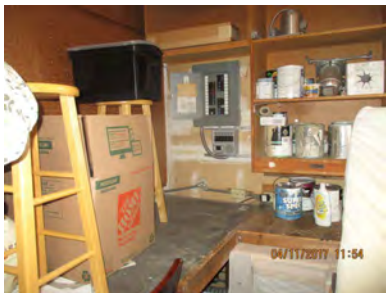
6. Access to the electrical panel is blocked by shelving. Shelves should be removed or modified so that there is a 30" wide by 36" deep by 7' tall clearance in front of the panel.

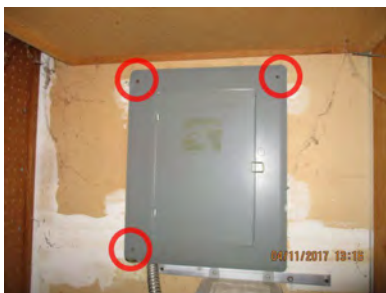
7.8 SERVICE PANEL

7. Screws that secure the panel cover to the panel box are missing. This is a potential hazard. Missing screws should be replaced with the original style blunt end screws.

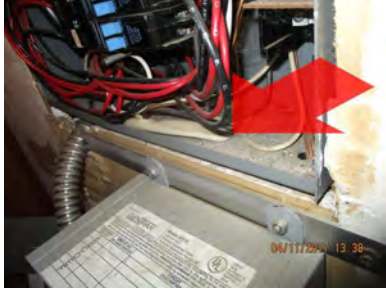
8. There is an electrical cable emanating from the service panel that is not clamped. The sharp edge of the panel box could cut through the wire insulation and cause a short circuit or fire. Clamping the cable to the panel box using an approved cable clamp is recommended.

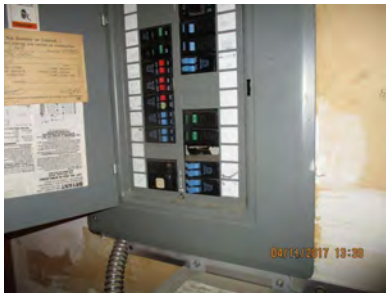
9. Twist-outs are missing from the service panel cover. This exposes live conductors and is a shock hazard. The installation of snap-in replacement blanks is recommended.

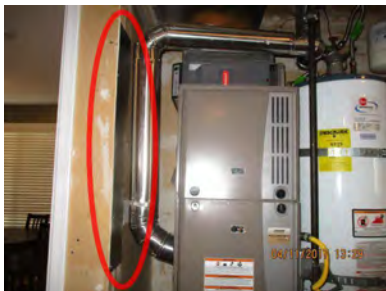
8.10 VENT

12. The furnace vent connector is too close to a combustible material. This is a hazard. A minimum clearance of 6" is required between the single wall vent connector and the combustible material. The double wall type B vent requires only 1" of clearance. Repairs are recommended.

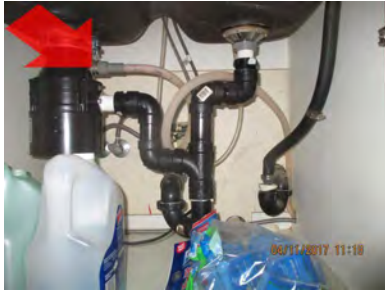
10.8 AIR GAP

13. The dishwasher drain lacks an air gap. The dishwasher will function without one, but there is a risk of contamination of the inside of the dishwasher by waste water. The installation of an air gap is recommended.

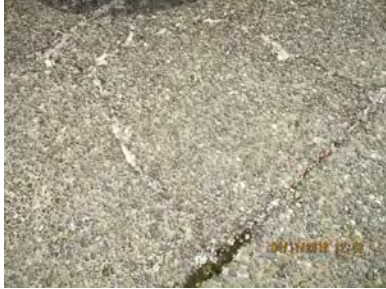
1. Cracks were observed in the concrete surface of the driveway. Minor cracks can be sealed to minimize moisture entry and further settlement of the concrete. Minor cracks are common and do not affect the serviceability of the concrete.

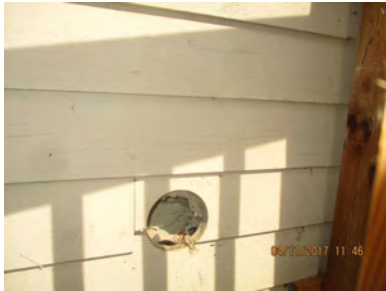
3. There is a large gap in the wall adjacent the laundry room door. Consideration should be given to installing siding, flashing and/or caulk to prevent moisture or pest entry into these areas.

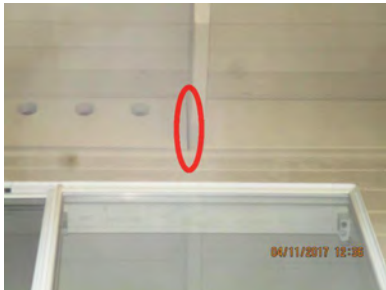
3.3 SOFFITS AND OVERHANGS

4. There are large gaps over 1/4" in size adjacent the soffit vent blocks. These gaps allow insects and rodents to enter the attic. Covering the gaps with screening, a strip of wood and/or caulking is recommended.

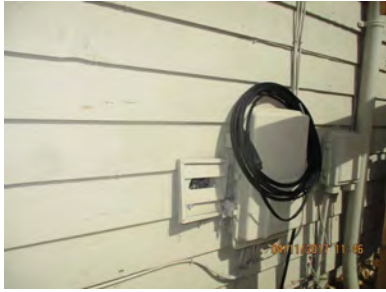
6. The dryer duct back-draft damper is damaged at the termination. The installation of a hooded back-draft damper is recommended to prevent entry by rodents, birds insects, etc.

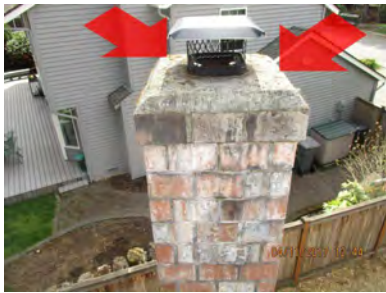
4.4 CHIMNEYS

7. The chimney crowns are cracked. The mortar chimney crowns prevent water from entering and damaging the masonry. Repairing or replacing the chimney crowns will extend the service life of the chimneys.

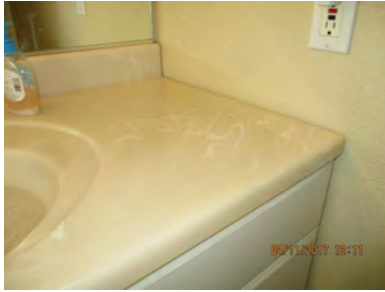
and it is difficult to clean. Caulking should be installed at this location.

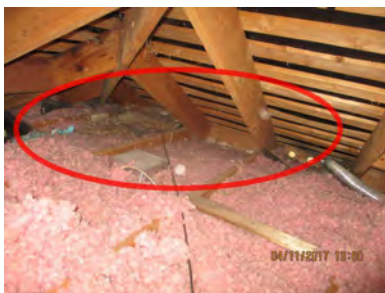
There is a large thermal bypasses in the northwest corner of the attic. A thermal bypass is an opening between an insulated and uninsulated part of the house through which heated air can escape. As air is heated, it rises and pulls cool air in to the space to replace it. This condition will result in significant heat loss. Sealing up all thermal bypass routes is recommended. The installation of additional attic insulation is recommended.

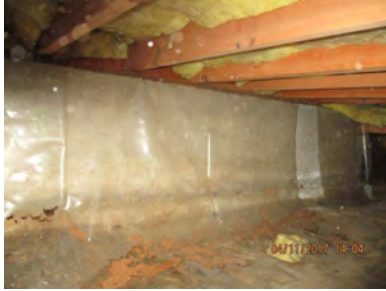
19.4 VAPOR RETARDER

20. The foundation walls are covered with the plastic vapor retarder. This allows the transmission of water

vapor from the soil up and into the exterior wall framing. The plastic vapor retarder should be removed from the foundation so that it covers the entire surface of the soil only.

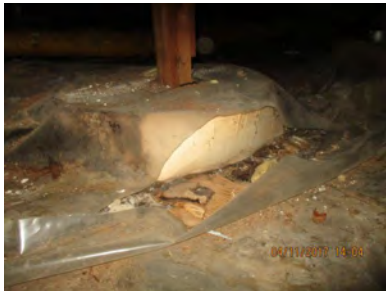
19.5 PEST CONTROL

22. Scrap-wood and other cellulose debris was observed on the crawl floor. This wood debris creates conducive conditions for wood boring insects. The removal of all cellulose debris is recommended.

Cellulose forms were left in place on the pier footings. This cellulose is conducive to the infestation of various wood destroying organisms. The removal of the cellulose is recommended.

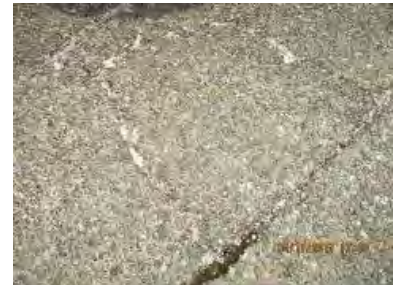
Cracks were observed in the concrete surface of the driveway. Minor cracks can be sealed to minimize moisture entry and further settlement of the concrete. Minor cracks are common and do not affect the serviceability of the concrete.

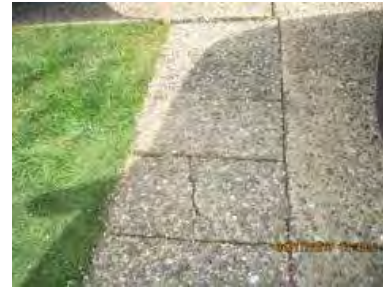
The walking surface was not even and trip hazards were present. We recommend all walking surfaces be maintained free of trip hazards.

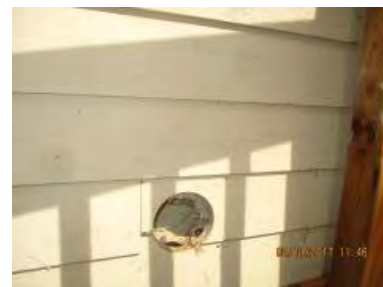
There is a large gap in the wall adjacent the laundry room door. Consideration should be given to installing siding, flashing and/or caulk to prevent moisture or pest entry into these areas.

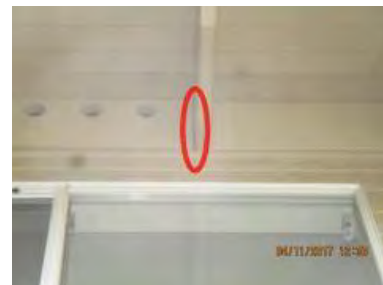
There are large gaps over 1/4" in size adjacent the soffit vent blocks. These gaps allow insects and rodents to enter the attic. Covering the gaps with screening, a strip of wood and/or caulking is recommended.

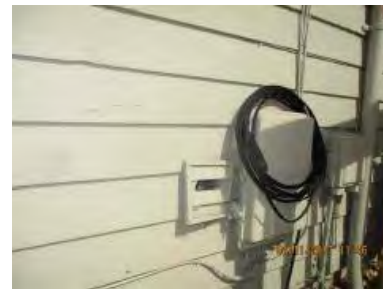
The dryer duct back-draft damper is damaged at the termination. The installation of a hooded back-draft damper is recommended to prevent entry by rodents, birds insects, etc.

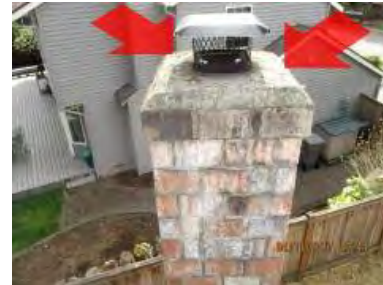
The chimney crowns are cracked. The mortar chimney crowns prevent water from entering and damaging the masonry. Repairing or replacing the chimney crowns will extend the service life of the chimneys.

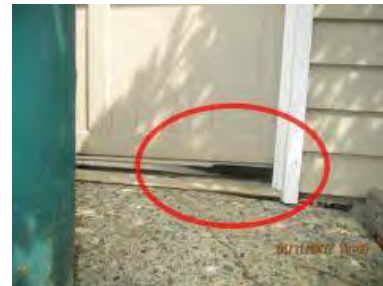
The east overhead door is damaged. This is a cosmetic condition that does not affect the function of the door. The damaged door should be repaired as necessary.

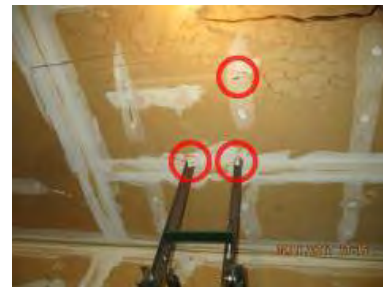
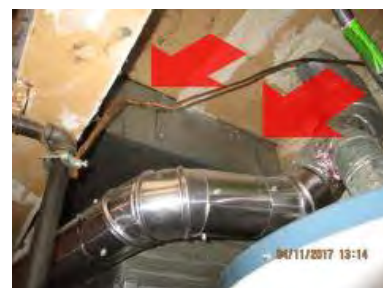
There are voids in the fire resistive barrier between the living space and garage that will allow flames to penetrate. The gypsum barrier slows the spread of a fire from the garage to the structure and/or living space. Patching the voids is recommended.

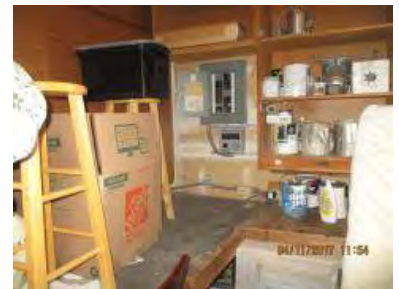
Access to the electrical panel is blocked by shelving. Shelves should be removed or modified so that there is a 30" wide by 36" deep by 7' tall clearance in front of the panel.

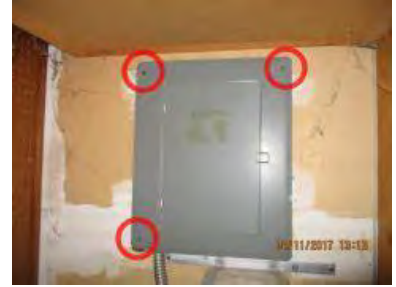
Screws that secure the panel cover to the panel box are missing. This is a potential hazard. Missing screws should be replaced with the original style blunt end screws.

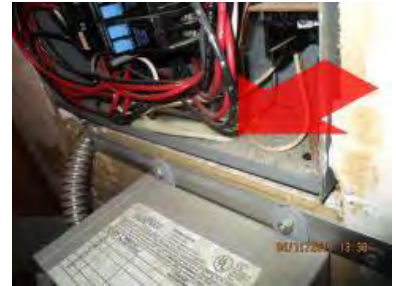
There is an electrical cable emanating from the service panel that is not clamped. The sharp edge of the panel box could cut through the wire insulation and cause a short circuit or fire. Clamping the cable to the panel box using an approved cable clamp is recommended.

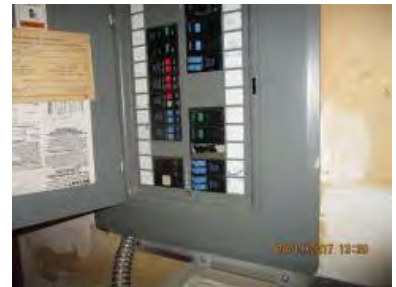
Twist-outs are missing from the service panel cover. This exposes live conductors and is a shock hazard. The installation of snap-in replacement blanks is recommended.

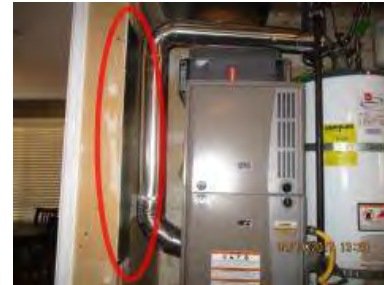
The furnace vent connector is too close to a combustible material. This is a hazard. A minimum clearance of 6" is required between the single wall vent connector and the combustible material. The double wall type B vent requires only 1" of clearance. Repairs are recommended.

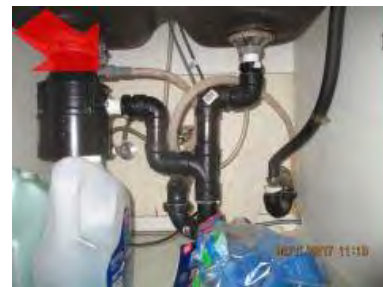
The dishwasher drain lacks an air gap. The dishwasher will function without one, but there is a risk of contamination of the inside of the dishwasher by waste water. The installation of an air gap is recommended.

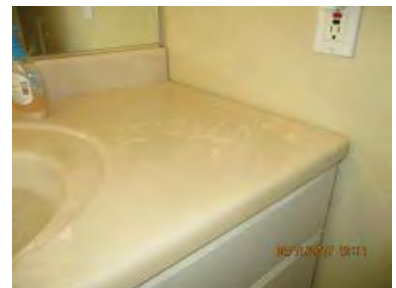
The backsplash is not caulked. This allows water to enter the gap between the back splash and counter and it is difficult to clean. Caulking should be installed at this location.

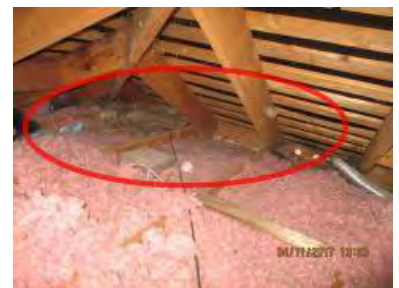
There is a large thermal bypasses in the northwest corner of the attic. A thermal bypass is an opening between an insulated and uninsulated part of the house through which heated air can escape. As air is heated, it rises and pulls cool air in to the space to replace it. This condition will result in significant heat loss. Sealing up all thermal bypass routes is recommended. The installation of additional attic insulation is recommended.

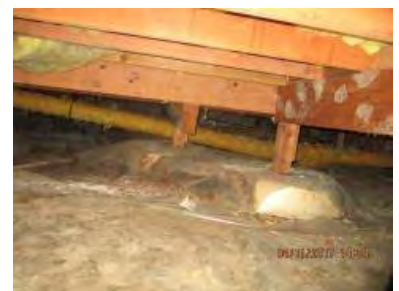
The support post concrete piers are covered with the plastic vapor retarder. This allows the transmission of water vapor from the soil up and into the floor framing. The plastic vapor retarder should be removed from the pier so that it covers the entire surface of the soil only.

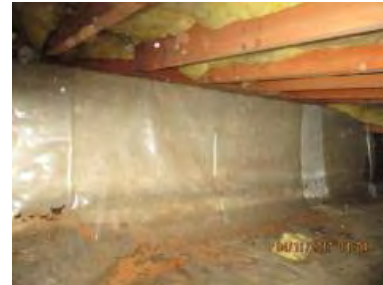
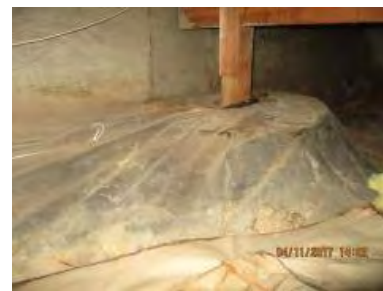
The foundation walls are covered with the plastic vapor retarder. This allows the transmission of water vapor from the soil up and into the exterior wall framing. The plastic vapor retarder should be removed from the foundation so that it covers the entire surface of the soil only.

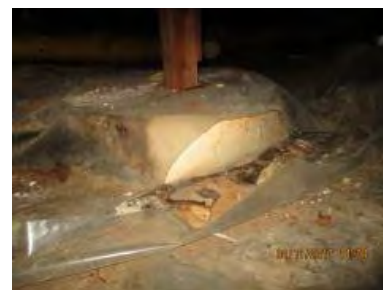
There should be no soil to wood contact in any part of the building exterior or crawlspace, unless that wood is pressure treated. For the greatest safety to permanent structures there should be no soil to wood contact of any kind. Untreated wood in direct contact with exterior

flatwork should also be avoided.
