**NOTICE TO BUYER: SELLER-PROCURED INSPECTION REPORT**

Dean and Courtney Russell  
13820 176<sup>th</sup> PI NE, Redmond WA 98052

May 5, 2017

**Re: 13820 176th Pl. NE**  
**Redmond, WA.**

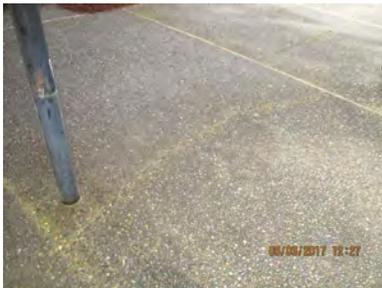
#### **2.5 PATIO**

1. One or more of the wooden dividers separating the concrete patio sections were infested by wood destroying organisms and have deteriorated to a point where they are becoming a trip hazard. Replacement with mortar is recommended.

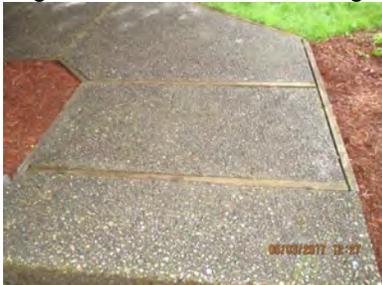
#### **2.6 WALKWAY**

2. The wooden dividers separating the concrete walkway sections have deteriorated to a point where the gaps are a trip hazard. Replacement with mortar is recommended.

The walkway has cracked and settled differentially. This was probably caused by inadequate preparation of the soil prior to the placement of the concrete. This condition can be repaired by pressure grouting the sunken portion of the walkway or by removing and replacing it. The walkway remains functional despite this condition. However, the raised edges of the concrete can be a trip hazard for some people. Grinding down the raised edges of the concrete will mitigate the hazard. Repairs should be made as necessary.

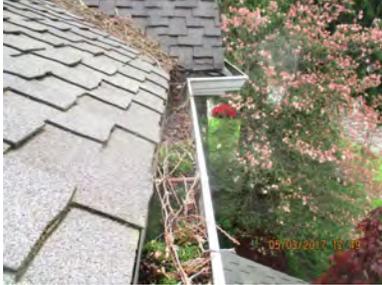
### 3.5 GUTTERS AND DOWNSPOUTS

3. There is a build-up of organic debris inside the gutters. Proper maintenance of gutters and downspouts is essential and should be performed routinely in order to prevent clogging. Maintenance consists primarily of keeping leaves and other organic debris out of the system. Failure to clean the gutters will result in water splash on the building when they overflow. Gutters can be damaged under the weight of the water and organic matter inside the gutter. Gutters should be cleaned as necessary to maintain a free flow of water into the downspouts.

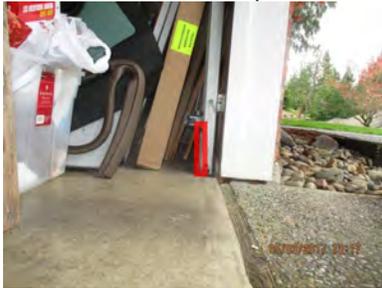
5. The Photo-eye beam was installed too high above the floor of the garage to adequately offer protection for small children and/or pets. We recommend that the photo-eye be lowered to within 4-6" of the floor.

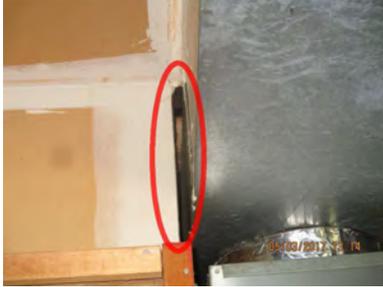
#### 6.4 FIRE SEPARATION

6. There are voids in the fire resistive barrier between the living space and garage that will allow flames to penetrate. The gypsum barrier slows the spread of a fire from the garage to the structure and/or living space. Patching the voids is recommended.

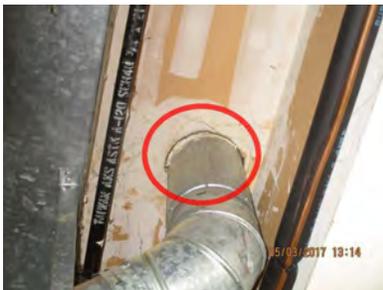
#### 8.10 VENT

10. The furnace vent connector is too close to a combustible material. This is a hazard. A minimum clearance of 6" is required between the single wall vent connector and the combustible material. The double wall type B vent requires only 1" of clearance. Repairs are recommended.

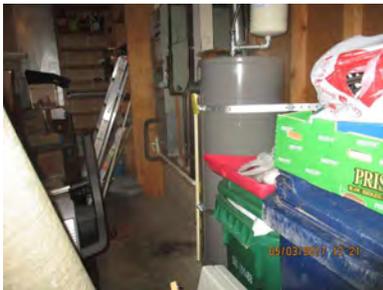
15. The gas pipes in front of the furnace and water heater are not protected by a bumper stop. A vertical steel pipe, bolted to the floor, is typically installed in front of the water heater to prevent a car bumper from damaging the gas lines.

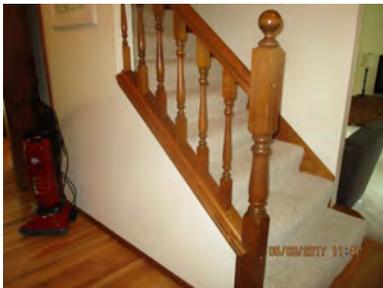
### 15.3 STAIRS

16. The stair railing baluster spacing is too wide. This is a hazard for small children. The baluster spacing should be reduced as a safety upgrade. Current standards require that a 4" sphere not pass through the railing.

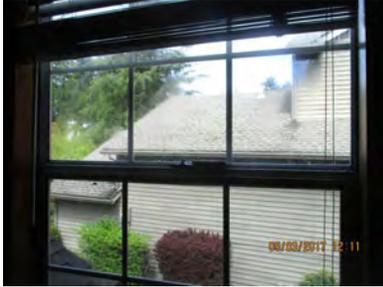
### 15.7 WINDOWS

17. There is condensation or mineral deposits between the panes of glass in one of the insulated glass window panes. This indicates a failed seal. The glass assembly should be replaced, which is the only method for correcting this deficiency.

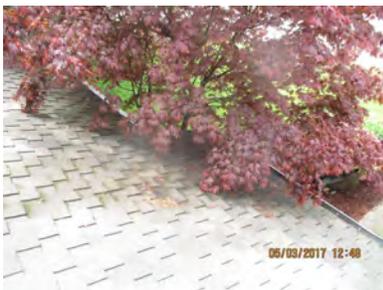
1. Trees are touching the building on the west side. Low hanging tree branches can damage the roof. Tree branches should be trimmed back where necessary.

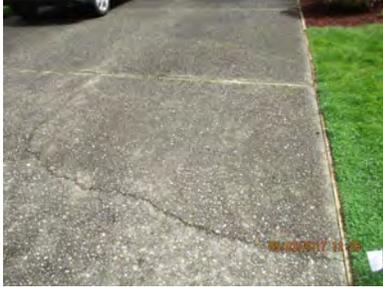
#### 2.4 DRIVEWAY

2. Cracks were observed in the concrete surface of the driveway. Minor cracks can be sealed to minimize moisture entry and further settlement of the concrete. Minor cracks are common and do not affect the serviceability of the concrete.

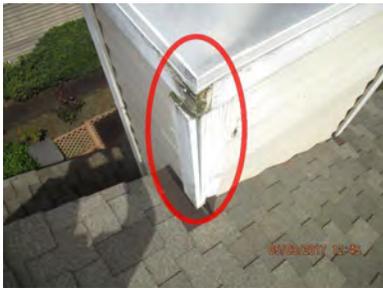
### 3.1 PRIMARY EXTERIOR WALL CLADDING

3. Trim boards at the top edge of the chimney chase are warped, cupped and generally deteriorated. Consideration should be given to replacing the damaged trim boards.

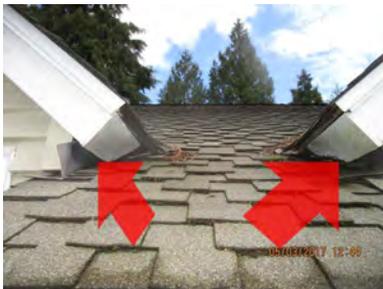
### 3.4 SOFFITS AND OVERHANGS

4. There are large gaps over 1/4" in size adjacent the soffit vent blocks. These gaps allow insects and rodents to enter the attic. Covering the gaps with screening, a strip of wood and/or caulking is recommended.

There are openings at the intersection between the overhang and the roof through which birds and rodents can enter into the attic. These openings should be covered with wood, wire mesh or filled with aerosol foam.

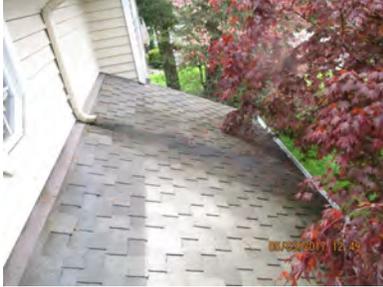
### 3.5 GUTTERS AND DOWNSPOUTS

5. Downspouts draining directly onto the asphalt shingle surface causes excessive wear of the roofing material. Downspout extensions to the lower gutters should be installed to prevent excessive wear and tear of the roofing.

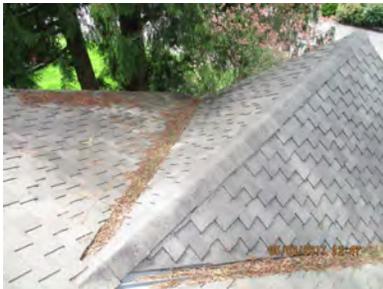
### 4.6 MAINTENANCE AND REPAIRS

6. The roof is in need of routine maintenance. The surface should be blown off or washed with a high volume low pressure garden hose to remove moss and organic debris. Performing this maintenance will improve the appearance and increase the life expectancy of the roof.

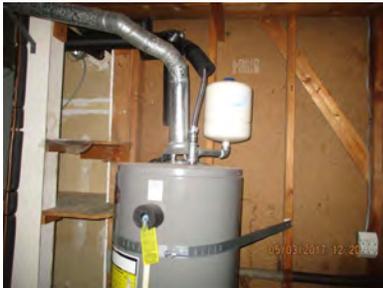
### 10.6 EXPANSION TANK

7. The expansion tank is not adequately secured to the wall. This could result in damage to the water pipe and leakage during an earth quake. A seismic restraint should be installed to secure the expansion tank.

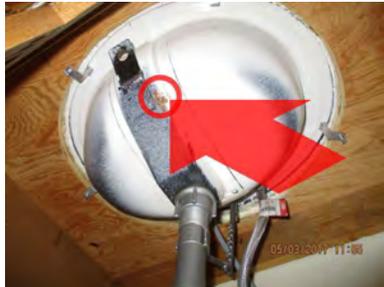
13. The overflow portion of the sink drain is rusted. This will cause the sink to leak. Replacement of the sink is recommended.

The drain stop is not operational. It should be repaired or replaced.

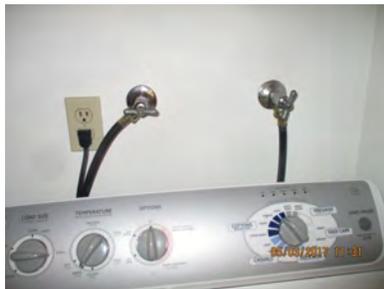
13.2 APPLIANCES

14. Upgrading the washer connections to high pressure (steel braided) lines is recommended.

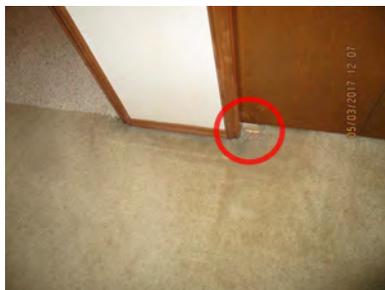
15.2 FLOORS

15. Bedroom carpet is damaged adjacent the closet. Carpet replacement should be considered.

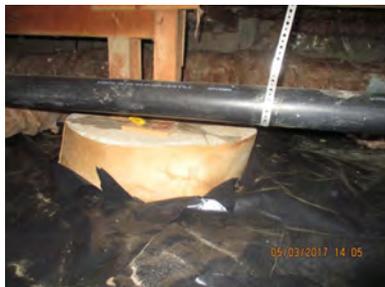
17. Scrap-wood and other cellulose debris was observed on the crawl floor. This wood debris creates conducive conditions for wood boring insects. The removal of all cellulose debris is recommended.

Cellulose forms were left in place on the pier footings. This cellulose is conducive to the infestation of various wood destroying organisms. The removal of the cellulose is recommended.

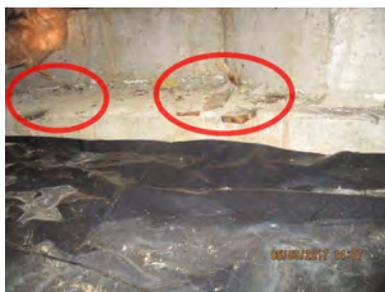
18. Form wood was left in place on the footings. This wood is conducive to the infestation of various wood destroying organisms. The removal of the form wood is recommended.

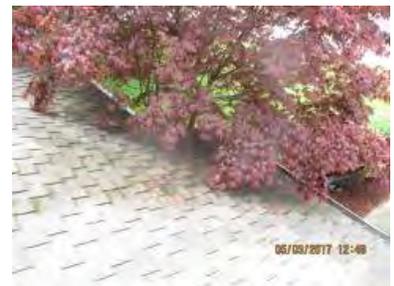
Trees are touching the building on the west side. Low hanging tree branches can damage the roof. Tree branches should be trimmed back where necessary.

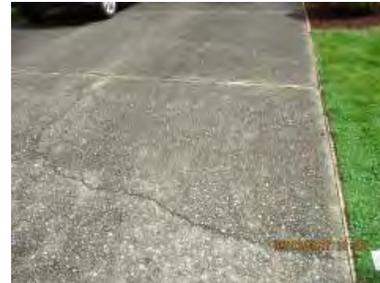
### 2.4 DRIVEWAY

Cracks were observed in the concrete surface of the driveway. Minor cracks can be sealed to minimize moisture entry and further settlement of the concrete. Minor cracks are common and do not affect the serviceability of the concrete.

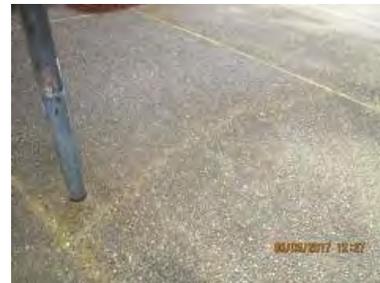
## 2.5 PATIO

One or more of the wooden dividers separating the concrete patio sections were infested by wood destroying organisms and have deteriorated to a point where they are becoming a trip hazard. Replacement with mortar is recommended.

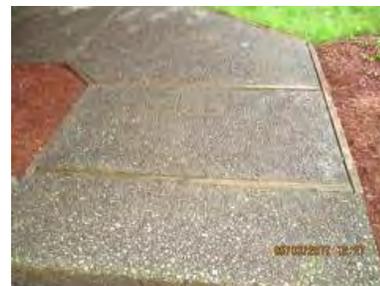
## 2.6 WALKWAY

The wooden dividers separating the concrete walkway sections have deteriorated to a point where the gaps are a trip hazard. Replacement with mortar is recommended.

The walkway has cracked and settled differentially. This was probably caused by inadequate preparation of the soil prior to the placement of the concrete. This condition can be repaired by pressure grouting the sunken portion of the walkway or by removing and replacing it. The walkway remains functional despite this condition. However, the raised edges of the concrete can be a trip hazard for some people. Grinding down the raised edges of the concrete will mitigate the hazard. Repairs should be made as necessary.

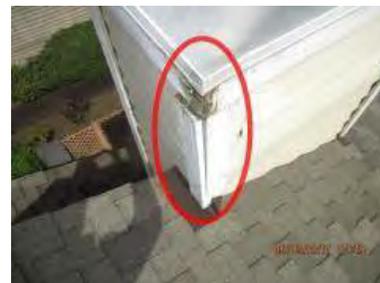
Trim boards at the top edge of the chimney chase are warped, cupped and generally deteriorated. Consideration should be given to replacing the damaged trim boards.

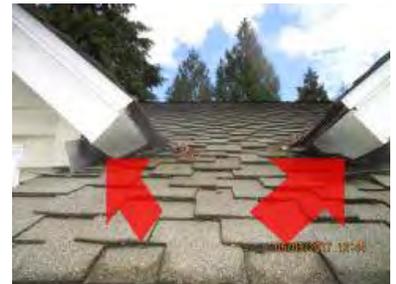
There are openings at the intersection between the overhang and the roof through which birds and rodents can enter into the attic. These openings should be covered with wood, wire mesh or filled with aerosol foam.

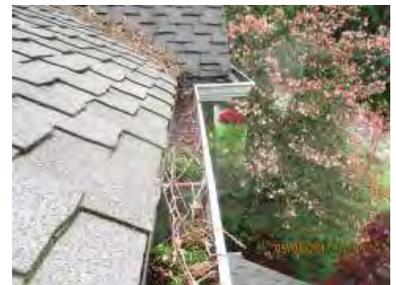
### 3.5 GUTTERS AND DOWNSPOUTS

There is a build-up of organic debris inside the gutters. Proper maintenance of gutters and downspouts is essential and should be performed routinely in order to prevent clogging. Maintenance consists primarily of keeping leaves and other organic debris out of the system. Failure to clean the gutters will result in water splash on the building when they overflow. Gutters can be damaged under the weight of the water and organic matter inside the gutter. Gutters should be cleaned as necessary to maintain a free flow of water into the downspouts.

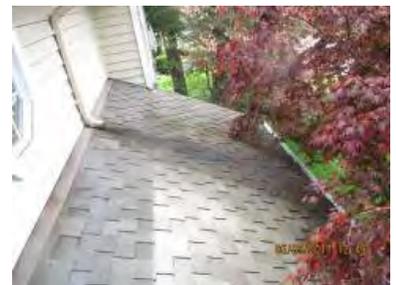
Downspouts draining directly onto the asphalt shingle surface causes excessive wear of the roofing material. Downspout extensions to the lower gutters should be installed to prevent excessive wear and tear of the roofing.

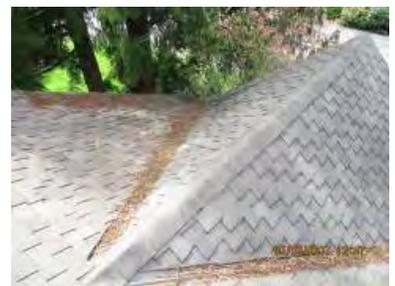
The roof is in need of routine maintenance. The surface should be blown off or washed with a high volume low pressure garden hose to remove moss and organic debris. Performing this maintenance will improve the appearance and increase the life expectancy of the roof.

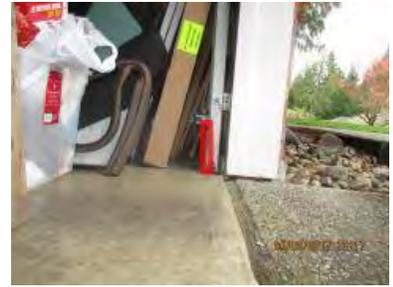
The Photo-eye beam was installed to high above the floor of the garage to adequately offer protection for small children and/or pets. We recommend that the photo-eye be lowered to within 4-6" of the floor.

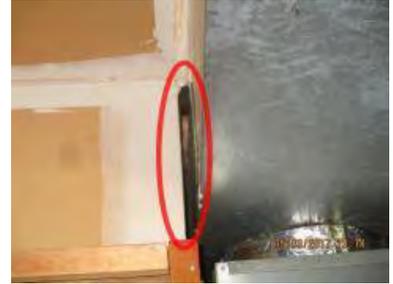
#### 6.4 FIRE SEPARATION

There are voids in the fire resistive barrier between the living space and garage that will allow flames to penetrate. The gypsum barrier slows the spread of a fire from the garage to the structure and/or living space. Patching the voids is recommended.

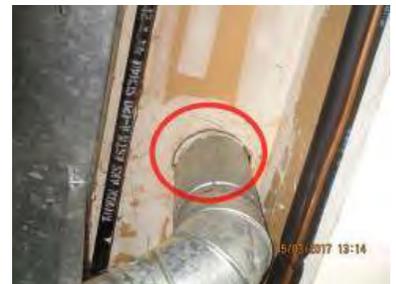
The furnace vent connector is too close to a combustible material. This is a hazard. A minimum clearance of 6" is required between the single wall vent connector and the combustible material. The double wall type B vent requires only 1" of clearance. Repairs are recommended.

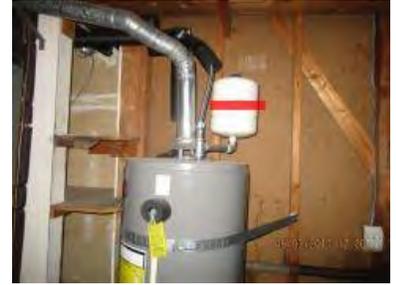
The expansion tank is not adequately secured to the wall. This could result in damage to the water pipe and leakage during an earth quake. A seismic restraint should be installed to secure the expansion tank.

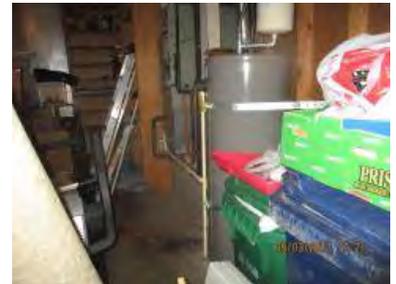
The gas pipes in front of the furnace and water heater are not protected by a bumper stop. A vertical steel pipe, bolted to the floor, is typically installed in front of the water heater to prevent a car bumper from damaging the gas lines.

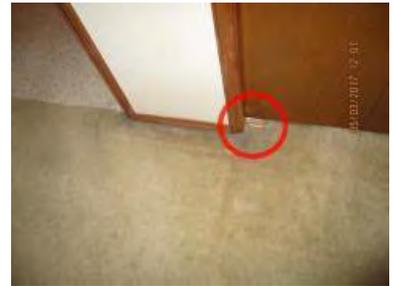
Bedroom carpet is damaged adjacent the closet. Carpet replacement should be considered.

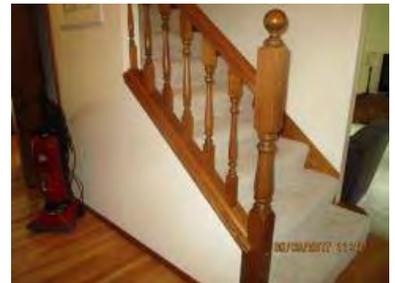
### 15.3 STAIRS

The stair railing baluster spacing is too wide. This is a hazard for small children. The baluster spacing should be reduced as a safety upgrade. Current standards require that a 4" sphere not pass through the railing.

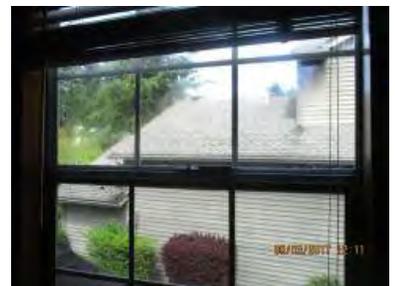
There is condensation or mineral deposits between the panes of glass in one of the insulated glass window panes. This indicates a failed seal. The glass assembly should be replaced, which is the only method for correcting this deficiency.

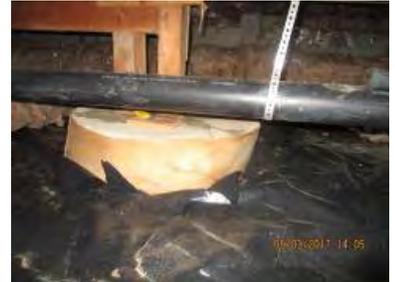
Good building practice requires that foundation walls or pier footings supporting wood frame construction, should extend at least 8" above the finish grade with at least a 6" clearance between the top of the soil and the bottom of the wood finish materials. Untreated wood should be raised 1-2" above surrounding flatwork and should have a moisture barrier such as 30 lb. asphalt impregnated felt installed between the concrete and wood. For additional information and treatment options, you should retain the services of a qualified pest control operator.

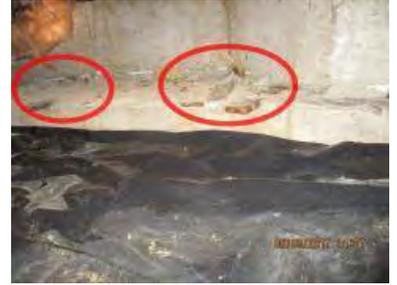
Form wood was left in place on the footings. This wood is conducive to the infestation of various wood destroying organisms. The removal of the form wood is recommended.
