**NOTICE TO BUYER: SELLER-PROCURED INSPECTION REPORT**

The following notice is given with respect to the Purchase and Sale Agreement dated \_\_\_\_\_  
between \_\_\_\_\_ (“Buyer”)  
and Estate of Wilhelmina Zent, Sarah R. Johnson as Personal Representative (“Seller”)  
concerning 14130 174th PINE, Redmond WA 98052 (“the Property”).

At your request, a visual inspection of the above referenced property was conducted on 05/24/2017. We have inspected the major structural components, plumbing, heating and electrical systems for signs of significant non-performance, excessive or unusual wear and general state of repair.

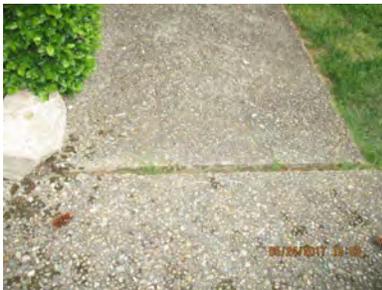
The wooden divider separating the concrete driveway and walkway sections has deteriorated to a point where it is a trip hazard. Replacement with mortar is recommended.

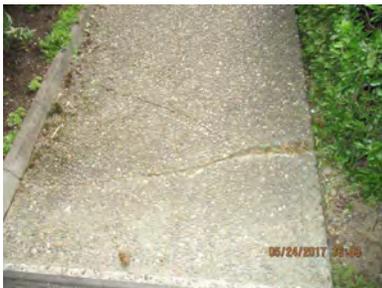
**2.6 WALKWAY**

The gaps in the concrete walkway are a trip hazard. Repairs are recommended.

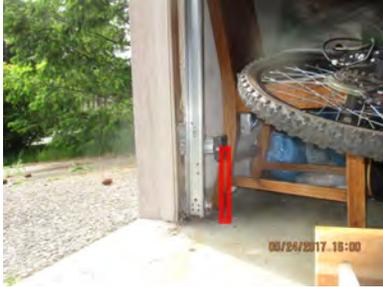
There was no photo-eye sensor installed for the garage door to offer protection for small children and/or pets. When an opener is in use we recommend that a photo-eye sensor be installed for the garage door at a height of within 4-6" of the floor.

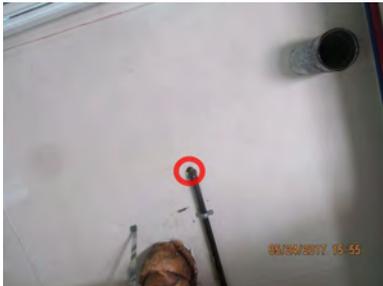
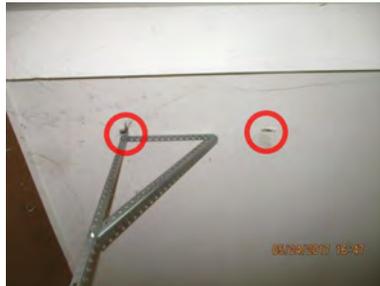
### 6.4 FIRE SEPARATION

There are voids in the fire resistive barrier between the living space and garage that will allow flames to penetrate. The gypsum barrier slows the spread of a fire from the garage to the structure and/or living space. Patching the voids with a fire retardant caulk is recommended.

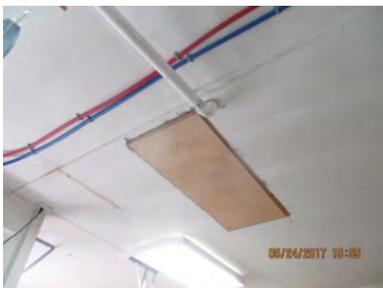
The pull down ladder is a breach in the fire resistive barrier in the garage. This is a safety concern. The gypsum barrier on the ceiling slows the spread of a fire from the garage to the attic. The installation of a layer of 5/8" gypsum type X board over the 1/4" plywood is recommended.

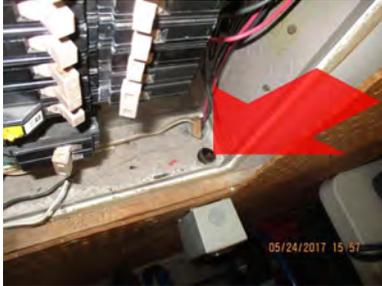
There are openings in the panel where knock-outs have been removed.

There are openings in the panel box where knock-outs have been removed. Missing knock-outs should be replaced with snap in metal plugs.

Missing knock outs have been replaced with snap metal plugs

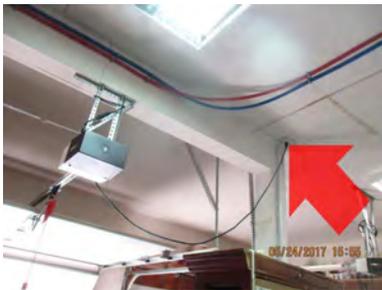
### 7.10 WIRING

An extension cord is used as a temporary power source for the garage door openers. An extension cord is not suitable as a permanent wiring method. The installation of a receptacle within cords length of the motors is recommended.

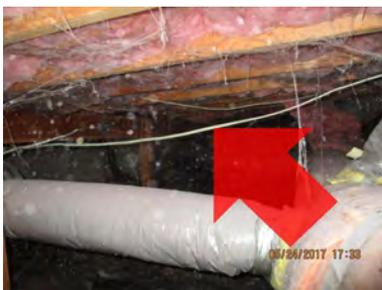
Loose electrical cable was observed in the crawl space.

A loose electrical cable was observed in the crawlspace. Loose cables are vulnerable to damage. All loose cables should be secured at 4' intervals using approved cable staples.

Loose cable will be secured with approved cable staples

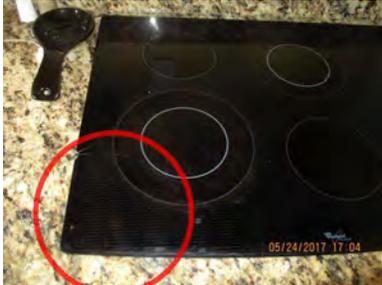
The built-in cooktop glass is broken. Replacement of the cooktop should be recommended.

10:11 Replaced glass cooktop

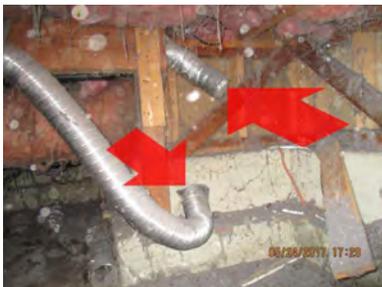
The dryer vent duct has become disconnected and is now discharging moisture and lint in the crawlspace. The duct should be reconnected and secured to avoid lint and moisture problems in this area.

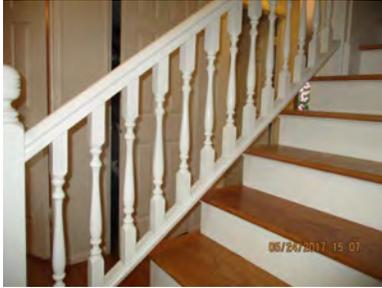
The stair railing spacing at the stair treads is too wide. This is a hazard for small children. The railing spacing should be reduced as a safety upgrade. Current standards require that a 4" sphere not pass through or under the railing.

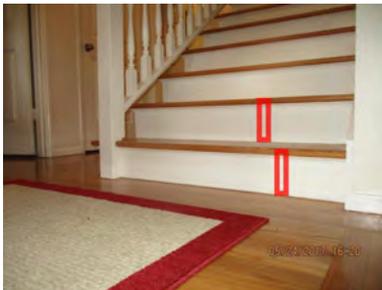
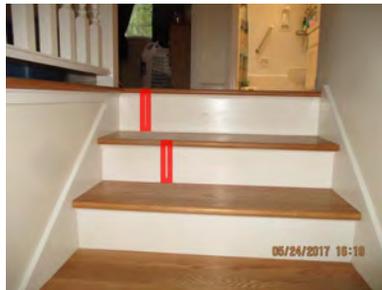
The stairs are non-conforming due to the variable and/or excessive rise. Stair design standards require that stair risers do not exceed 8" and that the variation in rise not exceed 3/8" in order to reduce falls from tripping. To increase the margin of safety, consideration should be given to reconfiguring the stairs so that rise and run do not vary by more than 3/8". If this proves to be too impractical or expensive, then we recommend exercising caution when using these stairs.

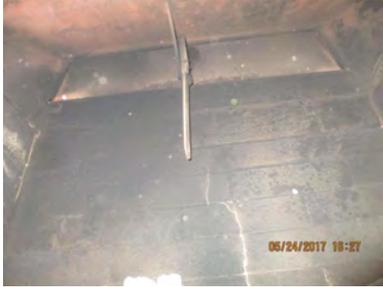
A C-clamp should be installed on the fireplace damper to prevent full closure. This is a safety measure designed to insure that carbon monoxide does not spill out into the room in the event that you forget to open the damper after lighting the gas log.

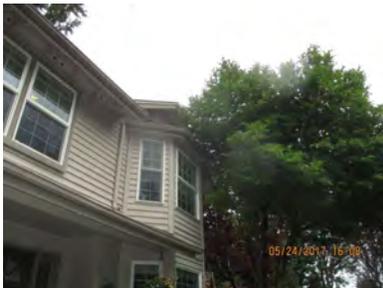
Trees are touching the building on the south side. Low hanging tree branches can damage the roof. Tree branches should be trimmed back where necessary.

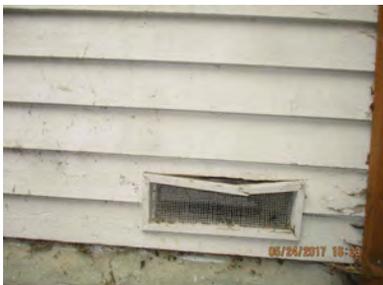
**3.2 PEST CONTROL**

There is a damaged rodent screened crawl space vent on the east side of the house. The vent and screen should be repaired to prevent insect, bird and/or rodent entry.

3:2 Replace or repair rodent screen on east side of house

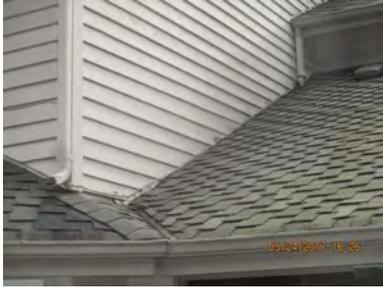
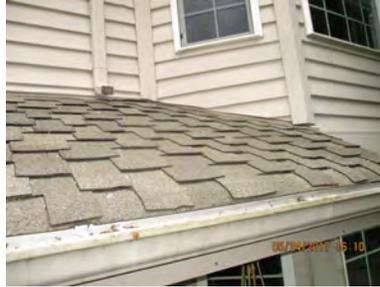
Downspouts draining directly onto the asphalt shingle surface causes excessive wear of the roofing material. Downspout extensions to the lower gutters should be installed to prevent excessive wear and tear of the roofing.

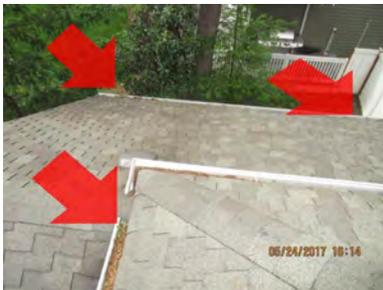
There is a build-up of organic debris inside the gutters. Proper maintenance of gutters and downspouts is essential and should be performed routinely in order to prevent clogging. Maintenance consists primarily of keeping leaves and other organic debris out of the system. Failure to clean the gutters will result in water splash on the building when they overflow. Gutters can be damaged under the weight of the water and organic matter inside the gutter. Gutters should be cleaned as necessary to maintain a free flow of water into the downspouts.

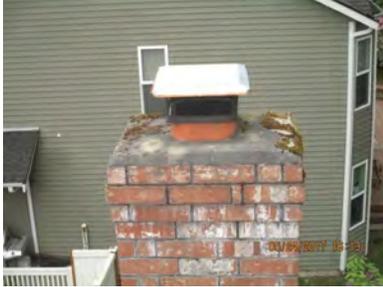
### 4.4 CHIMNEYS

The chimney crown is cracked and deteriorated. The mortar chimney crown prevents water from entering and damaging the masonry. Repairing or replacing the chimney crown will extend the service life of the chimney.

Moss/vegetation was observed in several areas around the upper portion of the chimney. This will lead to accelerated deterioration of the brick masonry mortar. We recommend removal of all organic growth. Damaged areas can be repaired by filling in cutout or defective mortar joints with fresh mortar. (Tuck pointing)

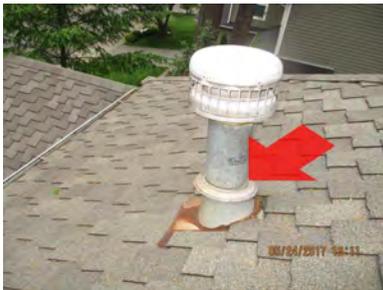
#### **4.5 GAS APPLIANCE VENTS**

The storm collar is not sealed. This is allowing leakage to occur. Sealing the storm collar is recommended.

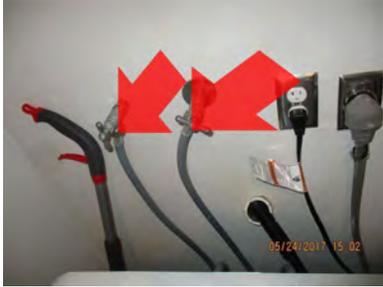
Upgrading the washer connections to high pressure (steel braided) lines is recommended.

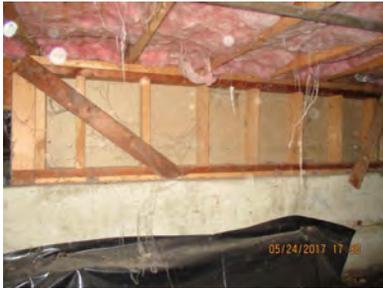
### 18.6 SHEAR PANELS

Shear panels are plywood or OSB panels that are mechanically fastened to both vertical and horizontal framing members in critical structural areas of the building. They prevent lateral movement of the structure during an earthquake. Shear panels are often visible in the crawlspace on cripple walls between the first floor and foundation. They may also be installed on interior walls that are covered with drywall. An examination of the crawlspace revealed the absence of shear panels on the cripple walls. The installation of shear panels on the cripple walls is recommended as an upgrade.

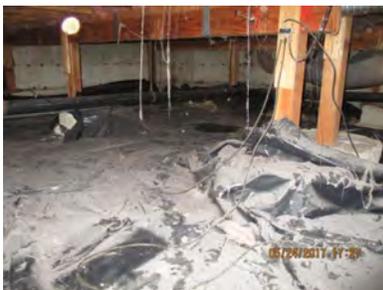
### 19.4 VAPOR RETARDER

The support post concrete piers are covered with the plastic vapor retarder. This allows the transmission of water vapor from the soil up and into the floor framing. The plastic vapor retarder should be removed from the pier so that it covers the entire surface of the soil only.

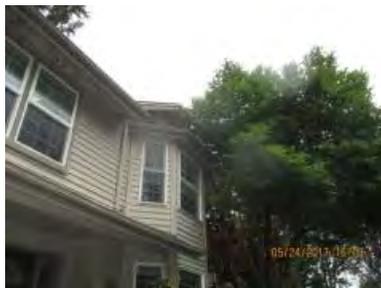
Trees are touching the building on the south side. Low hanging tree branches can damage the roof. Tree branches should be trimmed back where necessary.

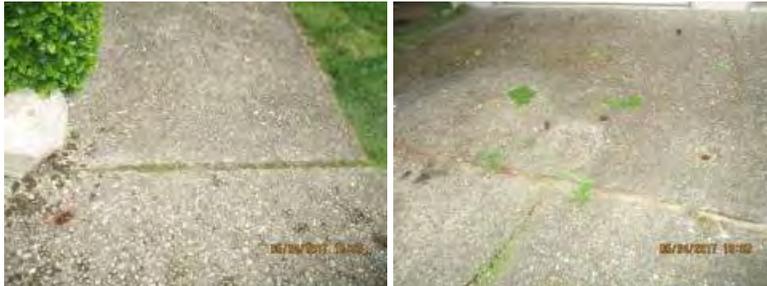
When the wooden dividers separating the concrete driveway sections have deteriorated to a point where they become a trip hazard. Replacement with mortar is recommended.

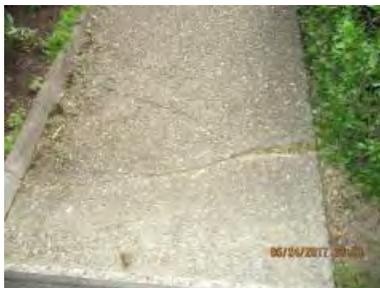
Many legal and public works departments have defined a trip hazard as an irregularity in a walking surface exceeding one inch (1") in height. All walking surfaces should maintain, free of a vertical surface change of 3/4" or more, in the interest of public and personal safety.

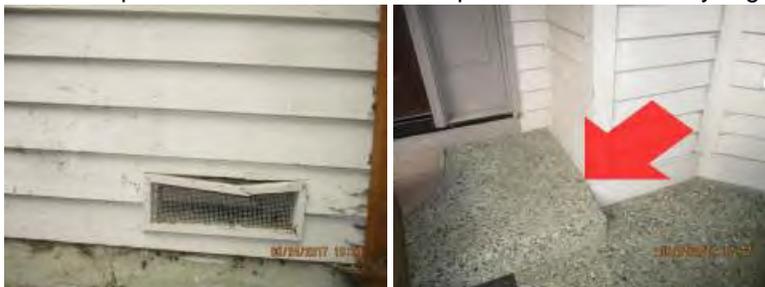
Untreated wood in direct contact with concrete was observed along the front porch stoop. Untreated wood should be raised 1-2" above the concrete. Treating the wood with a preservative sometimes will prevent wood destroy organism damage.

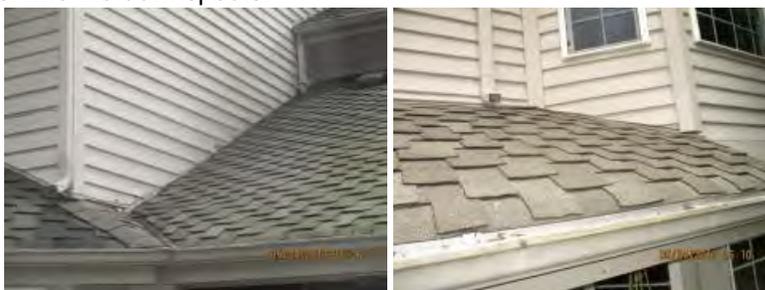
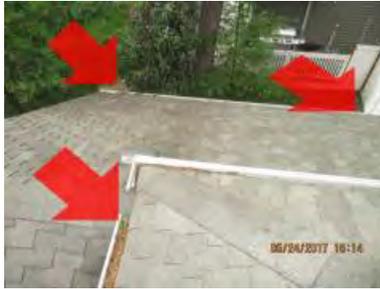
There is a build-up of organic debris inside the gutters. Proper maintenance of gutters and downspouts is essential and should be performed routinely in order to prevent clogging. Maintenance consists primarily of keeping leaves and other organic debris out of the system. Failure to clean the gutters will result in water splash on the building when they overflow. Gutters can be damaged under the weight of the water and organic matter inside the gutter. Gutters should be cleaned as necessary to maintain a free flow of water into the downspouts.

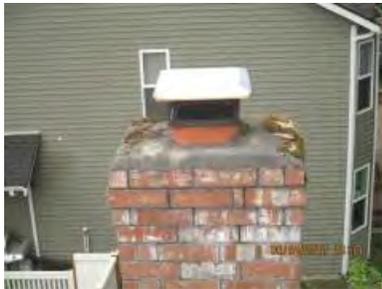
Moss/vegetation was observed in several areas around the upper portion of the chimney. This will lead to accelerated deterioration of the brick masonry mortar. We recommend removal of all organic growth. Damaged areas can be repaired by filling in cutout or defective mortar joints with fresh mortar. (Tuck pointing)

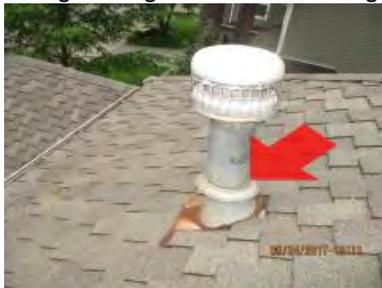
#### 4.5 GAS APPLIANCE VENTS

The storm collar is not sealed. This is allowing leakage to occur. Sealing the storm collar is recommended.

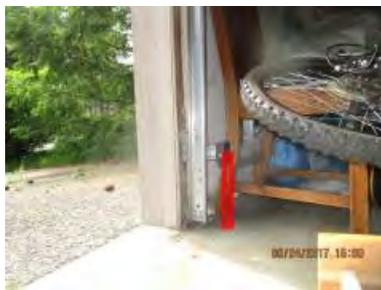
There was no photo-eye sensor installed for the garage door to offer protection for small children and/or pets. When an opener is in use we recommend that a photo-eye sensor be installed for the garage door at a height of within 4-6" of the floor.

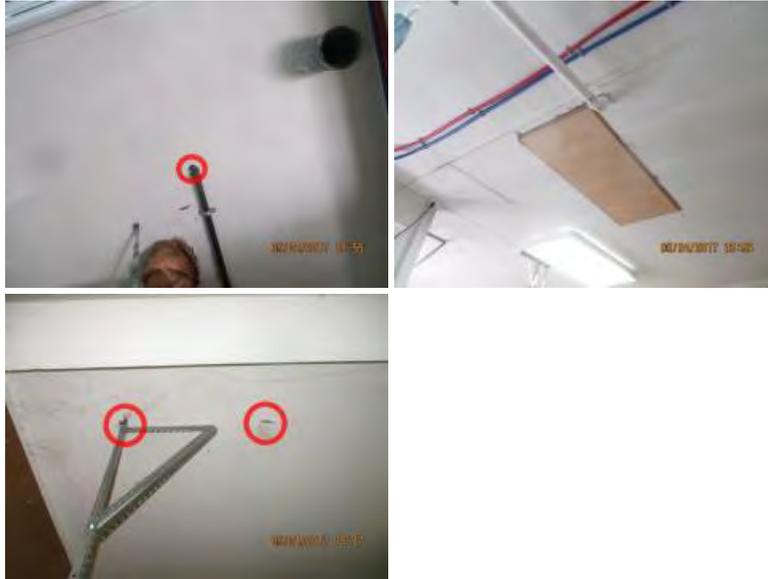
The pull down ladder is a breach in the fire resistive barrier in the garage. This is a safety concern. The gypsum barrier on the ceiling slows the spread of a fire from the garage to the attic. The installation of a layer of 5/8" gypsum type X board over the 1/4" plywood is recommended.

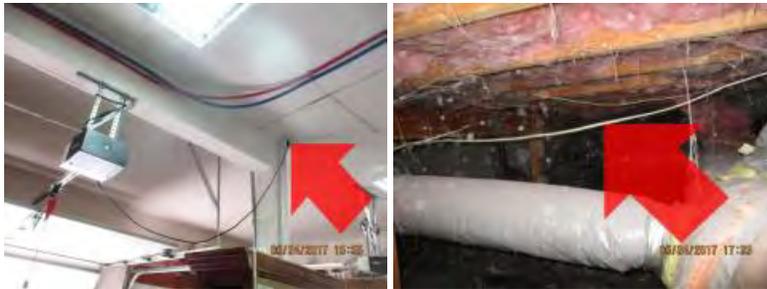
A loose electrical cable was observed in the crawlspace. Loose cables are vulnerable to damage. All loose cables should be secured at 4' intervals using approved cable staples.

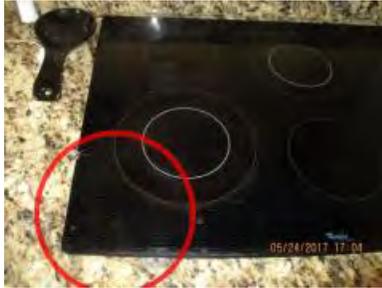
The built-in cooktop glass is broken. Replacement of the cooktop should be recommended.

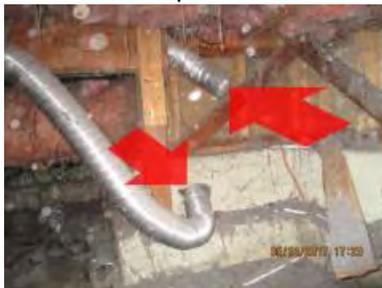
### 12.4 DRYER VENT

The dryer vent duct has become disconnected and is now discharging moisture and lint in the crawlspace. The duct should be reconnected and secured to avoid lint and moisture problems in this area.

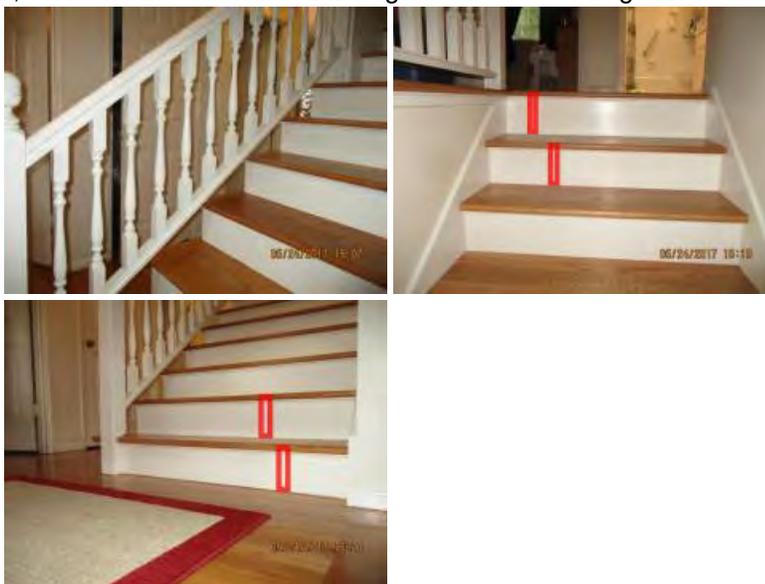
The stairs are non-conforming due to the variable and/or excessive rise. Stair design standards require that stair risers do not exceed 8" and that the variation in rise not exceed 3/8" in order to reduce falls from tripping. To increase the margin of safety, consideration should be given to reconfiguring the stairs so that rise and run do not vary by more than 3/8". If this proves to be too impractical or expensive, then we recommend exercising caution when using these stairs.

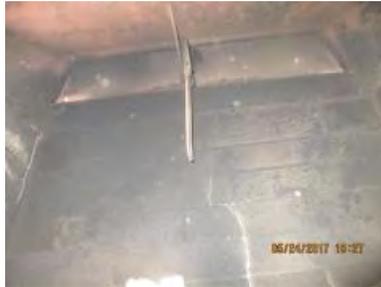
A C-clamp should be installed on the fireplace damper to prevent full closure. This is a safety measure designed to insure that carbon monoxide does not spill out into the room in the event that you forget to open the damper after lighting the gas log.

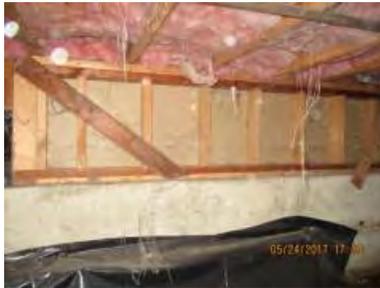
Shear panels are plywood or OSB panels that are mechanically fastened to both vertical and horizontal framing members in critical structural areas of the building. They prevent lateral movement of the structure during an earthquake. Shear panels are often visible in the crawlspace on cripple walls between the first floor and foundation. They may also be installed on interior walls that are covered with drywall. An examination of the crawlspace revealed the absence of shear panels on the cripple walls. The installation of shear panels on the cripple walls is recommended as an upgrade.

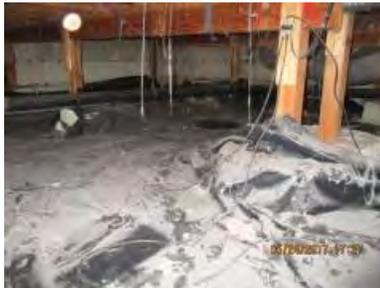
The support post concrete piers are covered with the plastic vapor retarder. This allows the transmission of water vapor from the soil up and into the floor framing. The plastic vapor retarder should be removed from the pier so that it covers the entire surface of the soil only.
