**NOTICE TO BUYER: SELLER-PROCURED INSPECTION REPORT**

17626 NE 129th Place Redmond, WA 98052

April 28, 2017

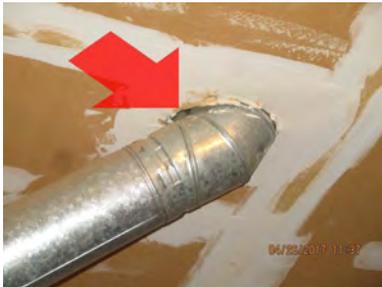
3. There are voids in the fire resistive barrier between the living space and garage that will allow flames to penetrate. The gypsum barrier slows the spread of a fire from the garage to the structure and/or living space. Patching the voids is recommended.

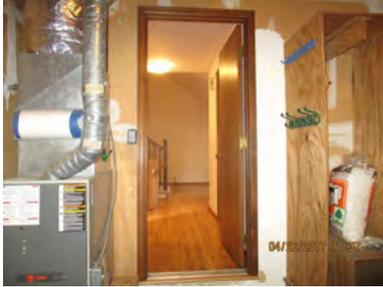
#### *6.5 PASSAGE DOOR*

4. The self closing hinge has been disabled and therefore the door is no longer part of the fire rated assembly between the living space and garage. Resetting the self closing hinge spring is recommended.

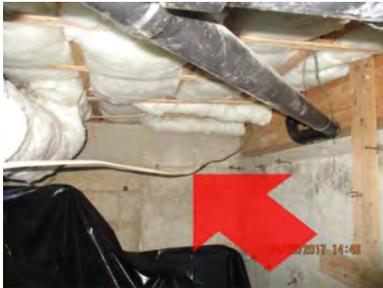
### 7.10 WIRING

5. A loose electrical cable was observed in the crawlspace. Loose cables are vulnerable to damage. All loose cables should be secured at 4' intervals using approved cable staples.

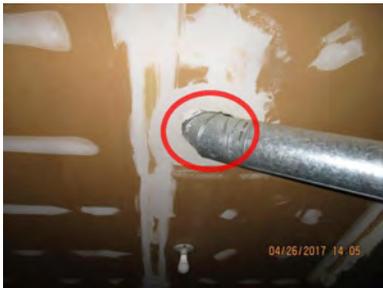
#### 8.10 VENT

7. The furnace vent connector is too close to a combustible material. This is a hazard. A minimum clearance of 6" is required between the single wall vent connector and the combustible material. The double wall type B vent requires only 1" of clearance. Repairs are recommended.

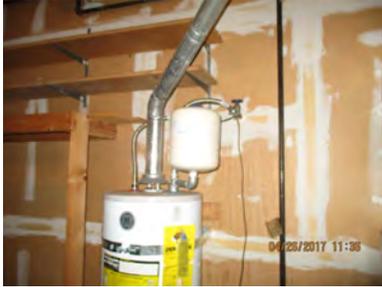
### 9.6 EXPANSION TANK

8. The expansion tank is not adequately secured to the wall. This could result in damage to the water pipe and leakage during an earth quake. A seismic restraint should be installed to secure the expansion tank.

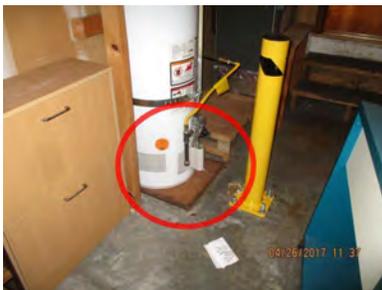
**9.13 ELEVATION ABOVE GARAGE FLOOR**

9. The water heater is not elevated above the garage floor in accordance with industry standards. This is a hazard. Elevating the water heater so that the burner is at least 18" above the garage floor prevents ignition of gasoline fumes.

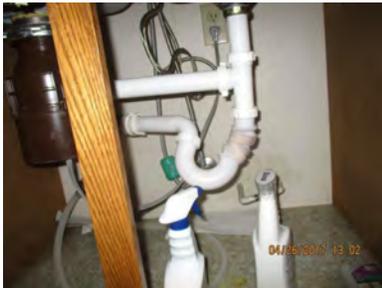
**10.7 DRAINS, TRAPS AND TRAP ARMS**

10. Improper, non-conforming material has been used for the drain pipe fitting. This material will not function reliably. Replacement with industry standard fittings is recommended.

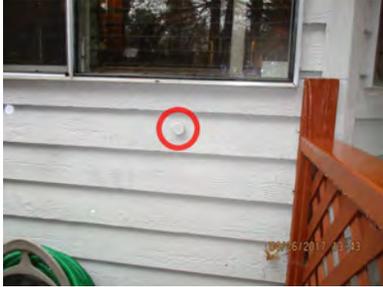
**10.8 AIR GAP**

11. An air gap called a Johnson Tee is installed in the kitchen wall. This air gap protects the dishwasher from contamination caused by a backflow of waste water. The cap protruding on the exterior wall opposite the dishwasher is not drilled. This renders the air gap non-functional. Drilling a 1/4" hole in the end of the cap will restore its function. The remaining visible portions of the Johnson Tee were properly installed and functioning as intended.

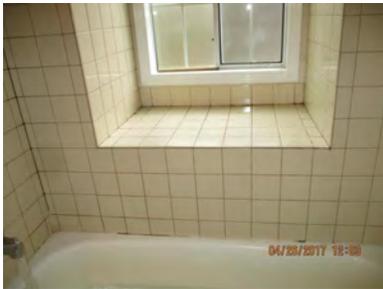
12. Grout is missing from between some of the wall tiles. This can allow water to enter through the tile and can damage the walls. Regrouting the wall tile is recommended.

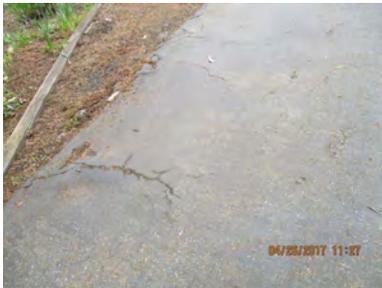
1. There is minor tree root damage visible in the asphalt driveway. The damage is not affecting the function of the driveway. Seal coating the surface of the asphalt is recommended to maximize the service life of the paving. Asphalt sealers are available at most home improvement stores.

Portions of the asphalt driveway and parking areas have settled. The gaps are not adversely affecting the function of the driveway, therefore patching or resurfacing is optional.

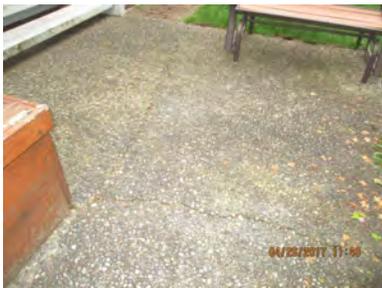
**2.5 WALKWAY**

3. Cracks were observed in the concrete surface of the walkway. Minor cracks can be sealed to minimize moisture entry and further settlement of the concrete.

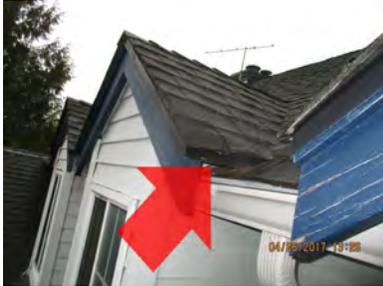
4. There are openings at the intersection between the overhang and the roof through which birds and rodents can enter into the attic. These openings should be covered with wood, wire mesh or filled with aerosol foam.

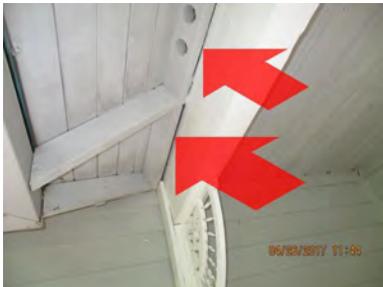
5. There are large gaps over 1/4" in size adjacent the soffit vent blocks. These gaps allow insects and rodents to enter the attic. Covering the gaps with screening, a strip of wood and/or caulking is recommended.

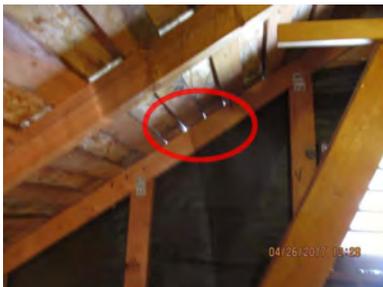
6. There are openings adjacent the ends of the outlook boards under the overhang through which insects and rodents can enter into the attic. These openings should be covered with wood, wire mesh or filled with aerosol foam. Viewed from within the attic.

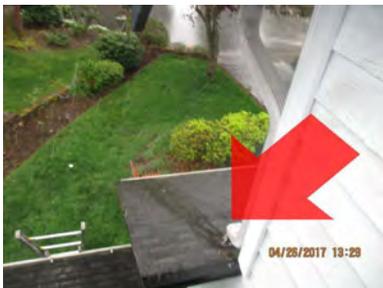
### 3.4 GUTTERS AND DOWNSPOUTS

7. Downspouts draining directly onto the asphalt shingle surface causes excessive wear of the roofing material. Downspout extensions to the lower gutters should be installed to prevent excessive wear and tear of the roofing.

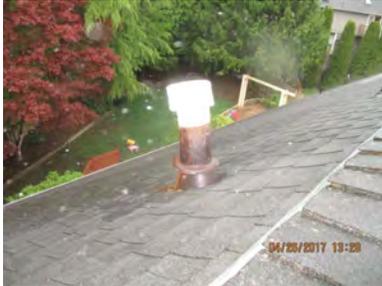
### 4.4 GAS APPLIANCE VENTS

8. The gas appliance vent is corroded above the roof line. Cleaning and painting the vent will prolong its service life.

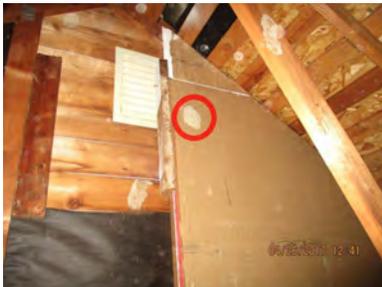
10. There is a yellow jacket (mud wasp) nest in the attic. Yellow jackets are very aggressive in late summer and their sting is painful. Yellow jacket activity can be avoided by sealing all openings into the attic, particularly above the gable end walls and below vent blocks.

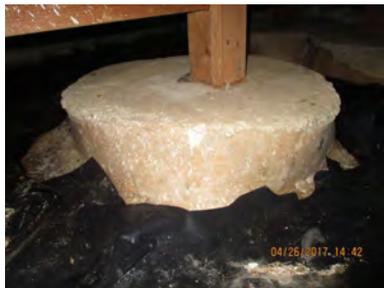
19. There is evidence of rodent activity in the crawlspace. The first step in eliminating rodents from the crawlspace is to seal all possible entry points using wire mesh, caulking, wood, stainless steel wool, aerosol foam or mortar. Careful work sealing cracks, holes, gaps, and covering ground water drain inlets will discourage rodent activity. Once this work is completed, snap traps baited with peanut butter should be installed and monitored. The absence of rodents in the traps typically means that the rodents have been excluded from the area.

Cellulose forms were left in place on the pier footings. This cellulose is conducive to the infestation of various wood destroying organisms. The removal of the cellulose is recommended.

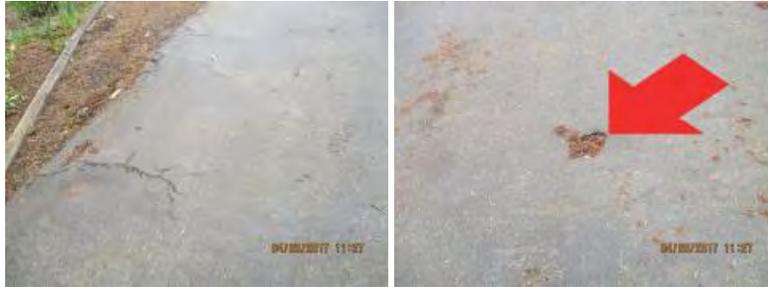
Portions of the asphalt driveway and parking areas have settled. The gaps are not adversely affecting the function of the driveway, therefore patching or resurfacing is optional.

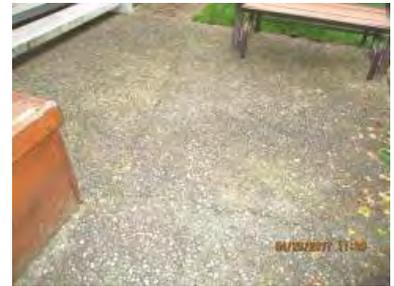
## 2.5 WALKWAY

Cracks were observed in the concrete surface of the walkway. Minor cracks can be sealed to minimize moisture entry and further settlement of the concrete.

Many legal and public works departments have defined a trip hazard as an irregularity in a walking surface exceeding one inch (1") in height. All walking surfaces should maintain, free of a vertical surface change of 3/4" or more, in the interest of public and personal safety.

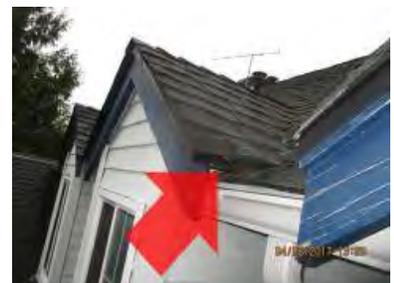
There are openings at the intersection between the overhang and the roof through which birds and rodents can enter into the attic. These openings should be covered with wood, wire mesh or filled with aerosol foam.

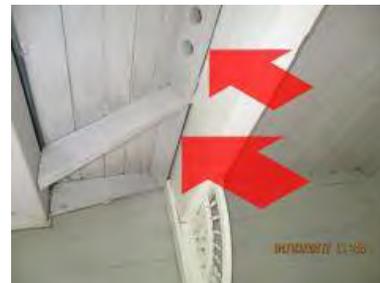
There are large gaps over 1/4" in size adjacent the soffit vent blocks. These gaps allow insects and rodents to enter the attic. Covering the gaps with screening, a strip of wood and/or caulking is recommended.

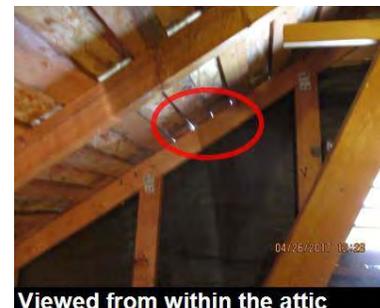
There are openings adjacent the ends of the outlook boards under the overhang through which insects and rodents can enter into the attic. These openings should be covered with wood, wire mesh or filled with aerosol foam.

Viewed from within the attic

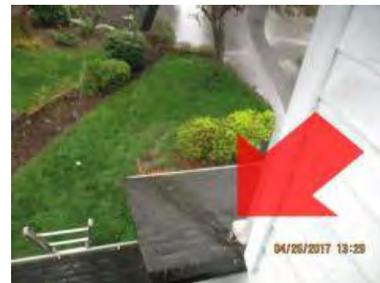
Downspouts draining directly onto the asphalt shingle surface causes excessive wear of the roofing material. Downspout extensions to the lower gutters should be installed to prevent excessive wear and tear of the roofing.

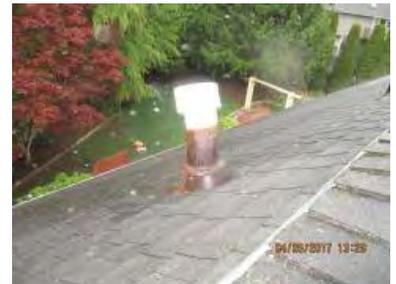
The gas appliance vent is corroded above the roof line. Cleaning and painting the vent will prolong its service life.

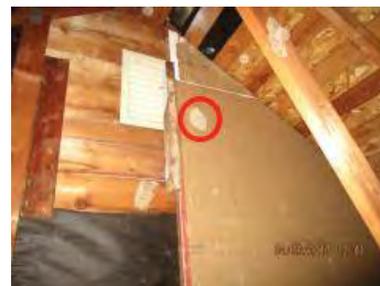
There is a yellow jacket (mud wasp) nest in the attic. Yellow jackets are very aggressive in late summer and their sting is painful. Yellow jacket activity can be avoided by sealing all openings into the attic, particularly above the gable end walls and below vent blocks.

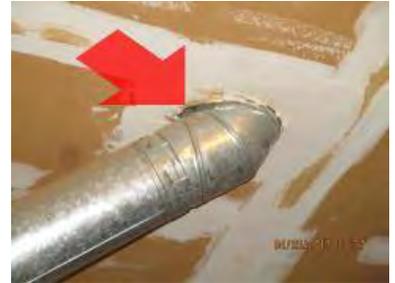
There are voids in the fire resistive barrier between the living space and garage that will allow flames to penetrate. The gypsum barrier slows the spread of a fire from the garage to the structure and/or living space. Patching the voids is recommended.

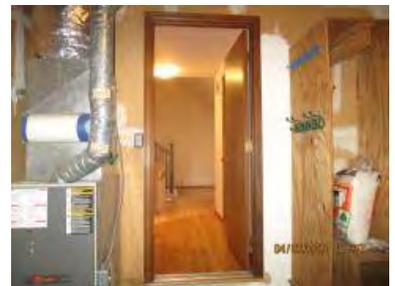
### 6.5 PASSAGE DOOR

The self closing hinge has been disabled and therefore the door is no longer part of the fire rated assembly between the living space and garage. Resetting the self closing hinge spring is recommended.

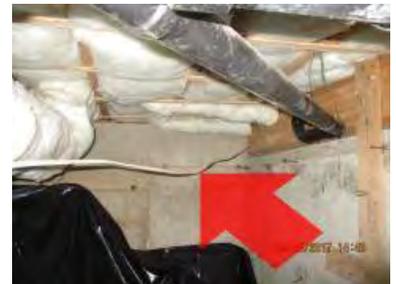
A loose electrical cable was observed in the crawlspace. Loose cables are vulnerable to damage. All loose cables should be secured at 4' intervals using approved cable staples.

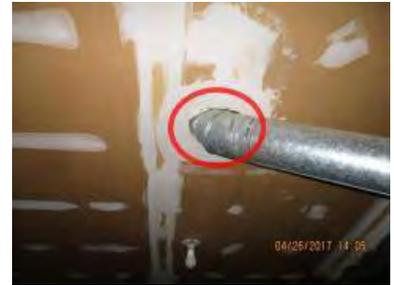
The furnace vent connector is too close to a combustible material. This is a hazard. A minimum clearance of 6" is required between the single wall vent connector and the combustible material. The double wall type B vent requires only 1" of clearance. Repairs are recommended.

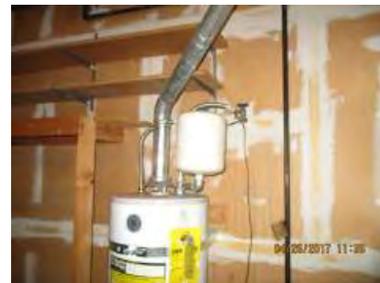
The expansion tank is not adequately secured to the wall. This could result in damage to the water pipe and leakage during an earth quake. A seismic restraint should be installed to secure the expansion tank.

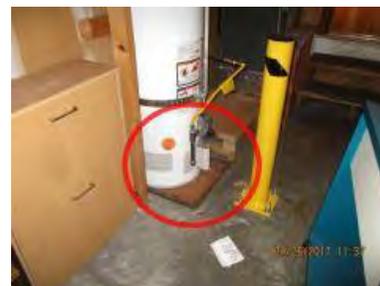
The water heater is not elevated above the garage floor in accordance with industry standards. This is a hazard. Elevating the water heater so that the burner is at least 18" above the garage floor prevents ignition of gasoline fumes.

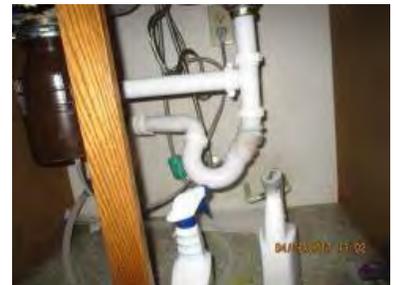
Improper, non-conforming material has been used for the drain pipe fitting. This material will not function reliably. Replacement with industry standard fittings is recommended.

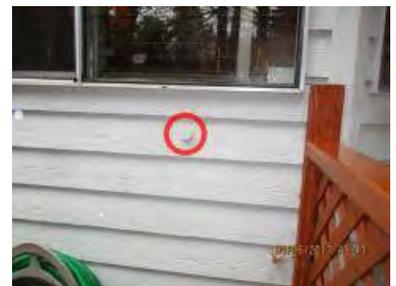
### 10.8 AIR GAP

An air gap called a Johnson Tee is installed in the kitchen wall. This air gap protects the dishwasher from contamination caused by a backflow of waste water. The cap protruding on the exterior wall opposite the dishwasher is not drilled. This renders the air gap non-functional. Drilling a 1/4" hole in the end of the cap will restore its function. The remaining visible portions of the Johnson Tee were properly installed and functioning as intended.

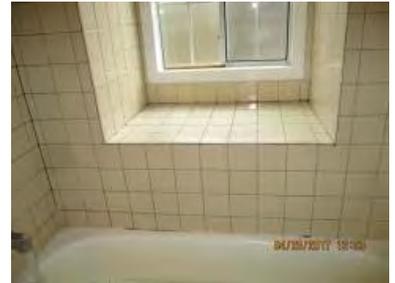
Most ceramic tile is applied directly over gypsum board rather than on a concrete board such as "Durock" or "Wonder Board". Where the tile is applied directly over the gypsum board, it is critical that the tile grout be maintained to prevent water intrusion behind the tile. Missing or cracked grout should be repaired. Inside corners, and penetrations in the tile should be kept sealed with a high quality caulk.

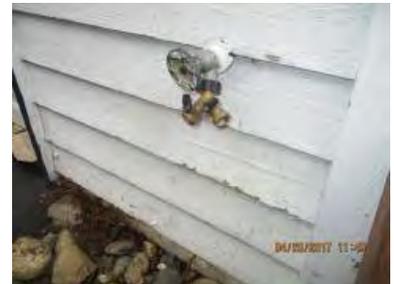
The hose bibb on the front of the house is dripping. This is indicative of a worn valve. Replacement of the hose bibb is recommended. The other hose bibb was functional.

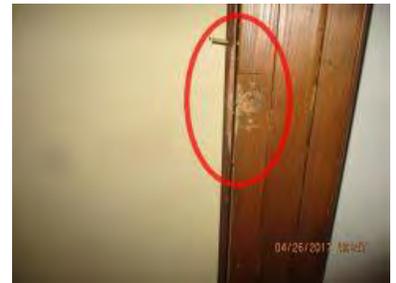
Some of the doors are missing their door stops. This condition will lead to damage of the wall surfaces. Door stops should be installed where necessary.

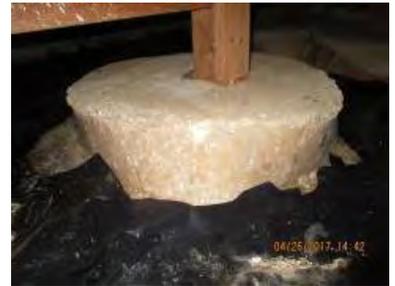
Good building practice requires that foundation walls or pier footings supporting wood frame construction, should extend at least 8" above the finish grade with at least a 6" clearance between the top of the soil and the bottom of the wood finish materials. Untreated wood should be raised 1-2" above surrounding flatwork and should have a moisture barrier such as 30 lb. asphalt impregnated felt installed between the concrete and wood. For additional information and treatment options, you should retain the services of a qualified pest control operator.
