NOTICE TO BUYER: SELLER-PROCURED INSPECTION REPORT

17630 NE 128th Pl, Redmond WA 98052

April 20, 2017

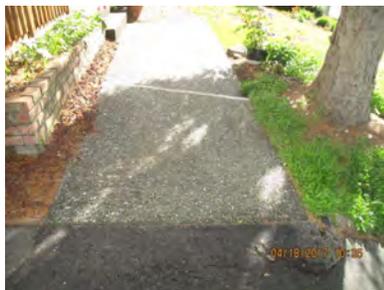
1. The walkway has cracked and settled differentially. This was probably caused by inadequate preparation of the soil prior to the placement of the concrete. This condition can be repaired by pressure grouting the sunken portion of the walkway or by removing and replacing it. The walkway remains functional despite this condition. However, the raised edges of the concrete can be a trip hazard for some people. Grinding down the raised edges of the concrete will mitigate the hazard. Repairs should be made as necessary.

The gap separating the asphalt and concrete walkway sections is a trip hazard. Replacement with mortar is recommended.

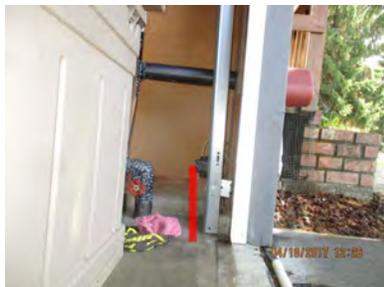
6.3 GARAGE DOOR OPENER

2. The Photo-eye beam was installed to high above the floor of the garage to adequately offer protection for small children and/or pets. We recommend that the photo-eye be lowered to within 4-6" of the floor.

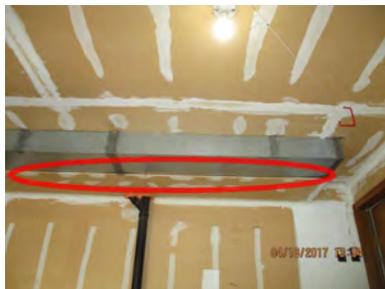
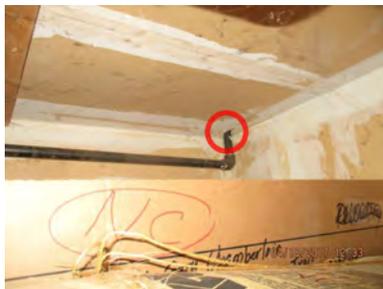
6.4 FIRE SEPARATION

3. There are voids in the fire resistive barrier between the living space and garage that will allow flames to penetrate. The gypsum barrier slows the spread of a fire from the garage to the structure and/or living space. Patching the voids is recommended.

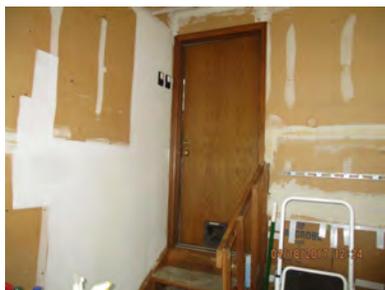
6.5 PASSAGE DOOR

5. The self closing hinge has been disabled and therefore the door is no longer part of the fire rated assembly between the living space and garage. Resetting the self closing hinge spring is recommended.

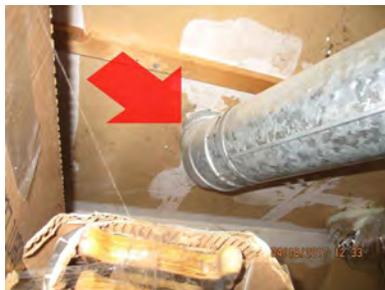
8. The furnace vent connector is too close to a combustible material. This is a hazard. A minimum clearance of 6" is required between the single wall vent connector and the combustible material. The double wall type B vent requires only 1" of clearance. Repairs are recommended.

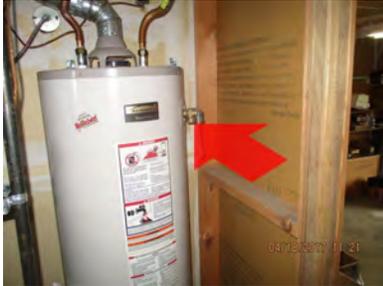
9.3 PRESSURE RELIEF VALVE

9. The pressure relief valve lacks a drain pipe. This is a scald hazard. The installation of a 3/4" copper, CPVC plastic or galvanized steel drain pipe is recommended. Ideally, the drain should be routed to the exterior. However, running the pipe straight down to the floor eliminates the scald hazard.

A pipe was installed on the pressure relief valve on the water heater to direct any water down and into the space below the floor.

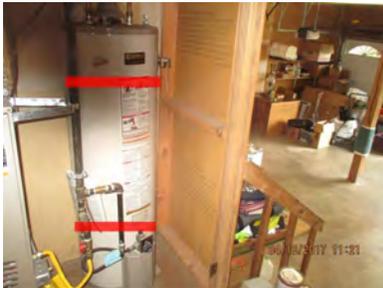
9.11 SEISMIC RESTRAINT

10. The water heater is not secured to the wall. A seismic restraint should be installed to secure the water heater and prevent it from falling over during an earthquake. This prevents the gas and water lines from rupturing.

There are 2 straps at the very top of the water heater that is secured to the wall so the handyman didn't do anything more.

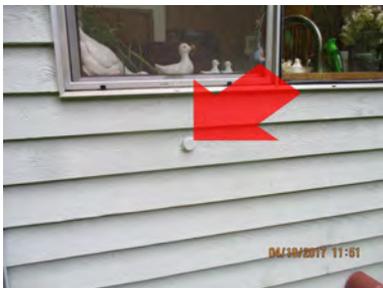
12. An air gap called a Johnson Tee is installed in the kitchen wall. This air gap protects the dishwasher from contamination caused by a backflow of waste water. The cap protruding on the exterior wall opposite the dishwasher is not drilled. This renders the air gap non-functional. Drilling a 1/4" hole in the end of the cap will restore its function. The remaining visible portions of the Johnson Tee were properly installed and functioning as intended.

The 1/4" hole was drilled in the end cap for the dishwasher (air gap).

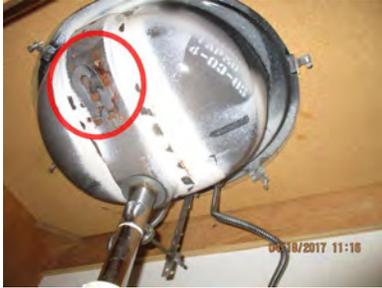
13. The sink is rusted and leaking at the overflow drain. Replacement of the sink is recommended.

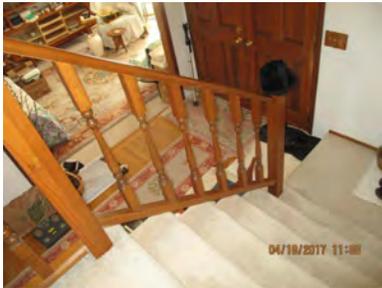
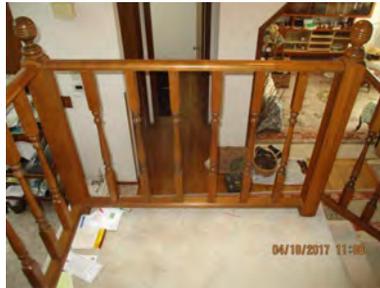
14.3 STAIRS

14. The stair railing baluster spacing is too wide. This is a hazard for small children. The baluster spacing should be reduced as a safety upgrade. Current standards require that a 4" sphere not pass through the railing.

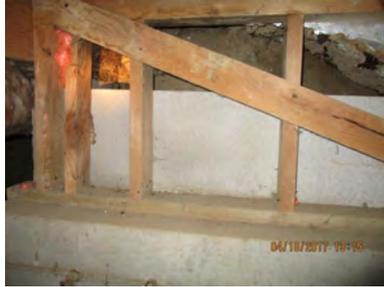
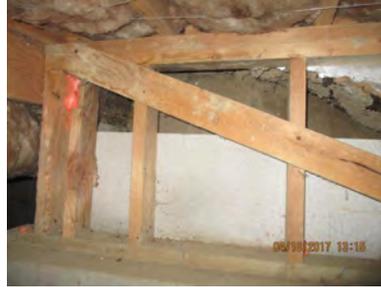
17. Rot damage was observed in some of the floor framing. Rot damaged wood should be repaired as

necessary. The conditions that caused the rot damage should be eliminated.

Wood rot commonly referred to as "Dry Rot" occurs when untreated wood is allowed to retain moisture for extended periods of time. Wood rot is caused by fungi which grow in the cell structure and spread like a root system through the wood. Fungi can also develop from spores which are present in the soil and are transferred through the air. Rotted wood creates an environment that is conducive to various types of wood boring insects (e.g. carpenter ants, moisture ants, dampwood termites, etc.) Wood rot can be prevented by keeping the wood dry, or if this is not possible, such as in the case of outdoor wood, by using pressure treated wood, by treating exposed wood with semi-transparent stain and/or wood preservative, and by keeping untreated wood out of and 6" above the soil.

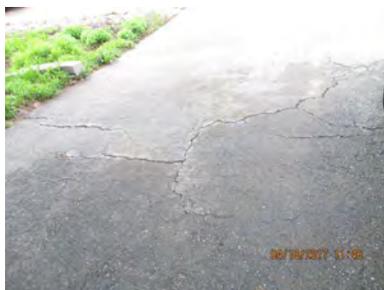
1. Cracks were also observed in the asphalt surface of the driveway. Cracks can be sealed to minimize moisture entry and further settlement of the asphalt.

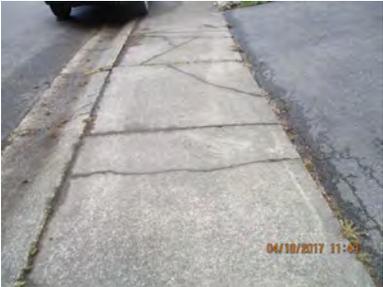
2.5 WALKWAY

2. Cracks were observed in the concrete surface of the concrete walkway. Minor cracks can be sealed to minimize moisture entry and further settlement of the concrete.

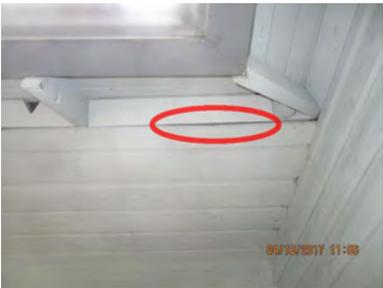
3.3 SOFFITS AND OVERHANGS

3. There are large gaps over 1/4" in size adjacent the soffit vent blocks. These gaps allow insects and rodents to enter the attic. Covering the gaps with screening, a strip of wood and/or caulking is recommended.

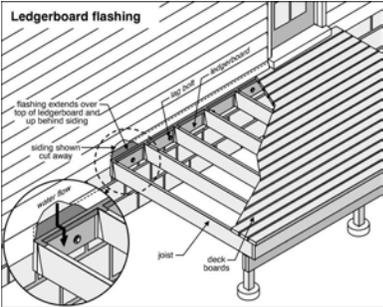
5. There is no flashing at the intersection between the deck and house. This will allow water to enter behind the siding. The installation of flashing in this area is recommended.

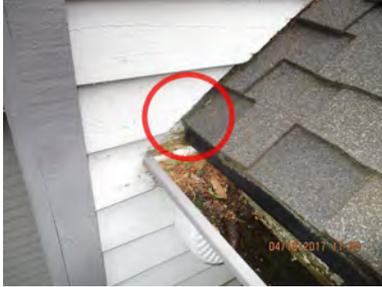
4.7 FLASHINGS

6. There is no kick out flashing at the roof edge to wall intersection above the gutter. This will allow water to enter the wall behind the siding. The installation of a kick-out flashing is recommended.

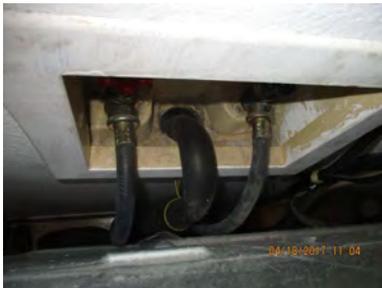
10. Upgrading the washer connections to high pressure (steel braided) lines is recommended.

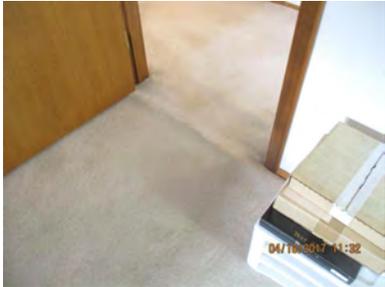
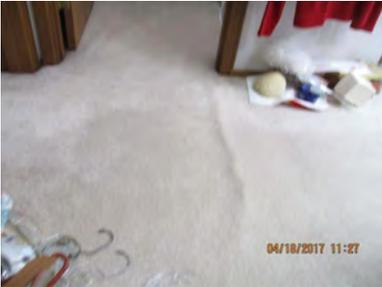
14.2 FLOORS

11. The carpeting is loose and buckling. Re-stretching the carpet is recommended to avoid trip hazards.

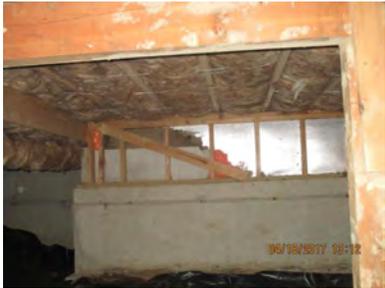
13. Shear panels are plywood or OSB panels that are mechanically fastened to both vertical and horizontal framing members in critical structural areas of the building. They prevent lateral movement of the structure during an earthquake. Shear panels are often visible in the crawlspace on cripple walls between the first floor and foundation. They may also be installed on interior walls that are covered with drywall. An examination of the crawlspace revealed the absence of shear panels on the cripple walls. The installation of shear panels on the cripple walls is recommended as an upgrade.

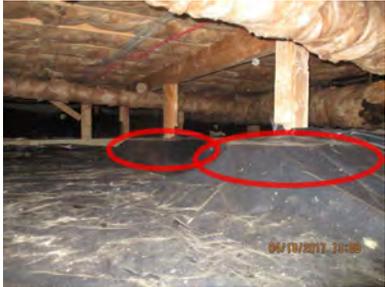
19.4 VAPOR RETARDER

14. The support post concrete piers are covered with the plastic vapor retarder. This allows the transmission of water vapor from the soil up and into the floor framing. The plastic vapor retarder should be removed from the pier so that it covers the entire surface of the soil only.

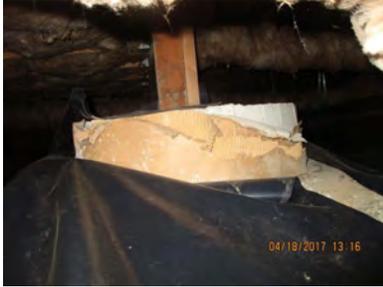
19.5 PEST CONTROL

15. Scrap-wood and other cellulose debris was observed on the crawl floor. This wood debris creates conducive conditions for wood boring insects. The removal of all cellulose debris is recommended.

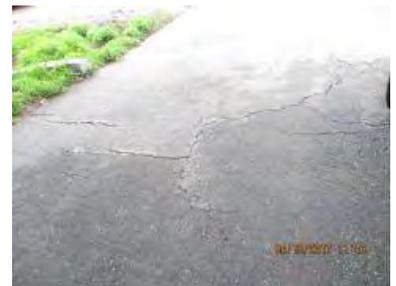
Cracks were also observed in the asphalt surface of the driveway. Cracks can be sealed to minimize moisture entry and further settlement of the asphalt.

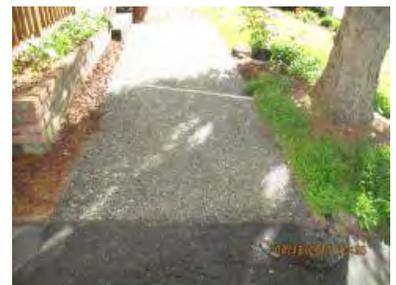
The gap separating the asphalt and concrete walkway sections are a trip hazard.

Replacement with mortar is recommended.

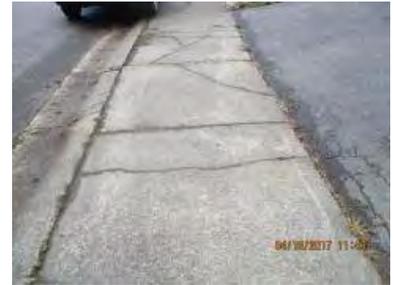
Cracks were observed in the concrete surface of the concrete walkway. Minor cracks can be sealed to minimize moisture entry and further settlement of the concrete.

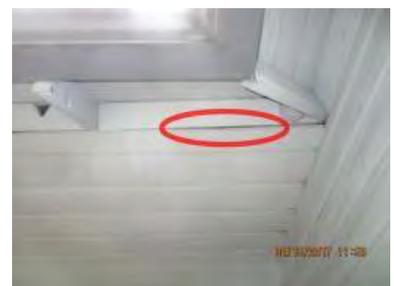
There are large gaps over 1/4" in size adjacent the soffit vent blocks. These gaps allow insects and rodents to enter the attic. Covering the gaps with screening, a strip of wood and/or caulking is recommended.

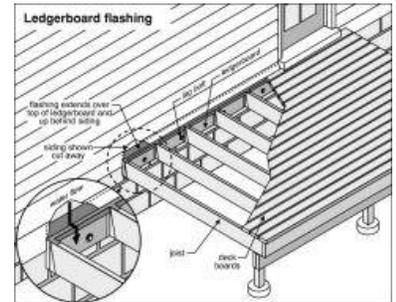
There is no flashing at the intersection between the deck and house. This will allow water to enter behind the siding. The installation of flashing in this area is recommended.

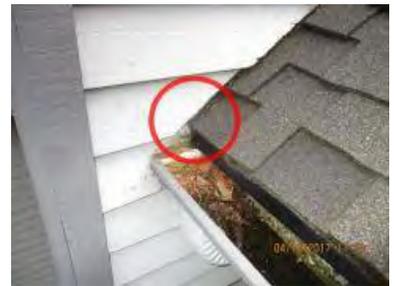
There is no kick out flashing at the roof edge to wall intersection above the gutter. This will allow water to enter the wall behind the siding. The installation of a kick-out flashing is recommended.

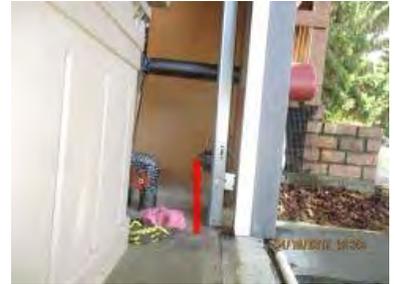
The Photo-eye beam was installed to high above the floor of the garage to adequately offer protection for small children and/or pets. We recommend that the photo-eye be lowered to within 4-6" of the floor.

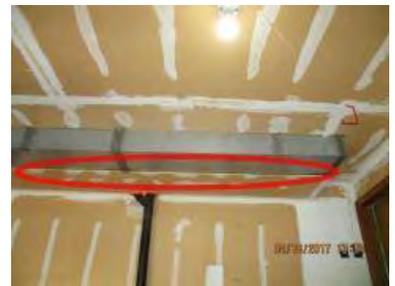
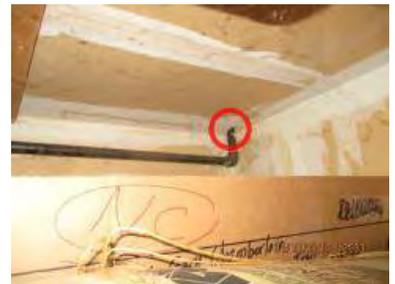
6.4 FIRE SEPARATION

There are voids in the fire resistive barrier between the living space and garage that will allow flames to penetrate. The gypsum barrier slows the spread of a fire from the garage to the structure and/or living space. Patching the voids is recommended.

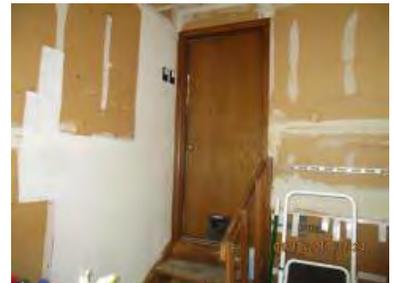
6.5 PASSAGE DOOR

The self closing hinge has been disabled and therefore the door is no longer part of the fire rated assembly between the living space and garage. Resetting the self closing hinge spring is recommended.

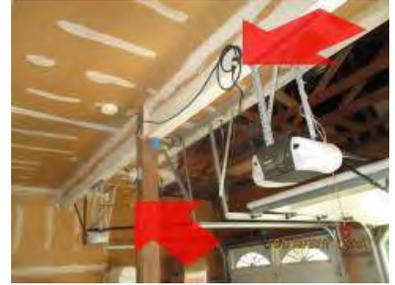
The visible portions of the wiring are properly installed except where noted below. An extension cord is used as a temporary power source for the garage door openers. An extension cord is not suitable as a permanent wiring method. The installation of a receptacle within cords length of the motors is recommended.

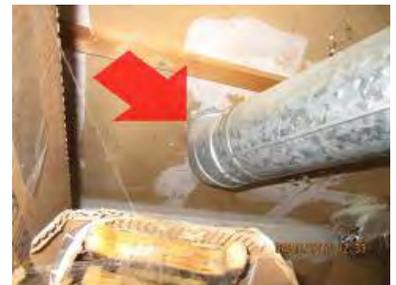
The furnace vent connector is too close to a combustible material. This is a hazard. A minimum clearance of 6" is required between the single wall vent connector and the combustible material. The double wall type B vent requires only 1" of clearance. Repairs are recommended.

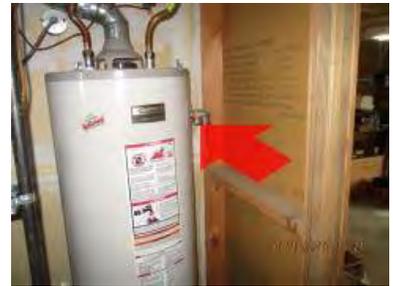
The pressure relief valve lacks a drain pipe. This is a scald hazard. The installation of a 3/4" copper, CPVC plastic or galvanized steel drain pipe is recommended. Ideally, the drain should be routed to the exterior. However, running the pipe straight down to the floor eliminates the scald hazard.

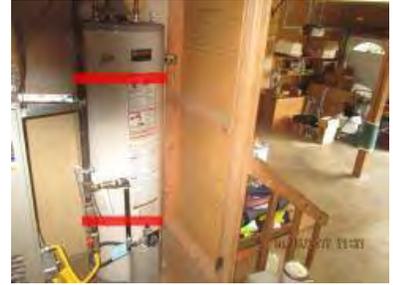
The water heater is not secured to the wall. A seismic restraint should be installed to secure the water heater and prevent it from falling over during an earthquake. This prevents the gas and water lines from rupturing.

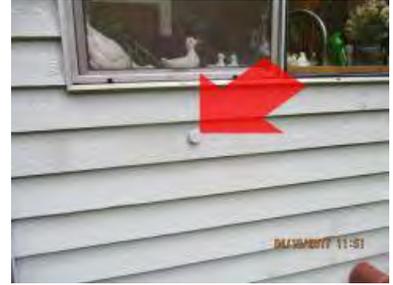
An air gap called a Johnson Tee is installed in the kitchen wall. This air gap protects the dishwasher from contamination caused by a backflow of waste water. The cap protruding on the exterior wall opposite the dishwasher is not drilled. This renders the air gap non-functional. Drilling a 1/4" hole in the end of the cap will restore its function. The remaining visible portions of the Johnson Tee were properly installed and functioning as intended.

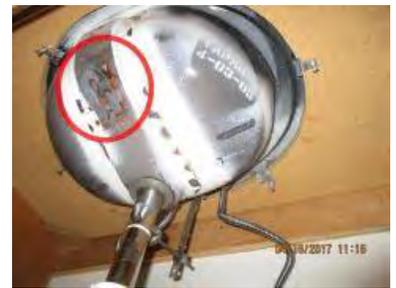
The sink is rusted and leaking at the overflow drain. Replacement of the sink is recommended.

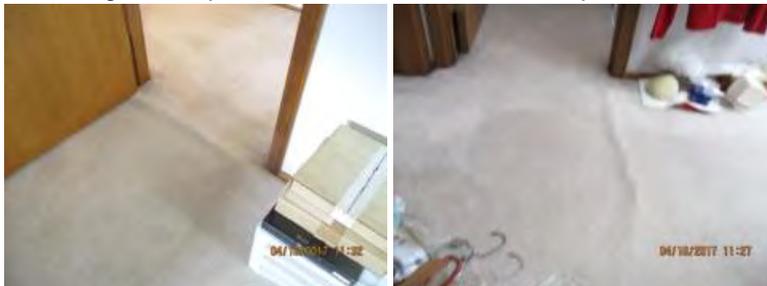
The carpeting is loose and buckling. Re-stretching the carpet is recommended to avoid trip hazards.

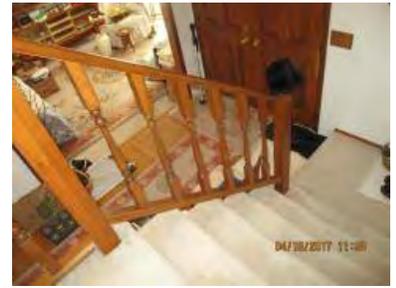
14.3 STAIRS

The stair railing baluster spacing is too wide. This is a hazard for small children. The baluster spacing should be reduced as a safety upgrade. Current standards require that a 4" sphere not pass through the railing.

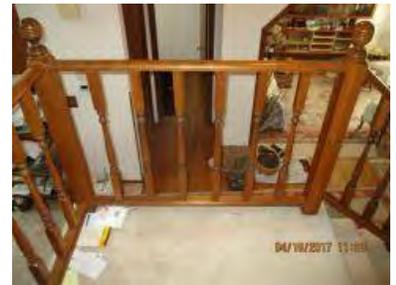
14.4 GUARD RAILINGS

The spacing between the balusters is too wide. This is a hazard to small children. The balusters should be spaced close enough together so that a 4" sphere cannot pass through. Upgrading the guard railing is recommended if small children are present.

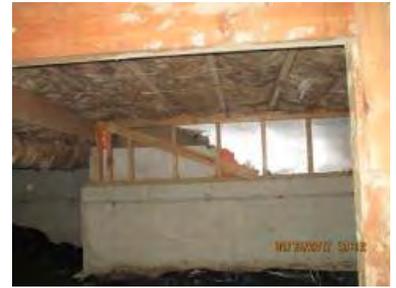
Shear panels are plywood or OSB panels that are mechanically fastened to both vertical and horizontal framing members in critical structural areas of the building. They prevent lateral movement of the structure during an earthquake. Shear panels are often visible in the crawlspace on cripple walls between the first floor and foundation. They may also be installed on interior walls that are covered with drywall. An examination of the crawlspace revealed the absence of shear panels on the cripple walls. The installation of shear panels on the cripple walls is recommended as an upgrade.

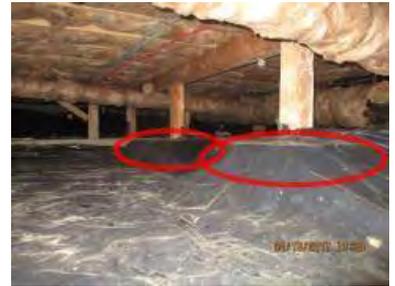
The support post concrete piers are covered with the plastic vapor retarder. This allows the transmission of water vapor from the soil up and into the floor framing. The plastic vapor retarder should be removed from the pier so that it covers the entire surface of the soil only.

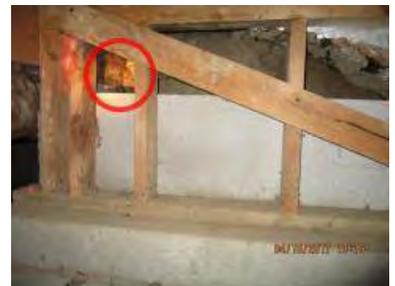
Wood rot commonly referred to as "Dry Rot" occurs when untreated wood is allowed to retain moisture for extended periods of time. Wood rot is caused by fungi which grow in the cell structure and spread like a root system through the wood. Fungi can also develop from spores which are present in the soil and are transferred through the air. Rotted wood creates an environment that is conducive to various types of wood boring insects (e.g. carpenter ants, moisture ants, dampwood termites, etc.) Wood rot can be prevented by keeping the wood dry, or if this is not possible, such as in the case of outdoor wood, by using pressure treated wood, by treating exposed wood with semi-transparent stain and/or wood preservative, and by keeping untreated wood out of and 6" above the soil.

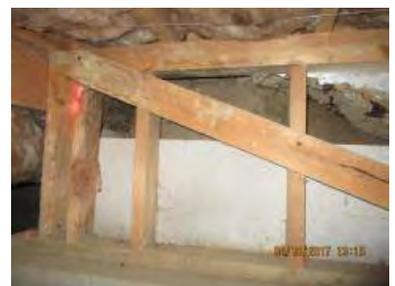
Soil is in contact with adjacent wood wall framing under the front porch. Good building practice requires that foundation walls or pier footings supporting wood frame construction, extend at least 8" above the finish grade with at least a 6" clearance between the soil and the wood finish materials. Soil in direct contact with wood creates a hospitable environment for wood destroying organisms. Establishing these minimum clearances is recommended.

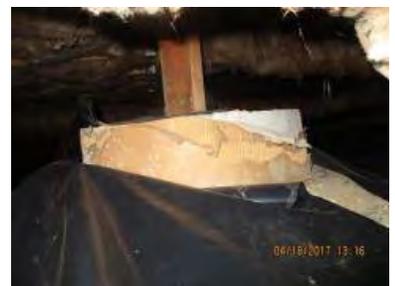
Scrap-wood and other cellulose debris was observed on the crawl floor. This wood debris creates conducive conditions for wood boring insects. The removal of all cellulose debris is recommended.

Wood boring insect activity in the Puget Sound area usually does not occur unless there is a ventilation problem inside or underneath the structure, a water leakage/rotting condition in the house or significant quantities of soil to untreated wood contact in a crawlspace or outside around the building exterior. Carpenter ant, termite and wood boring beetle activity is most often a direct result of rot damaged wood and/or excessively moist, humid or damp conditions inside, around or underneath the building. Structural damage from termites and
