NOTICE TO BUYER: SELLER-PROCURED INSPECTION REPORT

17903 NE 129th St, Redmond WA 98052

May 5, 2017

Re: 17903 NE 129th St.
Redmond, WA.

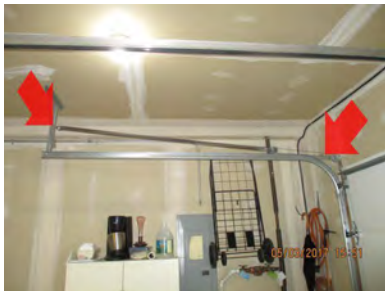
Safeties are cables run through the center of the garage door springs that prevent broken springs from becoming projectiles that can cause injury. There are no safeties installed. The installation of safeties is recommended.

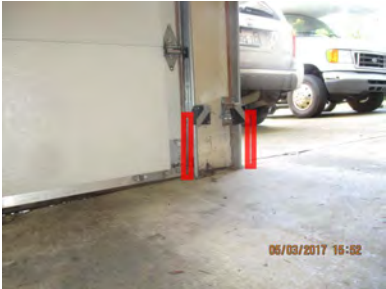
6.3 GARAGE DOOR OPENER

The Photo-eye beam was installed to high above the floor of the garage to adequately offer protection for small children and/or pets. We recommend that the photo-eye be lowered to within 4-6" of the floor.

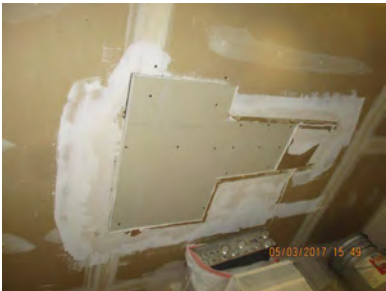
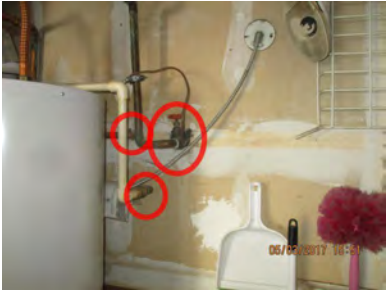
6.4 FIRE SEPARATION

3. There are voids in the fire resistive barrier between the living space and garage that will allow flames to penetrate. The gypsum barrier slows the spread of a fire from the garage to the structure and/or living space. Patching the voids is recommended.

3. corrected voids in fire resistant barrier in garage.

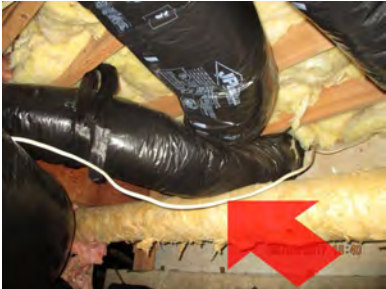
A loose electrical cable was observed in the crawlspace. Loose cables are vulnerable to damage. All loose cables should be secured at 4' intervals using approved cable staples.

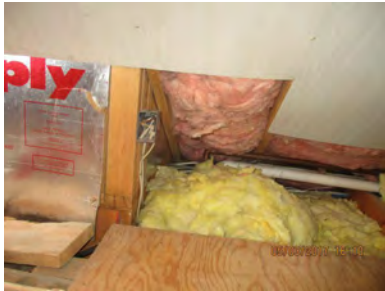
7.11 RECEPTACLES

The cover plate is missing from a receptacle in the storage attic. This is a shock and fire hazard. The installation of a cover plate is recommended.

6. *Cover plates on boxes installed*

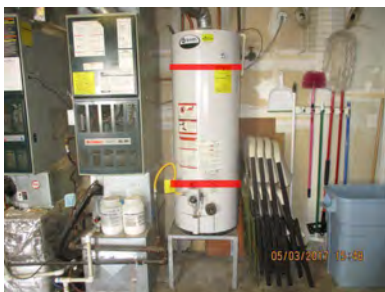
8. The water heater is not secured to the wall. A seismic restraint should be installed to secure the water heater and prevent it from falling over during an earthquake. This prevents the gas and water lines from rupturing.

Seismic Restraint installed

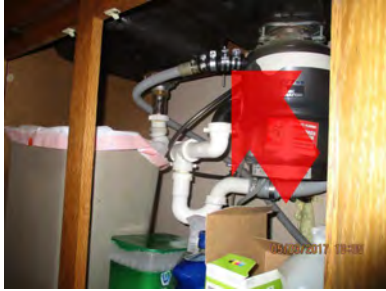
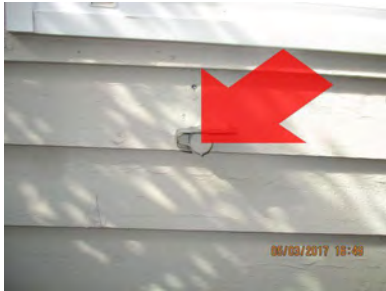
10. The dishwasher drain lacks an air gap. The dishwasher will function without one, but there is a risk of contamination of the inside of the dishwasher by waste water. The installation of an air gap is recommended

or connection to the Johnson Tee that is installed in the kitchen wall. This air gap protects the dishwasher from contamination caused by a backflow of waste water.

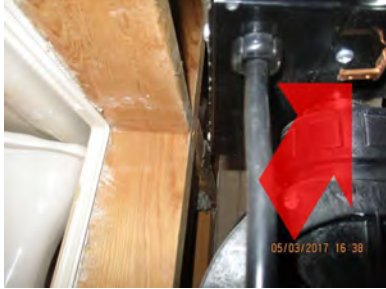
The pump motor is not bonded. This is a safety concern. The installation of a bonding wire between the motor chassis and water pipes is recommended.

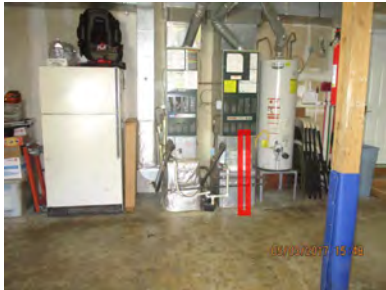
15. The gas pipes in front of the furnace and water heater are not protected by a bumper stop. A vertical steel pipe, bolted to the floor, is typically installed in front of the water heater to prevent a car bumper from damaging the gas lines.

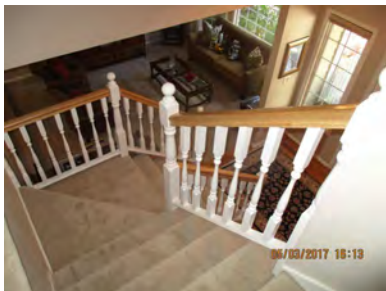
The stair railing baluster spacing is too wide. This is a hazard for small children. The baluster spacing should be reduced as a safety upgrade. Current standards require that a 4" sphere not pass through the railing.

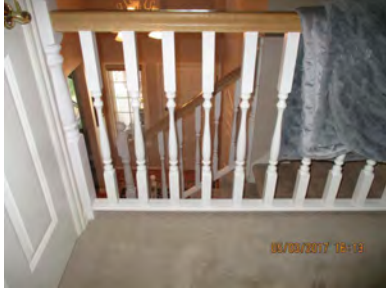
15.4 GUARD RAILINGS

17. The spacing between the balusters is too wide. This is a hazard to small children. The balusters should be spaced close enough together so that a 4" sphere cannot pass through. Upgrading the guard railing is recommended if small children are present.

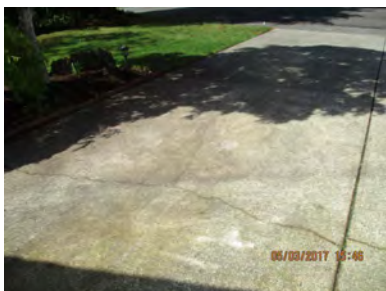
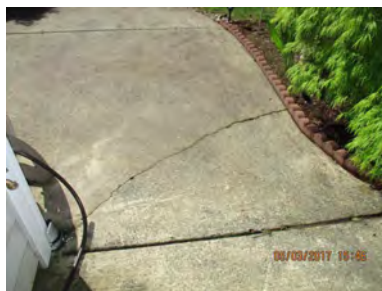
1. Cracks were observed in the concrete surface of the driveway. Minor cracks can be sealed to minimize moisture entry and further settlement of the concrete. Minor cracks are common and do not affect the serviceability of the concrete.

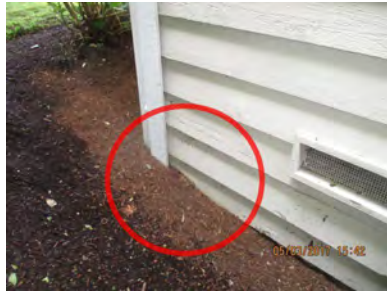
3. Soil is close to or in contact with siding in some areas around the building exterior. Good building practice requires that foundation walls or pier footings supporting wood frame construction, extend at least 8" above the finish grade with at least a 6" clearance between the top of the soil and the bottom of the wood finish materials. Soil in direct contact with wood creates a hospitable environment for wood destroying organisms. Establishing these minimum clearances is recommended.

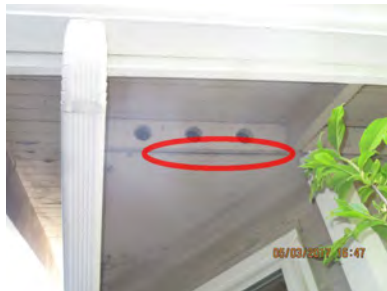
3.3 SOFFITS AND OVERHANGS

4. There are large gaps over 1/4" in size adjacent the soffit vent blocks. These gaps allow insects and rodents to enter the attic. Covering the gaps with screening, a strip of wood and/or caulking is recommended.

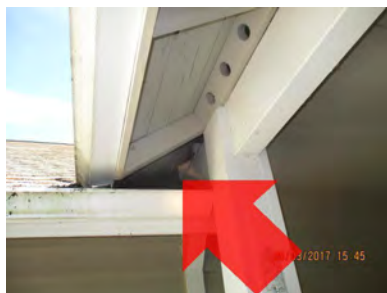
5. There are openings at the intersection between the overhang and the roof through which birds and rodents can enter into the attic. These openings should be covered with wood, wire mesh or filled with aerosol foam.

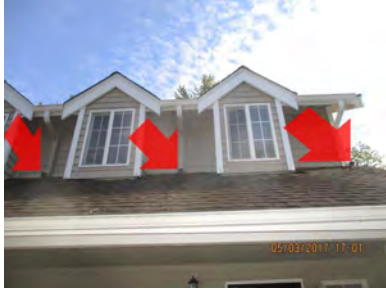
3.4 GUTTERS AND DOWNSPOUTS

6. Downspouts draining directly onto the asphalt shingle surface causes excessive wear of the roofing material. Downspout extensions to the lower gutters should be installed to prevent excessive wear and tear of the roofing.

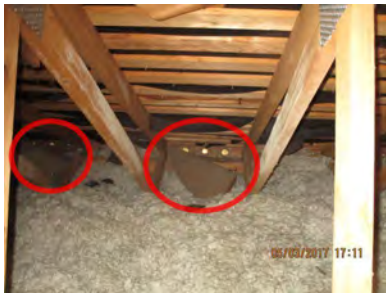
8. Wind baffles locations are compromised in some areas of the attic. The proper placement of wind baffles in front of all soffit vents is recommended.

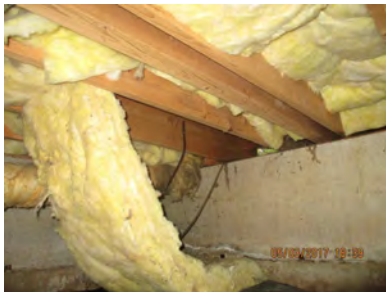
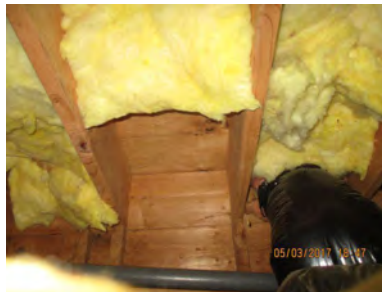
19. Some of the insulation batts are missing and several were not properly secured and have falling down. The fallen batts should be reinstalled and secured. The missing batts should be replaced.

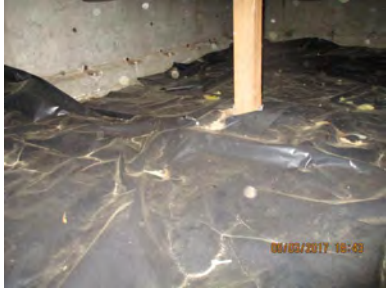
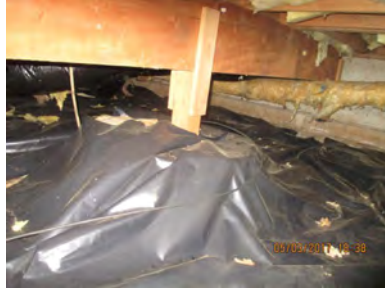
20.4 VAPOR RETARDER

21. The support post concrete piers are covered with the plastic vapor retarder. This allows the transmission of water vapor from the soil up and into the floor framing. The plastic vapor retarder should be removed from the pier so that it covers the entire surface of the soil only.

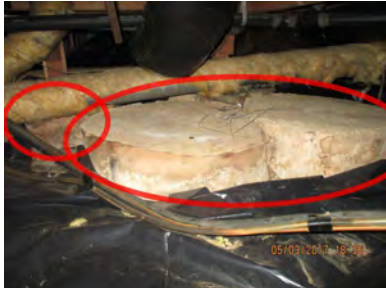
20.5 PEST CONTROL

23. Scrap-wood and other cellulose debris was observed on the crawl floor. This wood debris creates conducive conditions for wood boring insects. The removal of all cellulose debris is recommended.

Cellulose forms were left in place on the pier footings. This cellulose is conducive to the infestation of various wood destroying organisms. The removal of the cellulose is recommended.

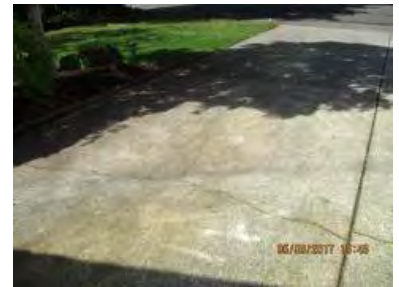
Cracks were observed in the concrete surface of the driveway. Minor cracks can be sealed to minimize moisture entry and further settlement of the concrete. Minor cracks are common and do not affect the serviceability of the concrete.

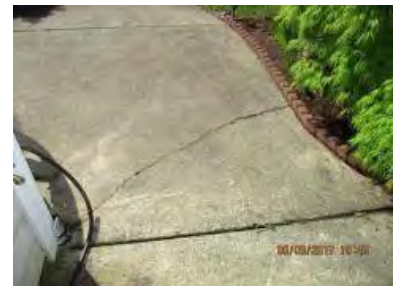
2.5 WALKWAY

There are minor cracks in the walkway, however, they do not affect its functionality and it remains in serviceable condition.

Many legal and public works departments have defined a trip hazard as an irregularity in a walking surface exceeding one inch (1") in height. All walking surfaces should maintain, free of a vertical surface change of 3/4" or more, in the interest of public and personal safety.

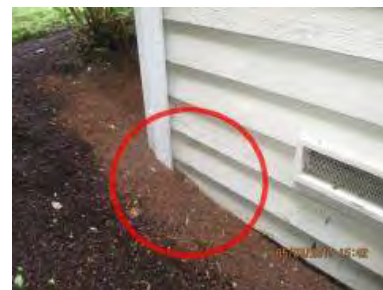
Soil is close to or in contact with siding in some areas around the building exterior. Good building practice requires that foundation walls or pier footings supporting wood frame construction, extend at least 8" above the finish grade with at least a 6" clearance between the top of the soil and the bottom of the wood finish materials. Soil in direct contact with wood creates a hospitable environment for wood destroying organisms. Establishing these minimum clearances is recommended.

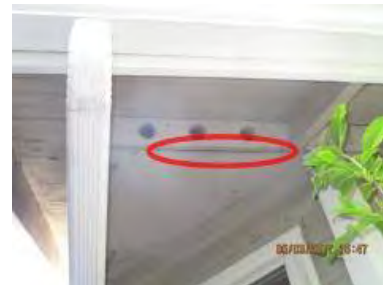
There are large gaps over 1/4" in size adjacent the soffit vent blocks. These gaps allow insects and rodents to enter the attic. Covering the gaps with screening, a strip of wood and/or caulking is recommended.

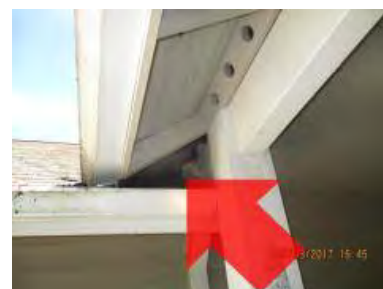
There are openings at the intersection between the overhang and the roof through which birds and rodents can enter into the attic. These openings should be covered with wood, wire mesh or filled with aerosol foam.

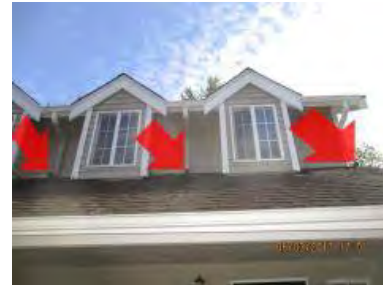
Downspouts draining directly onto the asphalt shingle surface causes excessive wear of the roofing material. Downspout extensions to the lower gutters should be installed to prevent excessive wear and tear of the roofing.

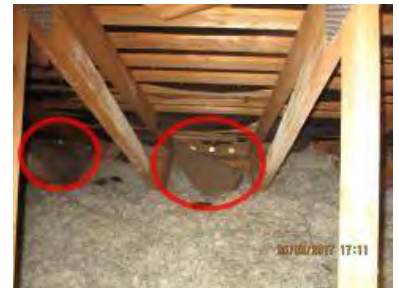
There is evidence of rodent activity in the attic. The first step in eliminating rodents from the attic is to seal all possible entry points using wire mesh, caulking, wood, stainless steel wool, or aerosol foam. Careful work sealing cracks, holes and gaps over 1/4" in size will discourage further activity. Once this work is completed, snap traps baited with peanut butter should be installed and monitored. The absence of rodents in the traps typically means that the rodents have been excluded from the area.

Rodent activity (droppings) unchanged – traps undisturbed over 3 year period.

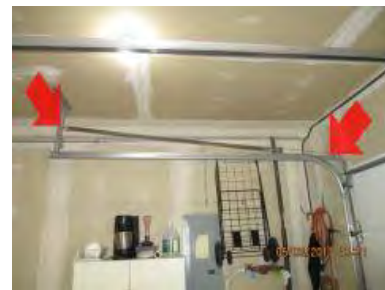
Safeties are cables run through the center of the garage door springs that prevent broken springs from becoming projectiles that can cause injury. There are no safeties installed. The installation of safeties is recommended.

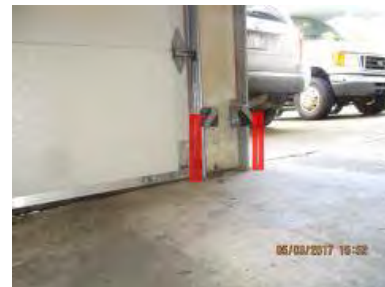
6.3 GARAGE DOOR OPENER

The Photo-eye beam was installed too high above the floor of the garage to adequately offer protection for small children and/or pets. We recommend that the photo-eye be lowered to within 4-6" of the floor.

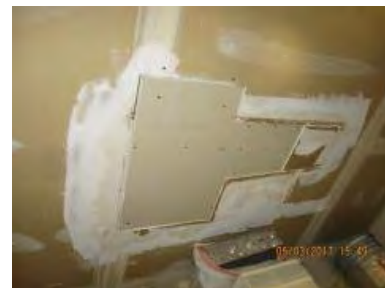
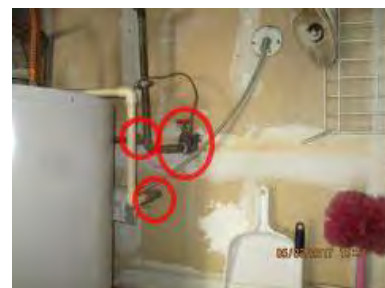
6.4 FIRE SEPARATION

There are voids in the fire resistive barrier between the living space and garage that will allow flames to penetrate. The gypsum barrier slows the spread of a fire from the garage to the structure and/or living space. Patching the voids is recommended.

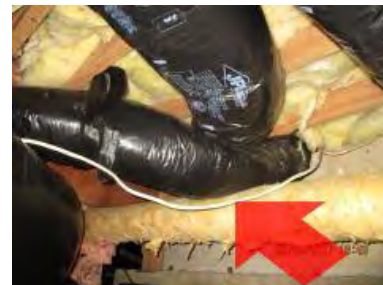
A loose electrical cable was observed in the crawlspace. Loose cables are vulnerable to damage. All loose cables should be secured at 4' intervals using approved cable staples.

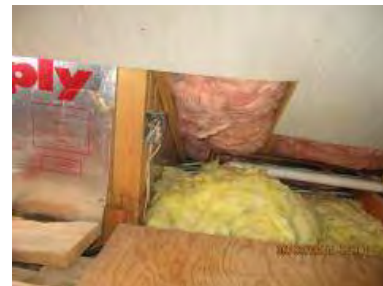
7.11 RECEPTACLES

The cover plate is missing from a receptacle in the storage attic. This is a shock and fire hazard. The installation of a cover plate is recommended.

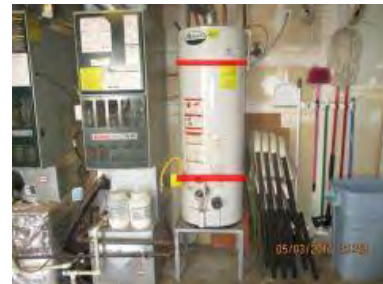
The water heater is not secured to the wall. A seismic restraint should be installed to secure the water heater and prevent it from falling over during an earthquake. This prevents the gas and water lines from rupturing.

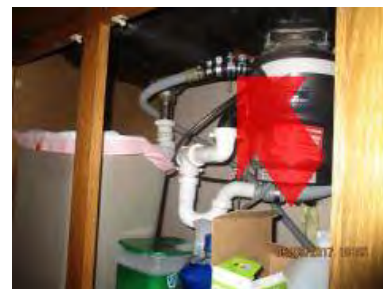
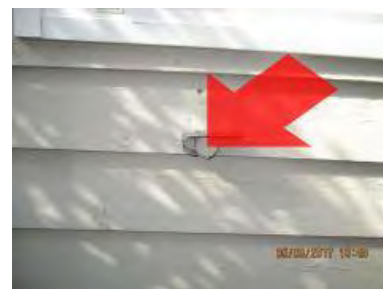
The dishwasher drain lacks an air gap. The dishwasher will function without one, but there is a risk of contamination of the inside of the dishwasher by waste water. The installation of an air gap is recommended or connection to the Johnson Tee that is installed in the kitchen wall. This air gap protects the dishwasher from contamination caused by a backflow of waste water.

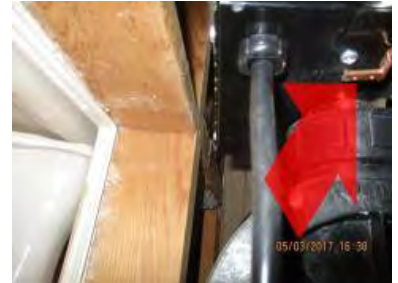
The pump motor is not bonded. This is a safety concern. The installation of a bonding wire between the motor chassis and water pipes is recommended.

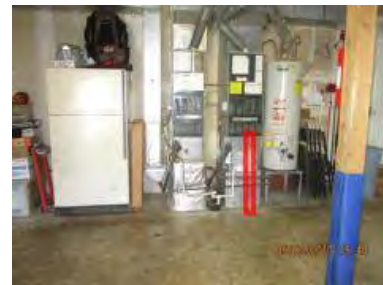
The gas pipes in front of the furnace and water heater are not protected by a bumper stop. A vertical steel pipe, bolted to the floor, is typically installed in front of the water heater to prevent a car bumper from damaging the gas lines.

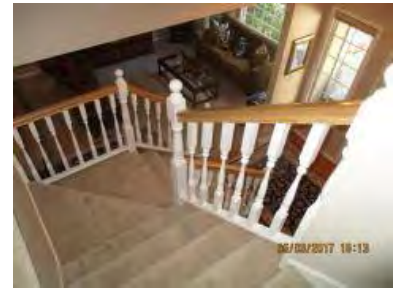
The stair railing baluster spacing is too wide. This is a hazard for small children. The baluster spacing should be reduced as a safety upgrade. Current standards require that a 4" sphere not pass through the railing.

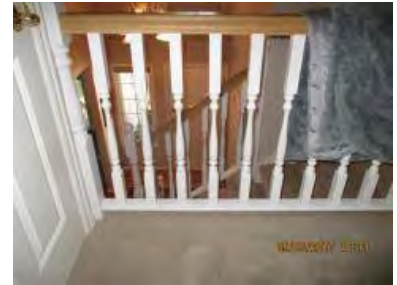
15.4 GUARD RAILINGS

The spacing between the balusters is too wide. This is a hazard to small children. The balusters should be spaced close enough together so that a 4" sphere cannot pass through. Upgrading the guard railing is recommended if small children are present.

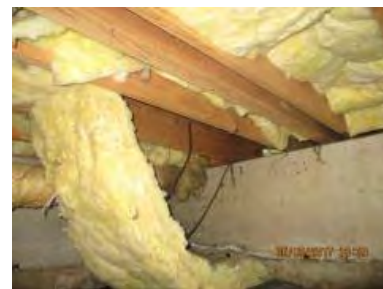
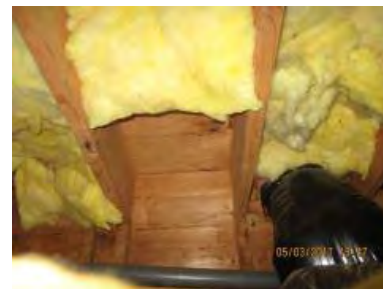
Some of the insulation batts are missing and several were not properly secured and have falling down. The fallen batts should be reinstalled and secured. The missing batts should be replaced.

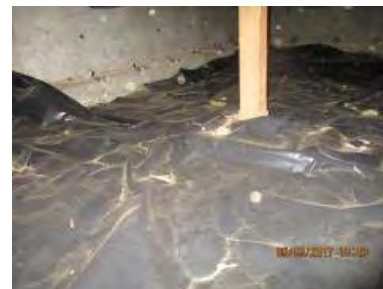
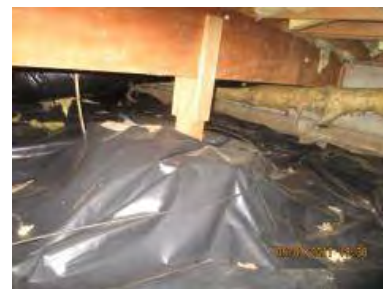
The support post concrete piers are covered with the plastic vapor retarder. This allows the transmission of water vapor from the soil up and into the floor framing. The plastic vapor retarder should be removed from the pier so that it covers the entire surface of the soil only.

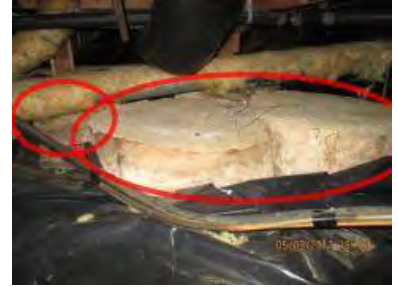
Good building practice requires that foundation walls or pier footings supporting wood frame construction, should extend at least 8" above the finish grade with at least a 6" clearance between the top of the soil and the bottom of the wood finish materials. Untreated wood should be raised 1-2" above surrounding flatwork and should have a moisture barrier such as 30 lb. asphalt impregnated felt installed between the concrete and wood. For additional information and treatment options, you should retain the services of a qualified pest control operator.
