NOTICE TO BUYER: SELLER-PROCURED INSPECTION REPORT

2818 220th Place NE Sammamish, WA 98074

May 5, 2017

**Re: 2818 220th Pl. NE
Sammamish, .**

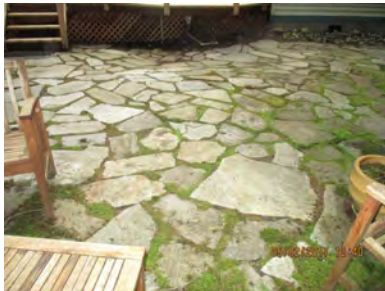
2.5 PATIO

1. The walking surface was not even and trip hazards were present. We recommend all walking surfaces be maintained free of trip hazards.

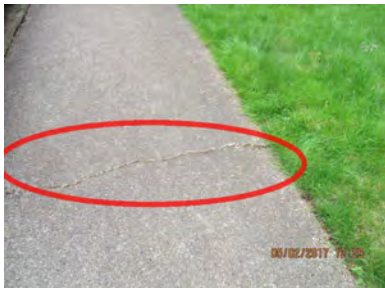
2.6 WALKWAY

2. The walkway has cracked and settled differentially. This was probably caused by inadequate preparation of the soil prior to the placement of the concrete. This condition can be repaired by pressure grouting the sunken portion of the walkway or by removing and replacing it. The walkway remains functional despite this condition. However, the raised edges of the concrete can be a trip hazard for some people. Grinding down the raised edges of the concrete will mitigate the hazard. Repairs should be made as necessary.

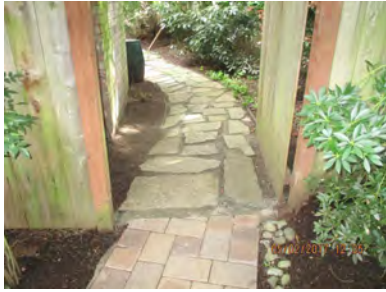
3. The walking surface was not even and trip hazards were present. We recommend all walking surfaces be maintained free of trip hazards.

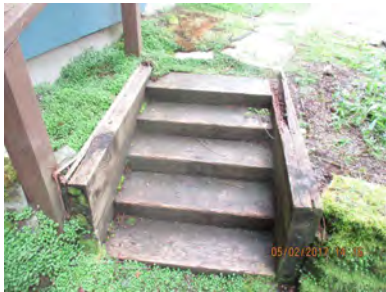
2.7 STEPS

4. The wood steps are deteriorated and are a trip hazard. Modern stair design standards require that the rise not vary by more than 3/8" and that the rise not exceed 8". Stair run (width of tread) should not be less than 9" with 11" being the ideal width. Rebuilding the steps is recommended.

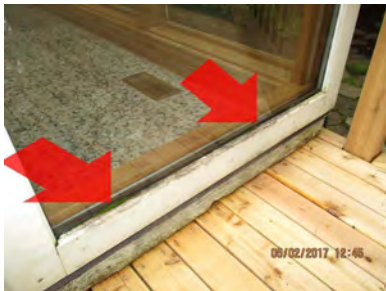
3.11 EXTERIOR WINDOWS

5. The lower window glass is not labeled as tempered safety glass. The existing glass is nonconforming by current building standards and would be hazardous if broken. The installation of safety glass is recommended as a safety upgrade for all windows less than 18" from the walking surface.

The window sills/frames are rotted. Repair or replacement of the damaged window frames is recommended.

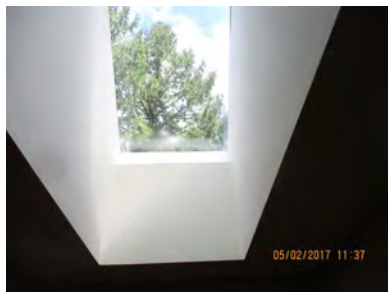
4.3 SKYLIGHTS

6. The seal between the glass panes has failed in the skylight above the master bathroom. Repairs should be made as necessary.

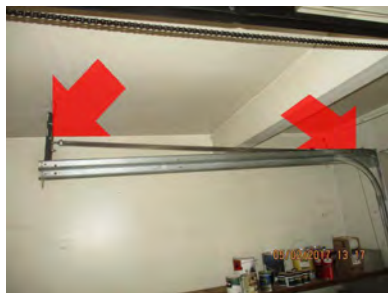
7. Safeties are cables run through the center of the garage door springs that prevent broken springs from becoming projectiles that can cause injury. There are no safeties installed. The installation of safeties is recommended.

There is no automatic garage door opener for the north garage door. The door must be opened manually.

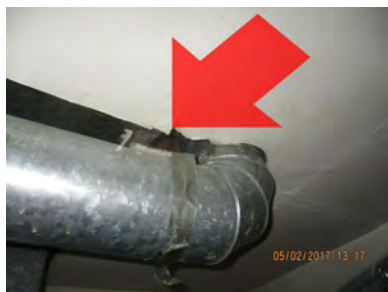
6.4 FIRE SEPARATION

8. There are voids in the fire resistive barrier between the living space and garage that will allow flames to penetrate. The gypsum barrier slows the spread of a fire from the garage to the structure and/or living space. Patching the voids is recommended.

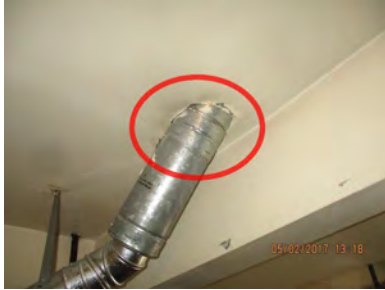
8.10 VENT

11. The furnace vent connector is too close to a combustible material. This is a hazard. A minimum clearance of 6" is required between the single wall vent connector and the combustible material. The double wall type B vent requires only 1" of clearance. Repairs are recommended.

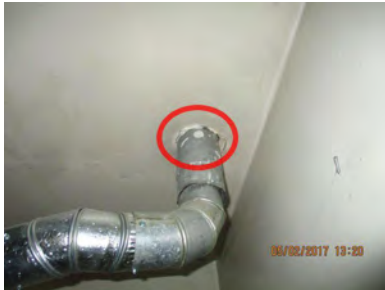
10.9 VENT

12. The water heater vent connector is too close to combustible material. The minimum clearance of 6" is required between the single wall vent connector and the combustible surface. The double wall type B vent requires only 1" of clearance.

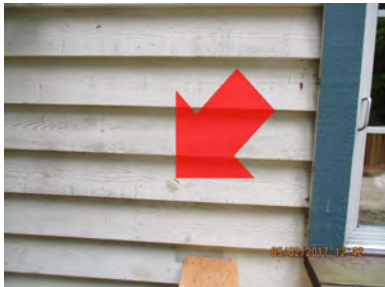
14. An air gap called a Johnson Tee is installed in the kitchen wall. This air gap protects the dishwasher from contamination caused by a backflow of waste water. The cap protruding on the exterior wall opposite the dishwasher is not drilled. This renders the air gap non-functional. Drilling a 1/4" hole in the end of the cap will restore its function. The remaining visible portions of the Johnson Tee were properly installed and functioning as intended.

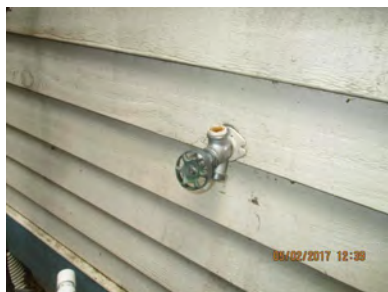
17. The hose bibb on the rear of the building is damaged. This is indicative of a frozen valve. Replacement of the hose bibb is recommended. The other hose bibb was functional.

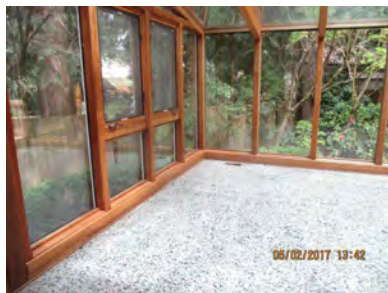
20. The lower window glass is not labeled as tempered safety glass. The existing glass is nonconforming by current building standards and would be hazardous if broken. The installation of safety glass is recommended as a safety upgrade for all windows less than 18" from the walking surface.

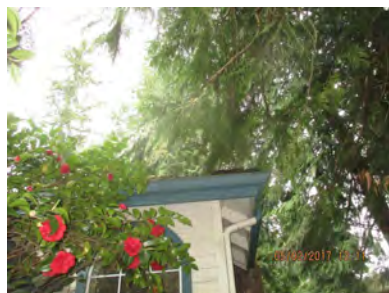
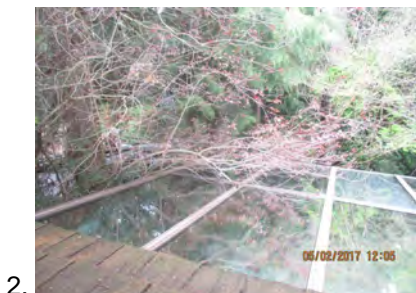
1. Trees are touching the building on the north side. Low hanging tree branches can damage the roof. Tree branches should be trimmed back where necessary.

Vines are touching the building on the north side. Vines can damage the roof, windows and other exterior building components. Consideration should be given to removing vines that are attached to the house. Vines could be trellised back from the structure.

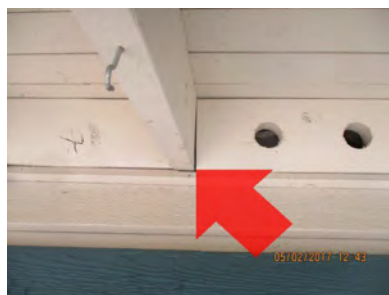
3.3 SOFFITS AND OVERHANGS

3. There are large gaps over 1/4" in size adjacent the soffit vent blocks. These gaps allow insects and rodents to enter the attic. Covering the gaps with screening, a strip of wood and/or caulking is recommended.

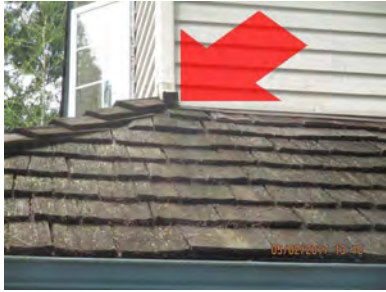
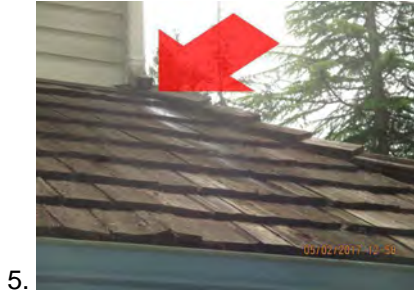
3.4 GUTTERS AND DOWNSPOUTS

4. Downspouts draining directly onto the asphalt shingle surface causes excessive wear of the roofing material. Downspout extensions to the lower gutters should be installed to prevent excessive wear and tear of

the roofing.

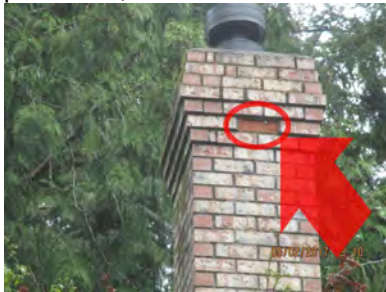
7. The brick is spalling on the exposed portion of the chimney. Spalling occurs during the winter when the surface of the soft brick absorbs moisture and freezes. The water expands as it freezes causing the surface of the brick to flake off. Spalling can be prevented by applying a sealer to the surface of the brick. For maximum protection, the sealer should be reapplied every 2-3 years.

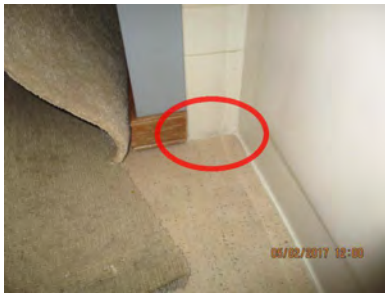
12. The caulking is deteriorated at the intersection between the tub/shower and floor. This can lead to water damage to the flooring and substrate. Recaulking this area is recommended.

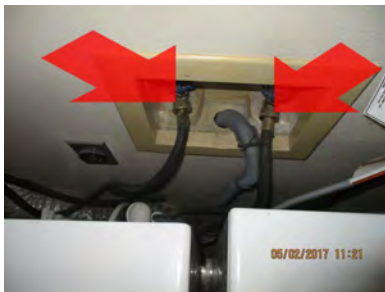
14. Upgrading the washer connections to high pressure (steel braided) lines is recommended.

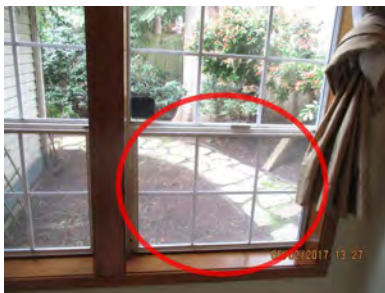
15.6 WINDOWS

15. One of the living room windows is stuck. They should be adjusted or repaired as necessary to restore proper operation.

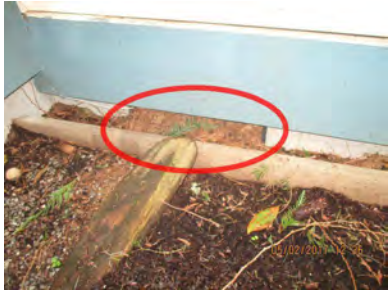
20.3 VENTILATION

16. The removal of vegetation and debris from the vent wells on a regular basis is recommended to reduce the potential for ventilation issues.

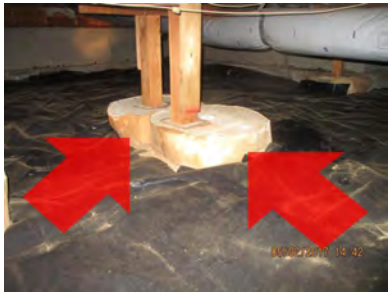
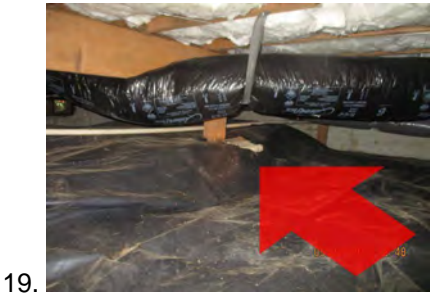
18. Cellulose forms were left in place on the pier footings. This cellulose is conducive to the infestation of various wood destroying organisms. The removal of the cellulose is recommended.

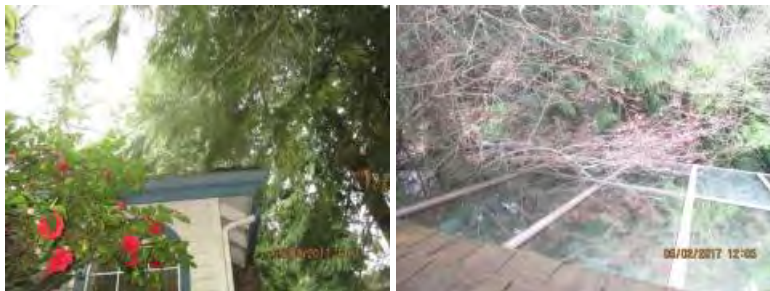
Vines are touching the building on the north side. Vines can damage the roof, windows and other exterior building components. Consideration should be given to removing vines that are attached to the house. Vines could be trellised back from the structure.

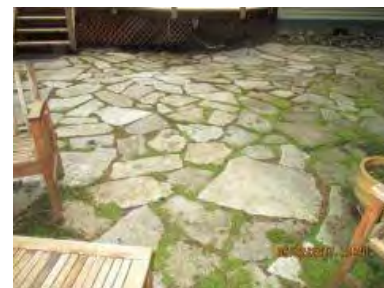
The walking surface was not even and trip hazards were present. We recommend all walking surfaces be maintained free of trip hazards.

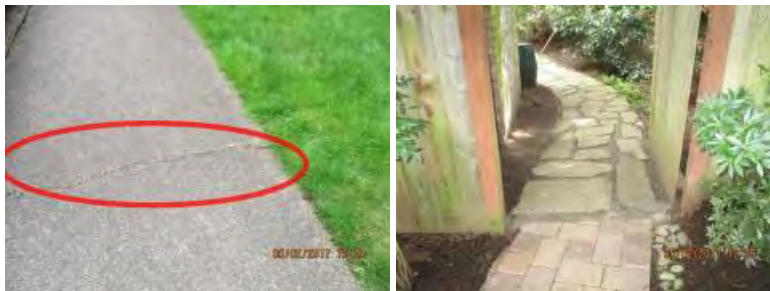
2.6 WALKWAY

The walkway has cracked and settled differentially. This was probably caused by inadequate preparation of the soil prior to the placement of the concrete. This condition can be repaired by pressure grouting the sunken portion of the walkway or by removing and replacing it. The walkway remains functional despite this condition. However, the raised edges of the concrete

The walking surface was not even and trip hazards were present. We recommend all walking surfaces be maintained free of trip hazards.

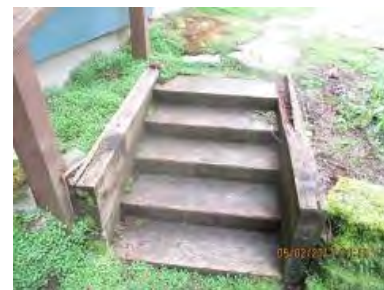
2.7 STEPS

The wood steps are deteriorated and are a trip hazard. Modern stair design standards require that the rise not vary by more than 3/8" and that the rise not exceed 8". Stair run (width of tread) should not be less than 9" with 11" being the ideal width. Rebuilding the steps is recommended.

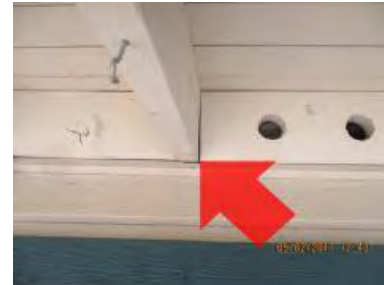
There are large gaps over 1/4" in size adjacent the soffit vent blocks. These gaps allow insects and rodents to enter the attic. Covering the gaps with screening, a strip of wood and/or caulking is recommended.

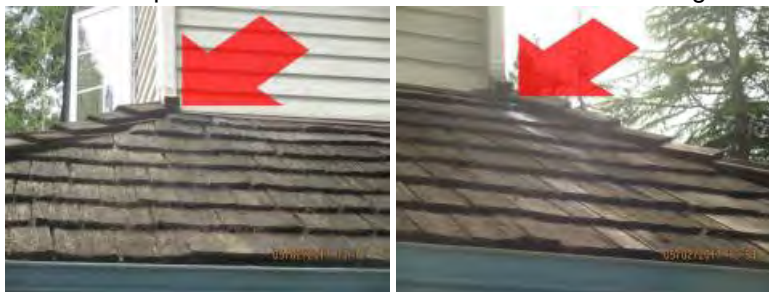
3.4 GUTTERS AND DOWNSPOUTS

Downspouts draining directly onto the asphalt shingle surface causes excessive wear of the roofing material. Downspout extensions to the lower gutters should be installed to prevent excessive wear and tear of the roofing.

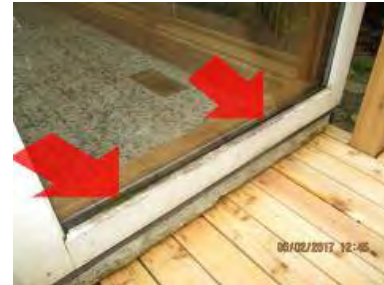
The window sills/frames are rotted. Repair or replacement of the damaged window frames is recommended.

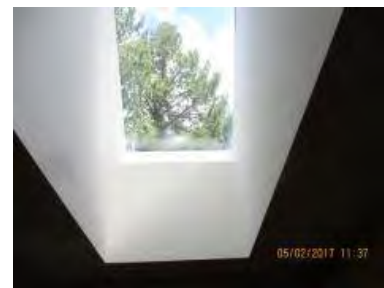
The seal between the glass panes has failed in the skylight above the master bathroom. Repairs should be made as necessary.

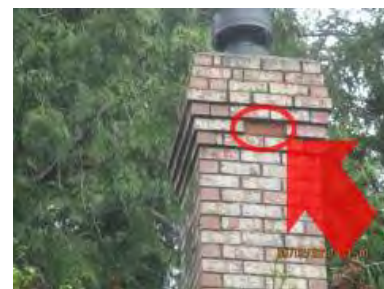
4.4 CHIMNEYS

The brick is spalling on the exposed portion of the chimney. Spalling occurs during the winter when the surface of the soft brick absorbs moisture and freezes. The water expands as it freezes causing the surface of the brick to flake off. Spalling can be prevented by applying a sealer to the surface of the brick. For maximum protection, the sealer should be reapplied every 2-3 years.

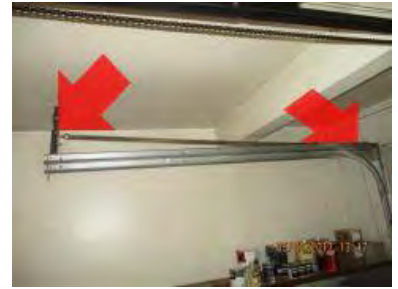
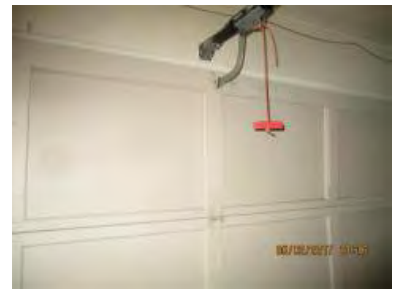
The top door panel frame on the north overhead door was broken and has been repaired. This condition that does not affect the function of the door.

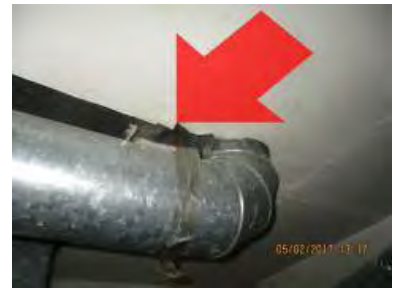
There are voids in the fire resistive barrier between the living space and garage that will allow flames to penetrate. The gypsum barrier slows the spread of a fire from the garage to the structure and/or living space. Patching the voids is recommended.

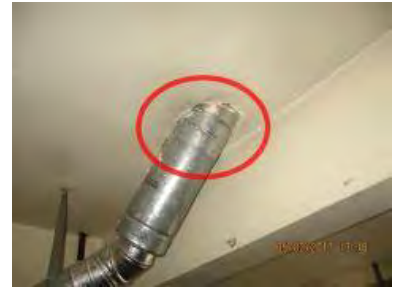
The furnace vent connector is too close to a combustible material. This is a hazard. A minimum clearance of 6" is required between the single wall vent connector and the combustible material. The double wall type B vent requires only 1" of clearance. Repairs are recommended.

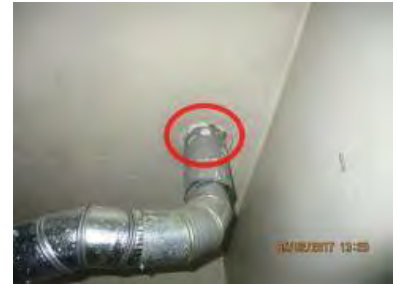
The water heater vent connector is too close to combustible material. The minimum clearance of 6" is required between the single wall vent connector and the combustible surface. The double wall type B vent requires only 1" of clearance.

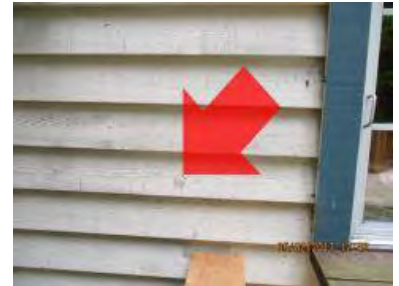
An air gap called a Johnson Tee is installed in the kitchen wall. This air gap protects the dishwasher from contamination caused by a backflow of waste water. The cap protruding on the exterior wall opposite the dishwasher is not drilled. This renders the air gap non-functional. Drilling a 1/4" hole in the end of the cap will restore its function. The remaining visible portions of the Johnson Tee were properly installed and functioning as intended.

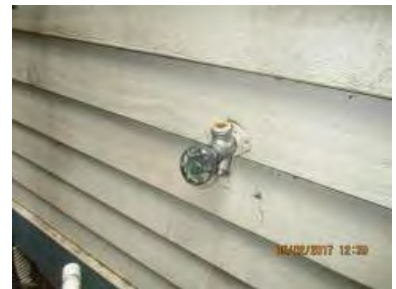
The hose bibb on the rear of the building is damaged. This is indicative of a frozen valve. Replacement of the hose bibb is recommended. The other hose bibb was functional.

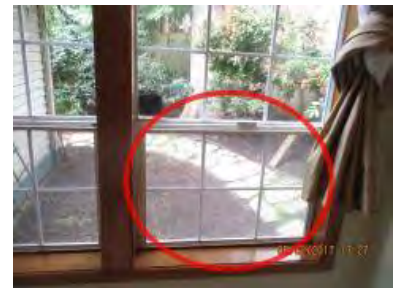
One of the living room windows is stuck. They should be adjusted or repaired as necessary to restore proper operation.

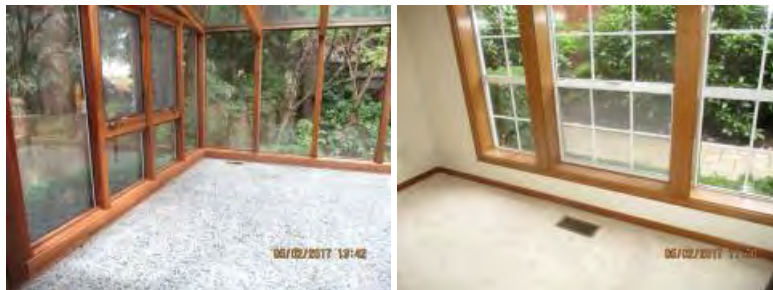
The lower window glass is not labeled as tempered safety glass. The existing glass is nonconforming by current building standards and would be hazardous if broken. The installation of safety glass is recommended as a safety upgrade for all windows less than 18" from the walking surface.

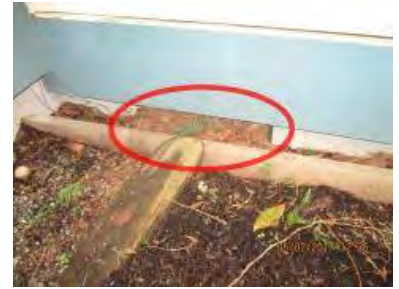
The removal of vegetation and debris from the vent wells on a regular basis is recommended to reduce the potential for ventilation issues.

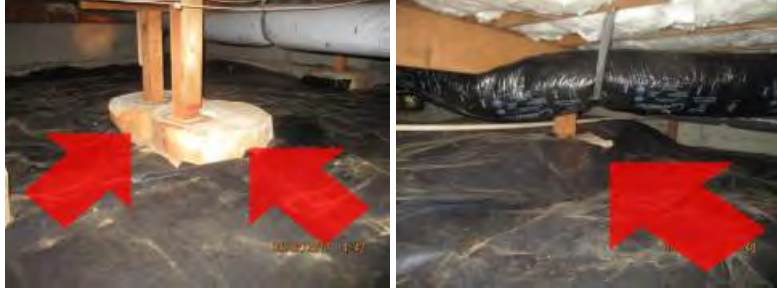
Good building practice requires that foundation walls or pier footings supporting wood frame construction, should extend at least 8" above the finish grade with at least a 6" clearance between the top of the soil and the bottom of the wood finish materials. Untreated wood should be raised 1-2" above surrounding flatwork and should have a moisture barrier such as 30 lb. asphalt impregnated felt installed between the concrete and wood. For additional information and treatment options, you should retain the services of a qualified pest control operator.
