NOTICE TO BUYER: SELLER-PROCURED INSPECTION REPORT

May 24, 2017

Re: 15820 SE 4th St.
Bellevue, WA.

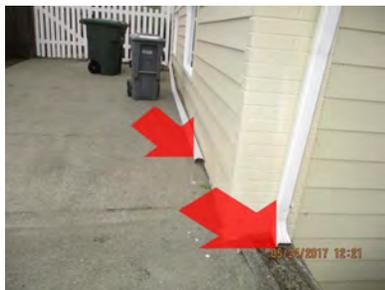
The building lacks a roof water drain system. Roof water discharging on the ground adjacent to the foundation wall is one of the most common causes of water or moisture problems in ground floor occupancies, basements and crawlspaces. Overflowing gutters and clogged downspouts and scuppers also frequently cause or exacerbate moisture or water entry problems in crawlspaces and basements. Consideration should be given to installing a below grade drain system to divert roof water away from the foundation system. Consult with a drain systems specialist for additional information and cost estimates.

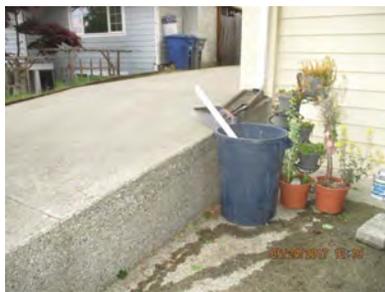
2.3 RETAINING WALLS

There is no guardrail along the walkway above the driveway retaining wall. This is a safety hazard. The installation of a guardrail or fence that conforms to present codes and industry standards is recommended.

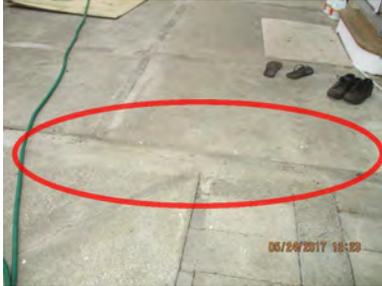
2.7 WALKWAY

The raised edge separating the concrete walkway and patio sections is a trip hazard. Repairs are recommended.

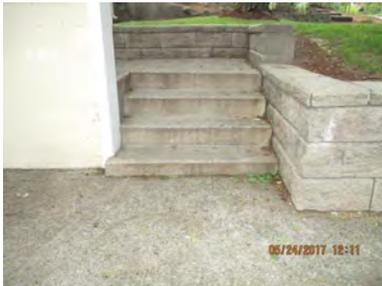
2.8 STEPS

The steps are non-conforming due to the variable and/or excessive rise. Stair design standards require that stair risers do not exceed 8" and that the variation in rise not exceed 3/8" in order to reduce falls from tripping. To increase the margin of safety, consideration should be given to reconfiguring the steps so that rise and run do not vary by more than 3/8". If this proves to be too impractical or expensive, then we recommend exercising caution when using these stairs.

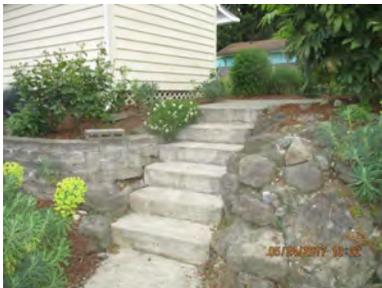
There is no handrail along the back stairs. This is a hazard. The installation of a handrail along the stairs is recommended.

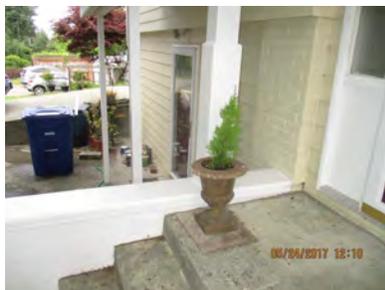
3.8 PORCH RAILING

There is no guardrail at the front porch. This is a safety hazard. The installation of a guardrail that conforms to present industry standards is recommended.

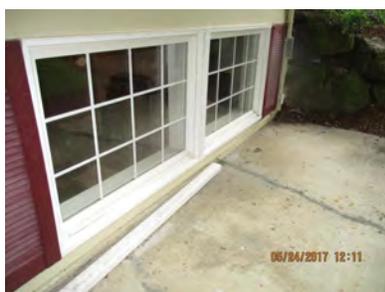
3.10 EXTERIOR WINDOWS

The lower window glass is not labeled as tempered safety glass. The existing glass is nonconforming by current building standards and would be hazardous if broken. The installation of safety glass is recommended as a safety upgrade for all windows less than 18" from the walking surface.

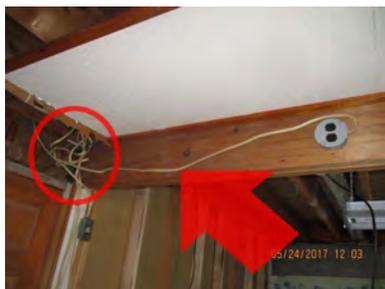
6.10 WIRING

Loose electrical cables were observed in the converted garage room. Loose cables are vulnerable to damage. All loose cables should be secured at 4' intervals using approved cable staples.

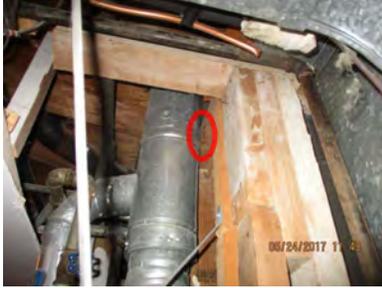
7.9 VENT

The furnace vent connector is too close to a combustible material. This is a hazard. A minimum clearance of 6" is required between the single wall vent connector and the combustible material. The double wall type B vent requires only 1" of clearance. Repairs are recommended.

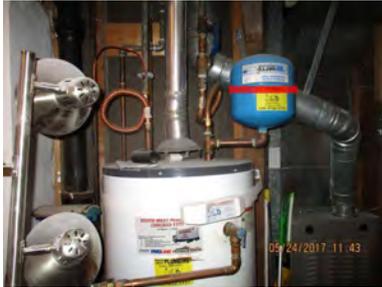
8.6 EXPANSION TANK

The expansion tank is not adequately secured to the wall. This could result in damage to the water pipe and leakage during an earth quake. A seismic restraint should be installed to secure the expansion tank.

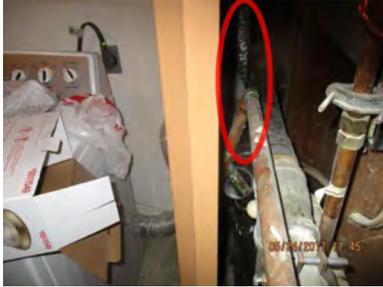
Improper material has been used for the dryer vent duct. This material tends to clog with lint and will lengthen the drying time for clothes. A new duct system should be installed that complies with present building standards. Present standards for dryer vents require a 4 inch, smooth wall duct, no longer than 35 feet, with a hooded damper at the exterior termination. A flexible duct (6 ft max) can only be used between the dryer and floor or wall inlet.

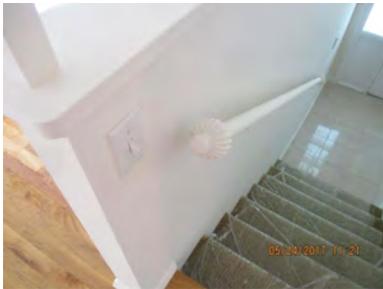
13.3 STAIRS

The stairs were used several times during the inspection. The stair components are properly installed however the railing ends in the stairwell does not return to the wall. This is a safety hazard. The installation of a continuous handrail should be considered as a safety upgrade.

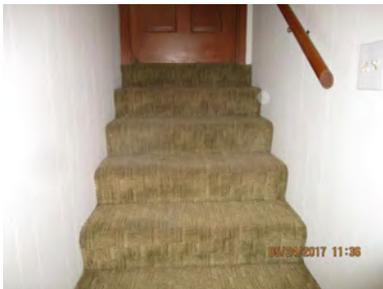
The stairs are non-conforming due to the variable and/or excessive rise. Stair design standards require that stair risers do not exceed 8" and that the variation in rise not exceed 3/8" in order to reduce falls from tripping. To increase the margin of safety, consideration should be given to reconfiguring the stairs so that rise and run do not vary by more than 3/8". If this proves to be too impractical or expensive, then we recommend exercising caution when using these stairs.

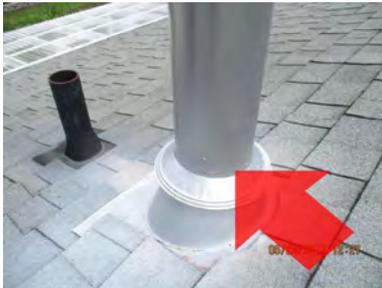
The storm collar is not sealed. This is allowing leakage to occur. Sealing the storm collar is recommended.

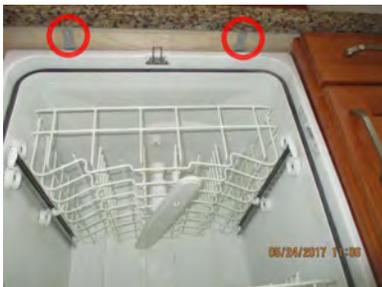
The dishwasher is not secured to the countertop. This allows the appliance to move around. The dishwasher should be secured to the bottom of the countertop in accordance with industry standards.

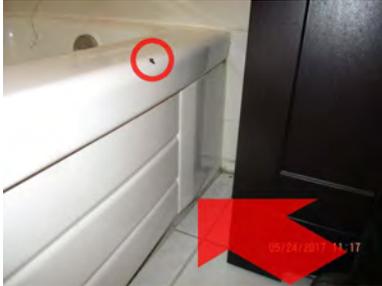
The surface of the bathtub is chipped. This defect is primarily cosmetic and therefore repairs are optional. Chips can be touched up with appliance repair touch-up paint available at most home improvement centers.

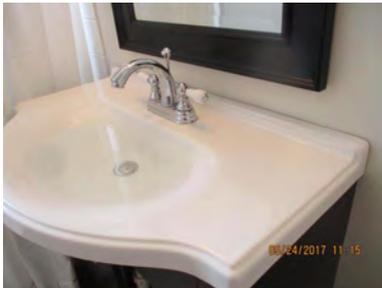
The backsplash is missing. The installation of a backsplash is recommended.

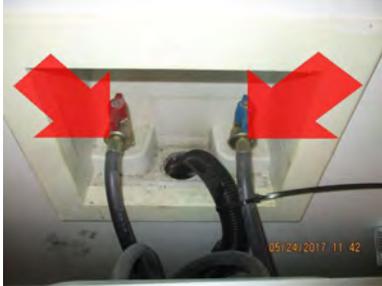
Upgrading the washer connections to high pressure (steel braided) lines is recommended.

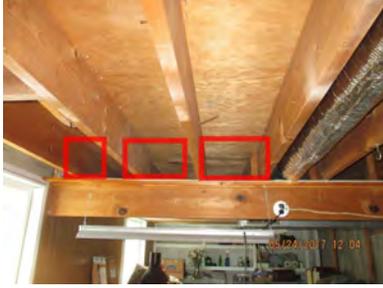
Blocks are missing from between the joists above the support beams under the load bearing walls. This can result in differential settlement of the wall structure particularly under highly stressed point loads like those found adjacent to door openings and under beam supports. Blocking also prevents lateral movement of the joists. The installation of blocking between the joists is recommended.

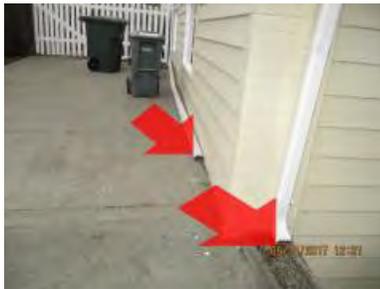
The building lacks a roof water drain system. Roof water discharging on the ground adjacent to the foundation wall is one of the most common causes of water or moisture problems in ground floor occupancies, basements and crawlspaces. Overflowing gutters and clogged downspouts and scuppers also frequently cause or exacerbate moisture or water entry problems in crawlspaces and basements. Consideration should be given to installing a below grade drain system to divert roof water away from the foundation system. Consult with a drain systems specialist for additional information and cost estimates.

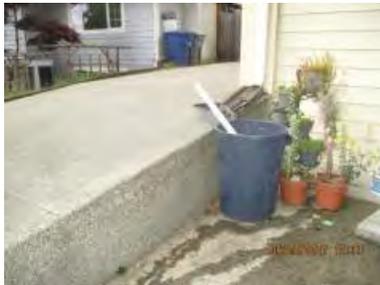
There is no guardrail along the walkway above the driveway retaining wall. This is a safety hazard. The installation of a guardrail or fence that conforms to present codes and industry standards is recommended.

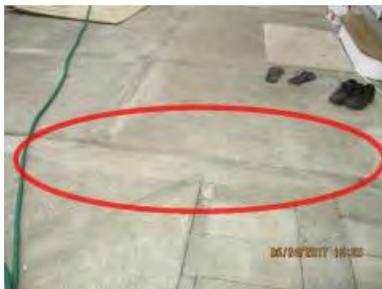
The raised edge separating the concrete walkway and patio sections is a trip hazard. Repairs are recommended.

Many legal and public works departments have defined a trip hazard as an irregularity in a walking surface exceeding one inch (1") in height. All walking surfaces should maintain, free of a vertical surface change of 3/4" or more, in the interest of public and personal safety.

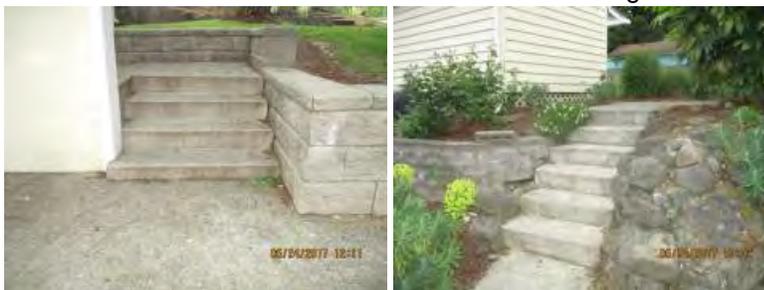
2.8 STEPS

The steps are non-conforming due to the variable and/or excessive rise. Stair design standards require that stair risers do not exceed 8" and that the variation in rise not exceed 3/8" in order to reduce falls from tripping. To increase the margin of safety, consideration should be given to reconfiguring the steps so that rise and run do not vary by more than 3/8". If this proves to be too impractical or expensive, then we recommend exercising caution when using these stairs.

There is no handrail along the back stairs. This is a hazard. The installation of a handrail along the stairs is recommended.

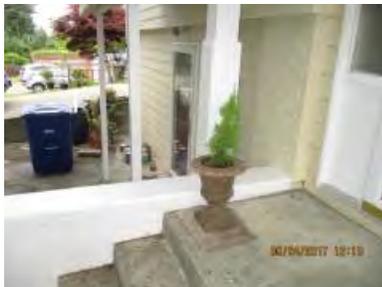
There is no guardrail at the front porch. This is a safety hazard. The installation of a guardrail that conforms to present industry standards is recommended.

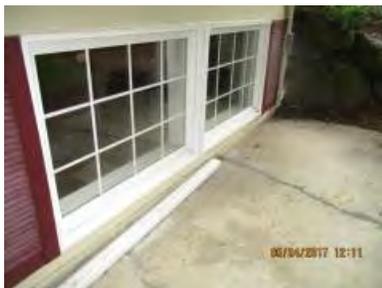
The removal of vegetation and debris from the window wells on a regular basis is recommended to reduce the potential for deterioration of the window frames.

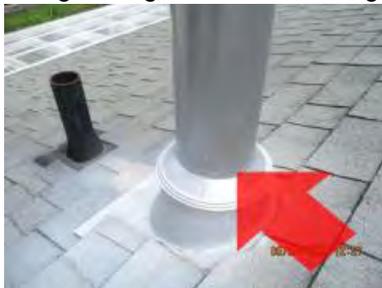
The storm collar is not sealed. This is allowing leakage to occur. Sealing the storm collar is recommended.

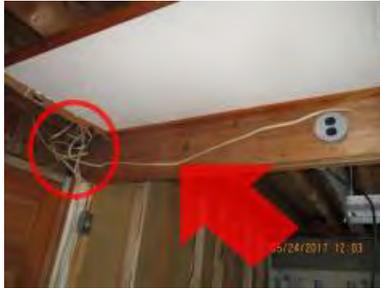
cables should be secured at 4' intervals using approved cable staples.

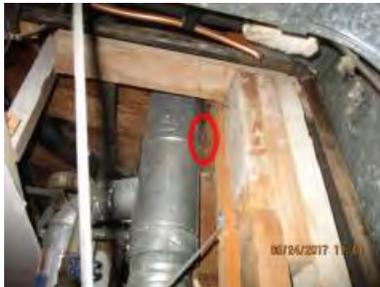
7.9 VENT

The furnace vent connector is too close to a combustible material. This is a hazard. A minimum clearance of 6" is required between the single wall vent connector and the combustible material. The double wall type B vent requires only 1" of clearance. Repairs are recommended.

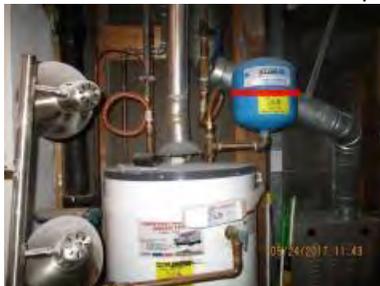
The expansion tank is not adequately secured to the wall. This could result in damage to the water pipe and leakage during an earth quake. A seismic restraint should be installed to secure the expansion tank.

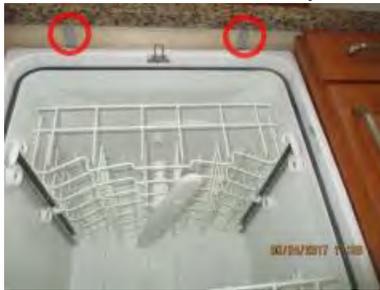
The dishwasher is not secured to the countertop. This allows the appliance to move around. The dishwasher should be secured to the bottom of the countertop in accordance with industry standards.

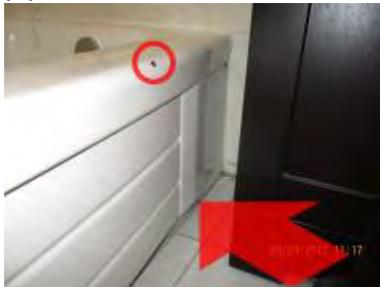
The surface of the bathtub is chipped. This defect is primarily cosmetic and therefore repairs are optional. Chips can be touched up with appliance repair touch-up paint available at most home improvement centers.

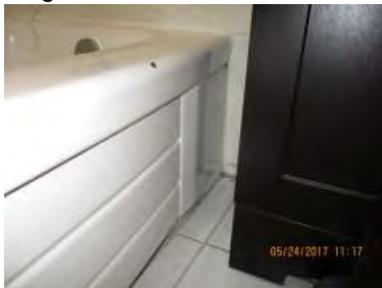
The grout is cracked at the intersection between the tub/shower and floor. This can lead to water damage to the flooring and substrate. Caulking this area with a flexible grout is recommended.

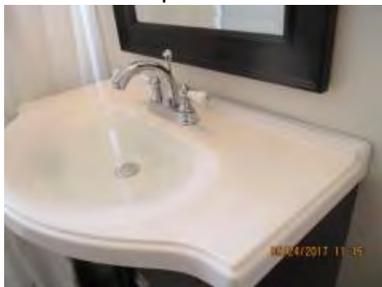
The backsplash is missing. The installation of a backsplash is recommended.

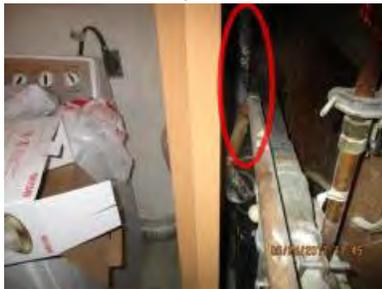
11.3 DRYER VENT

Improper material has been used for the dryer vent duct. This material tends to clog with lint and will lengthen the drying time for clothes. A new duct system should be installed that complies with present building standards. Present standards for dryer vents require a 4 inch, smooth wall duct, no longer than 35 feet, with a hooded damper at the exterior termination. A flexible duct (6 ft max) can only be used between the dryer and floor or wall inlet.

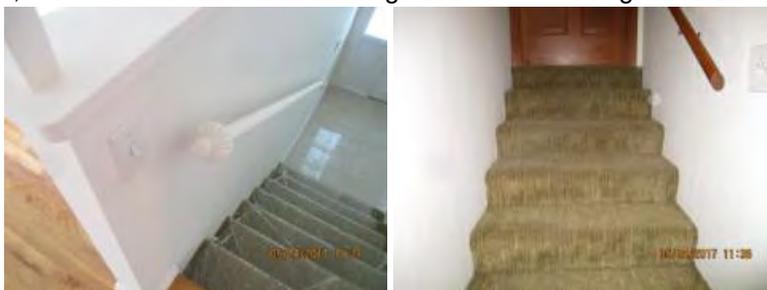
The stairs are non-conforming due to the variable and/or excessive rise. Stair design standards require that stair risers do not exceed 8" and that the variation in rise not exceed 3/8" in order to reduce falls from tripping. To increase the margin of safety, consideration should be given to reconfiguring the stairs so that rise and run do not vary by more than 3/8". If this proves to be too impractical or expensive, then we recommend exercising caution when using these stairs.

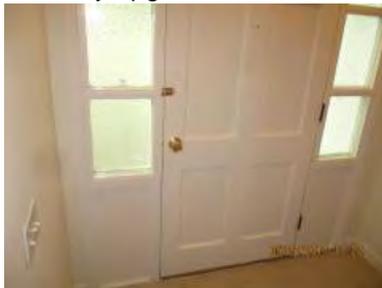
The glass adjacent to the front door is not tempered safety glass. Tempered glass can be identified by the etched emblem in one corner of each pane. A higher margin of safety could be achieved if the glass was approved safety glass. Consideration should be given to replacing the glass as a safety upgrade.

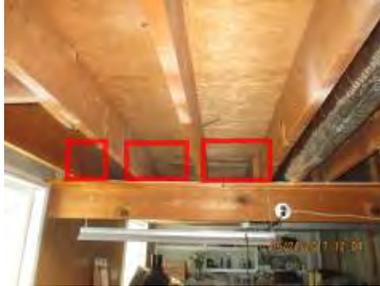
Blocks are missing from between the joists above the support beams under the load bearing walls. This can result in differential settlement of the wall structure particularly under highly stressed point loads like those found adjacent to door openings and under beam supports. Blocking also prevents lateral movement of the joists. The installation of blocking between the joists is recommended.
