NOTICE TO BUYER: SELLER-PROCURED INSPECTION REPORT

Re: 27301 NE 153rd Pl.
Duvall, WA.

At your request, a visual inspection of the above referenced property was conducted on 05/31/2017. We have inspected the major structural components, plumbing, heating and electrical systems for signs of significant non-performance, excessive or unusual wear and general state of repair.

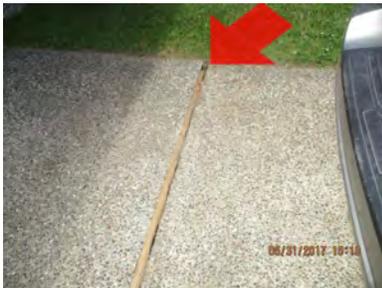
2.4 DRIVEWAY

One or more of the wooden dividers separating the concrete driveway sections were infested by wood destroying organisms and have deteriorated to a point where they are becoming a trip hazard. Replacement with mortar is recommended.

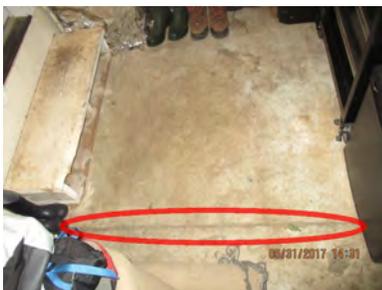
6.1 GARAGE FLOOR

The garage floor was not even and the raised edge of the concrete can be a trip hazard for some people. Grinding down the raised edge of the concrete will mitigate the hazard. Repairs should be made as necessary. We recommend all walking surfaces be maintained free of trip hazards.

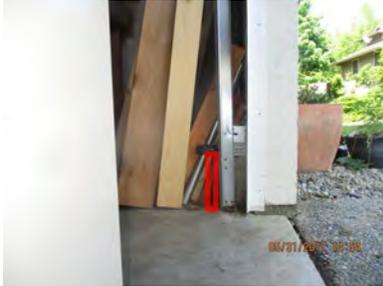
6.3 GARAGE DOOR OPENER

The Photo-eye beam was installed too high above the floor of the garage to adequately offer protection for small children and/or pets. We recommend that the photo-eye be lowered to within 4-6" of the floor.

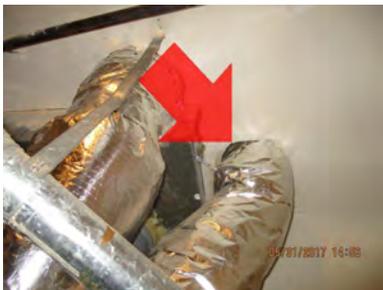
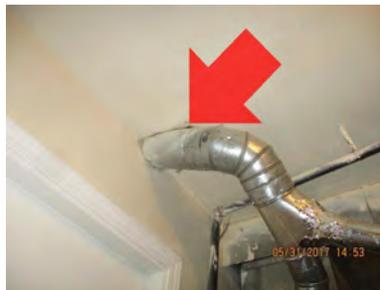
6.4 FIRE SEPARATION

There are voids in the fire resistive barrier between the living space and garage that will allow flames to penetrate. The gypsum barrier slows the spread of a fire from the garage to the structure and/or living space. Patching the voids with a fire retardant caulk is recommended.

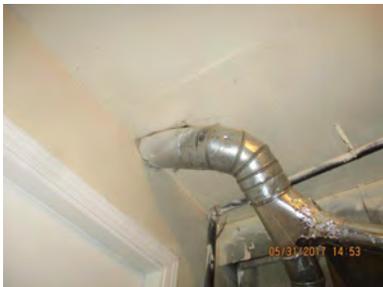
The furnace vent connector is too close to a combustible material. This is a hazard. A minimum clearance of 6" is required between the single wall vent connector and the combustible material. The double wall type B vent requires only 1" of clearance. Repairs are recommended.

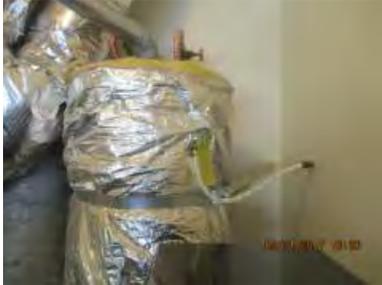
The pressure relief valve drain pipe is too small. This is a hazard. The drain pipe should be 3/4" from the valve outlet to the drain termination. A 3/4" copper, CPVC plastic or galvanized steel drain pipe is recommended. Ideally, the drain should be routed to the exterior. However, running the pipe straight down to the floor eliminates the scald hazard.

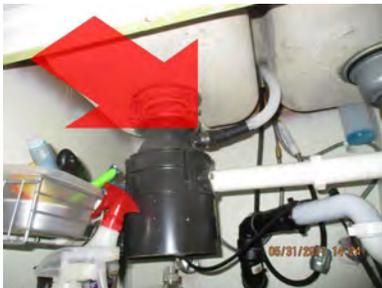
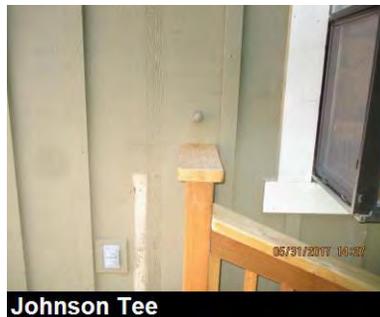
The dishwasher drain lacks an air gap. The dishwasher will function without one, but there is a risk of contamination of the inside of the dishwasher by waste water. The air gap is recommended to be installed above the flood rim of the sink or connected to the Johnson Tee that is installed in the kitchen wall. An air gap protects the dishwasher from contamination caused by a backflow of waste water.

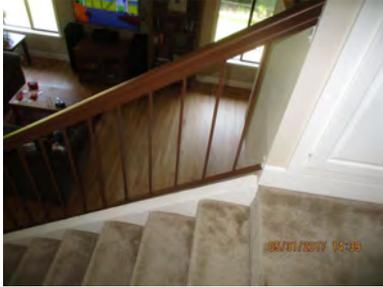
The stair railing baluster spacing is too wide. This is a hazard for small children. The baluster spacing should be reduced as a safety upgrade. Current standards require that a 4" sphere not pass through the railing.

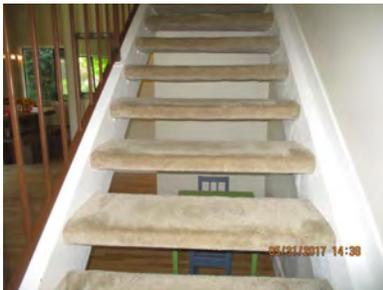
The stair rise spacing is too wide. This is a hazard for small children. The spacing should be reduced as a safety upgrade. Current standards require that a 4" sphere not pass through the opening.

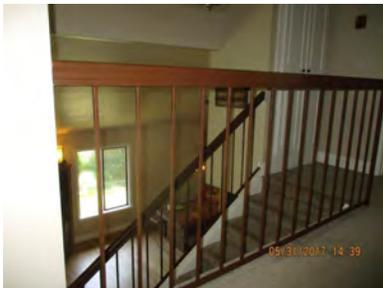
14.3 GUARD RAILINGS

The spacing between the balusters is too wide. This is a hazard to small children. The balusters should be spaced close enough together so that a 4" sphere cannot pass through. Upgrading the guard railing is recommended if small children are present.

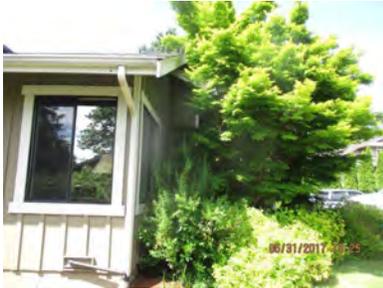
Trees are touching the building on the south side. Low hanging tree branches can damage the roof. Tree branches should be trimmed back where necessary.

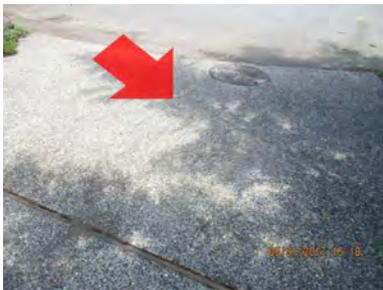
2.4 DRIVEWAY

Cracks were observed in the concrete surface of the driveway. Minor cracks can be sealed to minimize moisture entry and further settlement of the concrete. Minor cracks are common and do not affect the serviceability of the concrete.

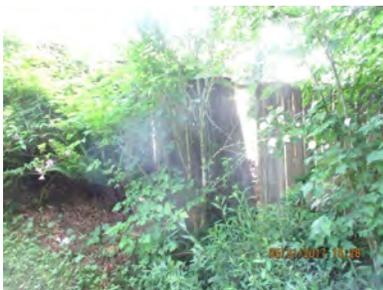
2.6 FENCES AND GATES

Portions of the fence are deteriorated. Fences should be repaired or replaced as necessary.

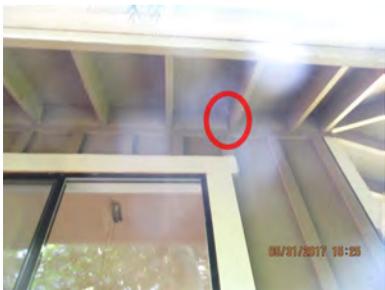
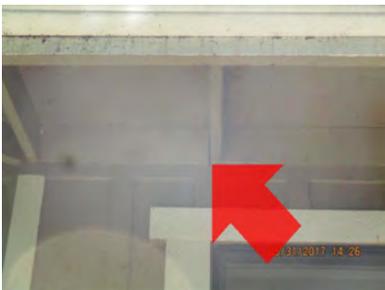
3.3 SOFFITS AND OVERHANGS

There are large gaps over 1/4" in size adjacent the soffit vent blocks. These gaps allow insects and rodents to enter the attic. Covering the gaps with screening, a strip of wood and/or caulking is recommended.

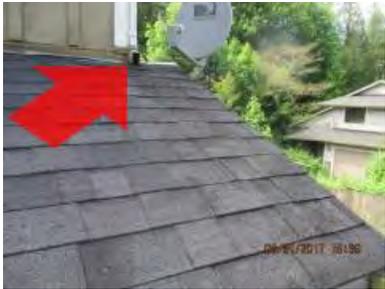
3.4 GUTTERS AND DOWNSPOUTS

Downspouts draining directly onto the asphalt shingle surface causes excessive wear of the roofing material. Downspout extensions to the lower gutters should be installed to prevent excessive wear and tear of the roofing.

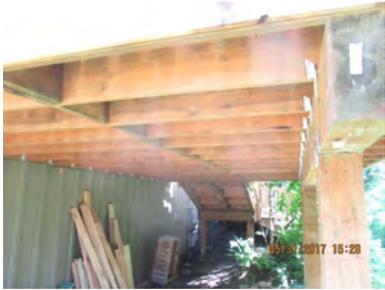
3.6 DECK

The deck structure lacks lateral bracing. The installation of a diagonal brace underneath the deck is recommended.

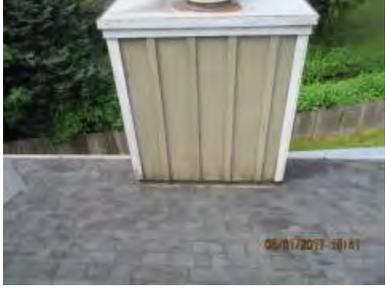
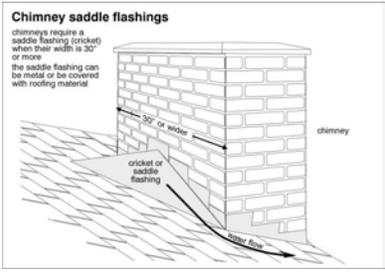
4.3 CHIMNEYS

There is no cricket on the up-slope side of the living room fireplace chimney. This is conducive to leakage. Consideration should be given to installing a cricket to divert water around the chimney.

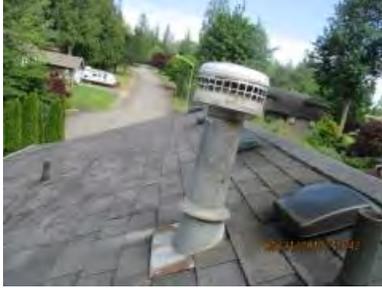
4.4 GAS APPLIANCE VENTS

The gas appliance vent is corroded above the roof line. Cleaning and painting the vent will prolong its service life.

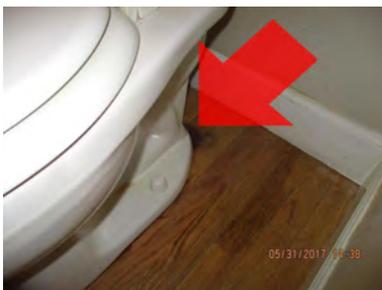
The hardwood floor is water damaged around the toilet. This damage is cosmetic and can probably be sanded out when the floor is refinished.

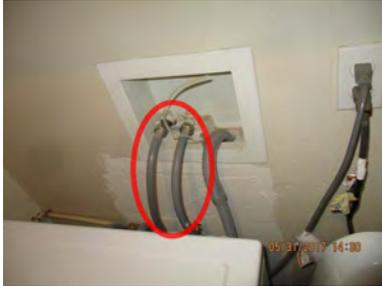
Upgrading the washer connections to high pressure (steel braided) lines is recommended.

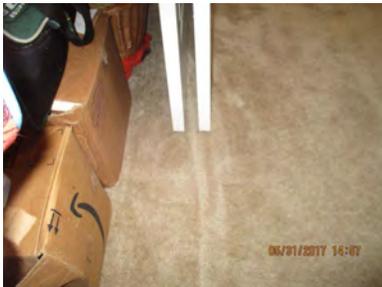
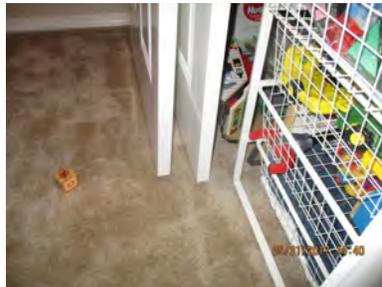
The floor guides are missing from the bypass closet doors in the bedroom. Missing floor guides could result in damage to the doors. The installation of floor guides is recommended.

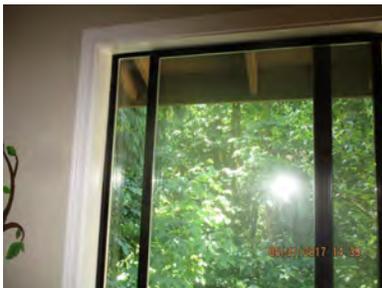
14.7 WINDOWS

There is condensation or mineral deposits between the panes of glass in one of the insulated glass window panes. This indicates a failed seal. The glass assembly should be replaced, which is the only method for correcting this deficiency.

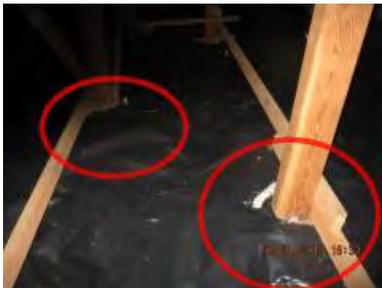
19.4 VAPOR RETARDER

The support post concrete piers are covered with the plastic vapor retarder. This allows the transmission of water vapor from the soil up and into the floor framing. The plastic vapor retarder should be removed from the pier so that it covers the entire surface of the soil only.

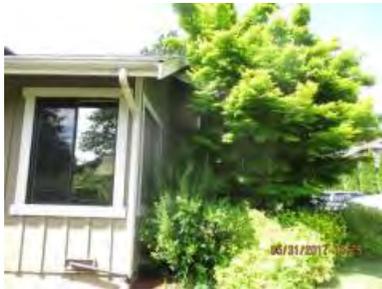
Trees are touching the building on the south side. Low hanging tree branches can damage the roof. Tree branches should be trimmed back where necessary.

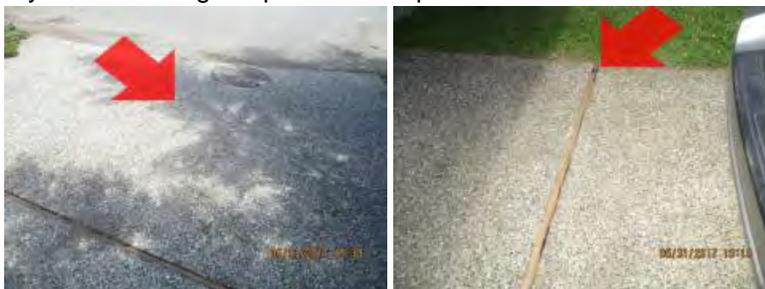
2.4 DRIVEWAY

One or more of the wooden dividers separating the concrete driveway sections were infested by wood destroying organisms and have deteriorated to a point where they are becoming a trip hazard. Replacement with mortar is recommended.

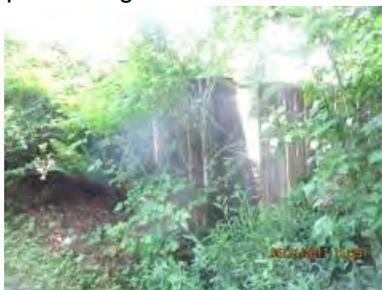
Portions of the fence are deteriorated. Fences should be repaired or replaced as necessary.

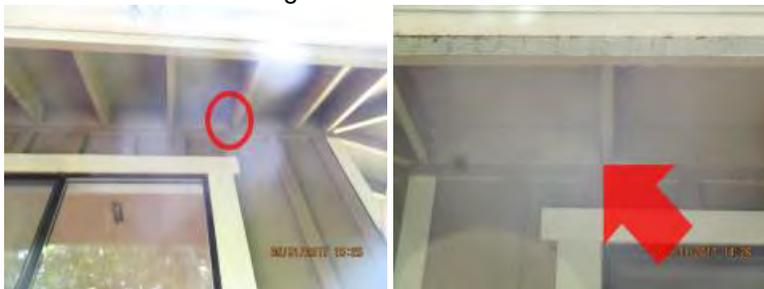
There are large gaps over 1/4" in size adjacent the soffit vent blocks. These gaps allow insects and rodents to enter the attic. Covering the gaps with screening, a strip of wood and/or caulking is recommended.

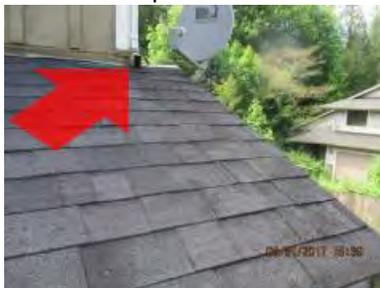
3.4 GUTTERS AND DOWNSPOUTS

Downspouts draining directly onto the asphalt shingle surface causes excessive wear of the roofing material. Downspout extensions to the lower gutters should be installed to prevent excessive wear and tear of the roofing.

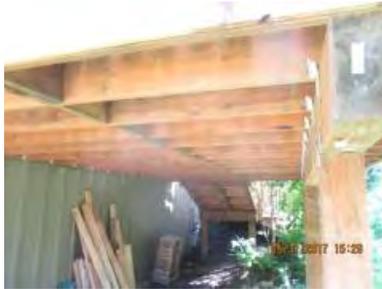
The deck structure lacks lateral bracing. The installation of a diagonal brace underneath the deck is recommended.

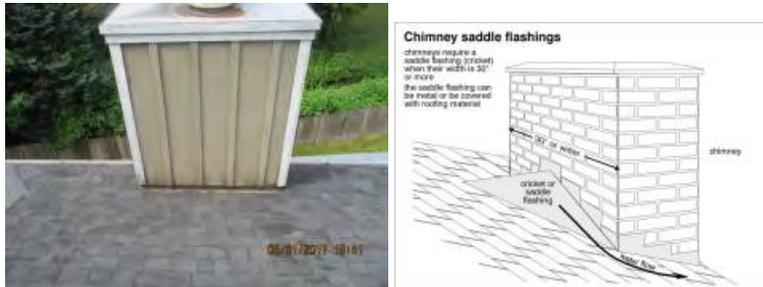
There is no cricket on the up-slope side of the living room fireplace chimney. This is conducive to leakage. Consideration should be given to installing a cricket to divert water around the chimney.

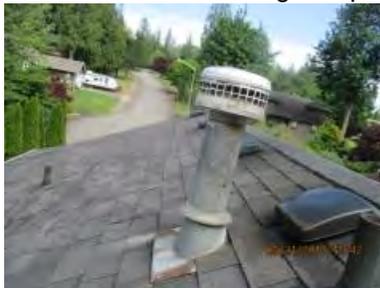
4.4 GAS APPLIANCE VENTS

The gas appliance vent is corroded above the roof line. Cleaning and painting the vent will prolong its service life.

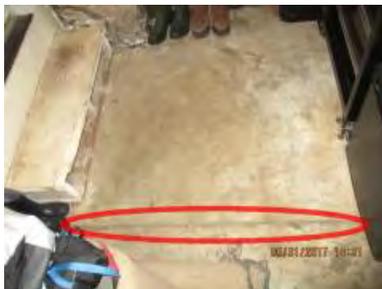
The garage floor was not even and the raised edge of the concrete can be a trip hazard for some people. Grinding down the raised edge of the concrete will mitigate the hazard. Repairs should be made as necessary. We recommend all walking surfaces be maintained free of trip hazards.

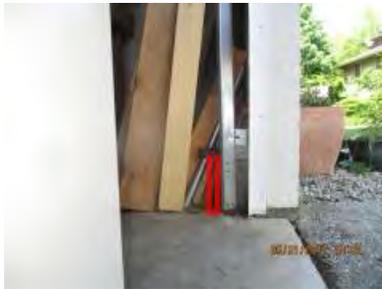
The Photo-eye beam was installed too high above the floor of the garage to adequately offer protection for small children and/or pets. We recommend that the photo-eye be lowered to within 4-6" of the floor.

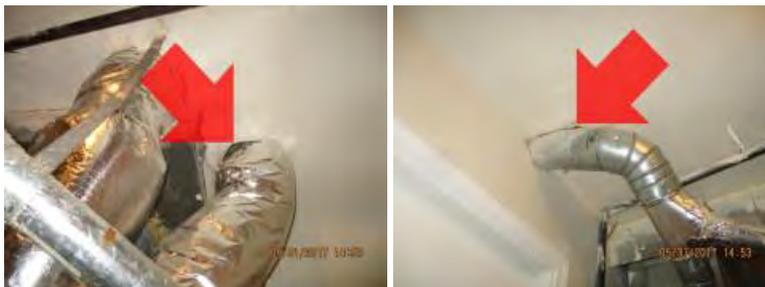
6.4 FIRE SEPARATION

There are voids in the fire resistive barrier between the living space and garage that will allow flames to penetrate. The gypsum barrier slows the spread of a fire from the garage to the structure and/or living space. Patching the voids with a fire retardant caulk is recommended.

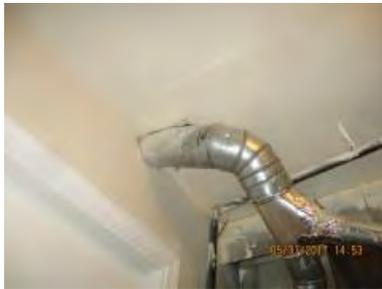
The furnace vent connector is too close to a combustible material. This is a hazard. A minimum clearance of 6" is required between the single wall vent connector and the combustible material. The double wall type B vent requires only 1" of clearance. Repairs are recommended.

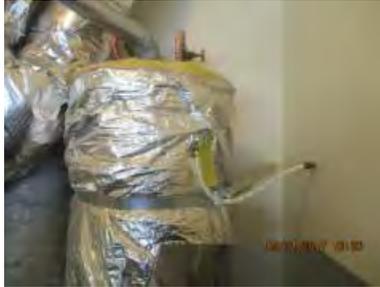
drain termination. A 3/4" copper, CPVC plastic or galvanized steel drain pipe is recommended. Ideally, the drain should be routed to the exterior. However, running the pipe straight down to the floor eliminates the scald hazard.

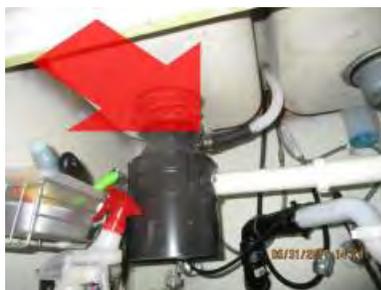
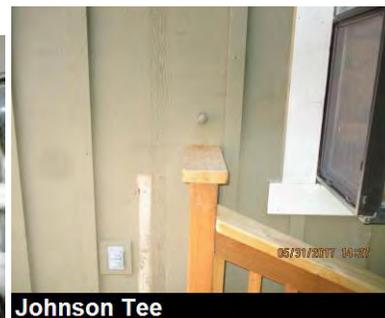
The dishwasher drain lacks an air gap. The dishwasher will function without one, but there is a risk of contamination of the inside of the dishwasher by waste water. The air gap is recommended to be installed above the flood rim of the sink or connected to the Johnson Tee that is installed in the kitchen wall. An air gap protects the dishwasher from contamination caused by a backflow of waste water.

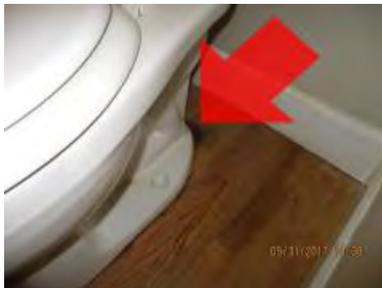
The hardwood floor is water damaged around the toilet. This damage is cosmetic and can probably be sanded out when the floor is refinished.

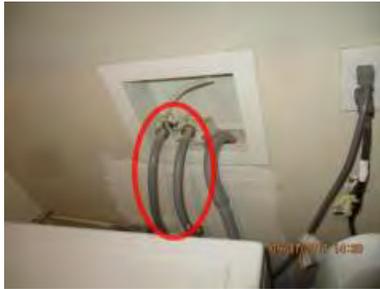
Upgrading the washer connections to high pressure (steel braided) lines is recommended.

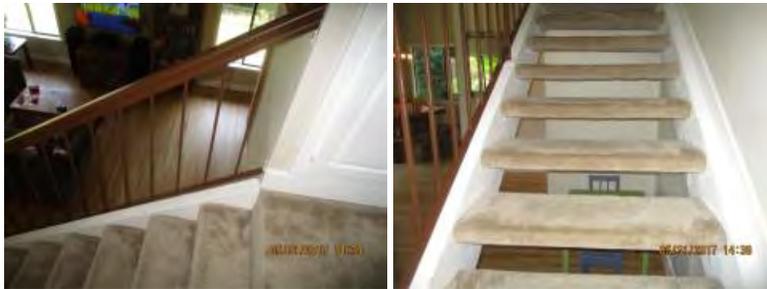
The stair rise spacing is too wide. This is a hazard for small children. The spacing should be reduced as a safety upgrade. Current standards require that a 4" sphere not pass through the opening.

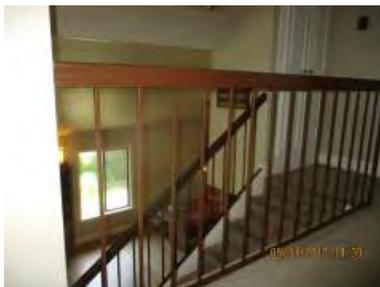
14.3 GUARD RAILINGS

The spacing between the balusters is too wide. This is a hazard to small children. The balusters should be spaced close enough together so that a 4" sphere cannot pass through. Upgrading the guard railing is recommended if small children are present.

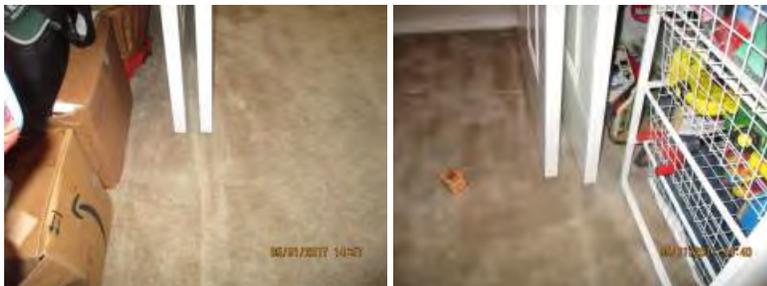
The floor guides are missing from the bypass closet doors in the bedroom. Missing floor guides could result in damage to the doors. The installation of floor guides is recommended.

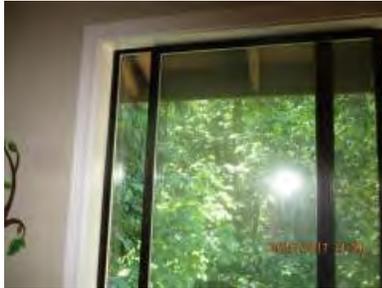
indicates a failed seal. The glass assembly should be replaced, which is the only method for correcting this deficiency.

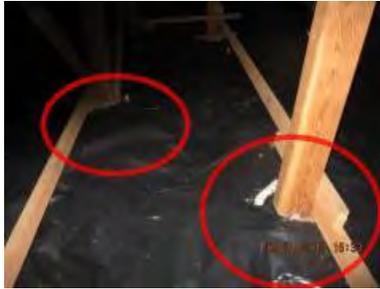
The support post concrete piers are covered with the plastic vapor retarder. This allows the transmission of water vapor from the soil up and into the floor framing. The plastic vapor retarder should be removed from the pier so that it covers the entire surface of the soil only.
