**Mr. & Mrs. Eric & Andrea James**  
**17015 NE 131st Pl.**  
**Redmond, WA.**

**Re: 17015NE 131st Pl.**  
**Redmond, WA.**

At your request, a visual inspection of the above referenced property was conducted on 08/07/2017. We have inspected the major structural components, plumbing, heating and electrical systems for signs of significant non-performance, excessive or unusual wear and general state of repair.

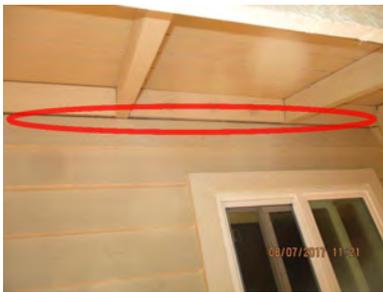
##### 3.3 SOFFITS AND OVERHANGS

There are large gaps over 1/4" in size adjacent the soffit vent blocks. These gaps allow insects and rodents to enter the attic. Covering the gaps with screening, a strip of wood and/or caulking is recommended.

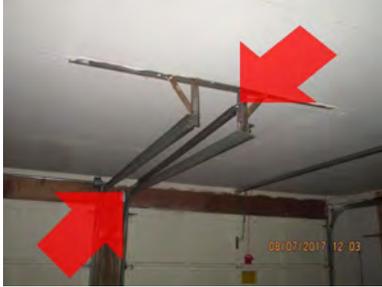
##### 6.2 OVERHEAD GARAGE DOORS

Safeties are cables run through the center of the garage door springs that prevent broken springs from becoming projectiles that can cause injury. There are no safeties installed. The installation of safeties is recommended.

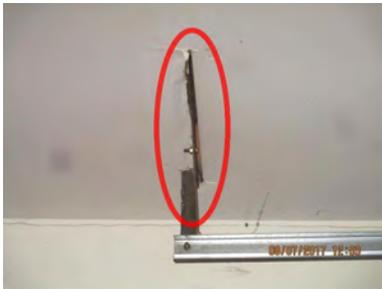
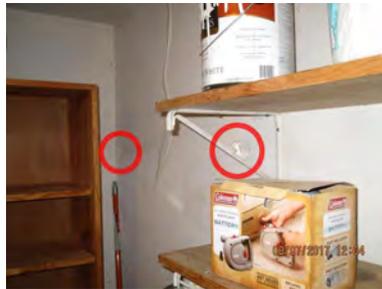
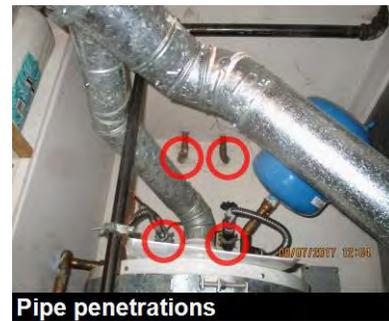
#### 6.4 FIRE SEPARATION

There are voids in the fire resistive barrier between the living space and garage that will allow flames to penetrate. The gypsum barrier slows the spread of a fire from the garage to the structure and/or living space. Patching the voids with a fire retardant caulk is recommended.

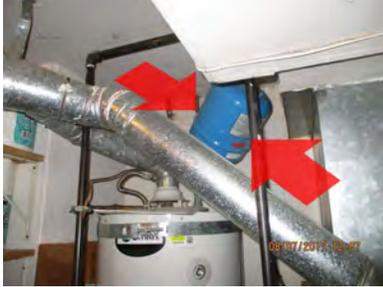
#### 9.6 EXPANSION TANK

The expansion tank is not adequately secured to the wall. This could result in damage to the water pipe and leakage during an earth quake. A seismic restraint should be installed to secure the expansion tank.

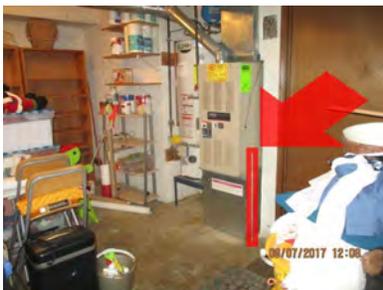
#### 13.11 GAS PIPING

The gas pipes in front of the furnace and water heater are not protected by a bumper stop. A vertical steel pipe, bolted to the floor, is typically installed in front of the water heater to prevent a car bumper from damaging the gas lines.

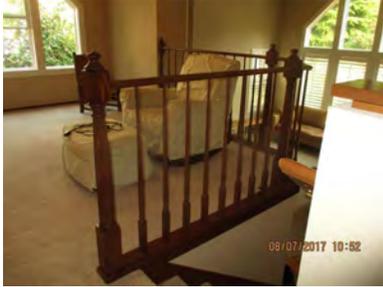
#### 14.3 GUARD RAILINGS

The spacing between the balusters is too wide. This is a hazard to small children. The balusters should be spaced close enough together so that a 4" sphere cannot pass through. Upgrading the guard railing is recommended if small children are present.

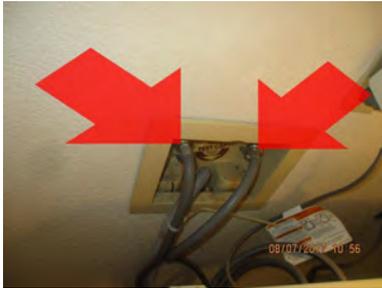
**12.1 APPLIANCES**

Upgrading the washer connections to high pressure (steel braided) lines is recommended.

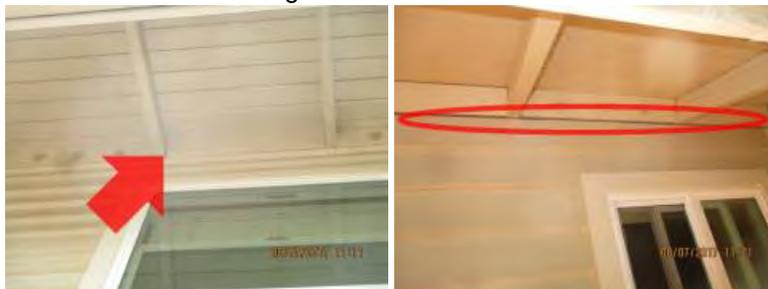
There are large gaps over 1/4" in size adjacent the soffit vent blocks. These gaps allow insects and rodents to enter the attic. Covering the gaps with screening, a strip of wood and/or caulking is recommended.

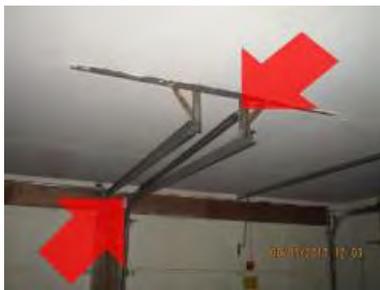
Safeties are cables run through the center of the garage door springs that prevent broken springs from becoming projectiles that can cause injury. There are no safeties installed. The installation of safeties is recommended.

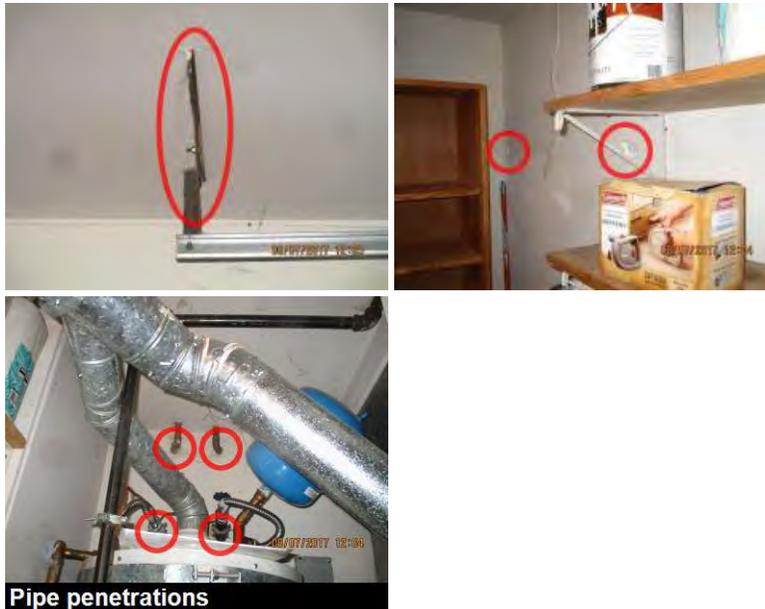
### **6.4 FIRE SEPARATION**

There are voids in the fire resistive barrier between the living space and garage that will allow flames to penetrate. The gypsum barrier slows the spread of a fire from the garage to the structure and/or living space. Patching the voids with a fire retardant caulk is recommended.

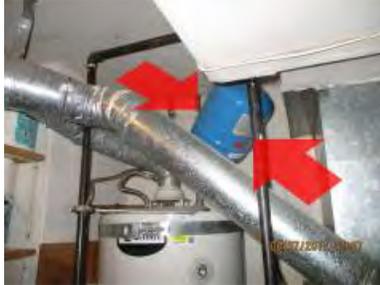
The expansion tank is not adequately secured to the wall. This could result in damage to the water pipe and leakage during an earth quake. A seismic restraint should be installed to secure the expansion tank.

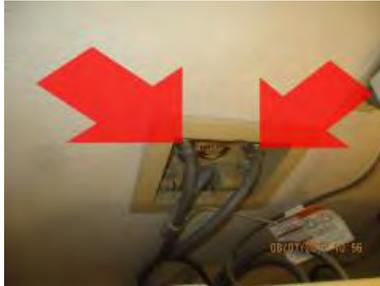
Upgrading the washer connections to high pressure (steel braided) lines is recommended.

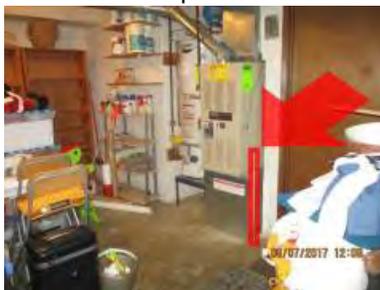
### 13.11 GAS PIPING

The gas pipes in front of the furnace and water heater are not protected by a bumper stop. A vertical steel pipe, bolted to the floor, is typically installed in front of the water heater to prevent a car bumper from damaging the gas lines.

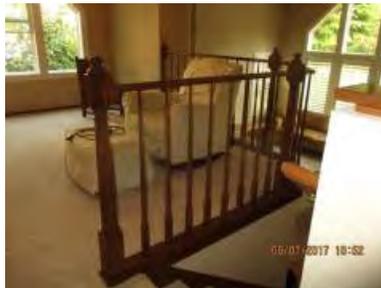
### 14.3 GUARD RAILINGS

The spacing between the balusters is too wide. This is a hazard to small children. The balusters should be spaced close enough together so that a 4" sphere cannot pass through. Upgrading the guard railing is recommended if small children are present.
