NOTICE TO BUYER: SELLER-PROCURED INSPECTION REPORT

July 25, 2017

Re: 7541 123rd Ave. NE
Kirkland, WA.

REPORT SUMMARY

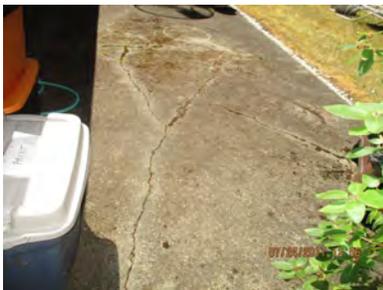
The patio has settled differentially. This was probably caused by inadequate preparation of the soil prior to the placement of the concrete. This condition can be repaired by pressure grouting the sunken portion of the patio or by removing and replacing it. The patio remains functional despite this condition. However, the raised edges of the concrete can be a trip hazard for some people. Repairs should be made as necessary.

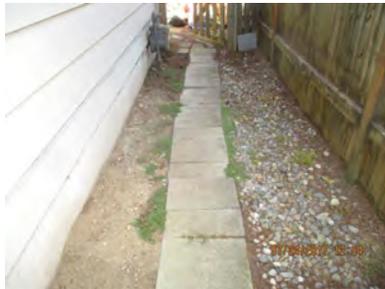
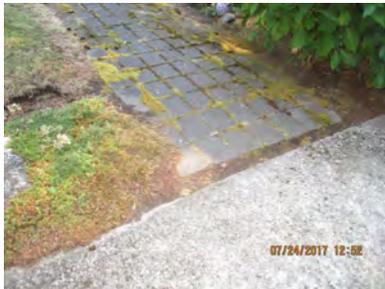
The walking surface was not even and trip hazards were present. We recommend all walking surfaces be maintained free of trip hazards.

The gaps separating the driveway and walkway is a trip hazard. Replacement with mortar is recommended.

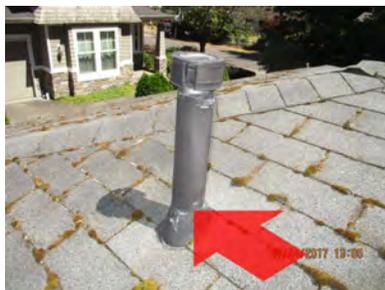
The storm collar is missing from the gas appliance vent. This will allow leakage to occur. The installation of a storm collar is recommended.

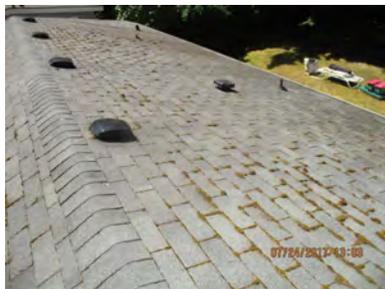
The roof is in need of routine maintenance. The surface should be treated for moss, lichen, and algae growth, then brushed and washed off with a high volume low pressure hose to remove moss and organic debris. Performing this maintenance will improve the appearance and increase the life expectancy of the roof.

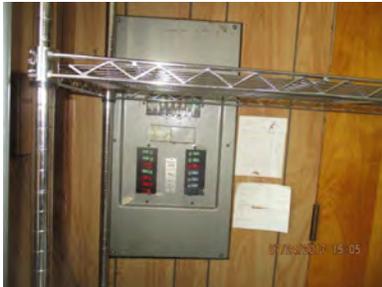
Access to the electrical panel is blocked by shelving. Shelves should be removed or modified so that there is a 30" wide by 36" deep by 7' tall clearance in front of the panel.

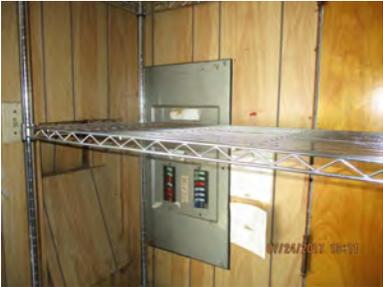
The breaker overheated and tripped when the washer and kitchen, hallway and bedroom circuits were tested simultaneously. This is a hazard. We recommend having an electrical contractor repair the defective circuit.

Overheating circuit breakers are considered a latent hazard and can fail, leading to electrical fires. Replacement of defective breakers are recommended.

The circuits are not labeled. Each circuit breaker should be labeled to allow servicing and repair of electrical circuits and equipment without having to shut off power to all electrical circuits. The services of a qualified electrician should be retained to perform this service.

Screws that secure the panel cover to the panel box are the wrong type. Screws should be replaced with the original style blunt end large head screws.

The main service panel was manufactured by Zinsco. Zinsco panels and circuit breakers have not been manufactured for some time, and some Zinsco circuit breakers have been known to fail to trip at their rated amperage. The panel and circuit breakers are considered a latent hazard and can fail leading to electrical fires. Replacement of this panel is recommended as a safety upgrade.

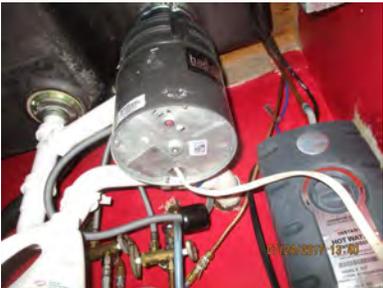
The cord is not clamped where it enters the disposal. This could damage the wires or cause a ground fault. The cord should be clamped in accordance with industry standards.

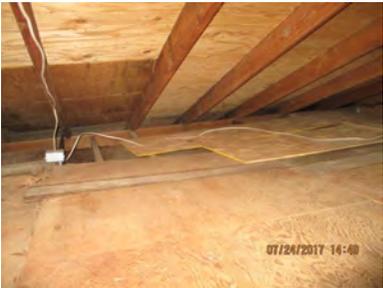
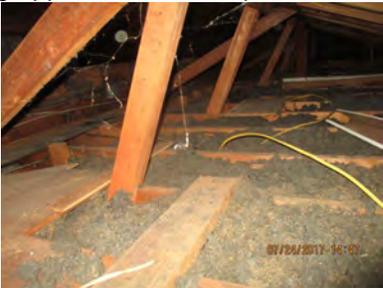
Loose electrical cables were observed in the attic. Loose cables are vulnerable to damage. All loose cables should be secured at 4' intervals using approved cable staples.

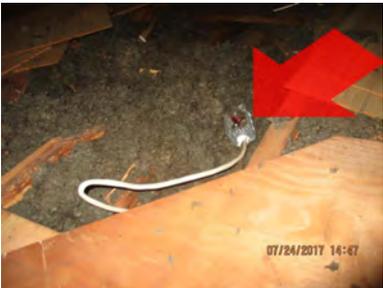
There is a loose junction box in the attic. This is a fire/shock hazard. All junction boxes should be secured to the framing.

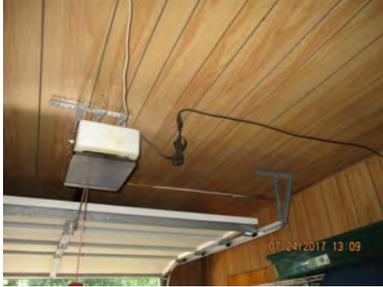
An extension cord is used as a temporary power source for the garage door opener. An extension cord is not suitable as a permanent wiring method. The installation of a receptacle within cords length of the motor is recommended.

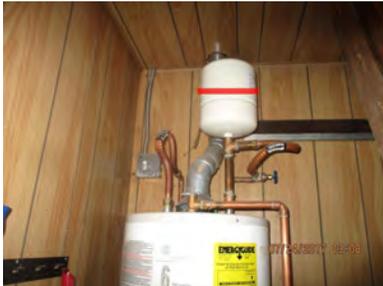
The expansion tank is not adequately secured to the wall. This could result in damage to the water pipe and leakage during an earth quake. A seismic restraint should be installed to secure the expansion tank.

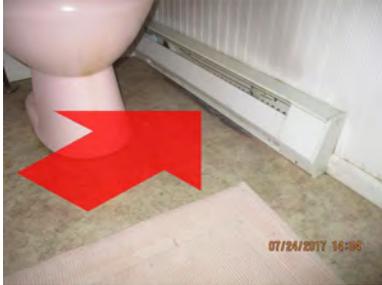
The vinyl flooring is damaged under the baseboard heater. The flooring should be replaced as necessary to restore cosmetic appearance. The subfloor underneath the vinyl flooring appears to be solid.

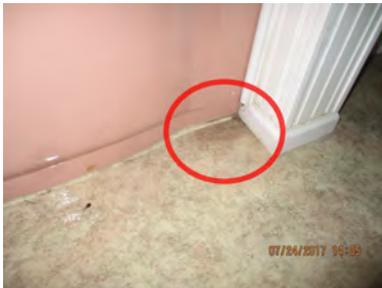
The vinyl flooring is damaged from water intrusion into the substrate. The flooring should be replaced as necessary to restore cosmetic appearance. The subfloor underneath the vinyl flooring appears to be solid.

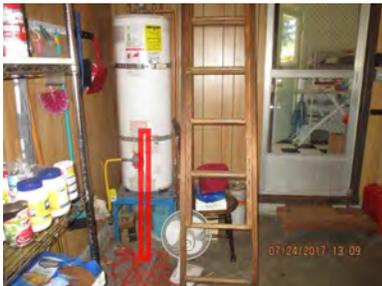
The gas pipes adjacent to the water heater are not protected by a bumper stop. A vertical steel pipe, bolted to the floor, is typically installed in front of the water heater to prevent a car bumper from damaging the gas lines.

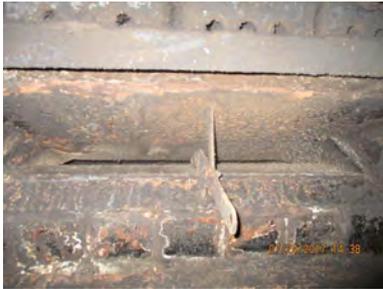
The fireplace damper is stuck in the open position. This allows heat to escape up the chimney and could result in odors emanating from the fireplace. Repairing the damper is recommended.

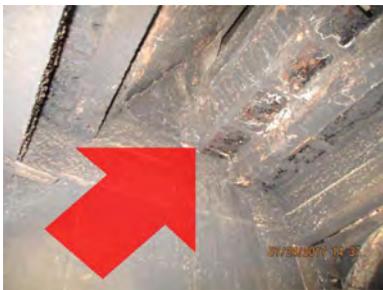
An examination of the inside of the chimney revealed a significant accumulation of creosote. Smoldering fires and the burning of green or wet wood are the primary contributors to creosote build-up. Creosote in a chimney flue is dangerous because it is the fuel for a chimney fire. Chimney fires produce intense heat and sparks. The intense heat can crack the flue tile, brick and mortar of a masonry chimney. After holes or cracks have developed, chimney fires can cause the wood framing or roof of the house to catch on fire. To avoid chimney fires, flues should be cleaned and inspected at least once a year with moderate use. More frequent cleaning may be required depending on amount of use and burning practice.

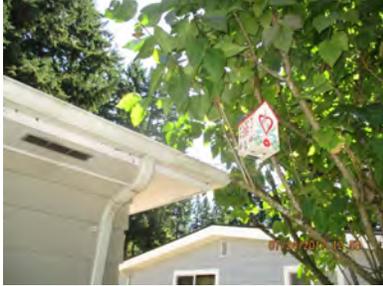
Trees are touching the building on the southwest corner.. Low hanging tree branches can damage the roof. Tree branches should be trimmed back where necessary.

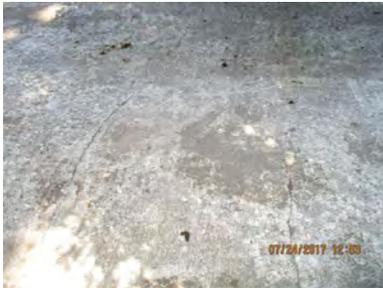
Cracks were observed in the concrete surface of the driveway. Minor cracks can be sealed to minimize moisture entry and further settlement of the concrete. Minor cracks are common and do not affect the serviceability of the concrete.

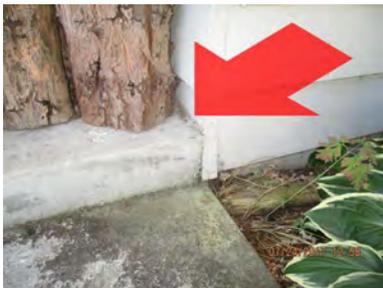
Firewood is stored directly on grade in a wet area adjacent to the building. This creates conducive conditions for wood boring insects. Firewood should be installed in a dry area (in a wood shed) and should be elevated at least 6" above the grade.

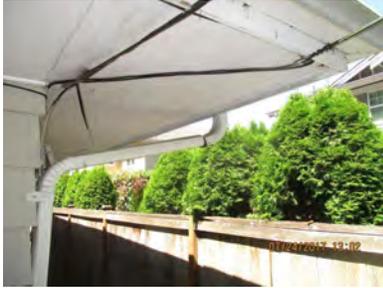
The downspout is detached from the gutter at the northeast corner. The downspout should be reattached and secured.

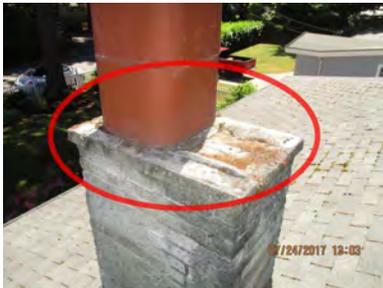
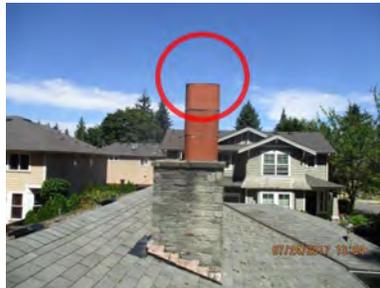
The chimney crown is cracked and deteriorated. The mortar chimney crown prevents water from entering and damaging the masonry. Repairing or replacing the chimney crown will extend the service life of the chimney.

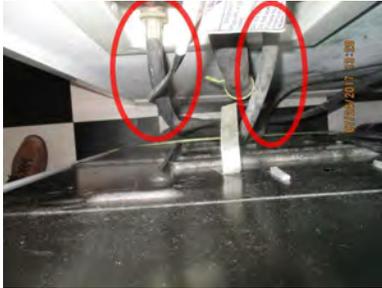
Upgrading the washer connections to high pressure (steel braided) lines is recommended.

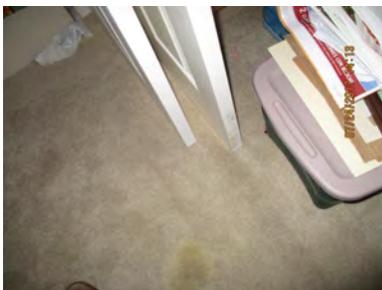
The floor guides are missing from the bypass closet doors in the bedroom. Missing floor guides could result in damage to the doors. The installation of floor guides is recommended.

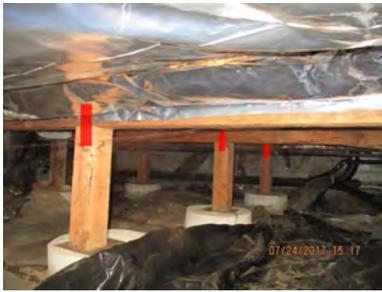
There are no gusset plates tying the beams and posts together. The installation of gusset plates is recommend to reduce the likelihood of damage during an earthquake.

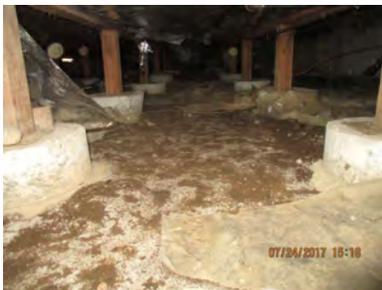
Some of the soil under the house is not covered with a polyethylene plastic vapor retarder. This component is typically referred to as a "vapor barrier". While not a true vapor barrier, it does reduce the transmission of water vapor from the soil to the air. Additional 6 mil black polyethylene plastic should be installed so that it covers the entire surface of the soil.

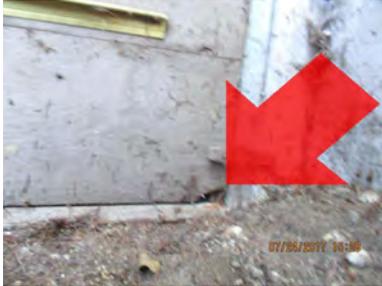
The crawlspace access door is not rodent proof. The installation of a tight fitting access door is recommended to exclude rodents from the crawlspace.

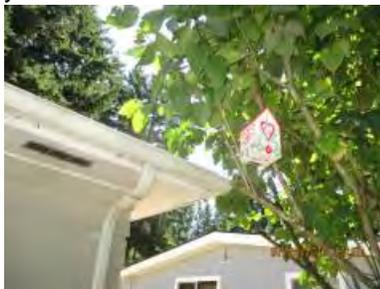
Trees are touching the building on the southwest corner.. Low hanging tree branches can damage the roof. Tree branches should be trimmed back where necessary.

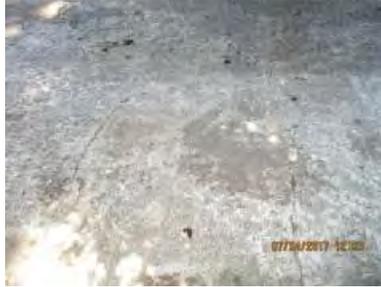
Cracks were observed in the concrete surface of the driveway. Minor cracks can be sealed to minimize moisture entry and further settlement of the concrete. Minor cracks are common and do not affect the serviceability of the concrete.

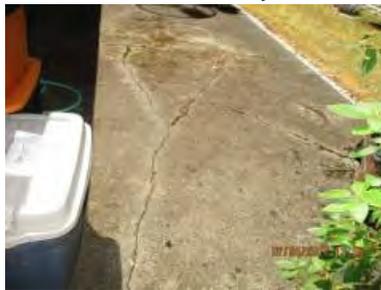
The patio has settled differentially. This was probably caused by inadequate preparation of the soil prior to the placement of the concrete. This condition can be repaired by pressure grouting the sunken portion of the patio or by removing and replacing it. The patio remains functional despite this condition. However, the raised edges of the concrete can be a trip hazard for some people. Repairs should be made as necessary.

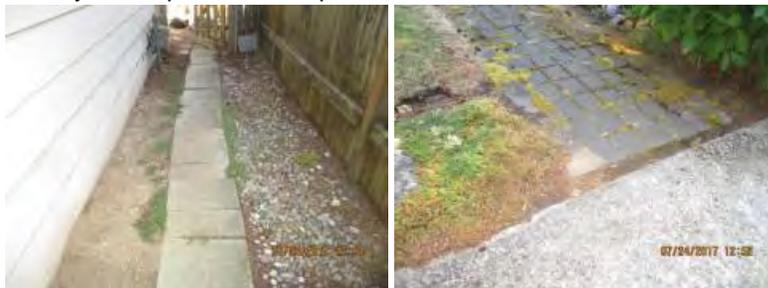
The gaps separating the driveway and walkway is a trip hazard. Replacement with mortar is recommended.

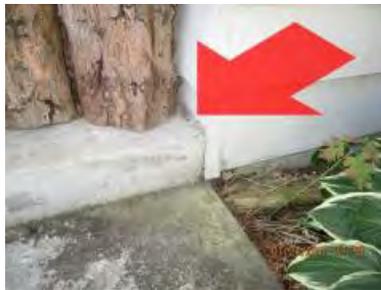
Firewood is stored directly on grade in a wet area adjacent to the building. This creates conducive conditions for wood boring insects. Firewood should be installed in a dry area (in a wood shed) and should be elevated at least 6" above the grade.

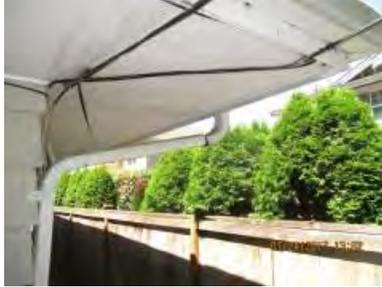
The downspout is detached from the gutter at the northeast corner. The downspout should be reattached and secured.

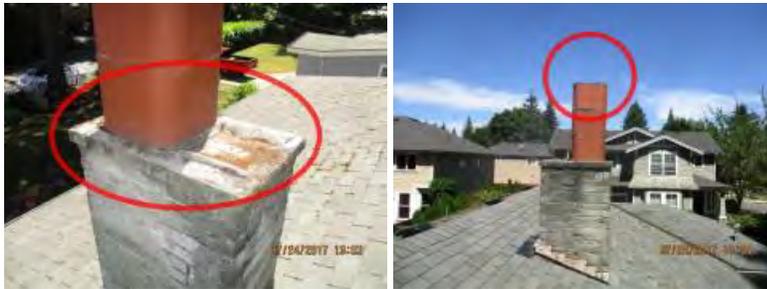
The top of the masonry chimney does not have a spark arrestor/rain cap. The installation of a spark arrestor/rain cap is recommended as a safety upgrade and to prevent moisture damage to the inside of the chimney and fireplace. An additional benefit of a rain cap is that it will keep birds and rodents from entering the house when the damper is left open.

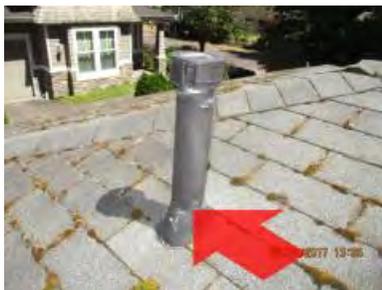
The storm collar is missing from the gas appliance vent. This will allow leakage to occur. The installation of a storm collar is recommended.

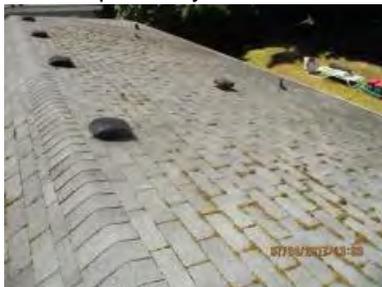
The roof is in need of routine maintenance. The surface should be treated for moss, lichen, and algae growth, then brushed and washed off with a high volume low pressure hose to remove moss and organic debris. Performing this maintenance will improve the appearance and increase the life expectancy of the roof.

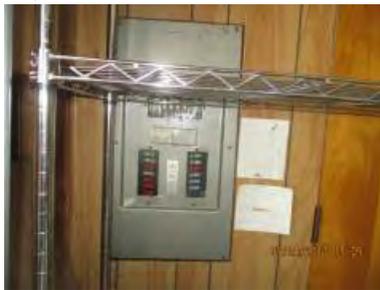
Access to the electrical panel is blocked by shelving. Shelves should be removed or modified so that there is a 30" wide by 36" deep by 7' tall clearance in front of the panel.

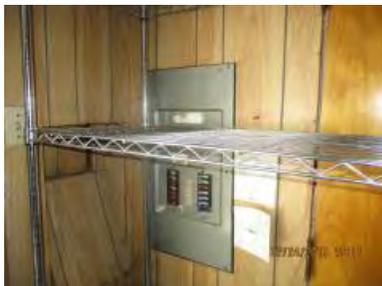
The main service panel was manufactured by Zinsco. Zinsco panels and circuit breakers have not been manufactured for some time, and some Zinsco circuit breakers have been known to fail to trip at their rated amperage. The panel and circuit breakers are considered a latent hazard and can fail leading to electrical fires. Replacement of this panel is recommended as a safety upgrade.

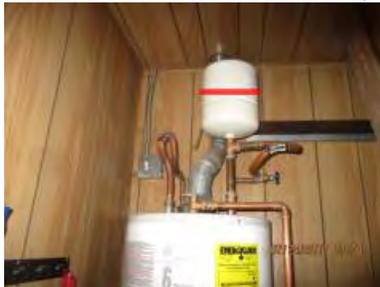
The expansion tank is not adequately secured to the wall. This could result in damage to the water pipe and leakage during an earth quake. A seismic restraint should be installed to secure the expansion tank.

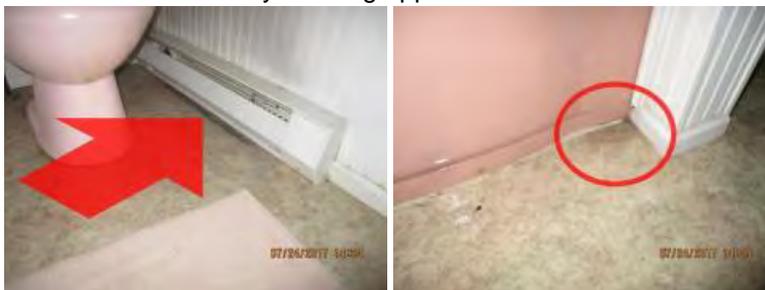
The vinyl flooring is damaged from water intrusion into the substrate. The flooring should be replaced as necessary to restore cosmetic appearance. The subfloor underneath the vinyl flooring appears to be solid.

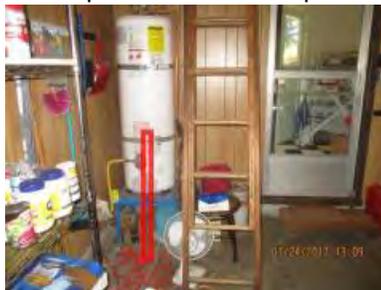
The gas pipes adjacent to the water heater are not protected by a bumper stop. A vertical steel pipe, bolted to the floor, is typically installed in front of the water heater to prevent a car bumper from damaging the gas lines.

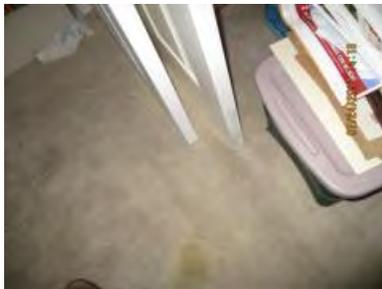
The floor guides are missing from the bypass closet doors in the bedroom. Missing floor guides could result in damage to the doors. The installation of floor guides is recommended.

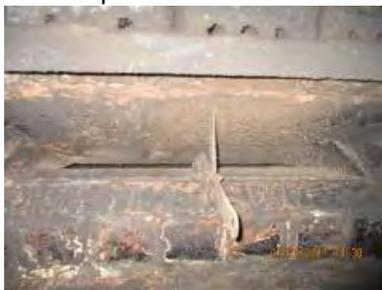
The fireplace damper is stuck in the open position. This allows heat to escape up the chimney and could result in odors emanating from the fireplace. Repairing the damper is recommended.

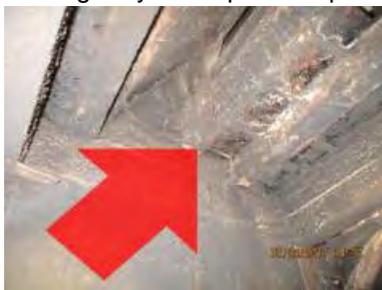
An examination of the inside of the chimney revealed a significant accumulation of creosote. Smoldering fires and the burning of green or wet wood are the primary contributors to creosote build-up. Creosote in a chimney flue is dangerous because it is the fuel for a chimney fire. Chimney fires produce intense heat and sparks. The intense heat can crack the flue tile, brick and mortar of a masonry chimney. After holes or cracks have developed, chimney fires can cause the wood framing or roof of the house to catch on fire. To avoid chimney fires, flues should be cleaned and inspected at least once a year with moderate use. More frequent cleaning may be required depending on amount of use and burning practice.

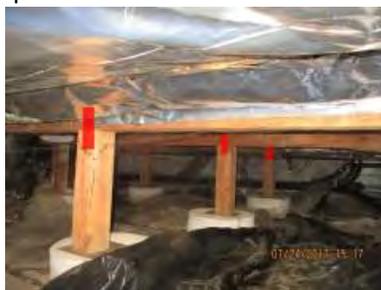
There are no gusset plates tying the beams and posts together. The installation of gusset plates is recommend to reduce the likelihood of damage during an earthquake.

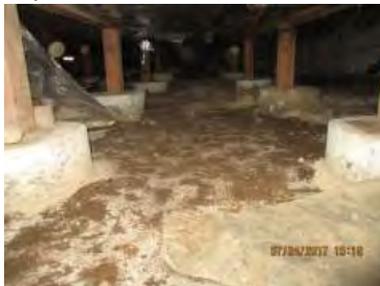
Some of the soil under the house is not covered with a polyethylene plastic vapor retarder. This component is typically referred to as a "vapor barrier". While not a true vapor barrier, it does reduce the transmission of water vapor from the soil to the air. Additional 6 mil black polyethylene plastic should be installed so that it covers the entire surface of the soil.

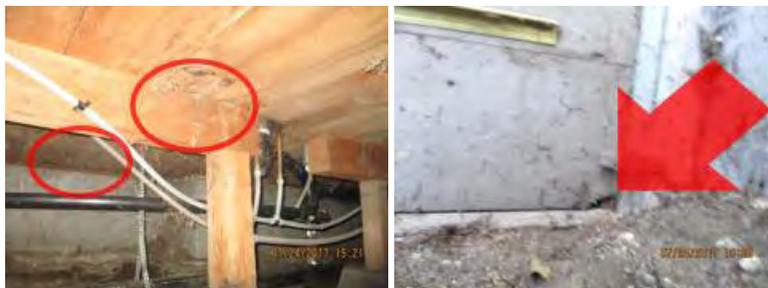
The crawlspace access door is not rodent proof. The installation of a tight fitting access door is recommended to exclude rodents from the crawlspace.
