NOTICE TO BUYER: SELLER-PROCURED INSPECTION REPORT

Nathan and Sarah Gai
13830 173rd Ave NE | Redmond, WA 98052

At your request, a visual inspection of the above referenced property was conducted on 08/31/2017. We have inspected the major structural components, plumbing, heating and electrical systems for signs of significant non-performance, excessive or unusual wear and general state of repair.

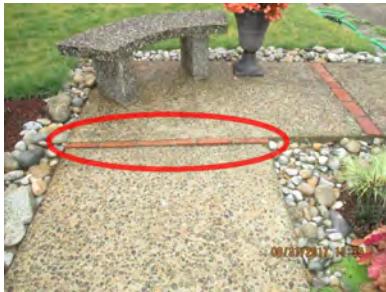
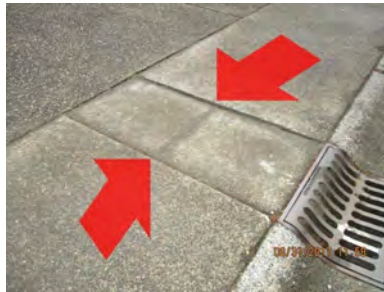
2.5 WALKWAY

The walking surface was not even and trip hazards were present. We recommend all walking surfaces be maintained free of trip hazards.

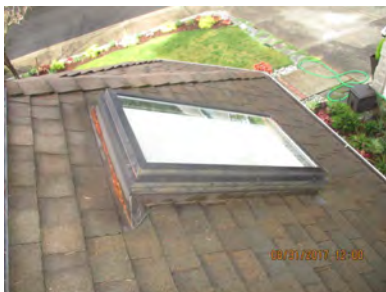
The skylight is not secured to the roof. Skylights can get blown off roofs during high winds if they are not secured. Fastening the skylight to the curb with four plated or stainless screws is recommended.

4.3 SKYLIGHTS – corrected on 9.3.17

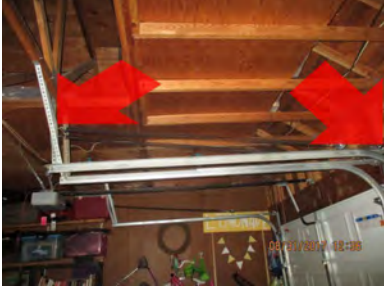
6.2 OVERHEAD GARAGE DOORS

Safeties are cables run through the center of the garage door springs that prevent broken springs from becoming projectiles that can cause injury. There are no safeties installed. The installation of safeties is recommended.

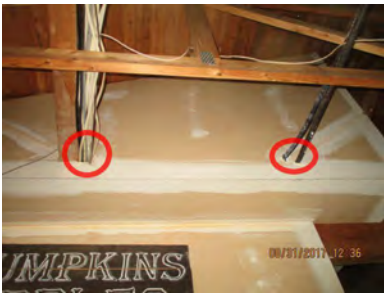
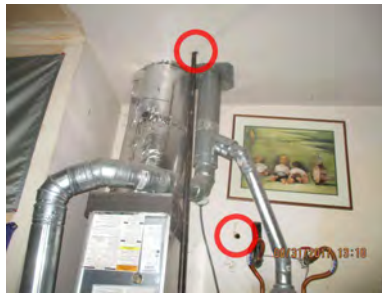
6.4 FIRE SEPARATION

There are voids in the fire resistive barrier between the living space and garage that will allow flames to penetrate. The gypsum barrier slows the spread of a fire from the garage to the structure and/or living space. Patching the voids with a fire retardant caulk is recommended.

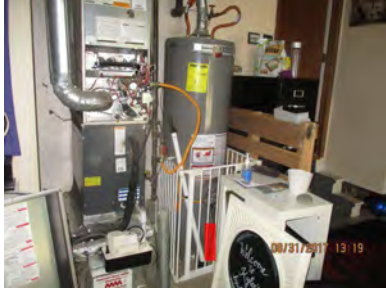
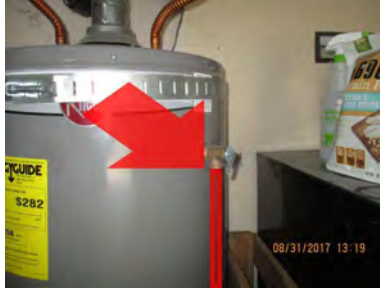
The pressure relief valve lacks a drain pipe. This is a scald hazard. The installation of a 3/4" copper, CPVC plastic or galvanized steel drain pipe is recommended. Ideally, the drain should be routed to the exterior. However, running the pipe straight down to the floor eliminates the scald hazard.

10.3 PRESSURE RELIEF VALVE – corrected on 9.3.17

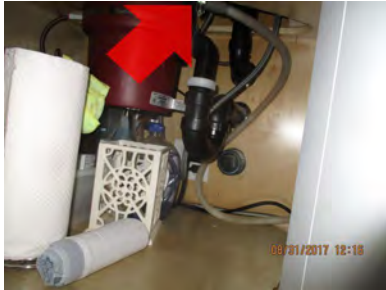
11.8 AIR GAP

The dishwasher drain lacks an air gap. The dishwasher will function without one, but there is a risk of contamination of the inside of the dishwasher by waste water. The installation of an air gap is recommended.

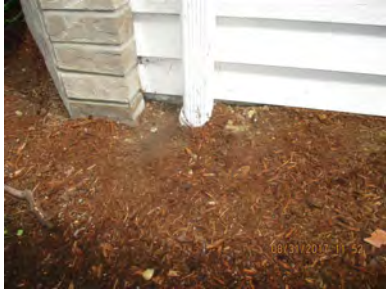
The inlet at the northwest corner is at or below grade level. This condition allows beauty bark and dirt to enter

the drain inlet and may eventually clog it up. Soil should be moved away from drain line inlets, or the drain line inlets should be extended up above the soil. Drain inlets should be capped to prevent rodent entry.

2.1 ROOF WATER DRAIN SYSTEM – corrected 9.3.17

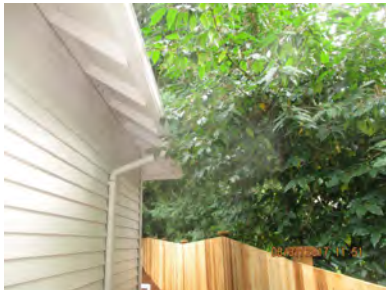
Trees are touching the building on the west side. Low hanging tree branches can damage the roof. Tree branches should be trimmed back where necessary.

2.3 VEGETATION – corrected 9.3.17

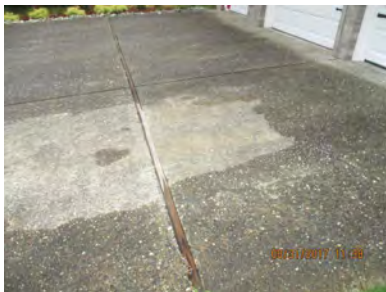
2.4 DRIVEWAY

One or more of the wooden dividers separating the concrete driveway sections were infested by wood destroying organisms and have deteriorated to a point where they are becoming a trip hazard. Replacement with mortar is recommended.

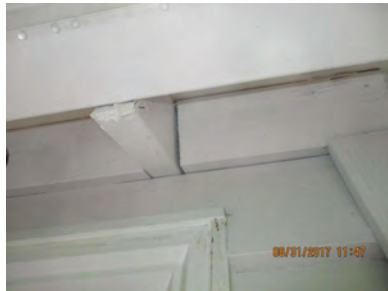
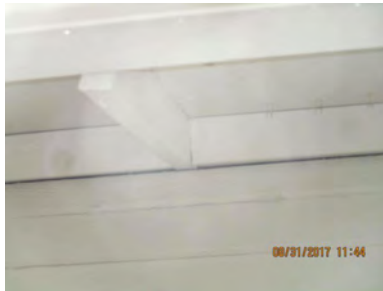
3.3 SOFFITS AND OVERHANGS

There are large gaps over 1/4" in size adjacent the soffit vent blocks. These gaps allow insects and rodents to enter the attic. Covering the gaps with screening, a strip of wood and/or caulking is recommended.

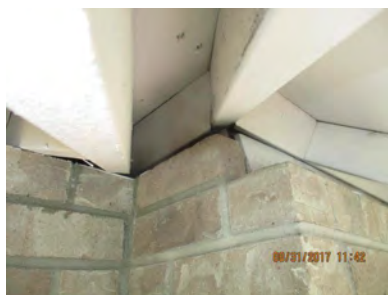
There are openings at the intersection between the overhang and the roof through which birds and rodents can enter into the attic. These openings should be covered with wood, wire mesh or filled with aerosol foam.

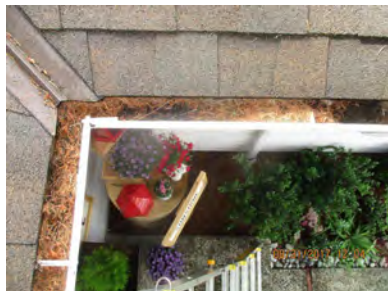
There is a build-up of organic debris inside the gutters. Proper maintenance of gutters and downspouts is essential and should be performed routinely in order to prevent clogging. Maintenance consists primarily of keeping leaves and other organic debris out of the system. Failure to clean the gutters will result in water splash on the building when they overflow. Gutters can be damaged under the weight of the water and organic matter inside the gutter. Gutters should be cleaned as necessary to maintain a free flow of water into the downspouts.

3.4 GUTTERS AND DOWNSPOUTS – corrected 9.3.17

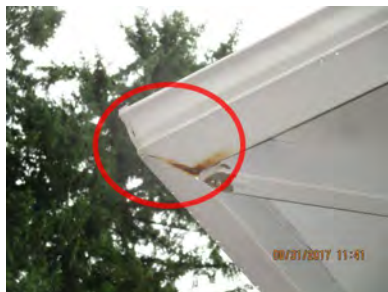
The gutters are leaking at the miter joints. The miter joints should be cleaned and sealed with "Gutter Seal" or a similar type gutter joint sealant.

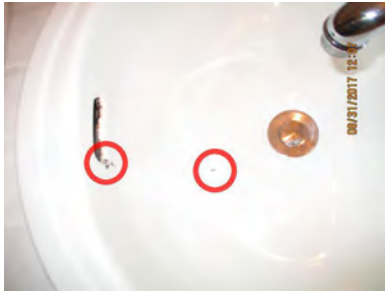
12.6 SINK

The surface of the sink is chipped. This is a cosmetic concern and does not affect the function of the sink. Replacement for better appearance should be considered.

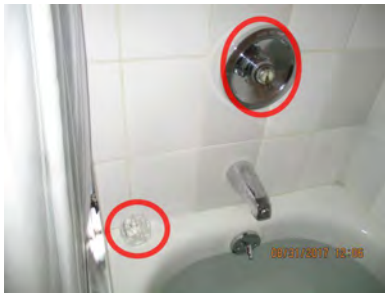
The bathtub faucet handle is damaged. The handle should be replaced.

12.8 FAUCET FIXTURES – corrected 9.3.17

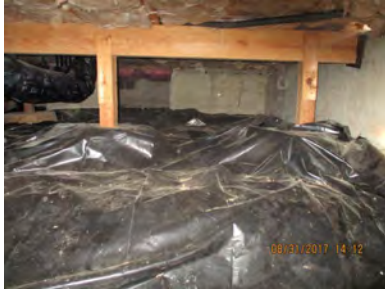
20.4 VAPOR RETARDER

The support post concrete piers are covered with the plastic vapor retarder. This allows the transmission of water vapor from the soil up and into the floor framing. The plastic vapor retarder should be removed from the pier so that it covers the entire surface of the soil only.

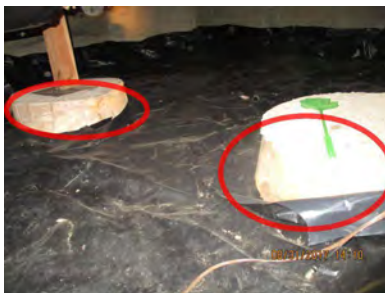
There is evidence of rodent activity in the crawlspace. The first step in eliminating rodents from the crawlspace is to seal all possible entry points using wire mesh, caulking, wood, stainless steel wool, aerosol foam or mortar. Careful work sealing cracks, holes, gaps, and covering ground water drain inlets will discourage rodent activity. Once this work is completed, snap traps baited with peanut butter should be installed and monitored. The absence of rodents in the traps typically means that the rodents have been excluded from the area.

Cellulose forms were left in place on the pier footings. This cellulose is conducive to the infestation of various wood destroying organisms. The removal of the cellulose is recommended.

All open spaces have been sealed. Activity was from construction activity, not rodents, per sellers' individual inspection. Seller will have a licensed pest company inspect the crawl space and perform additional repairs as needed.

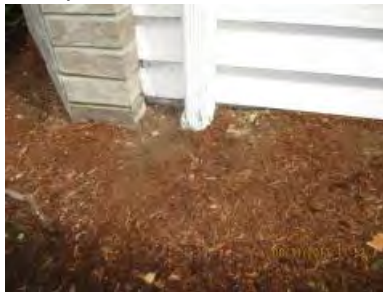
Defects in these drain systems are one of the most common causes of water or moisture problems in ground floor occupancies, basements and crawlspaces. Overflowing gutters and clogged downspouts and scuppers also frequently cause or exacerbate moisture or water entry problems in and around the building. If water entry or moisture problems are discovered, check the entire roof water drain system to insure that it is functioning properly.

Occasionally, (once a year) flushing out the drain lines with a garden hose will reduce the build-up of debris and sludge which could impede drainage. This type of maintenance is most effective if the end of the drain line terminates in open air or in a storm sewer. If the drain line terminates in a dry well or leach field, then the washing of debris down the line is not advisable. The debris may eventually clog the perforations in the line which allow the water to escape. This could render the drain system inoperative. It is always best to prevent debris from entering at the inlet.

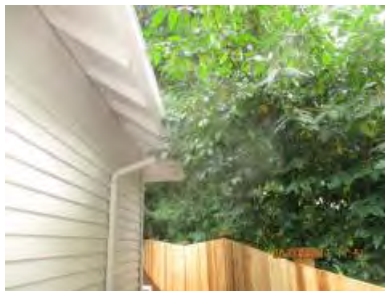
Trees are touching the building on the west side. Low hanging tree branches can damage the roof. Tree branches should be trimmed back where necessary.

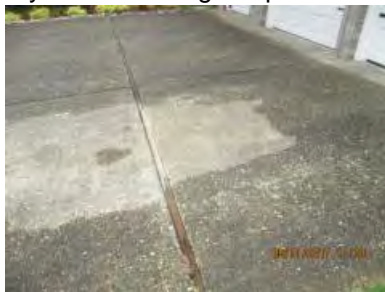
2.4 DRIVEWAY

One or more of the wooden dividers separating the concrete driveway sections were infested by wood destroying organisms and have deteriorated to a point where they are becoming a trip hazard. Replacement with mortar is recommended.

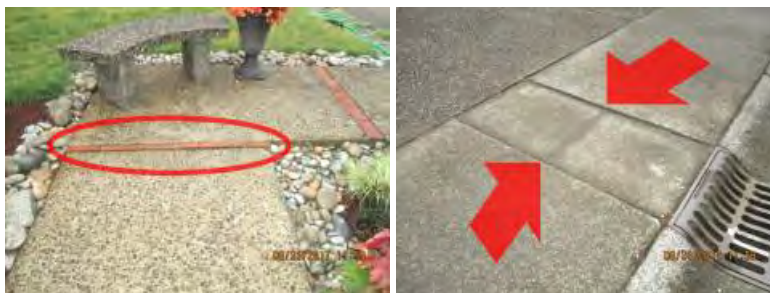
2.5 WALKWAY

The walking surface was not even and trip hazards were present. We recommend all walking surfaces be maintained free of trip hazards.

Many legal and public works departments have defined a trip hazard as an irregularity in a walking surface exceeding one inch (1") in height. All walking surfaces should maintain, free of a vertical surface change of 3/4" or more, in the interest of public and personal safety.

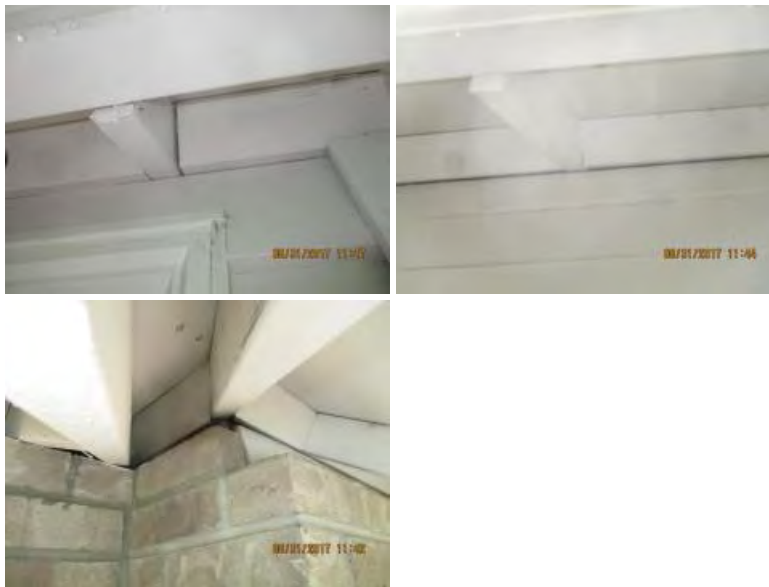
There are large gaps over 1/4" in size adjacent the soffit vent blocks. These gaps allow insects and rodents to enter the attic. Covering the gaps with screening, a strip of wood and/or caulking is recommended.

There are openings at the intersection between the overhang and the roof through which birds and rodents can enter into the attic. These openings should be covered with wood, wire mesh or filled with aerosol foam.

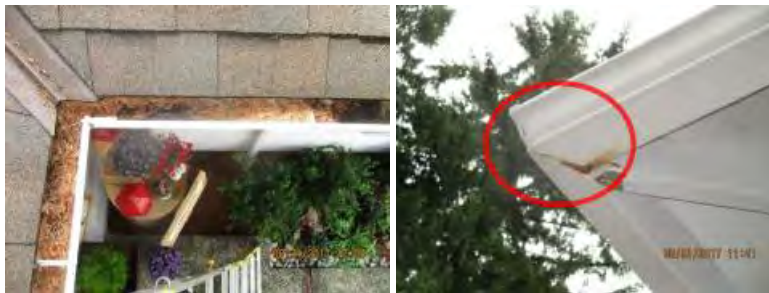
3.4 GUTTERS AND DOWNSPOUTS

There is a build-up of organic debris inside the gutters. Proper maintenance of gutters and downspouts is essential and should be performed routinely in order to prevent clogging. Maintenance consists primarily of keeping leaves and other organic debris out of the system. Failure to clean the gutters will result in water splash on the building when they overflow. Gutters can be damaged under the weight of the water and organic matter inside the gutter. Gutters should be cleaned as necessary to maintain a free flow of water into the downspouts.

The gutters are leaking at the miter joints. The miter joints should be cleaned and sealed with "Gutter Seal" or a similar type gutter joint sealant.

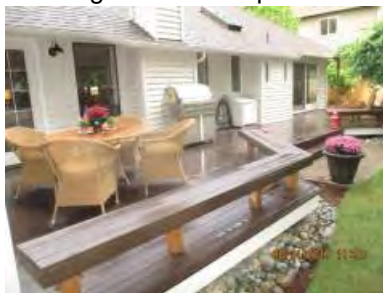
3.6 DECK

The deck is installed close to the ground making it more vulnerable to deterioration. The proximity of the deck to the ground also prevented an inspection of the deck framing. The visible portions of the deck are in good condition.

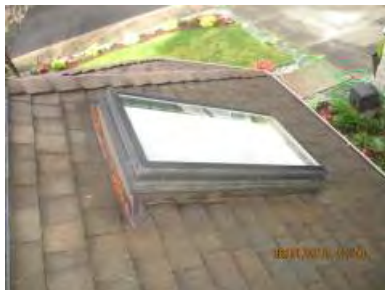
4.3 SKYLIGHTS

The skylight is not secured to the roof. Skylights can get blown off roofs during high winds if they are not secured. Fastening the skylight to the curb with four plated or stainless screws is recommended.

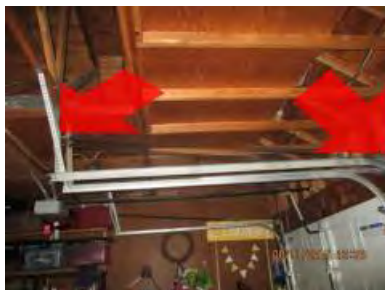
Safeties are cables run through the center of the garage door springs that prevent broken springs from becoming projectiles that can cause injury. There are no safeties installed. The installation of safeties is recommended.

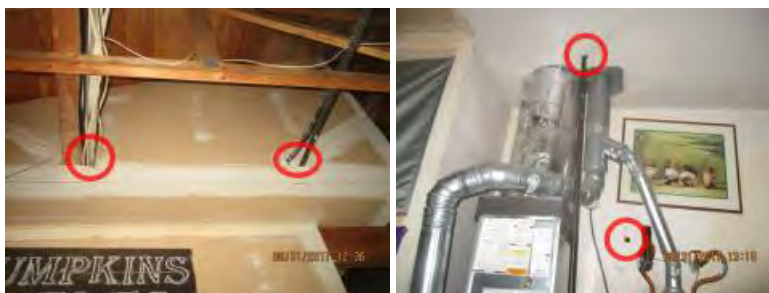
6.4 FIRE SEPARATION

There are voids in the fire resistive barrier between the living space and garage that will allow flames to penetrate. The gypsum barrier slows the spread of a fire from the garage to the structure and/or living space. Patching the voids with a fire retardant caulk is recommended.

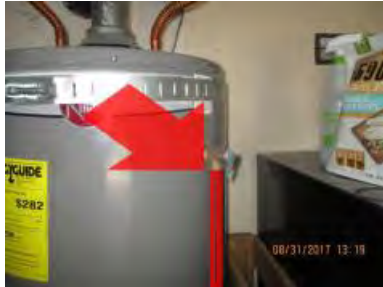
10.3 PRESSURE RELIEF VALVE

The pressure relief valve lacks a drain pipe. This is a scald hazard. The installation of a 3/4" copper, CPVC plastic or galvanized steel drain pipe is recommended. Ideally, the drain should be routed to the exterior. However, running the pipe straight down to the floor eliminates the scald hazard.

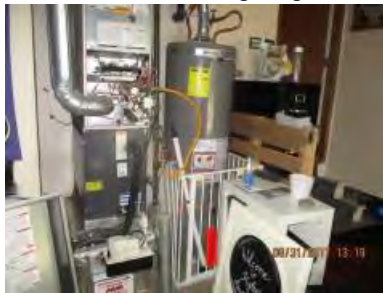
The water heater is not elevated above the garage floor in accordance with industry standards. This is a hazard. Elevating the water heater so that the burner is at least 18" above the garage floor prevents ignition of gasoline fumes.

10.12 ELEVATION ABOVE GARAGE FLOOR – corrected on 8.31.17

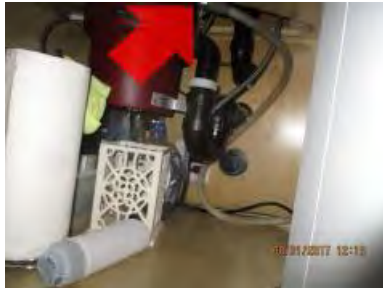
11.8 AIR GAP

The dishwasher drain lacks an air gap. The dishwasher will function without one, but there is a risk of contamination of the inside of the dishwasher by waste water. The installation of an air gap is recommended.

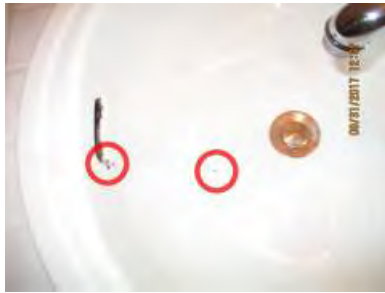
The surface of the sink is chipped. This is a cosmetic concern and does not affect the function of the sink. Replacement for better appearance should be considered.

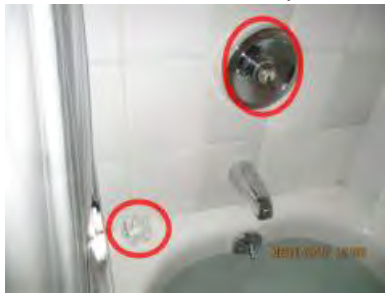
The bathtub faucet handle is damaged. The handle should be replaced.

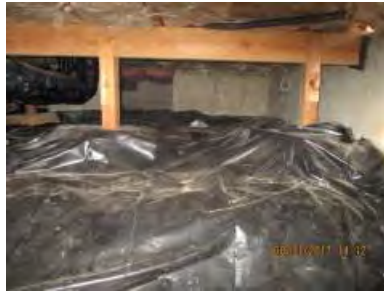
the soil up and into the floor framing. The plastic vapor retarder should be removed from the pier so that it covers the entire surface of the soil only.

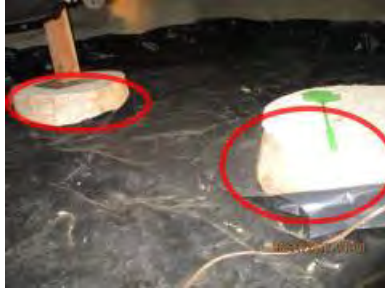
Good building practice requires that foundation walls or pier footings supporting wood frame construction, should extend at least 8" above the finish grade with at least a 6" clearance between the top of the soil and the bottom of the wood finish materials. Untreated wood should be raised 1-2" above surrounding flatwork and should have a moisture barrier such as 30 lb. asphalt impregnated felt installed between the concrete and wood. For additional information and treatment options, you should retain the services of a qualified pest control operator.
