NOTICE TO BUYER: SELLER-PROCURED INSPECTION REPORT

James and Amanda Records
8836 NE 138th St.
Kirkland WA 98034

At your request, a visual inspection of the above referenced property was conducted on 09/08/2017. We have inspected the major structural components, plumbing, heating and electrical systems for signs of significant non-performance, excessive or unusual wear and general state of repair.

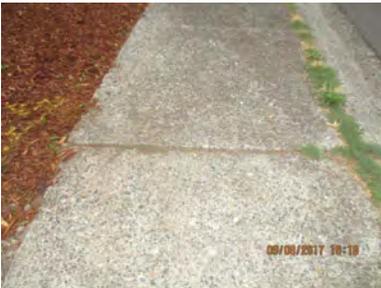
The walkway has cracked and settled differentially. This was probably caused by inadequate preparation of the soil prior to the placement of the concrete. This condition can be repaired by pressure grouting the sunken portion of the walkway or by removing and replacing it. The walkway remains functional despite this condition. However, the raised edges of the concrete can be a trip hazard for some people. Grinding down the raised edges of the concrete will mitigate the hazard. Repairs should be made as necessary.

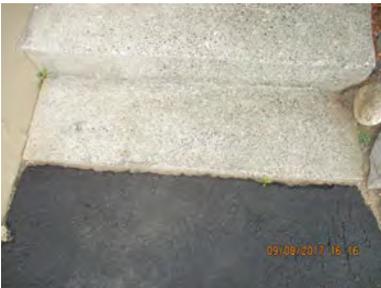
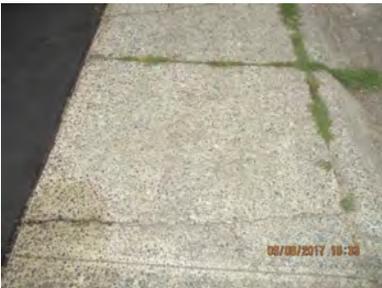
Cracks were observed in the concrete surface of the walkway. Minor cracks can be sealed to minimize moisture entry and further settlement of the concrete.

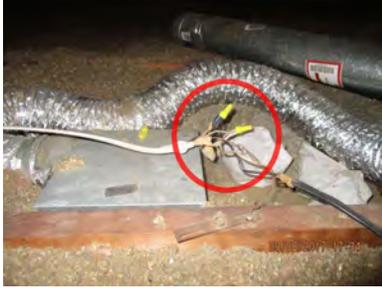
Splices in cable made outside of a junction box were observed in the attic. This is a fire hazard. The splices should be made inside an approved box with a cover.

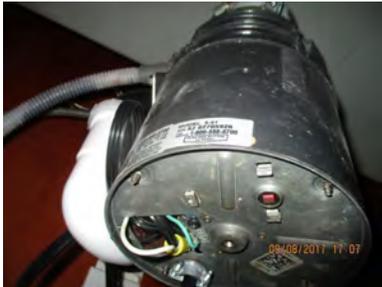
The wires are not protected where they enter the disposal. This could damage the wires or cause a ground fault. The cord should be clamped and covered in accordance with industry standards.

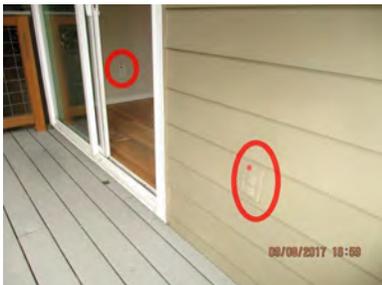
There are numerous loose receptacles throughout the home. This is a potential shock and a fire hazard. All loose receptacles should be repaired as necessary.

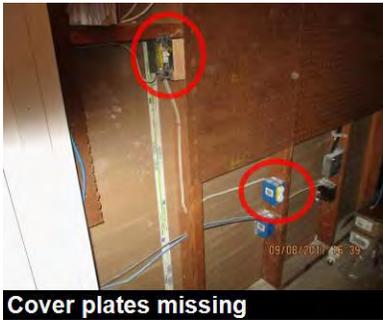
Cover plates are missing from receptacles in the closet under the stairs and adjacent to the water heating unit. This is a shock and fire hazard. The installation of cover plates on all receptacles is recommended.

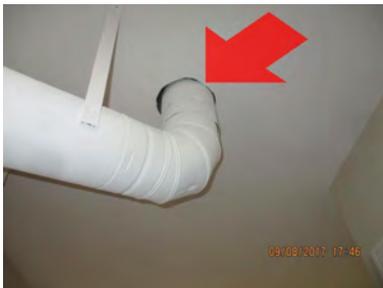
The furnace vent connector is too close to a combustible material. This is a hazard. A minimum clearance of 6" is required between the single wall vent connector and the combustible material. The double wall type B vent requires only 1" of clearance. Repairs are recommended.

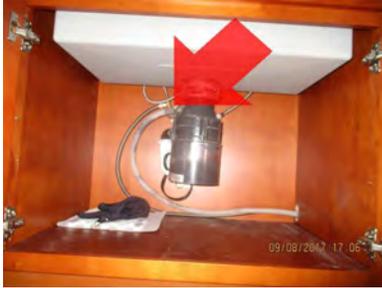
The dishwasher drain lacks an air gap. The dishwasher will function without one, but there is a risk of contamination of the inside of the dishwasher by waste water. The installation of an air gap is recommended.

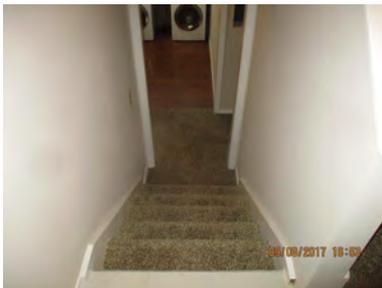
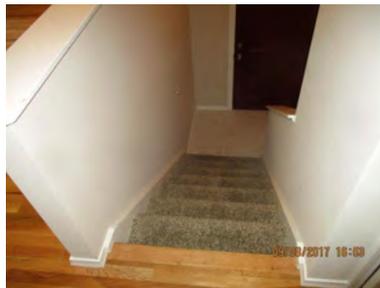
There is no handrail in the stairwell. This is a safety hazard. The installation of a graspable handrail that conforms to present industry standards is recommended.

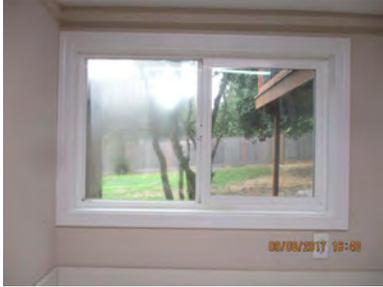
13.7 WINDOWS

There is condensation or mineral deposits between the panes of glass in one of the insulated glass window panes. This indicates a failed seal. The glass assembly should be replaced, which is the only method for correcting this deficiency.

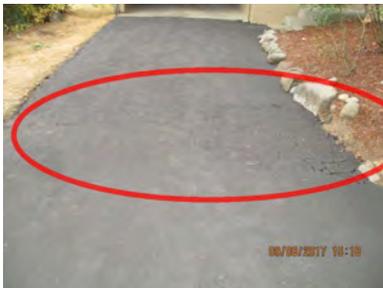
Portions of the asphalt driveway and parking areas are deteriorated. The deteriorated areas are not adversely affecting the function of the driveway, therefore patching or resurfacing is optional.

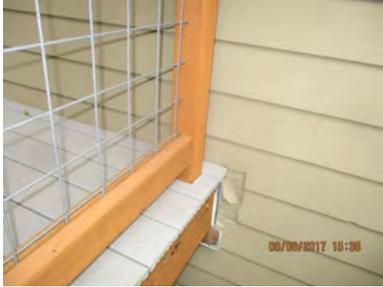
3.1 PRIMARY EXTERIOR WALL CLADDING

Sections of siding adjacent the deck are missing. Consideration should be given to installing flashing and/or caulk to prevent moisture or pest entry into this area.

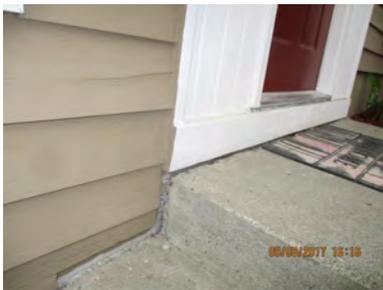
3.2 PEST CONTROL

Untreated wood in direct contact with concrete was observed along the entry stoop. Untreated wood should be raised 1-2" above the concrete. Treating the wood with a preservative sometimes will prevent wood destroy organism damage.

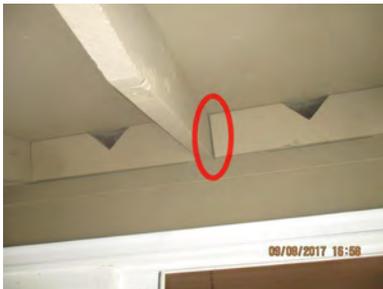
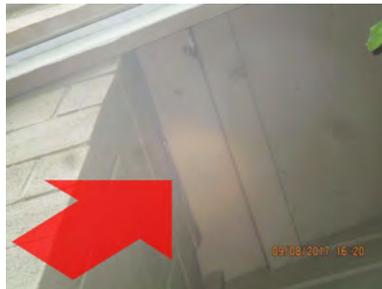
3.3 SOFFITS AND OVERHANGS

There are large gaps over 1/4" in size adjacent the soffit vent blocks. These gaps allow insects and rodents to enter the attic. Covering the gaps with screening, a strip of wood and/or caulking is recommended.

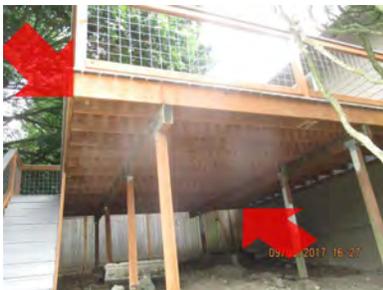
The deck structure lacks lateral bracing. The installation of a diagonal brace underneath the deck is recommended.

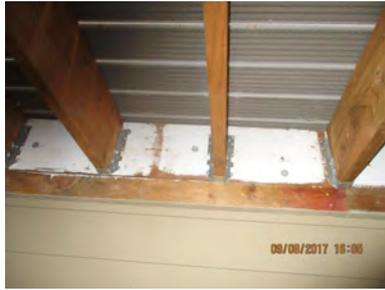
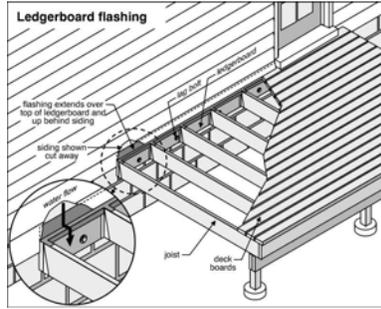
There is no flashing at the intersection between the deck and house. This will allow water to enter behind the siding. The installation of flashing in this area is recommended.

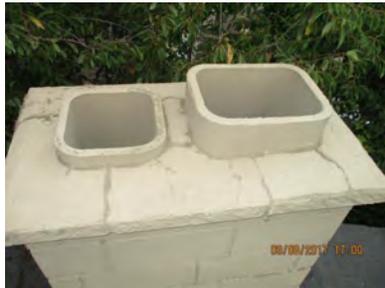
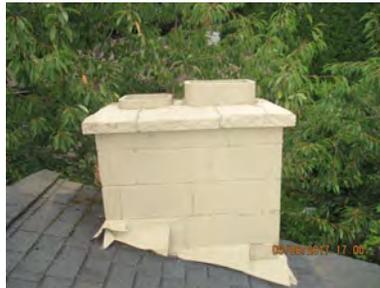
The chimney crown is cracked and deteriorated. The mortar chimney crown prevents water from entering and damaging the masonry. Repairing or replacing the chimney crown will extend the service life of the chimney.

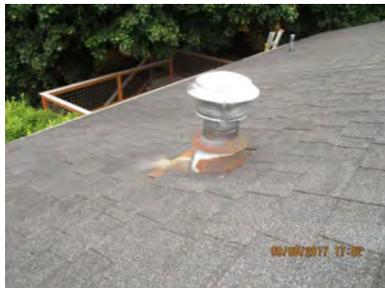
The gas appliance vent is corroded above the roof line. Cleaning and painting the vent will prolong its service life.

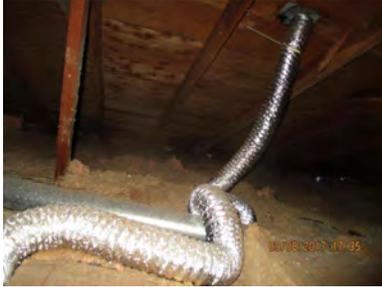
Flexible plastic duct is used to direct air from the vent fan to the exterior. This type of material is unreliable. Replacing the plastic duct with 4" smooth-wall sheet metal duct is recommended.

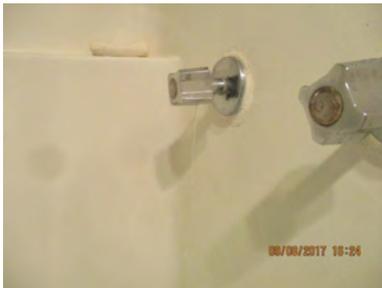
The shower faucet fixture is dripping. This wastes water and will erode the surface of the sink. The leaking faucet should be repaired or replaced.

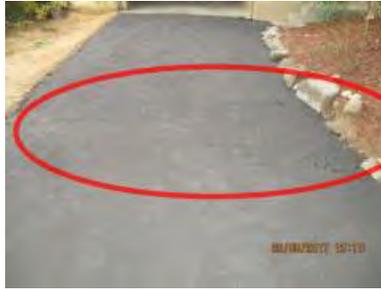
Portions of the asphalt driveway and parking areas are deteriorated. The deteriorated areas are not adversely affecting the function of the driveway, therefore patching or resurfacing is optional.

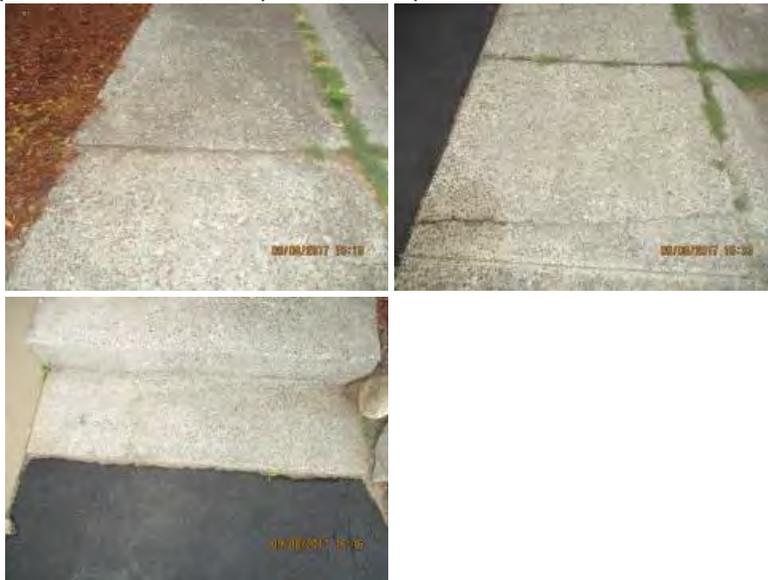
The walkway has cracked and settled differentially. This was probably caused by inadequate preparation of the soil prior to the placement of the concrete. This condition can be repaired by pressure grouting the sunken portion of the walkway or by removing and replacing it. The walkway remains functional despite this condition. However, the raised edges of the concrete can be a trip hazard for some people. Grinding down the raised edges of the concrete will mitigate the hazard. Repairs should be made as necessary.

The gap separating the concrete and asphalt sections are a trip hazard. Replacement with mortar is recommended.

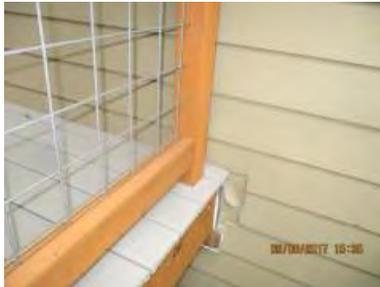
Sections of siding adjacent the deck are missing. Consideration should be given to installing flashing and/or caulk to prevent moisture or pest entry into this area.

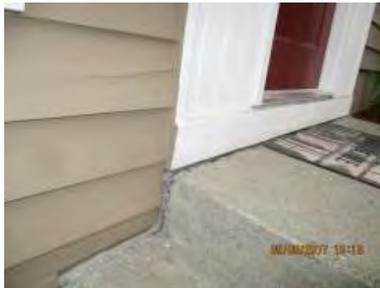
Untreated wood in direct contact with concrete was observed along the entry stoop. Untreated wood should be raised 1-2" above the concrete. Treating the wood with a preservative sometimes will prevent wood destroy organism damage.

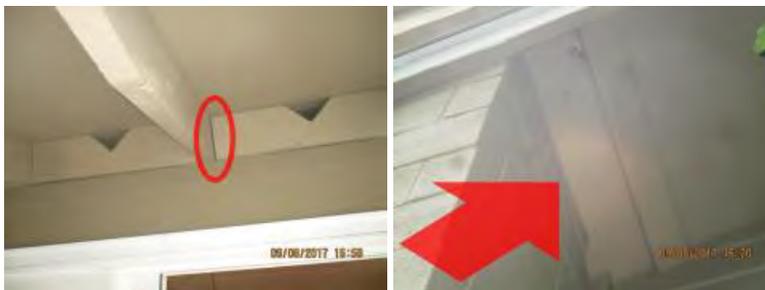
There are large gaps over 1/4" in size adjacent the soffit vent blocks. These gaps allow insects and rodents to enter the attic. Covering the gaps with screening, a strip of wood and/or caulking is recommended.

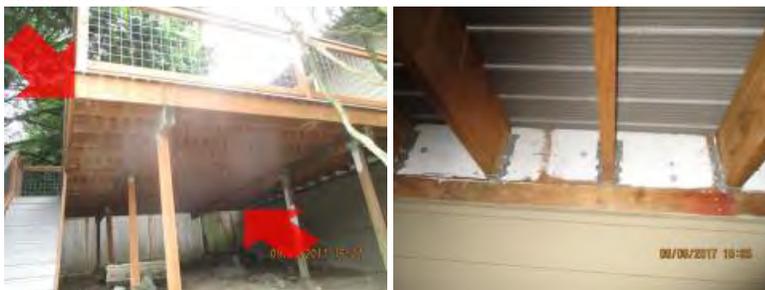
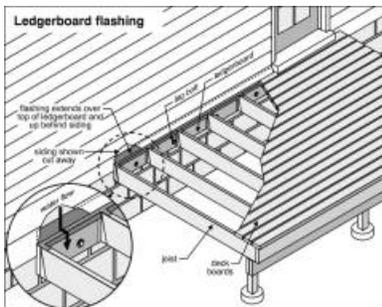
There is no flashing at the intersection between the deck and house. This will allow water to enter behind the siding. The installation of flashing in this area is recommended.

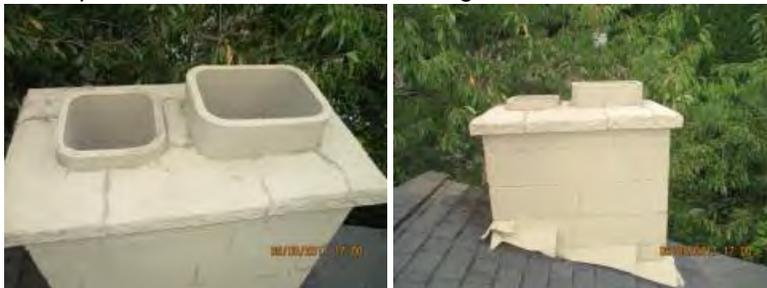
The top of the masonry chimney does not have spark arrestor/rain caps. The installation of a spark arrestor/rain cap for each flue is recommended as a safety upgrade and to prevent moisture damage to the inside of the chimney and fireplace. An additional benefit of a rain cap is that it will keep birds and rodents from entering the house when the damper is left open.

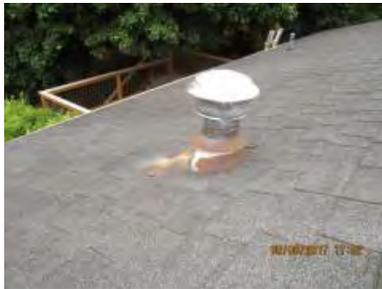
The gas appliance vent is corroded above the roof line. Cleaning and painting the vent will prolong its service life.

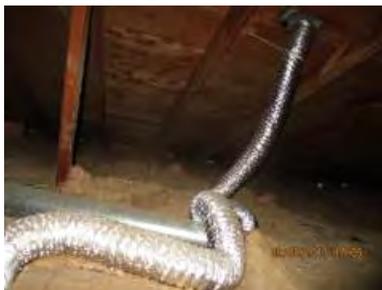
Flexible plastic duct is used to direct air from the vent fan to the exterior. This type of material is unreliable. Replacing the plastic duct with 4" smooth-wall sheet metal duct is recommended.

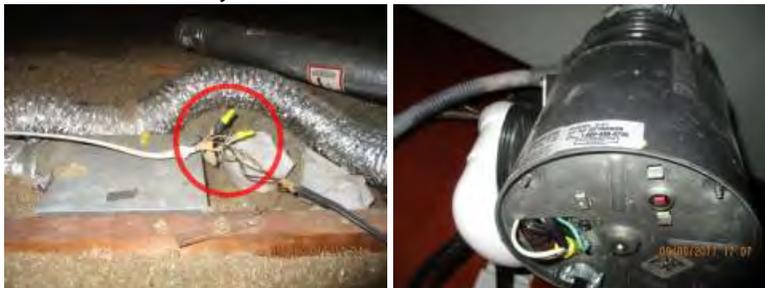
The wires are not protected where they enter the disposal. This could damage the wires or cause a ground fault. The cord should be clamped and covered in accordance with industry standards.

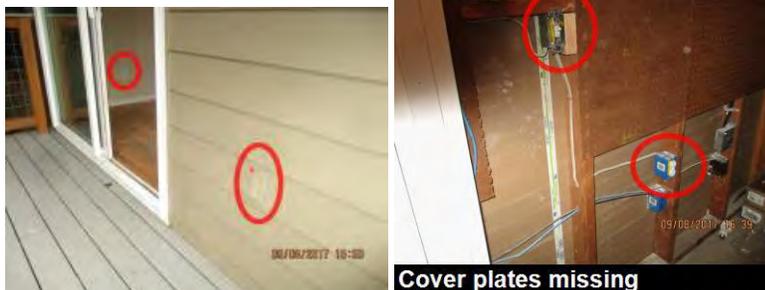
Cover plates are missing from receptacles in the closet under the stairs and adjacent to the water heating unit. This is a shock and fire hazard. The installation of cover plates on all receptacles is recommended.

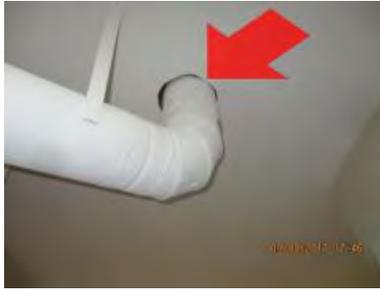
The furnace vent connector is too close to a combustible material. This is a hazard. A minimum clearance of 6" is required between the single wall vent connector and the combustible material. The double wall type B vent requires only 1" of clearance. Repairs are recommended.

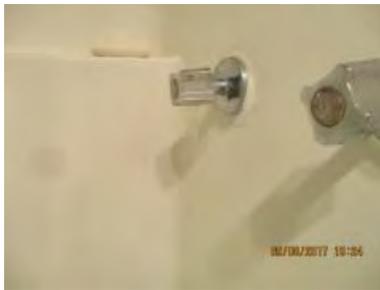
The shower faucet fixture is dripping. This wastes water and will erode the surface of the sink The leaking faucet should be repaired or replaced.

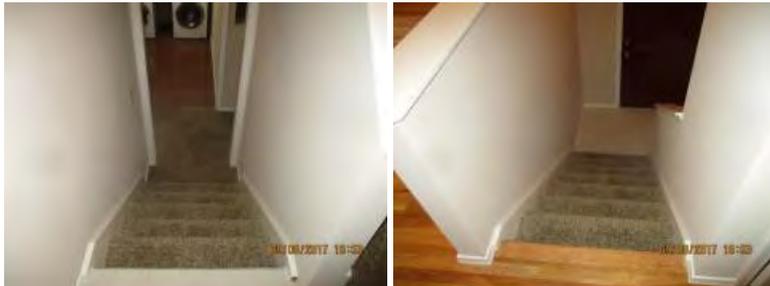
There is no handrail in the stairwell. This is a safety hazard. The installation of a graspable handrail that conforms to present industry standards is recommended.

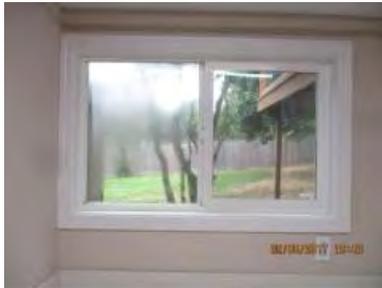
There is condensation or mineral deposits between the panes of glass in one of the insulated glass window panes. This indicates a failed seal. The glass assembly should be replaced, which is the only method for correcting this deficiency.

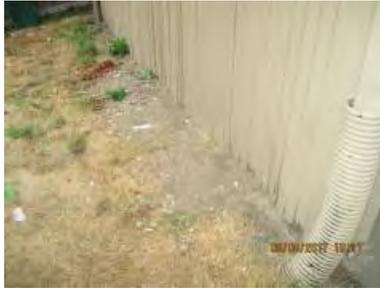
The bottom of the outbuilding walls are rotted where they have had chronic contact with moisture. Rot damaged material should be repaired and protected from chronic contact with moisture.
