NOTICE TO BUYER: SELLER-PROCURED INSPECTION REPORT

Hank and Constance Bynaker
17522 NE 136th St
Redmond, WA 98052

At your request, a visual inspection of the above referenced property was conducted on 10/23/2017. We have inspected the major structural components, plumbing, heating and electrical systems for signs of significant non-performance, excessive or unusual wear and general state of repair.

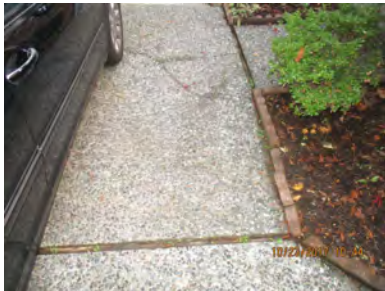
One or more of the wooden dividers separating the concrete walkway sections were infested by wood destroying organisms and have deteriorated to a point where they are becoming a trip hazard. Replacement with mortar is recommended.

2.5 WALKWAY – Will add new wood dividers

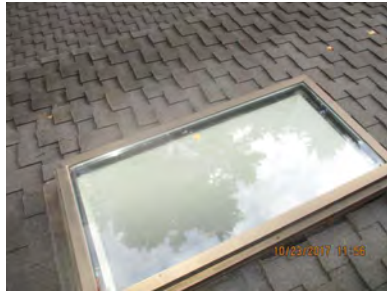
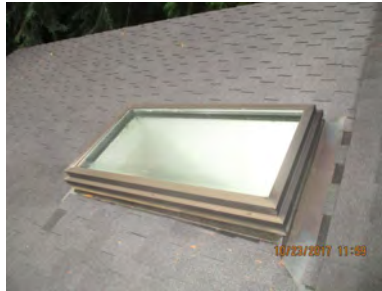
4.3 SKYLIGHTS

There is condensation or mineral deposits between the panes of glass in the skylights. This indicates failed seals. The glass assemblies should be replaced, which is the only method for correcting this deficiency.

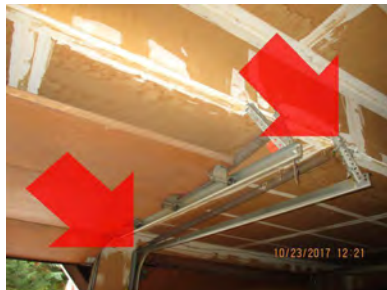
Safeties are cables run through the center of the garage door springs that prevent broken springs from becoming projectiles that can cause injury. There are no safeties installed. The installation of safeties is recommended.

6.2 OVERHEAD GARAGE DOORS – Will install safety cables

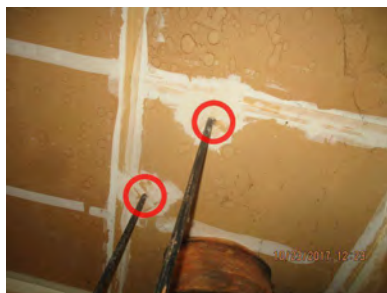
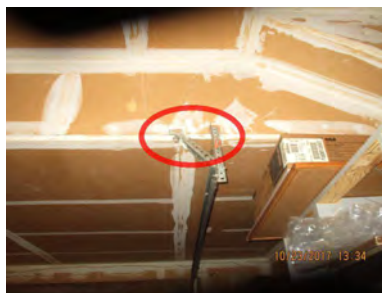
6.4 FIRE SEPARATION

There are voids in the fire resistive barrier between the living space and garage that will allow flames to penetrate. The gypsum barrier slows the spread of a fire from the garage to the structure and/or living space. Patching the voids with a fire retardant caulk is recommended.

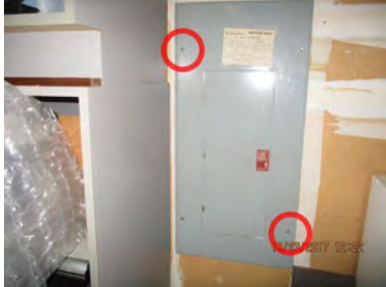
Screws that secure the panel cover to the panel box are missing. This is a potential hazard. Missing screws should be replaced with the original style blunt end screws.

7.8 SERVICE PANEL – Will replace missing screws on panel

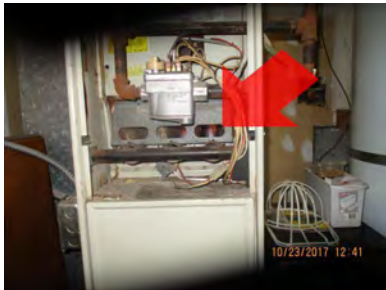
The burners are clogged with debris. This reduces the burner efficiency and produces carbon monoxide. Cleaning the burners is recommended.

8.5 BURNERS – Will have furnace serviced

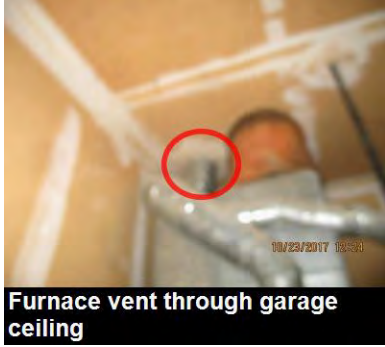
8.9 VENT

The furnace vent connector is too close to a combustible material. This is a hazard. A minimum clearance of 6" is required between the single wall vent connector and the combustible material. The double wall type B vent requires only 1" of clearance. Repairs are recommended.

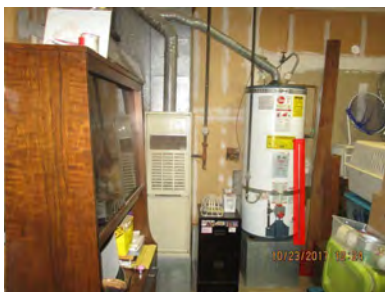
The gas pipes in front of the furnace and water heater are not protected by a bumper stop. A vertical steel pipe, bolted to the floor, is typically installed in front of the water heater to prevent a car bumper from damaging the gas lines.

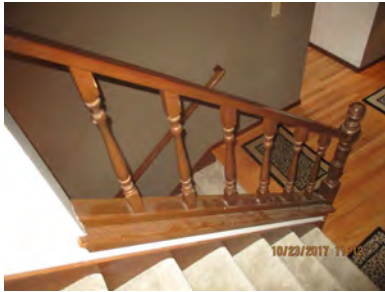
14.2 STAIRS

The stair railing baluster spacing is too wide. This is a hazard for small children. The baluster spacing should be reduced as a safety upgrade. Current standards require that a 4" sphere not pass through the railing.

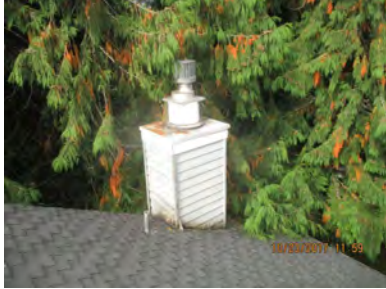
Trees are touching the building on several sides. Low hanging tree branches can damage the roof. Tree branches should be trimmed back where necessary.

2.3 VEGETATION – Branches have been trimmed away from the home.

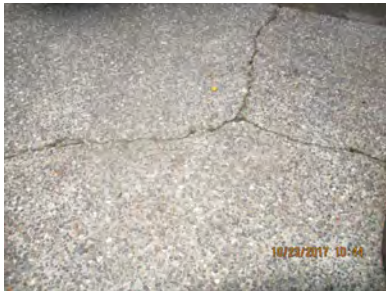
2.5 WALKWAY

Cracks were observed in the concrete surface of the walkway. Minor cracks can be sealed to minimize moisture entry and further settlement of the concrete.

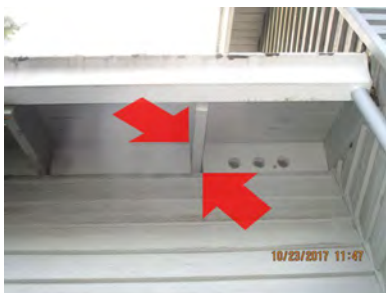
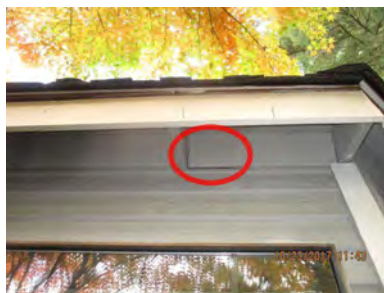
There are large gaps over 1/4" in size adjacent the soffit vent blocks. These gaps allow insects and rodents to enter the attic. Covering the gaps with screening, a strip of wood and/or caulking is recommended.

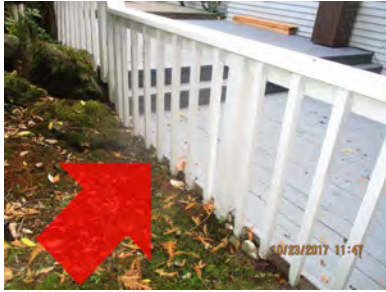
Areas of rot damage and rot fungi was observed around the decks perimeter. Rot weakens the wood and can result in failure of the structure. Rotted portions of the deck should be repaired as necessary.

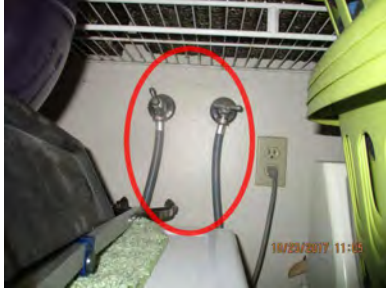
Upgrading the washer connections to high pressure (steel braided) lines is recommended.

12.8 APPLIANCES – Will upgrade to stainless lines

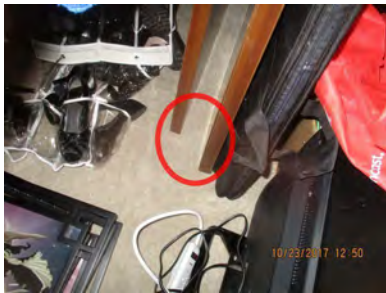
The floor guides are missing from the bypass closet doors in the bedroom. Missing floor guides could result in damage to the doors. The installation of floor guides is recommended.

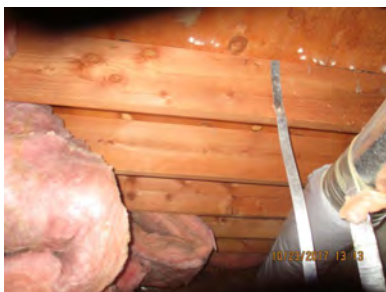
17.4 FLOOR INSULATION

Some of the insulation batts are missing and several were not properly secured and have falling down. The fallen batts should be reinstalled and secured. The missing batts should be replaced.

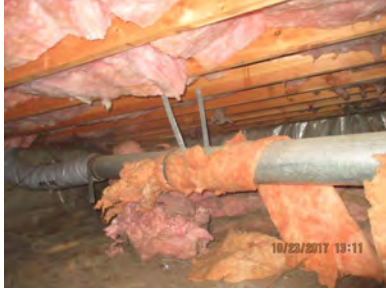
17.5 DUCT INSULATION

Some of the duct insulation is missing or has fallen off the ducts. This increases the amount of heat loss. The installation of new duct insulation is recommended in areas where insulation is missing.

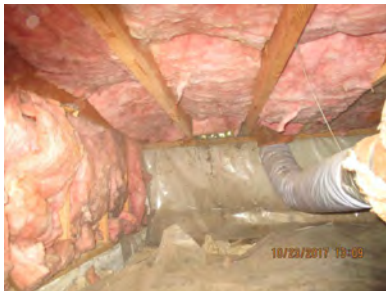
The foundation walls are covered with the plastic vapor retarder. This allows the transmission of water vapor from the soil up and into the exterior wall framing. The plastic vapor retarder should be removed from the foundation so that it covers the entire surface of the soil only.

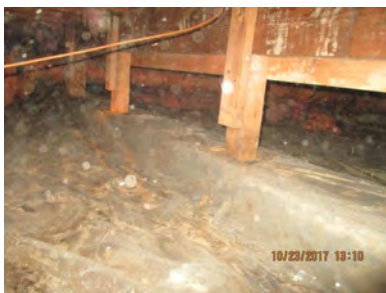
The support post concrete piers are covered with the plastic vapor retarder. This allows the transmission of water vapor from the soil up and into the floor framing. The plastic vapor retarder should be removed from the pier so that it covers the entire surface of the soil only.

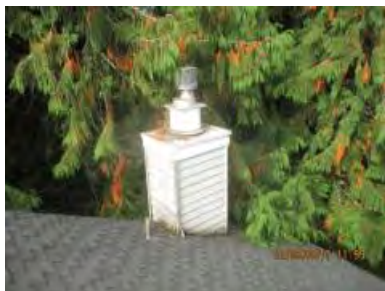
Trees are touching the building on several sides. Low hanging tree branches can damage the roof. Tree branches should be trimmed back where necessary.

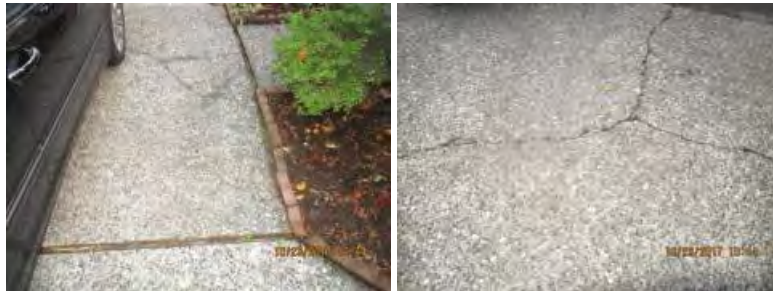
Cracks were observed in the concrete surface of the walkway. Minor cracks can be sealed to minimize moisture entry and further settlement of the concrete.

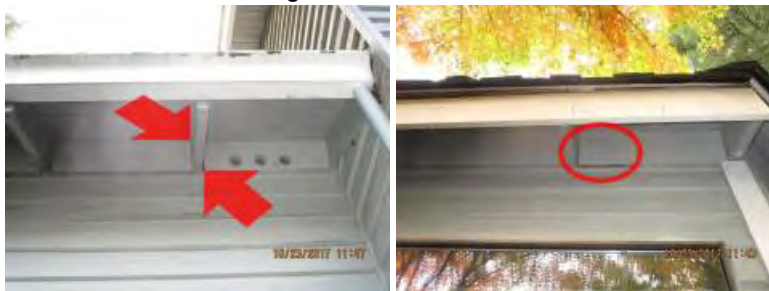
There are large gaps over 1/4" in size adjacent the soffit vent blocks. These gaps allow insects and rodents to enter the attic. Covering the gaps with screening, a strip of wood and/or caulking is recommended.

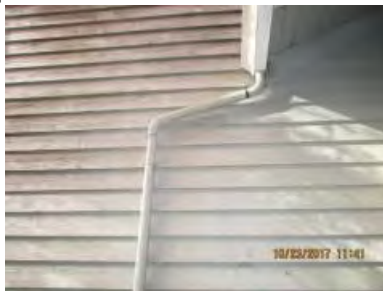
The 2" round downspouts are too small and are more vulnerable to clogging than the larger rectangular ones. Consideration should be given to upgrading the downspouts.

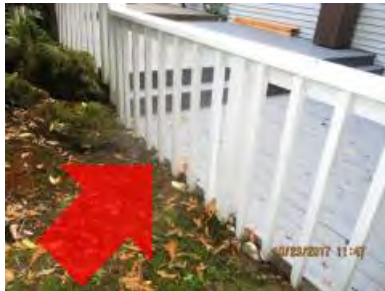
Areas of rot damage and rot fungi was observed around the decks perimeter. Rot weakens the wood and can result in failure of the structure. Rotted portions of the deck should be repaired as necessary.

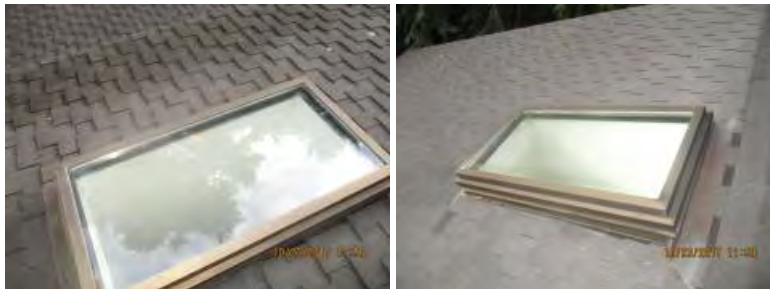
The skylights are not secured to the roof. Skylights can get blown off roofs during high winds if they are not secured. Fastening the skylights to the curb with plated or stainless screws is recommended.

4.3 SKYLIGHTS – Will secure with stainless screws

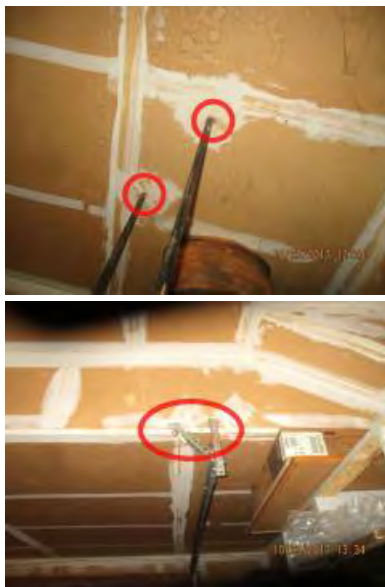
There are voids in the fire resistive barrier between the living space and garage that will allow flames to penetrate. The gypsum barrier slows the spread of a fire from the garage to the structure and/or living space. Patching the voids with a fire retardant caulk is recommended.

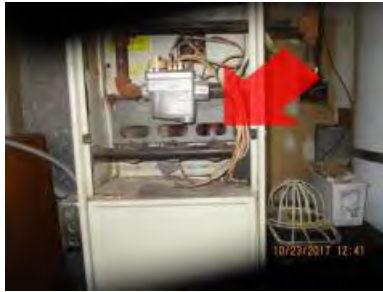
8.5 BURNERS

The burners are clogged with debris. This reduces the burner efficiency and produces carbon monoxide. Cleaning the burners is recommended.

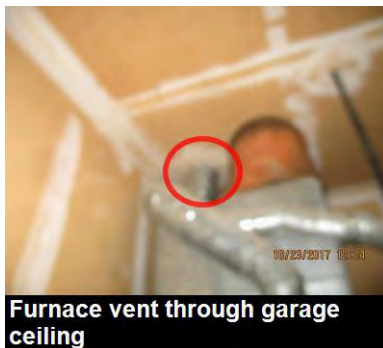
The furnace vent connector is too close to a combustible material. This is a hazard. A minimum clearance of 6" is required between the single wall vent connector and the combustible material. The double wall type B vent requires only 1" of clearance. Repairs are recommended.

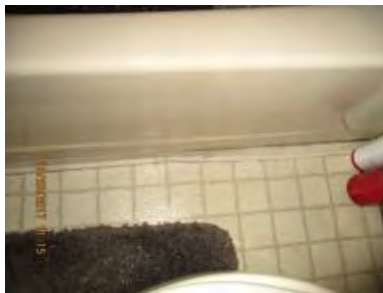
There are gaps at the intersection between the tub/shower and floor. This can lead to water damage to the flooring and substrate. Caulking this area with a flexible caulk is recommended.

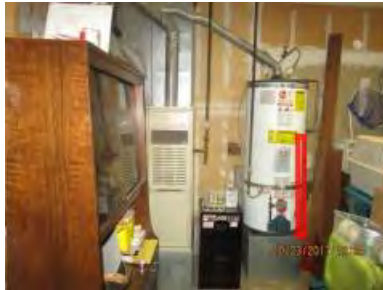
The gas pipes in front of the furnace and water heater are not protected by a bumper stop. A vertical steel pipe, bolted to the floor, is typically installed in front of the water heater to prevent a car bumper from damaging the gas lines.

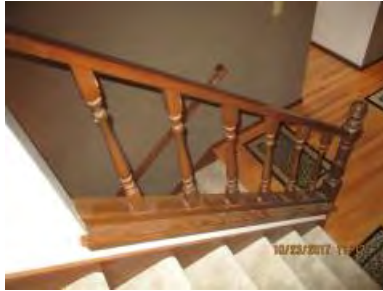
The stair railing baluster spacing is too wide. This is a hazard for small children. The baluster spacing should be reduced as a safety upgrade. Current standards require that a 4" sphere not pass through the railing.

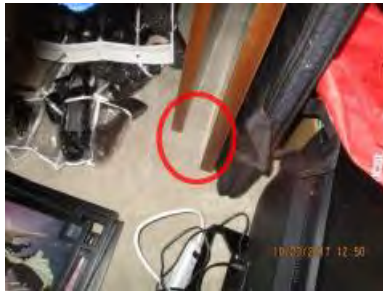
The floor guides are missing from the bypass closet doors in the bedroom. Missing floor guides could result in damage to the doors. The installation of floor guides is recommended.

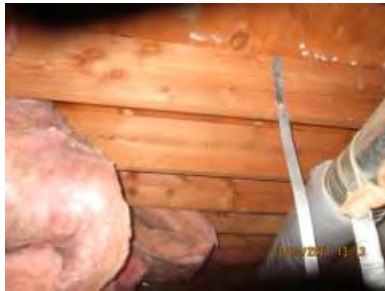
Some of the insulation batts are missing and several were not properly secured and have falling down. The fallen batts should be reinstalled and secured. The missing batts should be replaced.

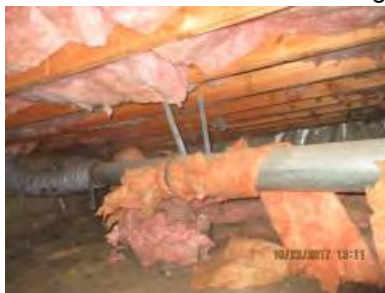
17.5 DUCT INSULATION

Some of the duct insulation is missing or has fallen off the ducts. This increases the amount of heat loss. The installation of new duct insulation is recommended in areas where insulation is missing.

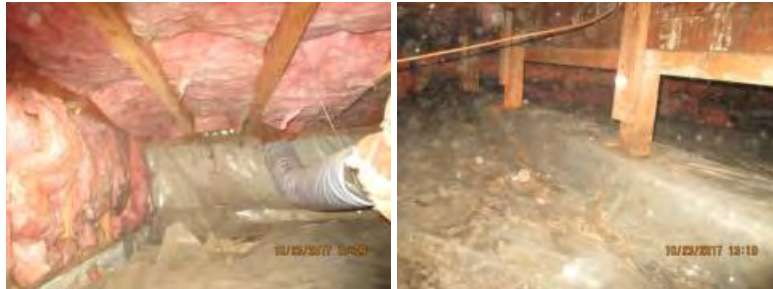
The support post concrete piers are covered with the plastic vapor retarder. This allows the transmission of water vapor from the soil up and into the floor framing. The plastic vapor retarder should be removed from the pier so that it covers the entire surface of the soil only.
