**Bernie Hedeem and Barbara Pickens
607 26th Ave E
Seattle, WA 98112**

Response to House Inspection Summary of October 28, 2017

607 26th Ave. E
Seattle WA.

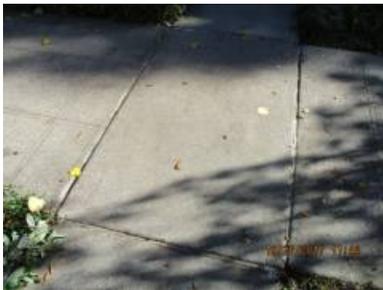
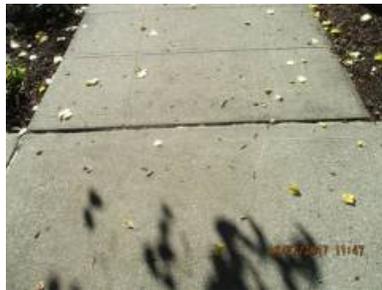
2.6 WALKWAY

The gaps separating the concrete walkway sections are a trip hazard. Replacement with mortar is recommended.

Prior to the inspection the original deteriorated fibrous asphalt expansion joint material was removed and replaced with Sikaflex self-leveling sealant. The sealant was purposely left a little low to aid in drainage runoff. Filling the balance of the joint with mortar defeats the purpose of an expansion joint, however if desired by the purchaser, the seller will fill the balance of the sidewalk expansion joint with Sikaflex self-leveling sealant.

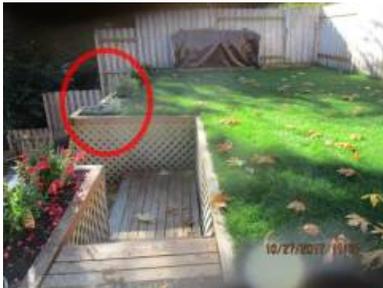
There is no guardrail at the yards edge. This is a hazard for small children. The installation of a guardrail that conforms to present industry standards is recommended if small children are present.

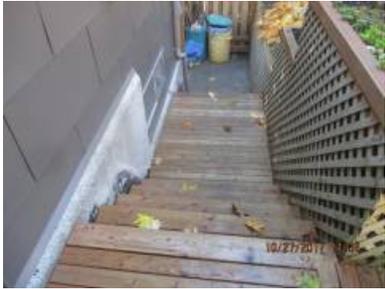
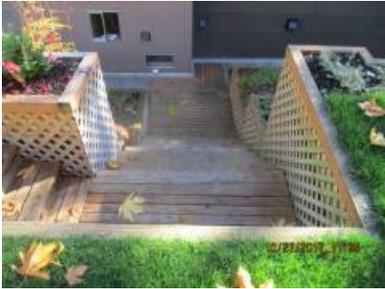
2.7 STEPS

There is no handrail along the stairs. This is a hazard. The installation of a handrail along the stairs is recommended.

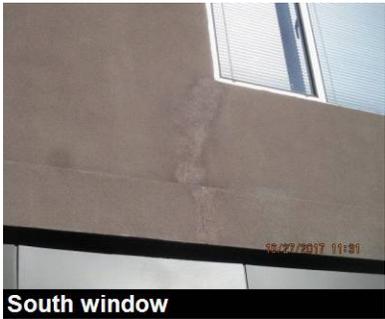
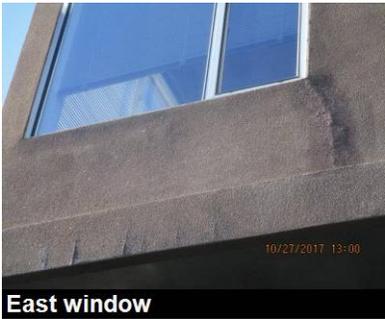
3.2 SECONDARY EXTERIOR WALL CLADDING

There is damage adjacent the south and east windows from what appear to be siding leaks. You should query the seller as to the history of these leaks and ask for confirmation that they have been repaired.

A complete evaluation of the EIFS is recommended. A complete evaluation of the EIFS is beyond the scope of this inspection.

During the remodel of 2001-2 all of the original corrugated galvanized siding was replaced by maintenance free siding, either an insulated Dryvit system or custom made pre-finished metal siding panels. To our knowledge there has never been any leaks detected in either of these systems. The "damage" addressed in the report was actually two small hairline cracks that are common on reentry corners, i.e. reentry corner cracking. These hairline cracks were filled with poly urethane calking and then were overlaid with a new acrylic finish coat.

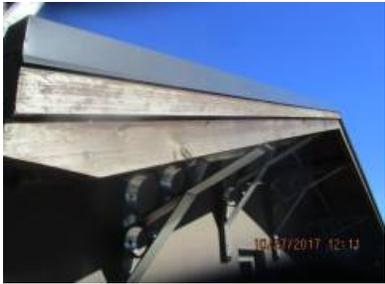
3.6 PAINT

The fascia board paint is weathered from age and exposure. Paint protects the wood from cupping, checking, warping and rot. Repainting the house trim will be required in the near future.

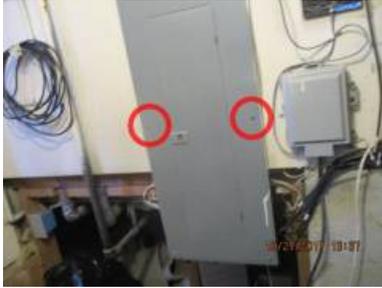
7.8 SERVICE PANEL

Screws that secure the panel cover to the panel box are missing. This is a potential hazard. Missing screws should be replaced with the original style blunt end screws.

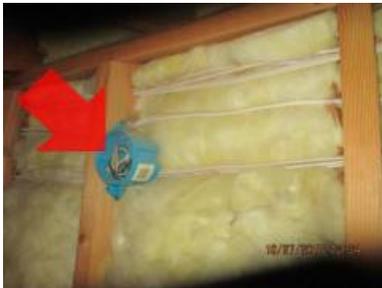
7.10 WIRING

There is a junction box with a missing cover in the attic. This is a fire/shock hazard. Covers should be installed on all junction boxes.

A cover plate has now been installed on the junction box in the attic.

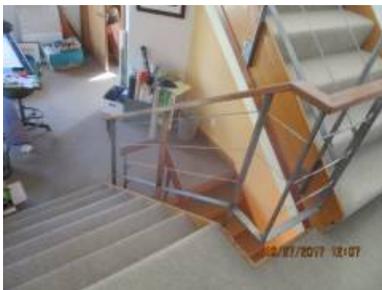
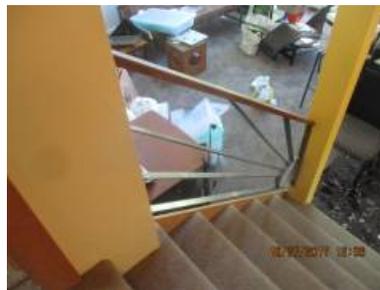
14.2 STAIRS

The stair railing baluster spacing is too wide. This is a hazard for small children. The baluster spacing should be reduced as a safety upgrade. Current standards require that a 4" sphere not pass through the railing.

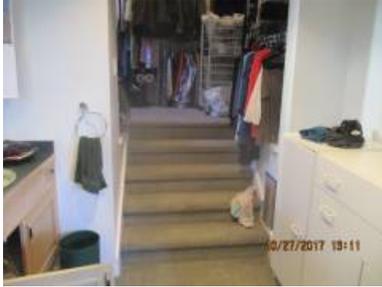
There is no handrail in the master bedroom bathroom. This is a safety hazard. The installation of a graspable handrail that conforms to present industry standards is recommended.

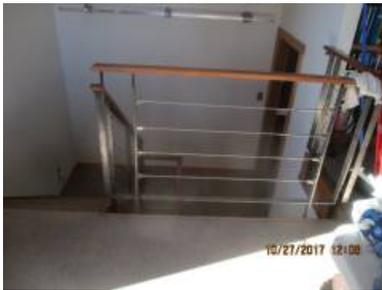
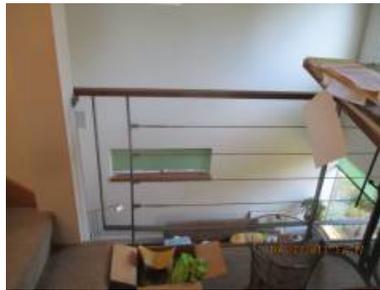
14.3 GUARD RAILINGS

The spacing between the balusters is too wide. This is a hazard to small children. The balusters should be spaced close enough together so that a 4" sphere cannot pass through. Upgrading the guard railing is recommended if small children are present.

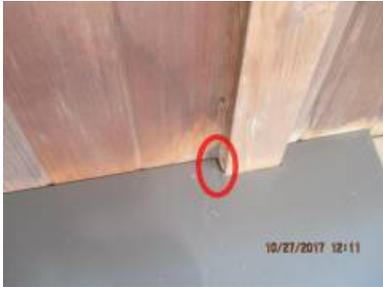
3.4 SOFFITS AND OVERHANGS

There are openings adjacent the ends of the outlook boards under the overhang through which insects and rodents can enter into the attic. These openings should be covered with wood, wire mesh or filled with aerosol foam.

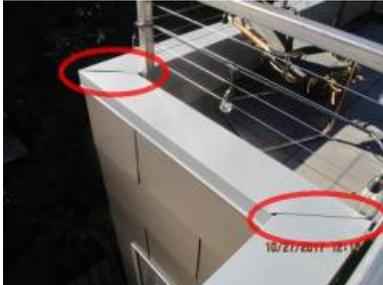
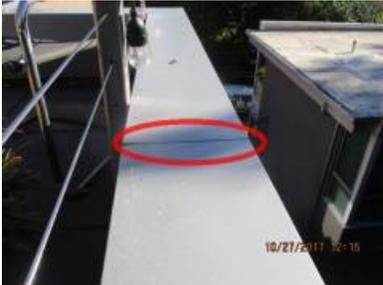
3.9 DECK RAILINGS

The parapet wall cap flashings have overlapping seams. These seams are vulnerable to water intrusion. Replacement of the parapet wall cap flashing with a standing seam cap flashing is recommended.

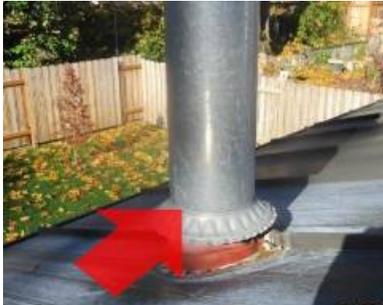
4.5 GAS APPLIANCE VENTS

The storm collar is not sealed. This is allowing leakage to occur. Sealing the storm collar is recommended.

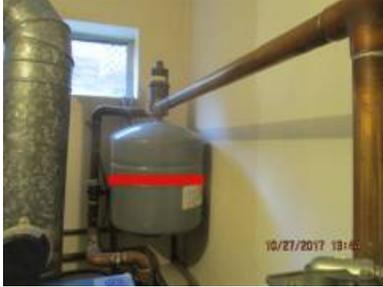
8.13 EXPANSION TANK

The expansion tank is not adequately secured to the wall. This could result in damage to the water pipe and leakage during an earthquake. Strapping the expansion tank to the wall with a steel strap is recommended.

Performed maintenance on buderus gas boiler. See checklist for maintenance details. I replaced a leaking air vent and strapped the expansion tank to wall as per customer request. System is operating normally at this time.

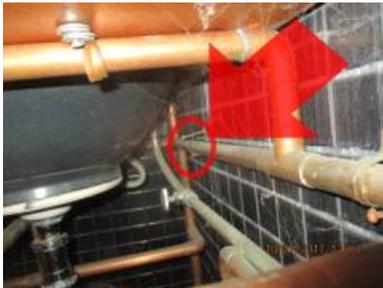
11.8 COUNTERTOP

The countertop is not securely fastened to the wall. Proper attachment of the counter to the wall is recommended.

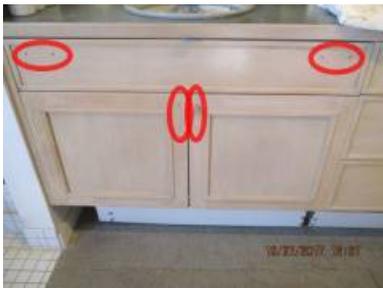
11.21 CABINETS

The bathroom cabinet hardware is missing replacement is recommended.. The cabinet is otherwise in serviceable condition.

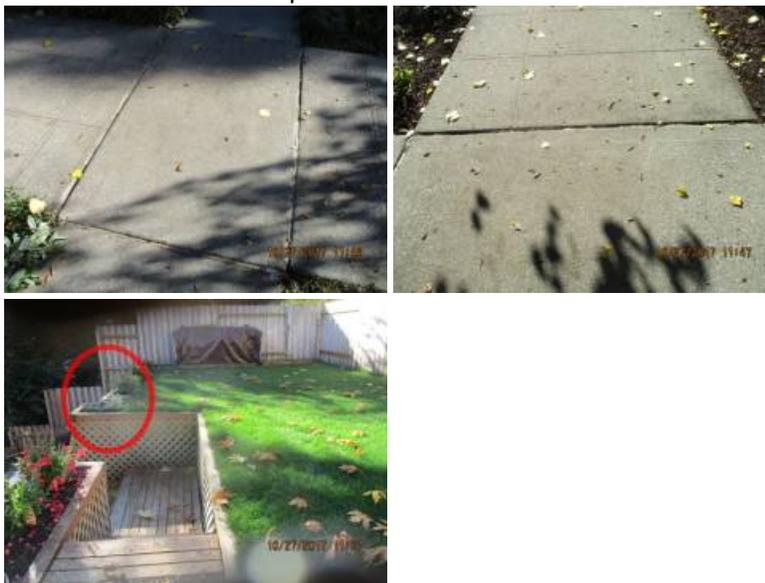
Many legal and public works departments have defined a trip hazard as an irregularity in a walking surface exceeding one inch (1") in height. All walking surfaces should maintain, free of a vertical surface change of 3/4" or more, in the interest of public and personal safety.

There is no guardrail at the yards edge. This is a hazard for small children. The installation of a guardrail that conforms to present industry standards is recommended if small children are present.

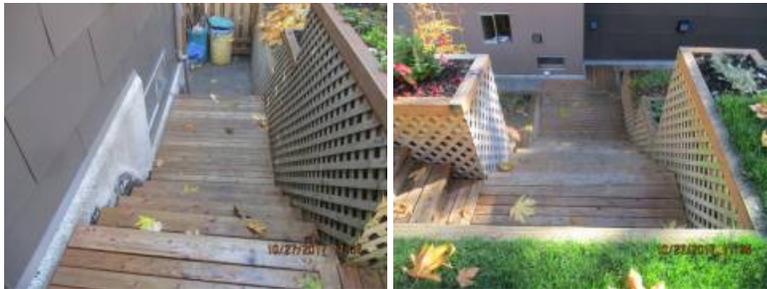
2.7 STEPS

There is no handrail along the stairs. This is a hazard. The installation of a handrail along the stairs is recommended.

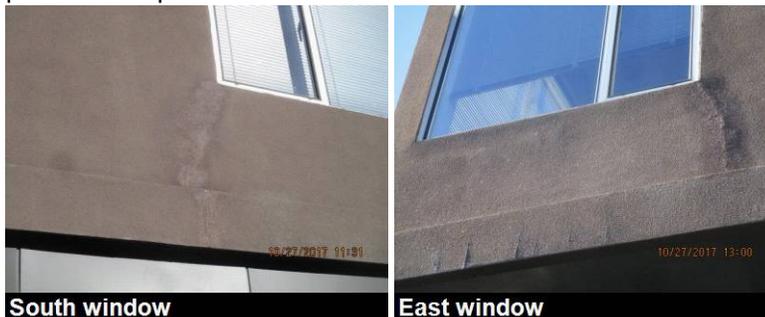
There is damage adjacent the south and east windows from what appear to be siding leaks. You should query the seller as to the history of these leaks and ask for confirmation that they have been repaired.

It is impossible perform a definitive evaluation of an EIFS clad wall after the installation is complete. However, a careful examination of the construction details combined with a systematic survey of the EIFS surfaces with a non-invasive moisture meter will often reveal water intrusion problems. A complete evaluation of the EIFS is recommended. A complete evaluation of the EIFS is beyond the scope of this inspection.

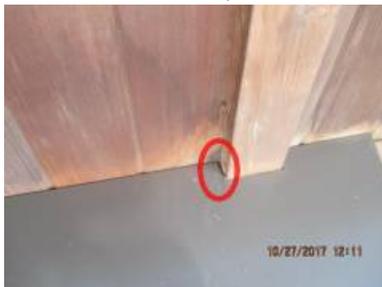
There are openings adjacent the ends of the outlook boards under the overhang through which insects and rodents can enter into the attic. These openings should be covered with wood, wire mesh or filled with aerosol foam.

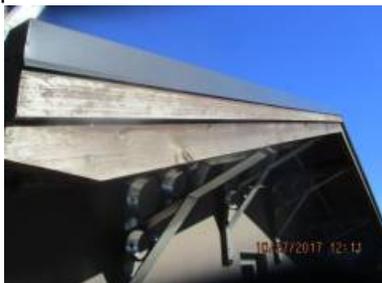
3.6 PAINT

The fascia board paint is weathered from age and exposure. Paint protects the wood from cupping, checking, warping and rot. Repainting the house trim will be required in the near future.

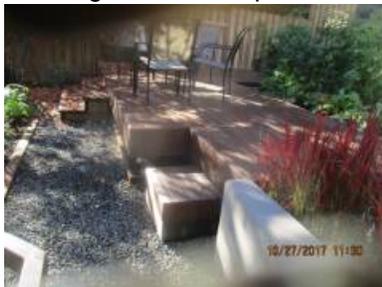
3.7 DECK

The deck is installed close to the ground making it more vulnerable to deterioration. The proximity of the deck to the ground also prevented an inspection of the deck framing. The visible portions of the deck are in good condition.

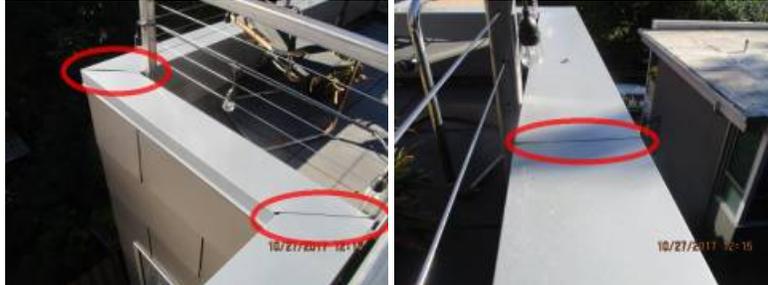
The parapet wall cap flashings have overlapping seams. These seams are vulnerable to water intrusion. Replacement of the parapet wall cap flashing with a standing seam cap flashing is recommended.

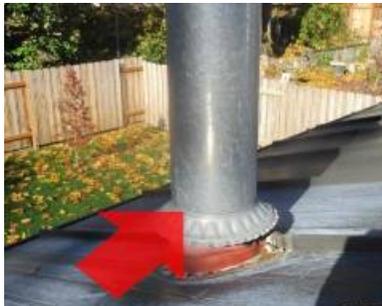
The storm collar is not sealed. This is allowing leakage to occur. Sealing the storm collar is recommended.

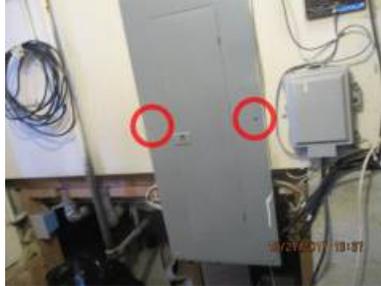
Screws that secure the panel cover to the panel box are missing. This is a potential hazard. Missing screws should be replaced with the original style blunt end screws.

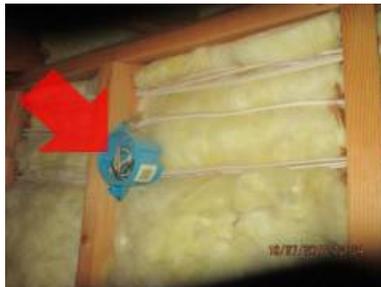
There is a junction box with a missing cover in the attic. This is a fire/shock hazard. Covers should be installed on all junction boxes.

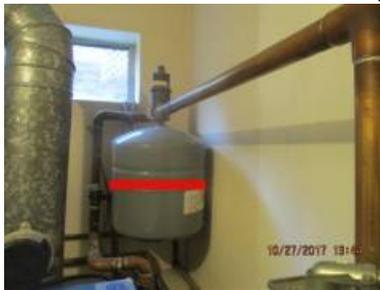
8.13 EXPANSION TANK

The expansion tank is not adequately secured to the wall. This could result in damage to the water pipe and leakage during an earthquake. Strapping the expansion tank to the wall with a steel strap is recommended.

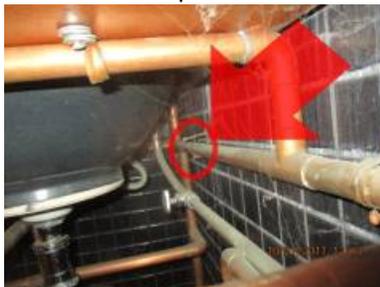
11.8 COUNTERTOP

The countertop is not securely fastened to the wall. Proper attachment of the counter to the wall is recommended.

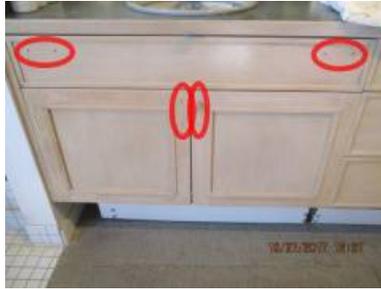
The bathroom cabinet hardware is missing replacement is recommended.. The cabinet is otherwise in serviceable condition.

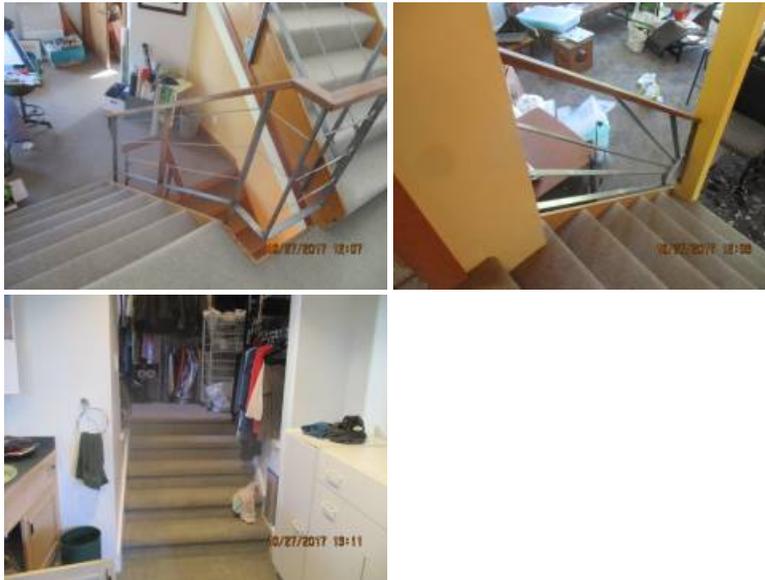
The stair railing baluster spacing is too wide. This is a hazard for small children. The baluster spacing should be reduced as a safety upgrade. Current standards require that a 4" sphere not pass through the railing.

There is no handrail in the master bedroom bathroom. This is a safety hazard. The installation of a graspable handrail that conforms to present industry standards is recommended.

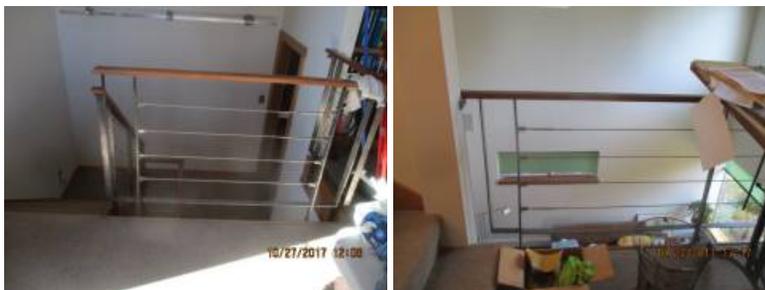
14.3 GUARD RAILINGS

The spacing between the balusters is too wide. This is a hazard to small children. The balusters should be spaced close enough together so that a 4" sphere cannot pass through. Upgrading the guard railing is recommended if small children are present.
