April 23, 2016

Re: 13927 SE 22nd St.
Bellevue, WA.

REPORT SUMMARY

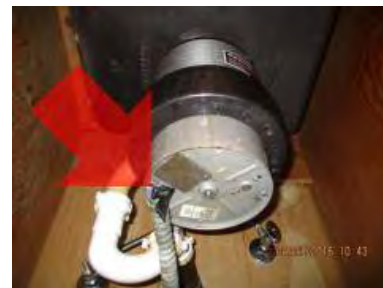
The garbage disposal is not working. It should be repaired or replaced as necessary.

The cord is not clamped where it enters the disposal. This could damage the wires or cause a ground fault. The cord should be clamped in accordance with industry standards.

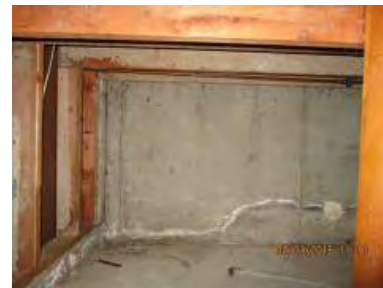
Efflorescence was observed on the foundation wall under the stairs. Efflorescence looks like lines of a fine white powder stuck to the wall. It is actually mineral salts that are left over after the water that carries them through the concrete or masonry. Efflorescence is a slow process that indicates long term exposure to moisture. Efflorescence is not toxic and can be easily removed. However, continued exposure of the foundation wall to moisture will cause it to return. To eliminate efflorescence you must reduce moisture on the outside of the foundation wall.

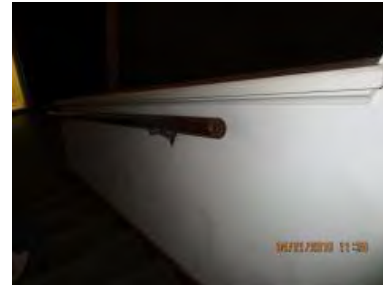
14.3 STAIRS

The stairs were used several times during the inspection. The stair components are properly installed however one railing deficiency was noted during use. The railing ends do not return to the wall. This is a safety hazard. The installation of a continuous handrail should be considered as a safety upgrade.

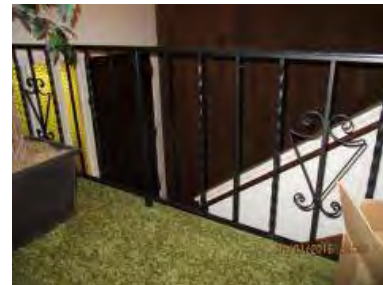
14.4 GUARD RAILINGS

The spacing between the balusters is too wide. This is a hazard to small children. The balusters should be spaced close enough together so that a 4" sphere cannot pass through. Upgrading the guard railing is recommended if small children are present.

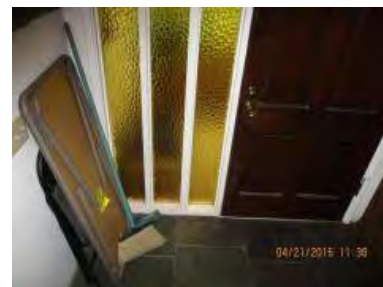
The stairway landing window glass is not labeled as tempered safety glass. The existing glass is nonconforming by current building standards and would be hazardous if broken. The installation of safety glass is recommended as a safety upgrade.

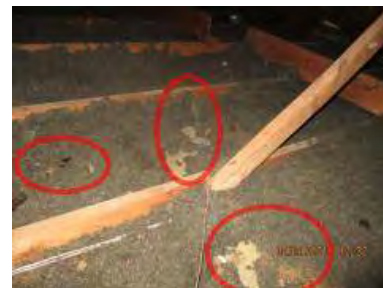
There are numerous thermal bypasses in the attic. A thermal bypass is an opening between an insulated and uninsulated part of the house through which heated air can escape. As air is heated, it rises and pulls cool air in to the space to replace it. This condition will result in significant heat loss. Sealing up all thermal bypass routes is recommended.
