NOTICE TO BUYER: SELLER-PROCURED INSPECTION REPORT

13405 179th Ave NE

At your request, a visual inspection of the above referenced property was conducted on May 24, 2016. We have inspected the major structural components, plumbing, heating and electrical systems for signs of significant non-performance, excessive or unusual wear and general state of repair.

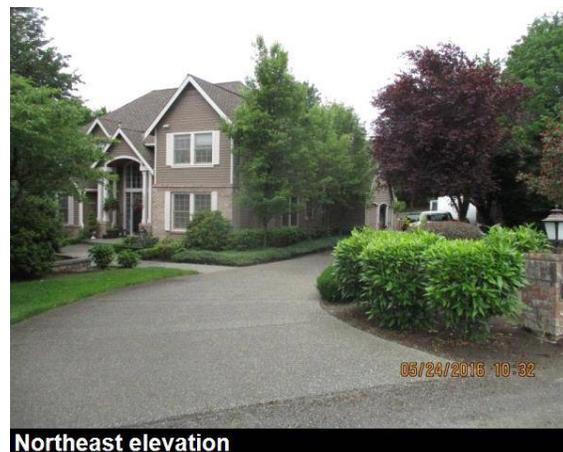
Northeast elevation

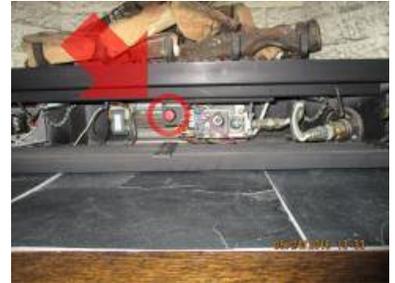
The pilot light was not working and the direct vent fireplace in the family room was not tested. The operation of this gas appliance was not verified.

The gas supply for the fireplace is located on the wall or floor adjacent to the hearth. The key that turns on this valve should be kept out of the reach of children.
