**NOTICE TO BUYER: SELLER-PROCURED INSPECTION REPORT**

The following notice is given with respect to the Purchase and Sale Agreement dated \_\_\_\_\_  
between \_\_\_\_\_ (“Buyer”)  
and **Robert Welch** \_\_\_\_\_ (“Seller”)  
concerning **9024 132nd Pl SE, Newcastle** (“the Property”).

May 21, 2016

9024 132nd Pl. SE  
Newcastle WA.

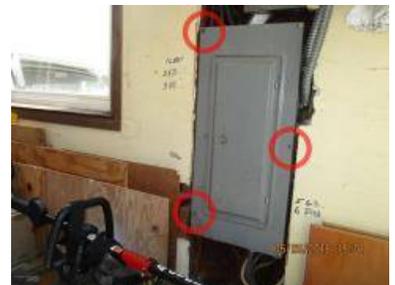
Screws that secure the panel cover to the panel box are missing. This is a potential hazard. Missing screws should be replaced with the original style blunt end screws.

7.9: Installed missing screws in service panel.
