September 14, 2016

Re: 17032 NE 131st Pl.
Redmond, WA.

17032 NE 131st Pl.
Redmond WA.

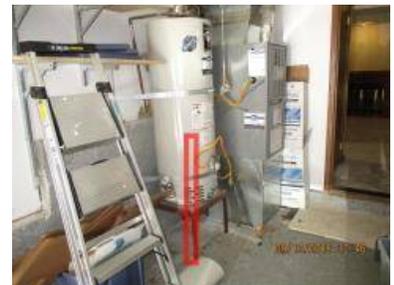
13.10 GAS PIPING

The gas pipes in front of the furnace and water heater are not protected by a bumper stop. A vertical steel pipe, bolted to the floor, is typically installed in front of the water heater to prevent a car bumper from damaging the gas lines.

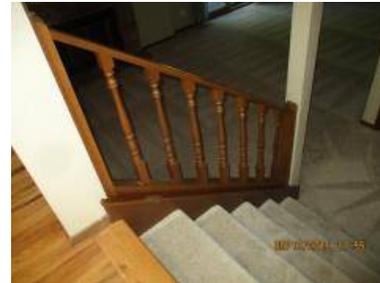
The lower stair railing baluster spacing is too wide. This is a hazard for small children. The baluster spacing should be reduced as a safety upgrade. Current standards require that a 4" sphere not pass through the railing.

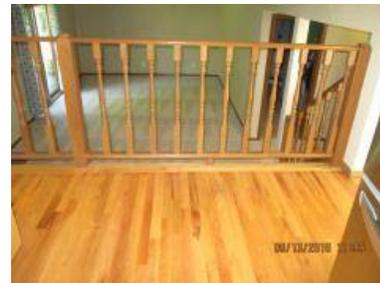
14.3 GUARD RAILINGS

The spacing between the balusters is too wide. This is a hazard to small children. The balusters should be spaced close enough together so that a 4" sphere cannot pass through. Upgrading the guard railing is recommended if small children are present.

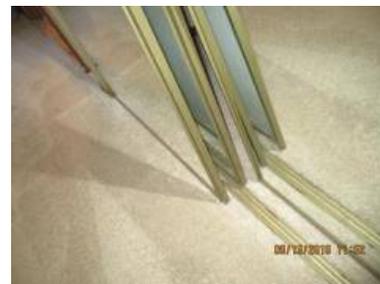
The floor guides are missing from the bypass closet doors in the master bedroom. Missing floor guides could result in damage to the doors. The installation of floor guides is recommended.

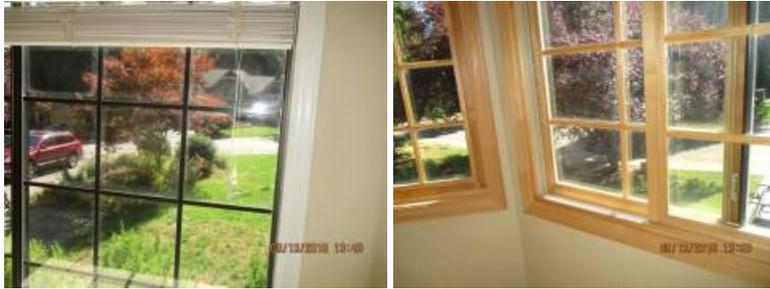
14.7 WINDOWS

There is condensation or mineral deposits between the panes of glass in several of the insulated glass windows. This indicates failed seals. The glass assemblies should be replaced, which is the only method for correcting this deficiency.

14.7.20 - Windows

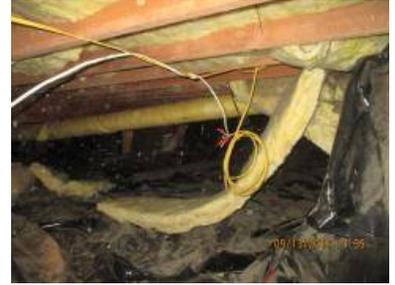
Some of the insulation batts were not properly secured and have falling down. The fallen batts should be reinstalled and secured.

17.4.17 - Insulation

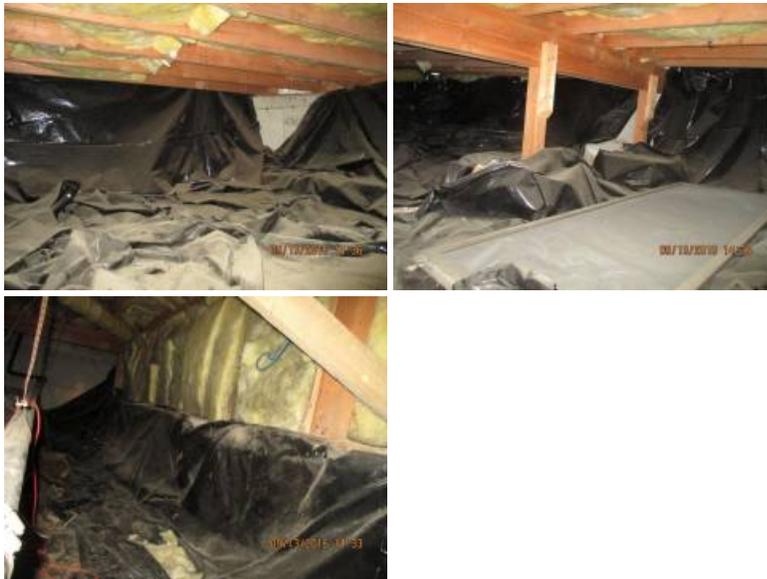
The foundation walls are covered with the plastic vapor retarder. This allows the transmission of water vapor from the soil up and into the exterior wall framing. The plastic vapor retarder should be removed from the foundation so that it covers the entire surface of the soil only.

The support post concrete piers are covered with the plastic vapor retarder. This allows the transmission of water vapor from the soil up and into the floor framing. The plastic vapor retarder should be removed from the pier so that it covers the entire surface of the soil only.

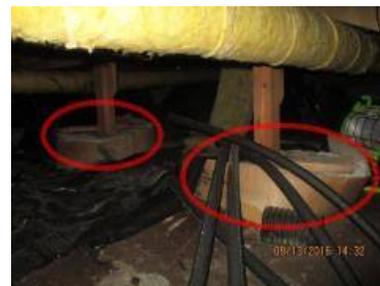
Scrap-wood and other cellulose debris was observed on the crawl floor. This wood debris creates conducive conditions for wood boring insects. The removal of all cellulose debris is recommended.

Cellulose forms were left in place on the pier footings. This cellulose is conducive to the infestation of various wood destroying organisms. The removal of the cellulose is recommended.
