NOTICE TO BUYER: SELLER-PROCURED INSPECTION REPORT

17207 NE 141st St

Redmond WA 98052

At your request, a visual inspection of the above referenced property was conducted on September 22, 2016. We have inspected the major structural components, plumbing, heating and electrical systems for signs of significant non-performance, excessive or unusual wear and general state of repair.

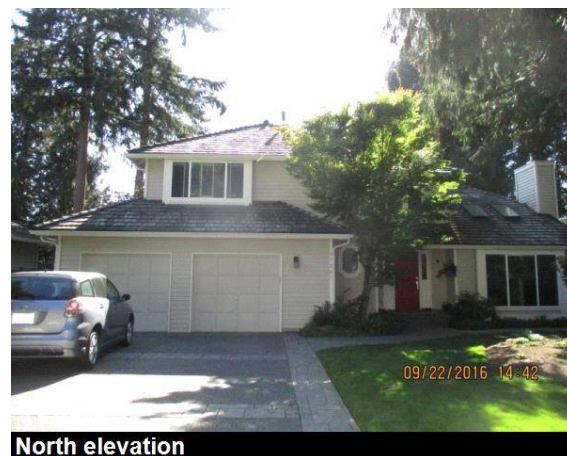
North elevation

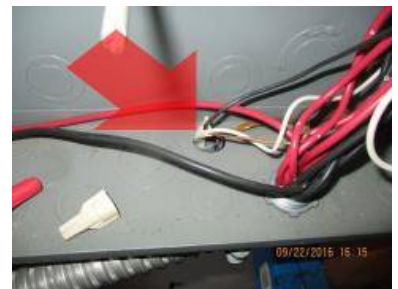
There is an electrical cable emanating from the service panel that is not clamped. The sharp edge of the panel box could cut through the wire insulation and cause a short circuit or fire. Clamping the cable to the panel box using an approved cable clamp is recommended.

The circuits are labeled. The accuracy of the labeling was not verified. Do not assume the labeled circuit is off unless it has been checked with a voltage tester.
