**NOTICE TO BUYER: SELLER-PROCURED INSPECTION REPORT**

Dean and Courtney Russell  
13820 176<sup>th</sup> PI NE, Redmond WA 98052

May 5, 2017

**Re: 13820 176th Pl. NE**  
**Redmond, WA.**

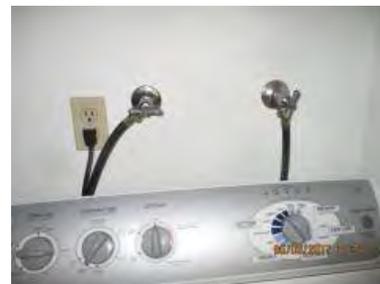
The hookups for the dryer are properly installed and in serviceable condition. The dryer itself was operated through a partial cycle, however we did not confirm the complete operation of the cycle timer.

Upgrading the washer connections to high pressure (steel braided) lines is recommended.
