**NOTICE TO BUYER: SELLER-PROCURED INSPECTION REPORT**

The following notice is given with respect to the Purchase and Sale Agreement dated \_\_\_\_\_  
between \_\_\_\_\_ (“Buyer”)  
and Estate of Wilhelmina Zent, Sarah R. Johnson as Personal Representative (“Seller”)  
concerning 14130 174th PINE, Redmond WA 98052 (“the Property”).

At your request, a visual inspection of the above referenced property was conducted on 05/24/2017. We have inspected the major structural components, plumbing, heating and electrical systems for signs of significant non-performance, excessive or unusual wear and general state of repair.

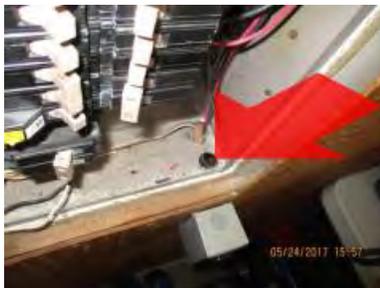
There are openings in the panel where knock-outs have been removed.

There are openings in the panel box where knock-outs have been removed. Missing knock-outs should be replaced with snap in metal plugs.

Missing knock outs have been replaced with snap metal plugs

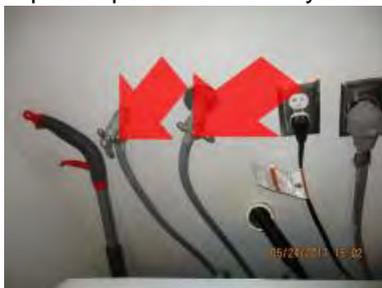
The hookups for the dryer are properly installed and in serviceable condition. The dryer itself was operated through a partial cycle, however we did not confirm the complete operation of the cycle timer.

Upgrading the washer connections to high pressure (steel braided) lines is recommended.

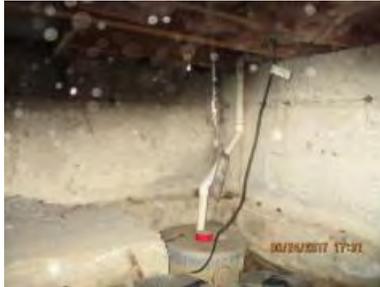
A sump pump has been installed to remove incoming ground water. The sump pump was tested and was operational.
