**NOTICE TO BUYER: SELLER-PROCURED INSPECTION REPORT**

17626 NE 129th Place Redmond, WA 98052

April 28, 2017

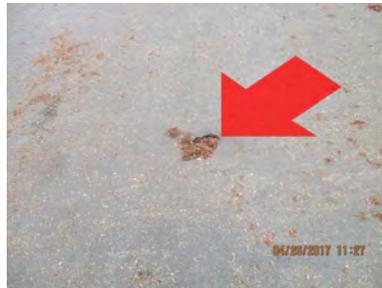
2.

3. Cracks were observed in the concrete surface of the walkway. Minor cracks can be sealed to minimize moisture entry and further settlement of the concrete.

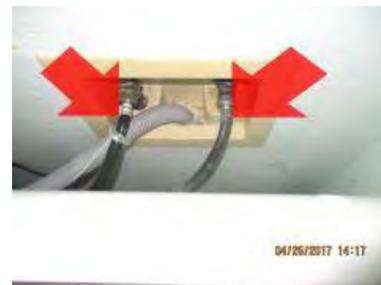
Upgrading the washer connections to high pressure (steel braided) lines is recommended.

The hookups for the dryer are properly installed and in serviceable condition. The dryer itself was operated through a partial cycle, however we did not confirm the complete operation of the cycle timer.
