NOTICE TO BUYER: SELLER-PROCURED INSPECTION REPORT

17630 NE 128th Pl, Redmond WA 98052

April 20, 2017

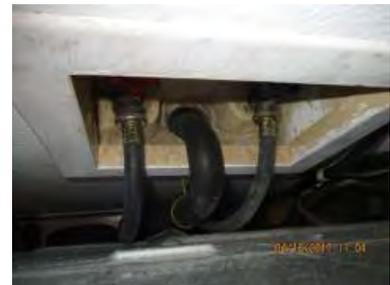
The hookups for the dryer are properly installed and in serviceable condition. The dryer itself was operated through a partial cycle, however we did not confirm the complete operation of the cycle timer.

Upgrading the washer connections to high pressure (steel braided) lines is recommended.
