NOTICE TO BUYER: SELLER-PROCURED INSPECTION REPORT

2818 220th Place NE Sammamish, WA 98074

May 5, 2017

**Re: 2818 220th Pl. NE
Sammamish, .**

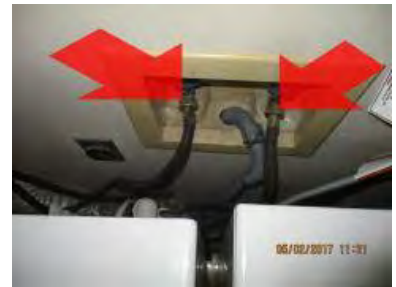
Upgrading the washer connections to high pressure (steel braided) lines is recommended.

The hookups for the dryer are properly installed and in serviceable condition. The dryer itself was operated through a partial cycle, however we did not confirm the complete operation of the cycle timer.

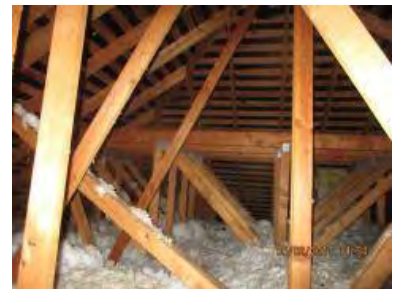
19.9 ROOF STRUCTURE

The roof structure is constructed from a combination of factory-built, engineered trusses and site cut and assembled dimensional lumber. The roof structure is constructed in a manner consistent with buildings of this type and is performing its intended function. No defects or deficiencies were observed.
