NOTICE TO BUYER: SELLER-PROCURED INSPECTION REPORT

July 25, 2017

Re: 7541 123rd Ave. NE
Kirkland, WA.

REPORT SUMMARY

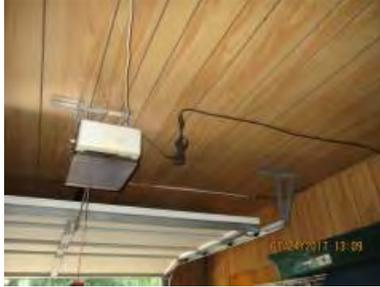
An extension cord is used as a temporary power source for the garage door opener. An extension cord is not suitable as a permanent wiring method. The installation of a receptacle within cords length of the motor is recommended.

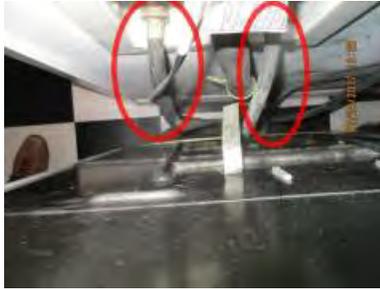
The hookups for the dryer are properly installed and in serviceable condition. The dryer itself was operated through a partial cycle, however we did not confirm the complete operation of the cycle timer.
