NOTICE TO BUYER: SELLER-PROCURED INSPECTION REPORT

James and Amanda Records
8836 NE 138th St.
Kirkland WA 98034

At your request, a visual inspection of the above referenced property was conducted on 09/08/2017. We have inspected the major structural components, plumbing, heating and electrical systems for signs of significant non-performance, excessive or unusual wear and general state of repair.

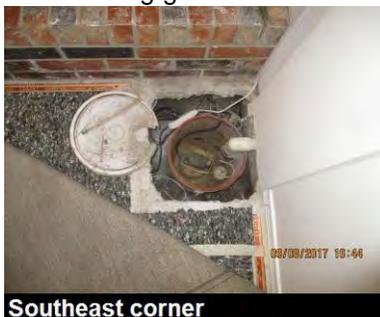
Southeast corner

A sump pump has been installed to remove incoming ground water. The sump pump was tested and was operational.
