NOTICE TO BUYER: SELLER-PROCURED INSPECTION REPORT

Hank and Constance Bynaker
17522 NE 136th St
Redmond, WA 98052

At your request, a visual inspection of the above referenced property was conducted on 10/23/2017. We have inspected the major structural components, plumbing, heating and electrical systems for signs of significant non-performance, excessive or unusual wear and general state of repair.

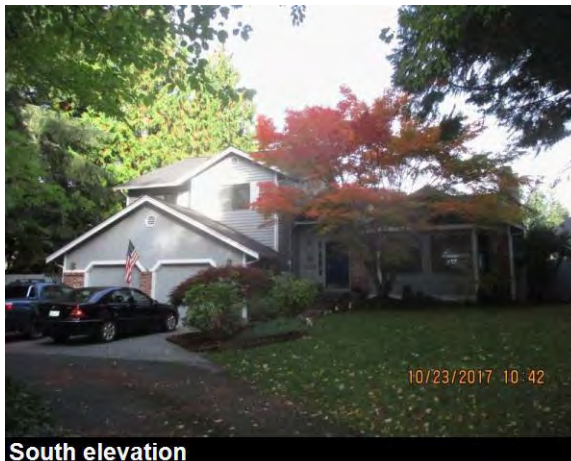
South elevation

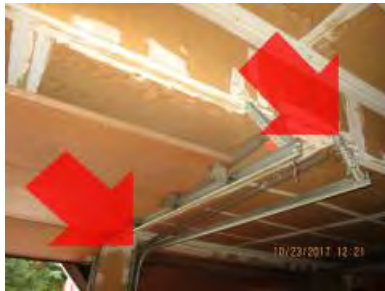
Safeties are cables run through the center of the garage door springs that prevent broken springs from becoming projectiles that can cause injury. There are no safeties installed. The installation of safeties is recommended.

There are no automatic garage door openers. The doors must be opened manually.

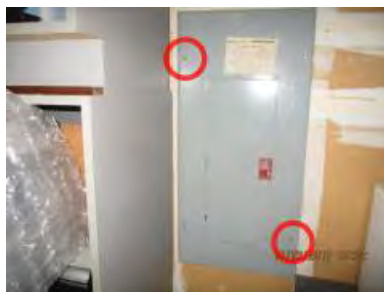
Screws that secure the panel cover to the panel box are missing. This is a potential hazard. Missing screws should be replaced with the original style blunt end screws.

The circuits are labeled. The accuracy of the labeling was not verified. Do not assume the labeled circuit is off unless it has been checked with a voltage tester.

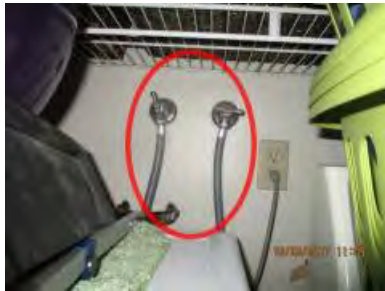
Upgrading the washer connections to high pressure (steel braided) lines is recommended.

The hookups for the dryer are properly installed and in serviceable condition. The dryer itself was operated through a partial cycle, however we did not confirm the complete operation of the cycle timer.
